**MINERALS PROGRAM INSPECTION REPORT**  
**PHONE: (303) 866-3567**

| <b>MINE NAME:</b><br>Allison Gravel Pit | <b>MINE/PROSPECTING ID#:</b><br>M-2001-010 | <b>MINERAL:</b><br>Gravel | <b>COUNTY:</b><br>Elbert |
| <b>INSPECTION TYPE:</b><br>Monitoring | <b>INSPECTOR(S):</b><br>Amy Eschberger | <b>INSP. DATE:</b><br>February 17, 2016 | <b>INSP. TIME:</b><br>12:30 |

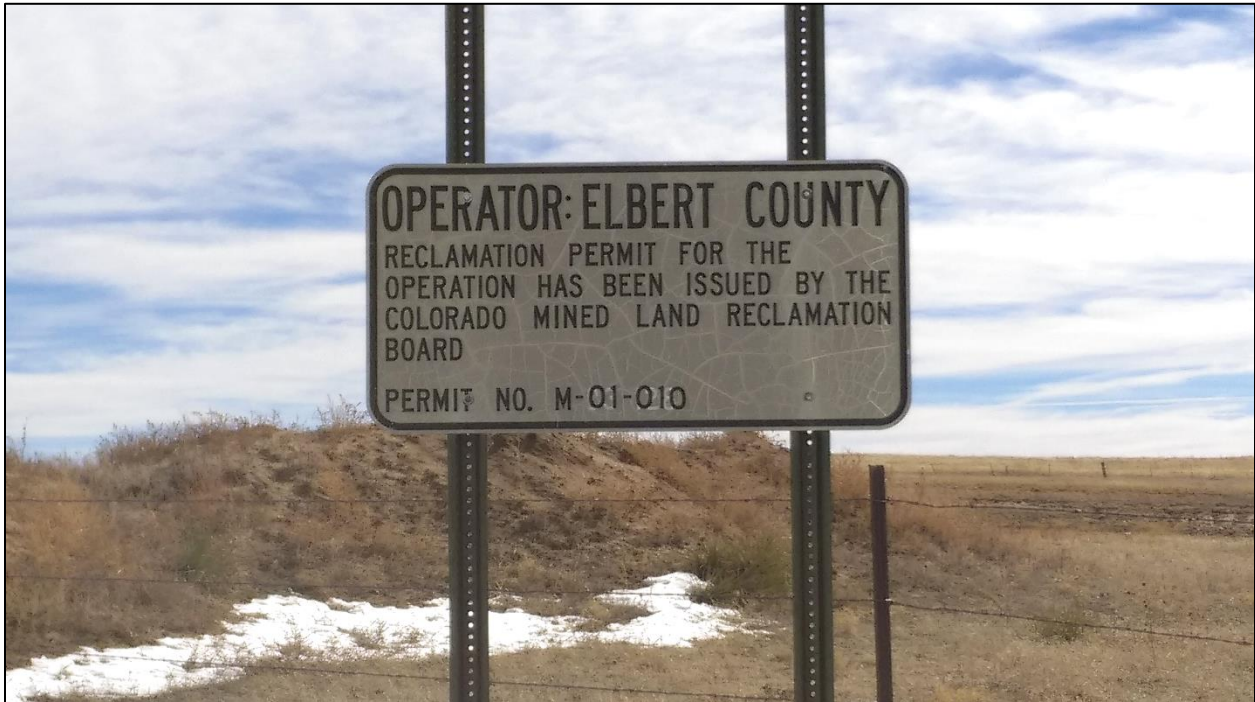
At the time of the inspection, it was partly cloudy and windy with some snow cover remaining. A proper permit sign was posted at the main entrance to the site off of Co Rd 149 (**Photo 1**). The affected land boundary was delineated with wooden stakes. The site was not active during the inspection, and no equipment was present on site. However, according to Mr. Dole (and as reported in annual reports), mining activity occurs at the site every year (e.g., extraction, hauling off from stockpiled material), which is compliant with its intermittent status. Approximately 6.4 acres of disturbed land (mining phase A), located south of the haul road and west of the active pit, has been reclaimed (**Photos 2 and 3**). All disturbed slopes in the reclaimed area were graded to 3H:1V or flatter, and the land was retopsoiled and revegetated with native grasses. The Division observed mainly blue grama and sideoats grama, with some switchgrass growing in the reclaimed area.

**Photo 1.** View of permit sign posted at main site entrance off of Co Rd 149.

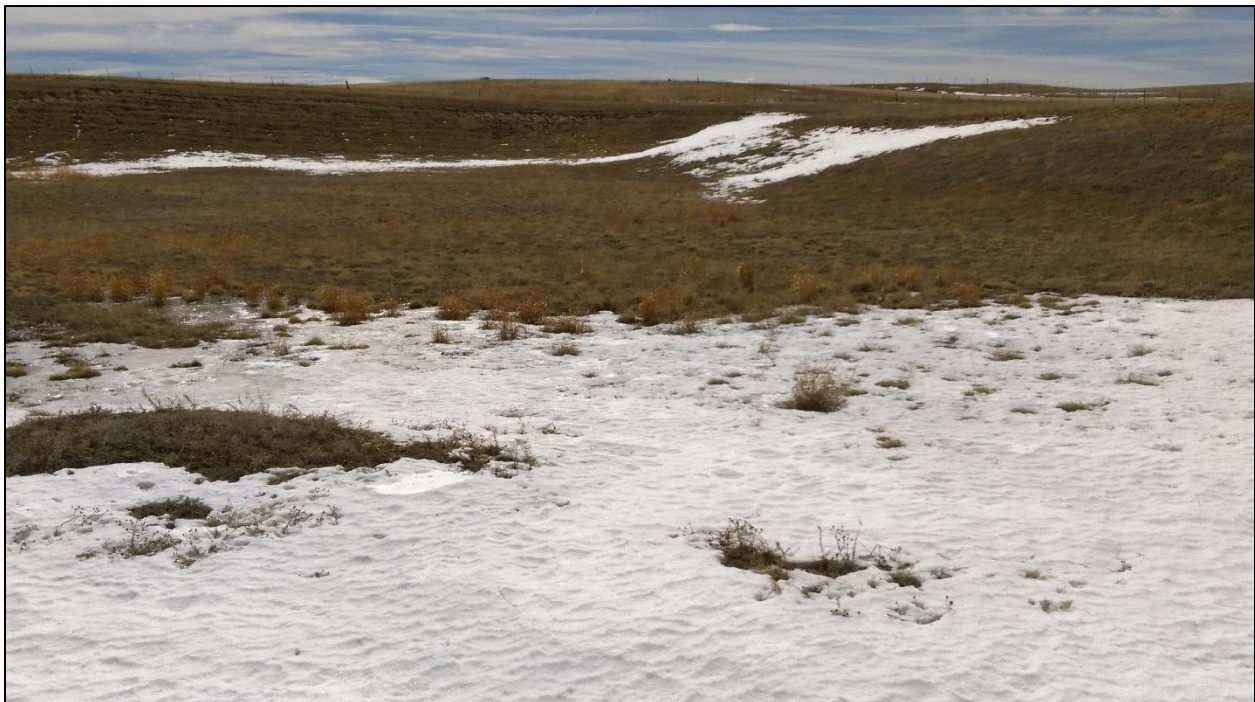
**Photo 2.** View of western portion of reclaimed area located south of main haul road and west of active pit. Note slopes graded 3H:1V or flatter, and native grasses established across area.

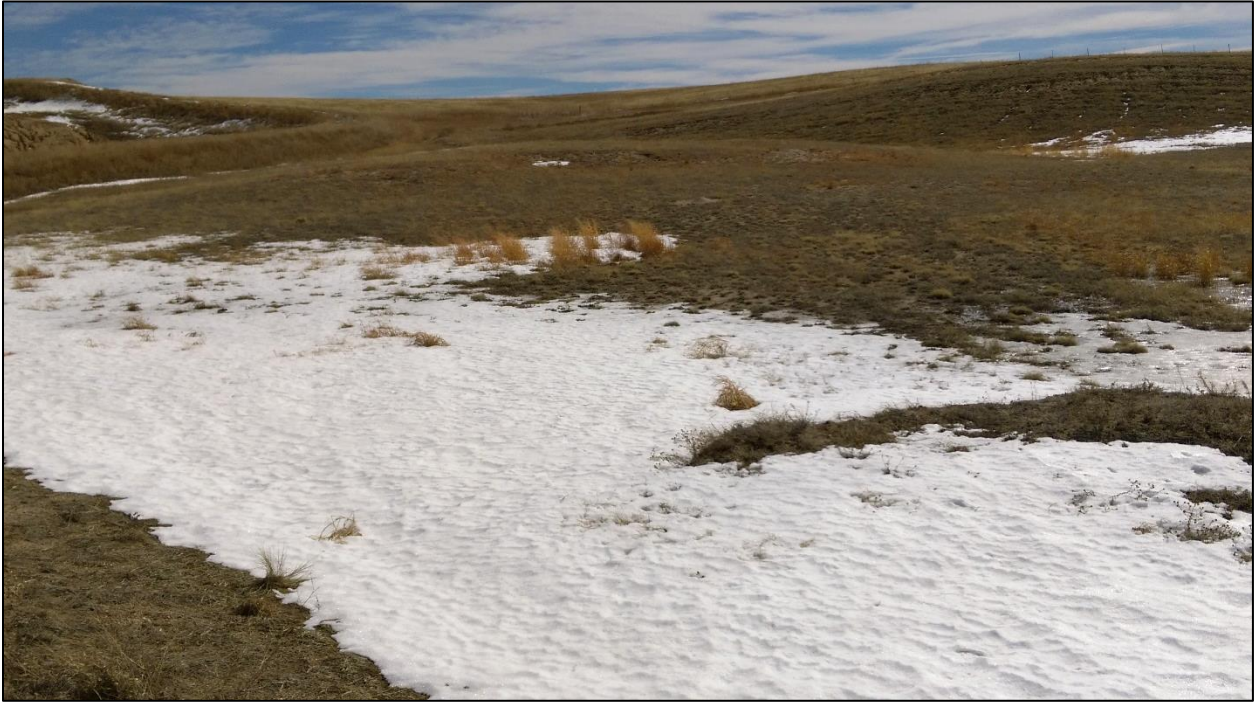
**Photo 3.** View of eastern portion of reclaimed area located south of main haul road and west of active pit. Note slopes graded 3H:1V or flatter, and native grasses established across area.

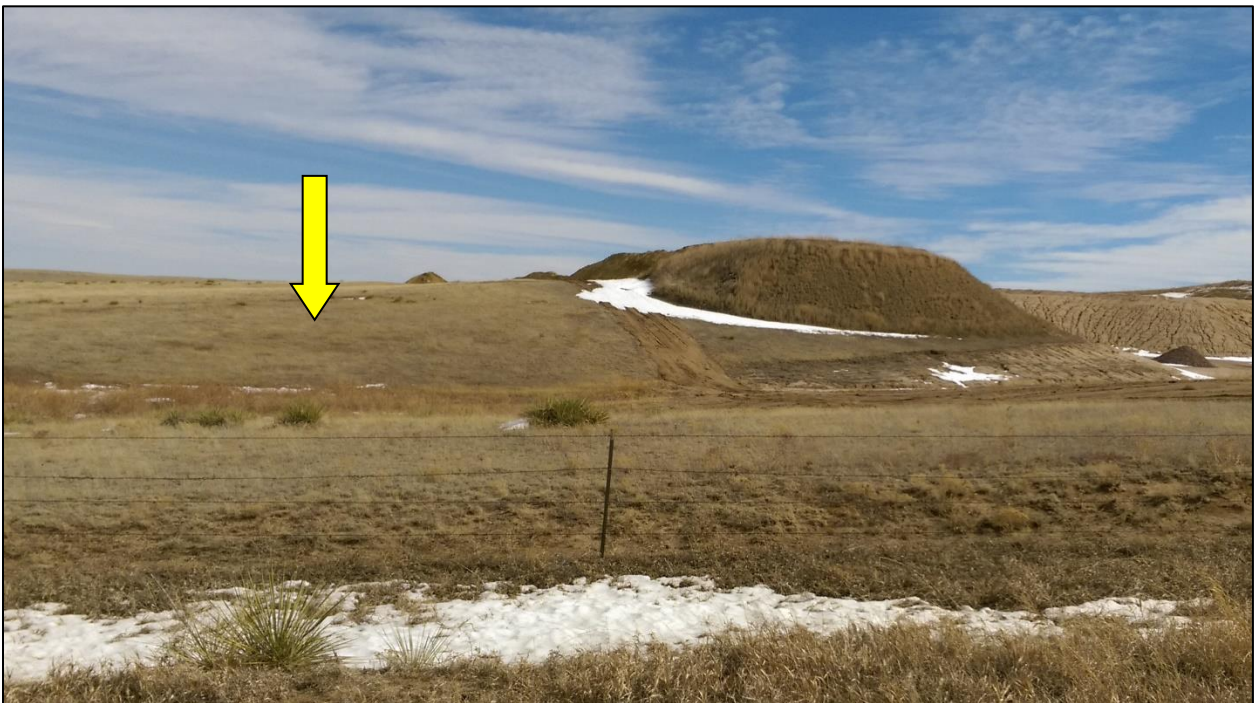
The operation also reclaimed approximately 1.2 acres located north of the haul road, and west of the active pit (**Photo 4**). A portion of this disturbed area had included a stormwater structure that was constructed in the drainage located west of the current active pit. The Division cited a problem in the inspection report for 09/27/2010, because the drainage structure was improperly impounding surface runoff. The problem was considered abated on 12/8/2010 when the Division received a response from the operator indicating the impoundment had been drained in a controlled manner, and the berm was modified to allow surface water to

pass. Since that time, active mining has proceeded eastward, thus the drainage structure has been removed and the area reclaimed.

**Photo 4.** View of portion of reclaimed area (indicated) located north of main haul road and west of active pit. Note topsoil stockpile at right.

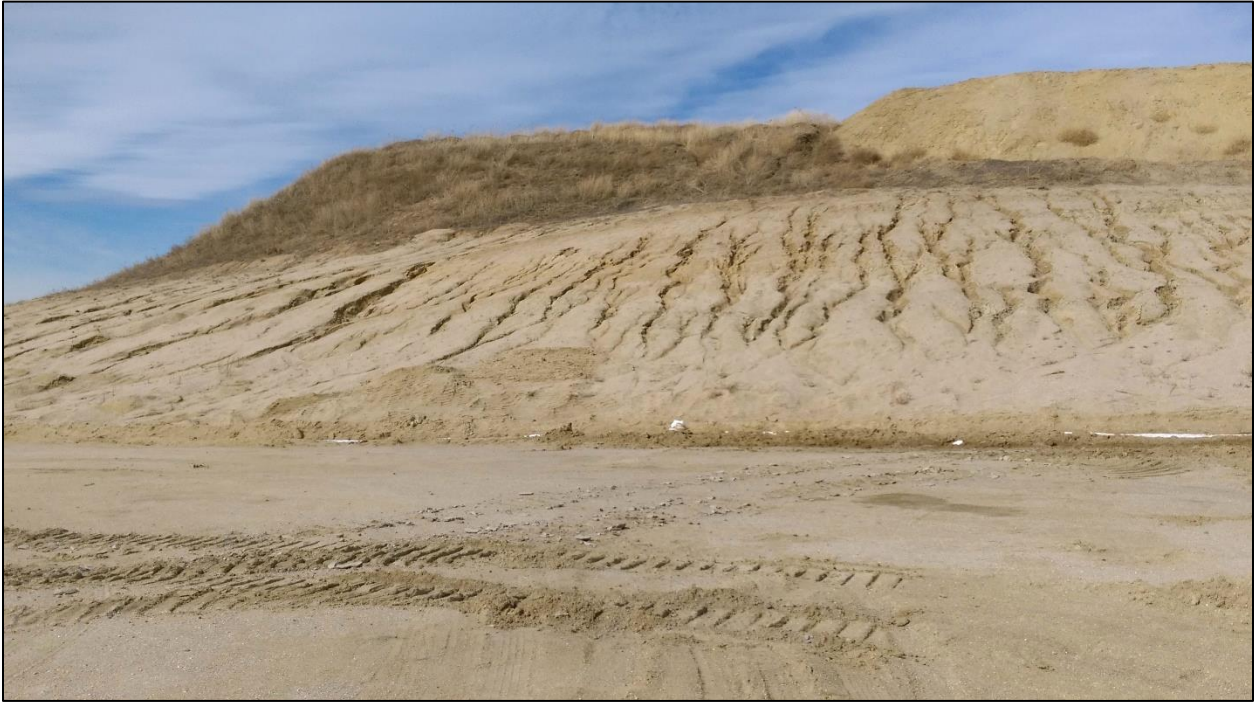
The active pit is located primarily in mining phases B and C. The operation has excavated approximately 40-50 feet deep into the hillside. The highwalls are being maintained at slope gradients of approximately 3H:1V (**Photos 5-8**). The southern pit wall has been reclaimed, and appears to be stable with native grasses and some annual weeds established across the slope (**Photos 9 and 10**). However, the active pit walls showed signs of erosional damage with abundant rilling and some minor gullies beginning to form (see Photos 5-8). Pursuant to Rule 3.1.6(3), all surfaces of the affected land, including spoil piles, shall be stabilized and protected so as to effectively control erosion. Therefore, the Division recommends the operator repair the erosion damage and work to protect the stability of mined slopes throughout the operation. Any slopes that will not be redisturbed by the operation should be retopsoiled and revegetated as soon as possible.

**Photo 5.** View of western portion of northern pit wall, showing slope gradients of approximately 3H:1V. Note presence of erosional rilling along slope.

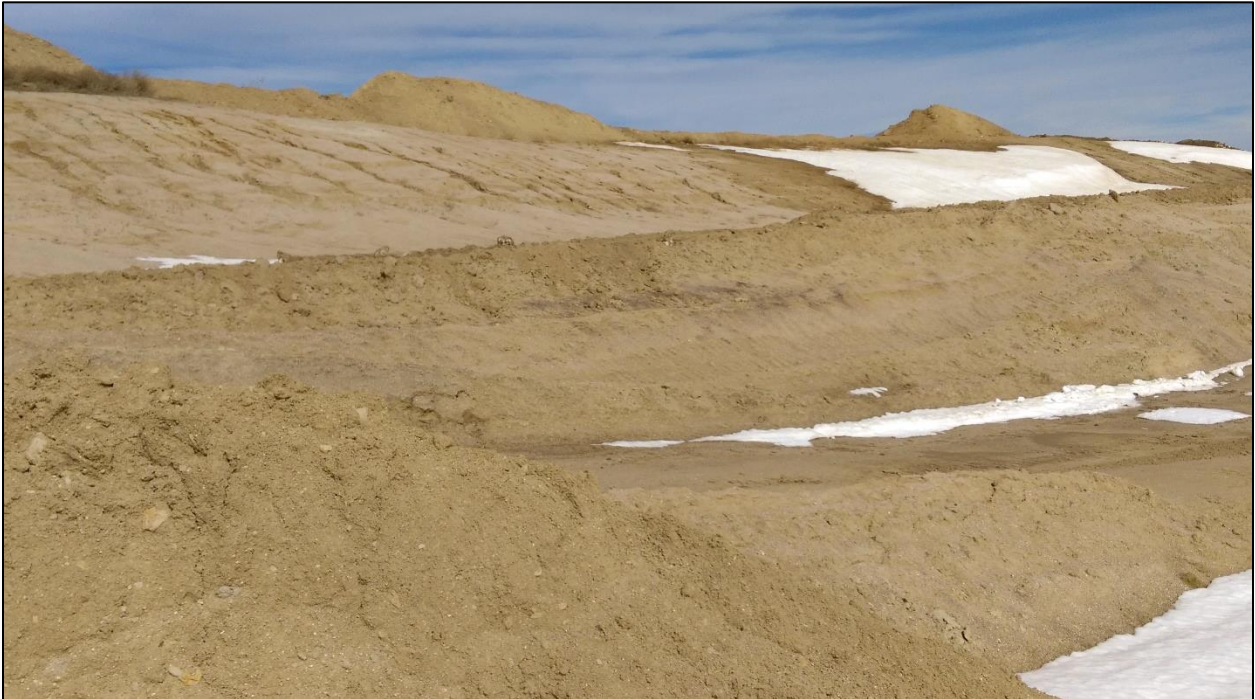
**Photo 6.** View of eastern portion of northern pit wall, showing slope gradients of approximately 3H:1V. Note presence of erosional rilling along top of slope.

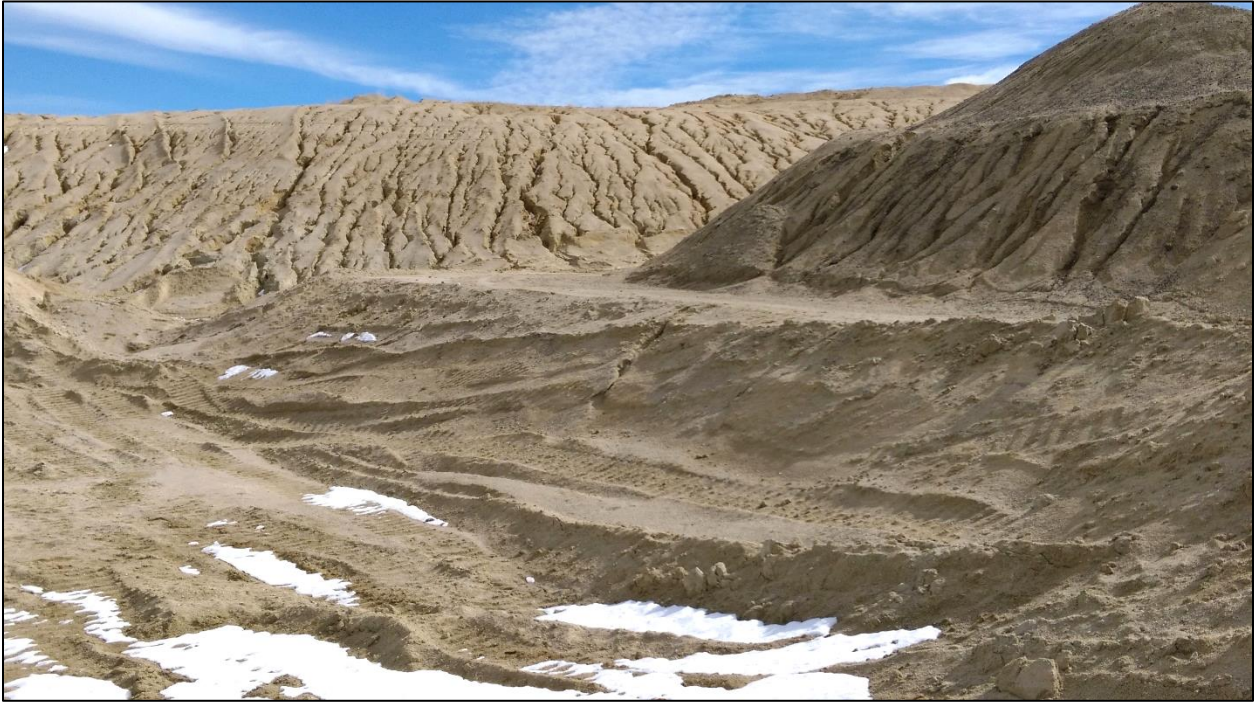
**Photo 7.** View of northern portion of eastern pit wall, showing slope gradients of approximately 3H:1V. Note presence of erosional rilling and some small gullies forming along top of slope.

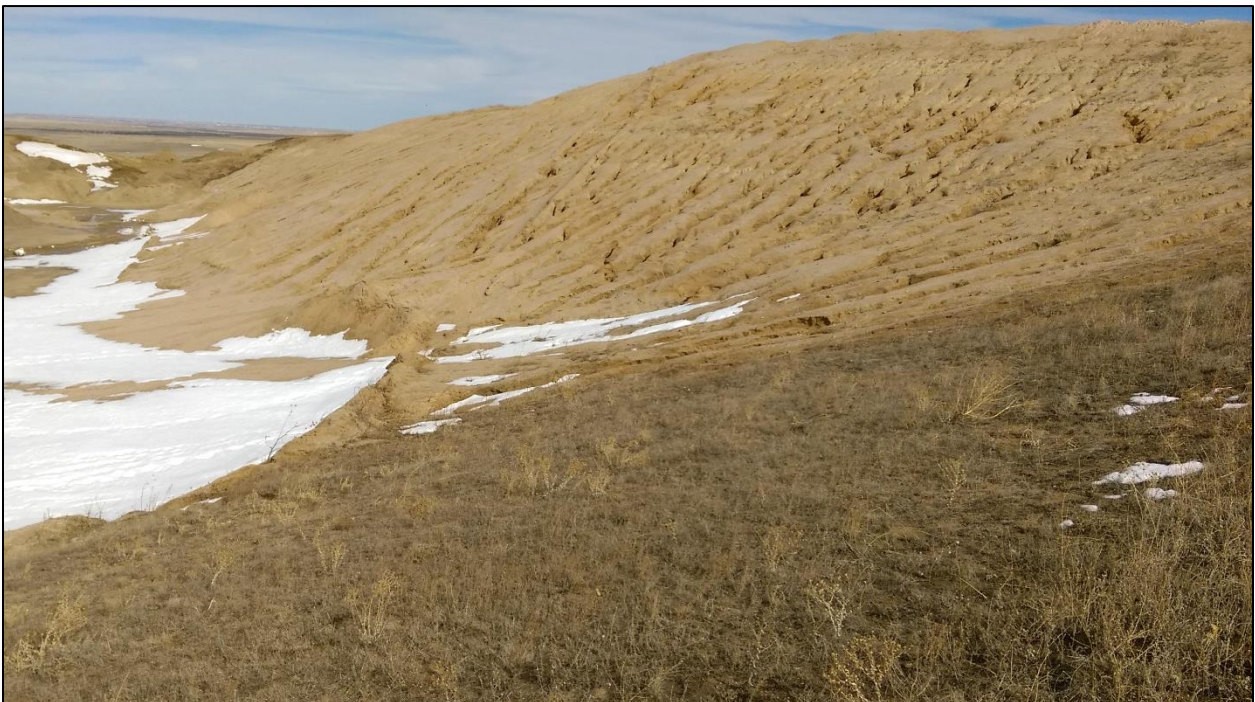
**Photo 8.** View of southern portion of eastern pit wall, showing slope gradients of approximately 3H:1V. Note presence of erosional rilling along slope. Portion of reclaimed southern wall shown in foreground.

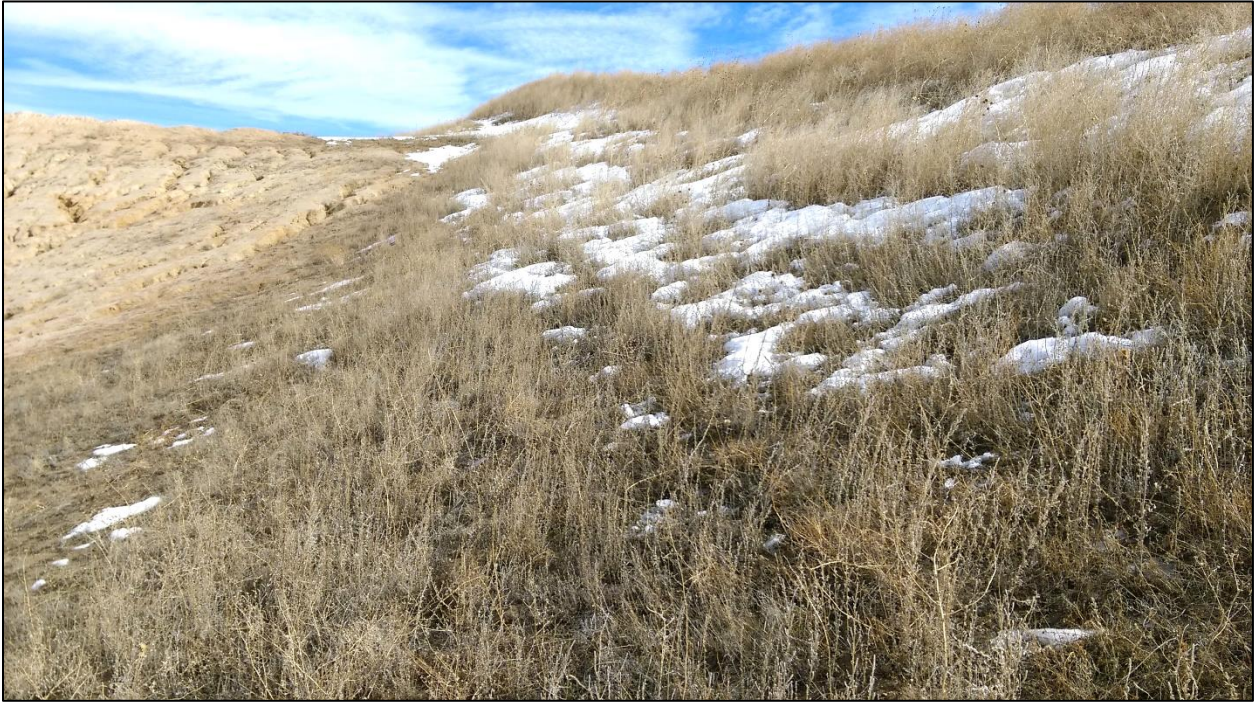
**Photo 9.** View of eastern portion of reclaimed southern pit wall, showing 3H:1V or flatter slope gradient and established native grasses with some annual weeds.

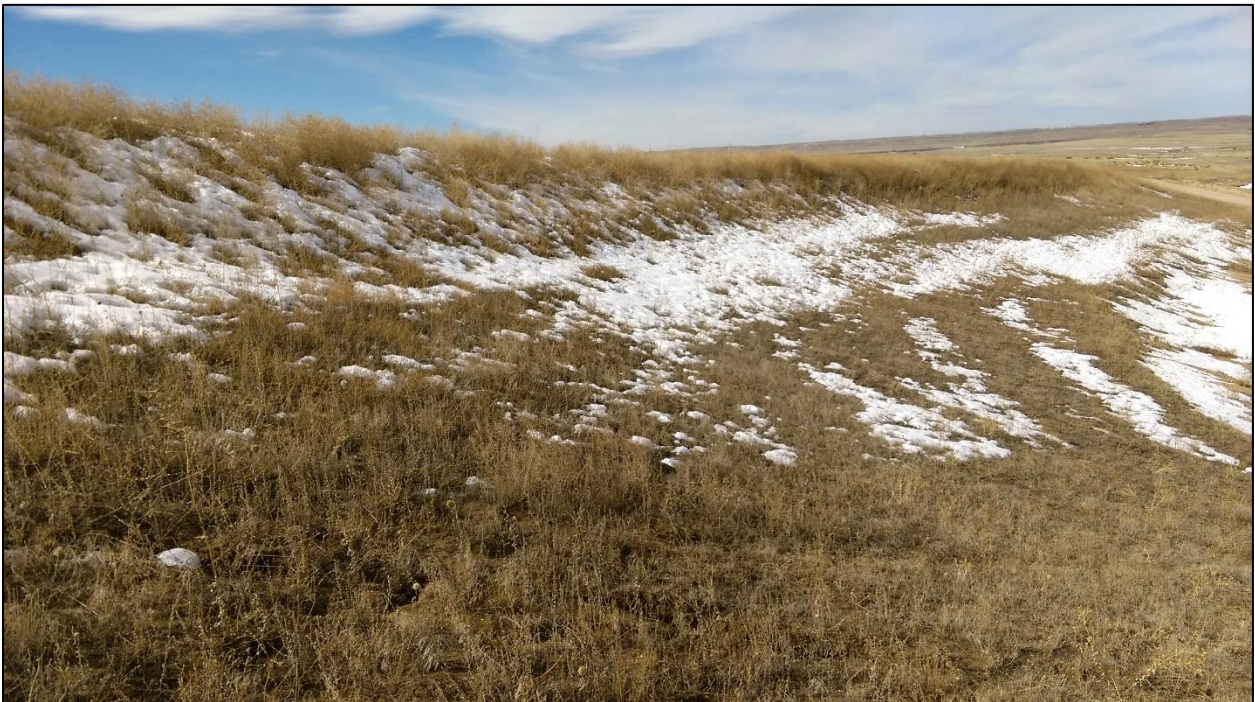
**Photo 10.** View of western portion of reclaimed southern pit wall, showing 3H:1V or flatter slope gradient and established native grasses with some annual weeds.

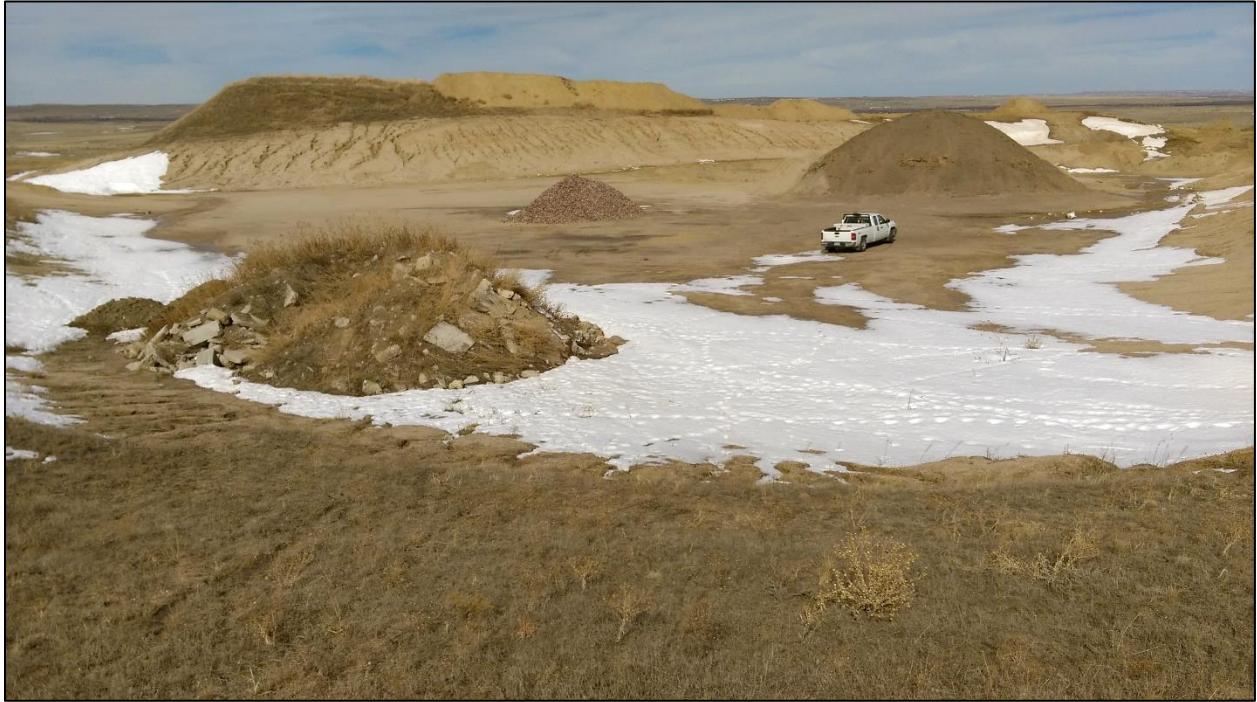
The operation stores mined material and recycled asphalt on the pit floor (**Photo 11**). Salvaged topsoil is stockpiled along the northern and southern edges of the active pit. These stockpiles appeared to be stable with good grass cover (**Photo 12**). A fresh topsoil stockpile stored north of the active pit was recently created from stripping the northeast area for construction of the drainage structure. Mr. Dole indicated this stockpile would be seeded for stabilization as soon as practical.

**Photo 11.** View looking northwest across pit from southern pit wall, showing stockpiles of mined material and recycled asphalt stored on pit floor.

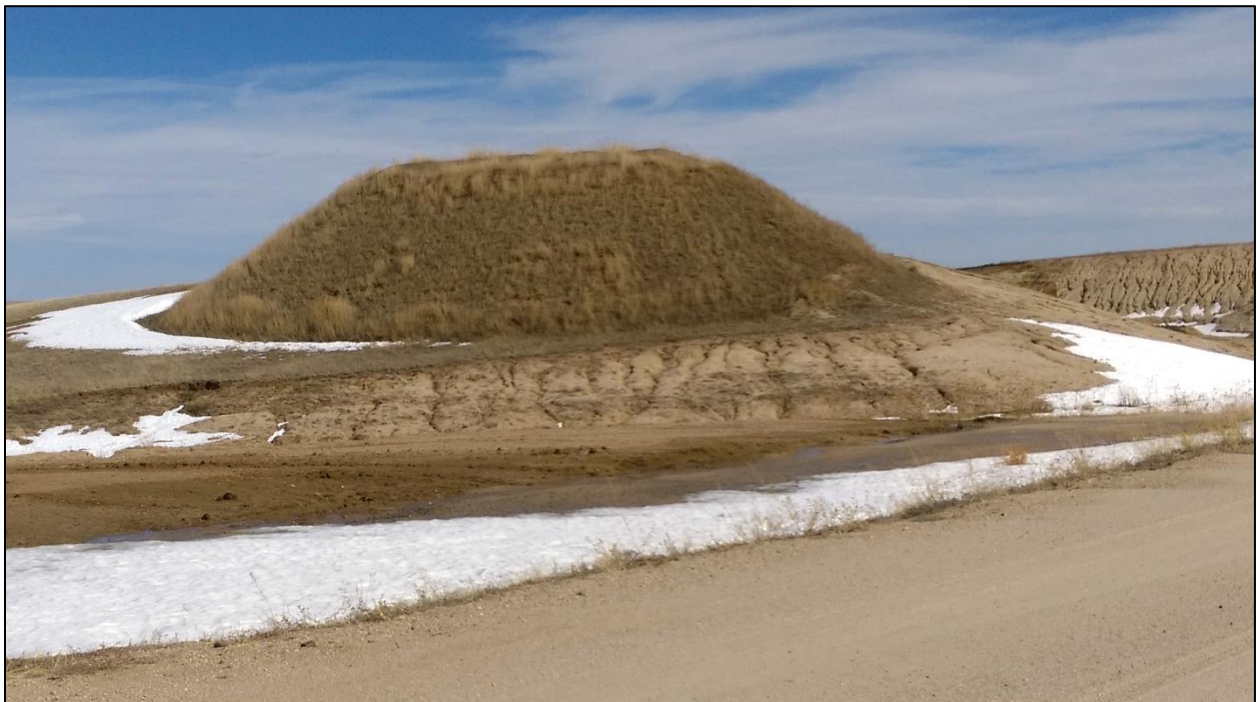
**Photo 12.** View of topsoil stockpile stored at northern edge of pit. Note stockpile is stable with vegetative cover.

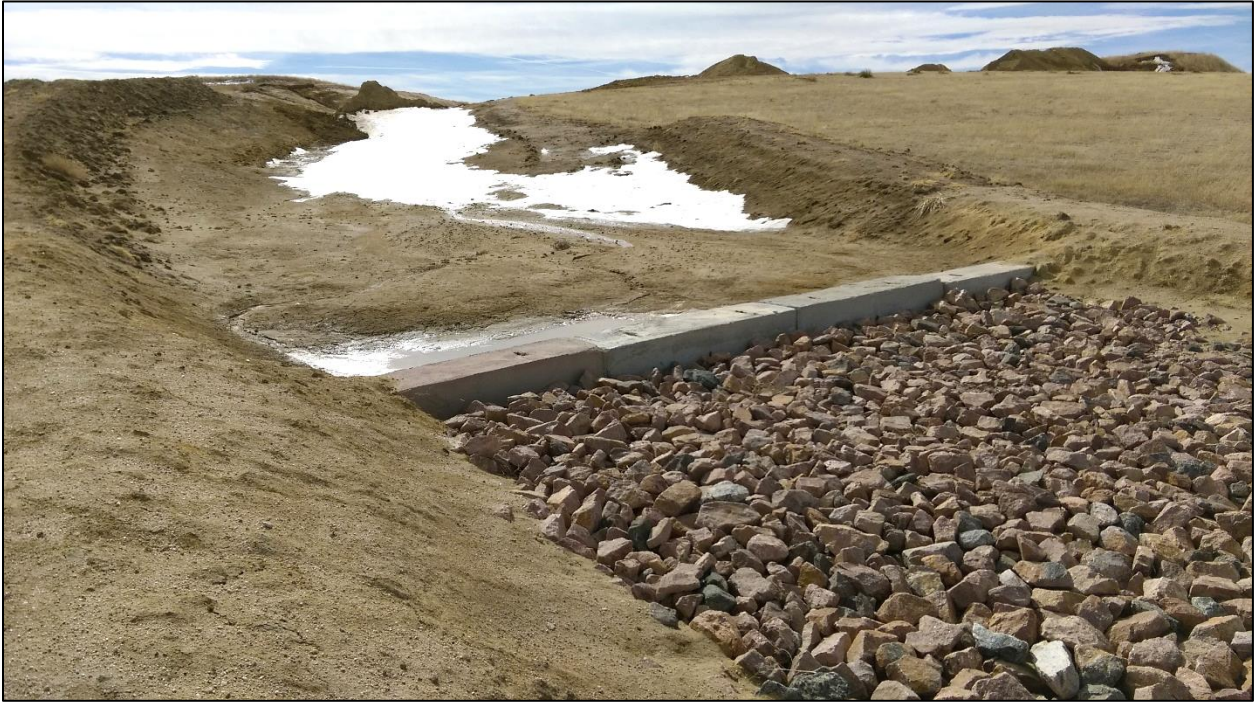
The drainage structure approved in TR-4 has been constructed to the northeast of the active pit (**Photos 13 and 14**). The structure appears to have been constructed in accordance with the approved design. The Division observed a minor amount of snowmelt water being retained in the impoundment. As the edge of the structure comes very close to the northern permit boundary, the operator should be sure that sediment does not leave the permit area. The operator should be advised the Division would consider such occurrence to be offsite damage, which would require enforcement action.

**Photo 13.** View looking southwest, showing drainage structure constructed at northeastern edge of pit, as approved in TR-4.

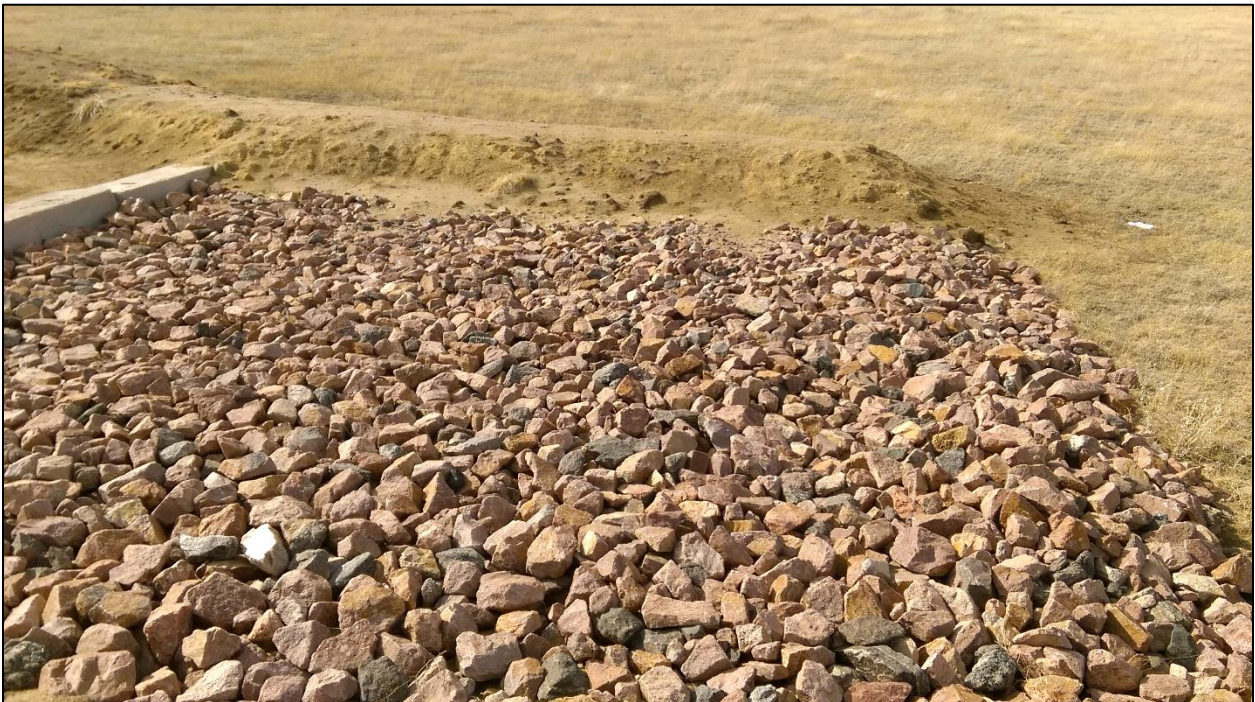
**Photo 14.** View looking west, showing rip rap portion of drainage structure constructed at northeastern edge of pit, as approved in TR-4.

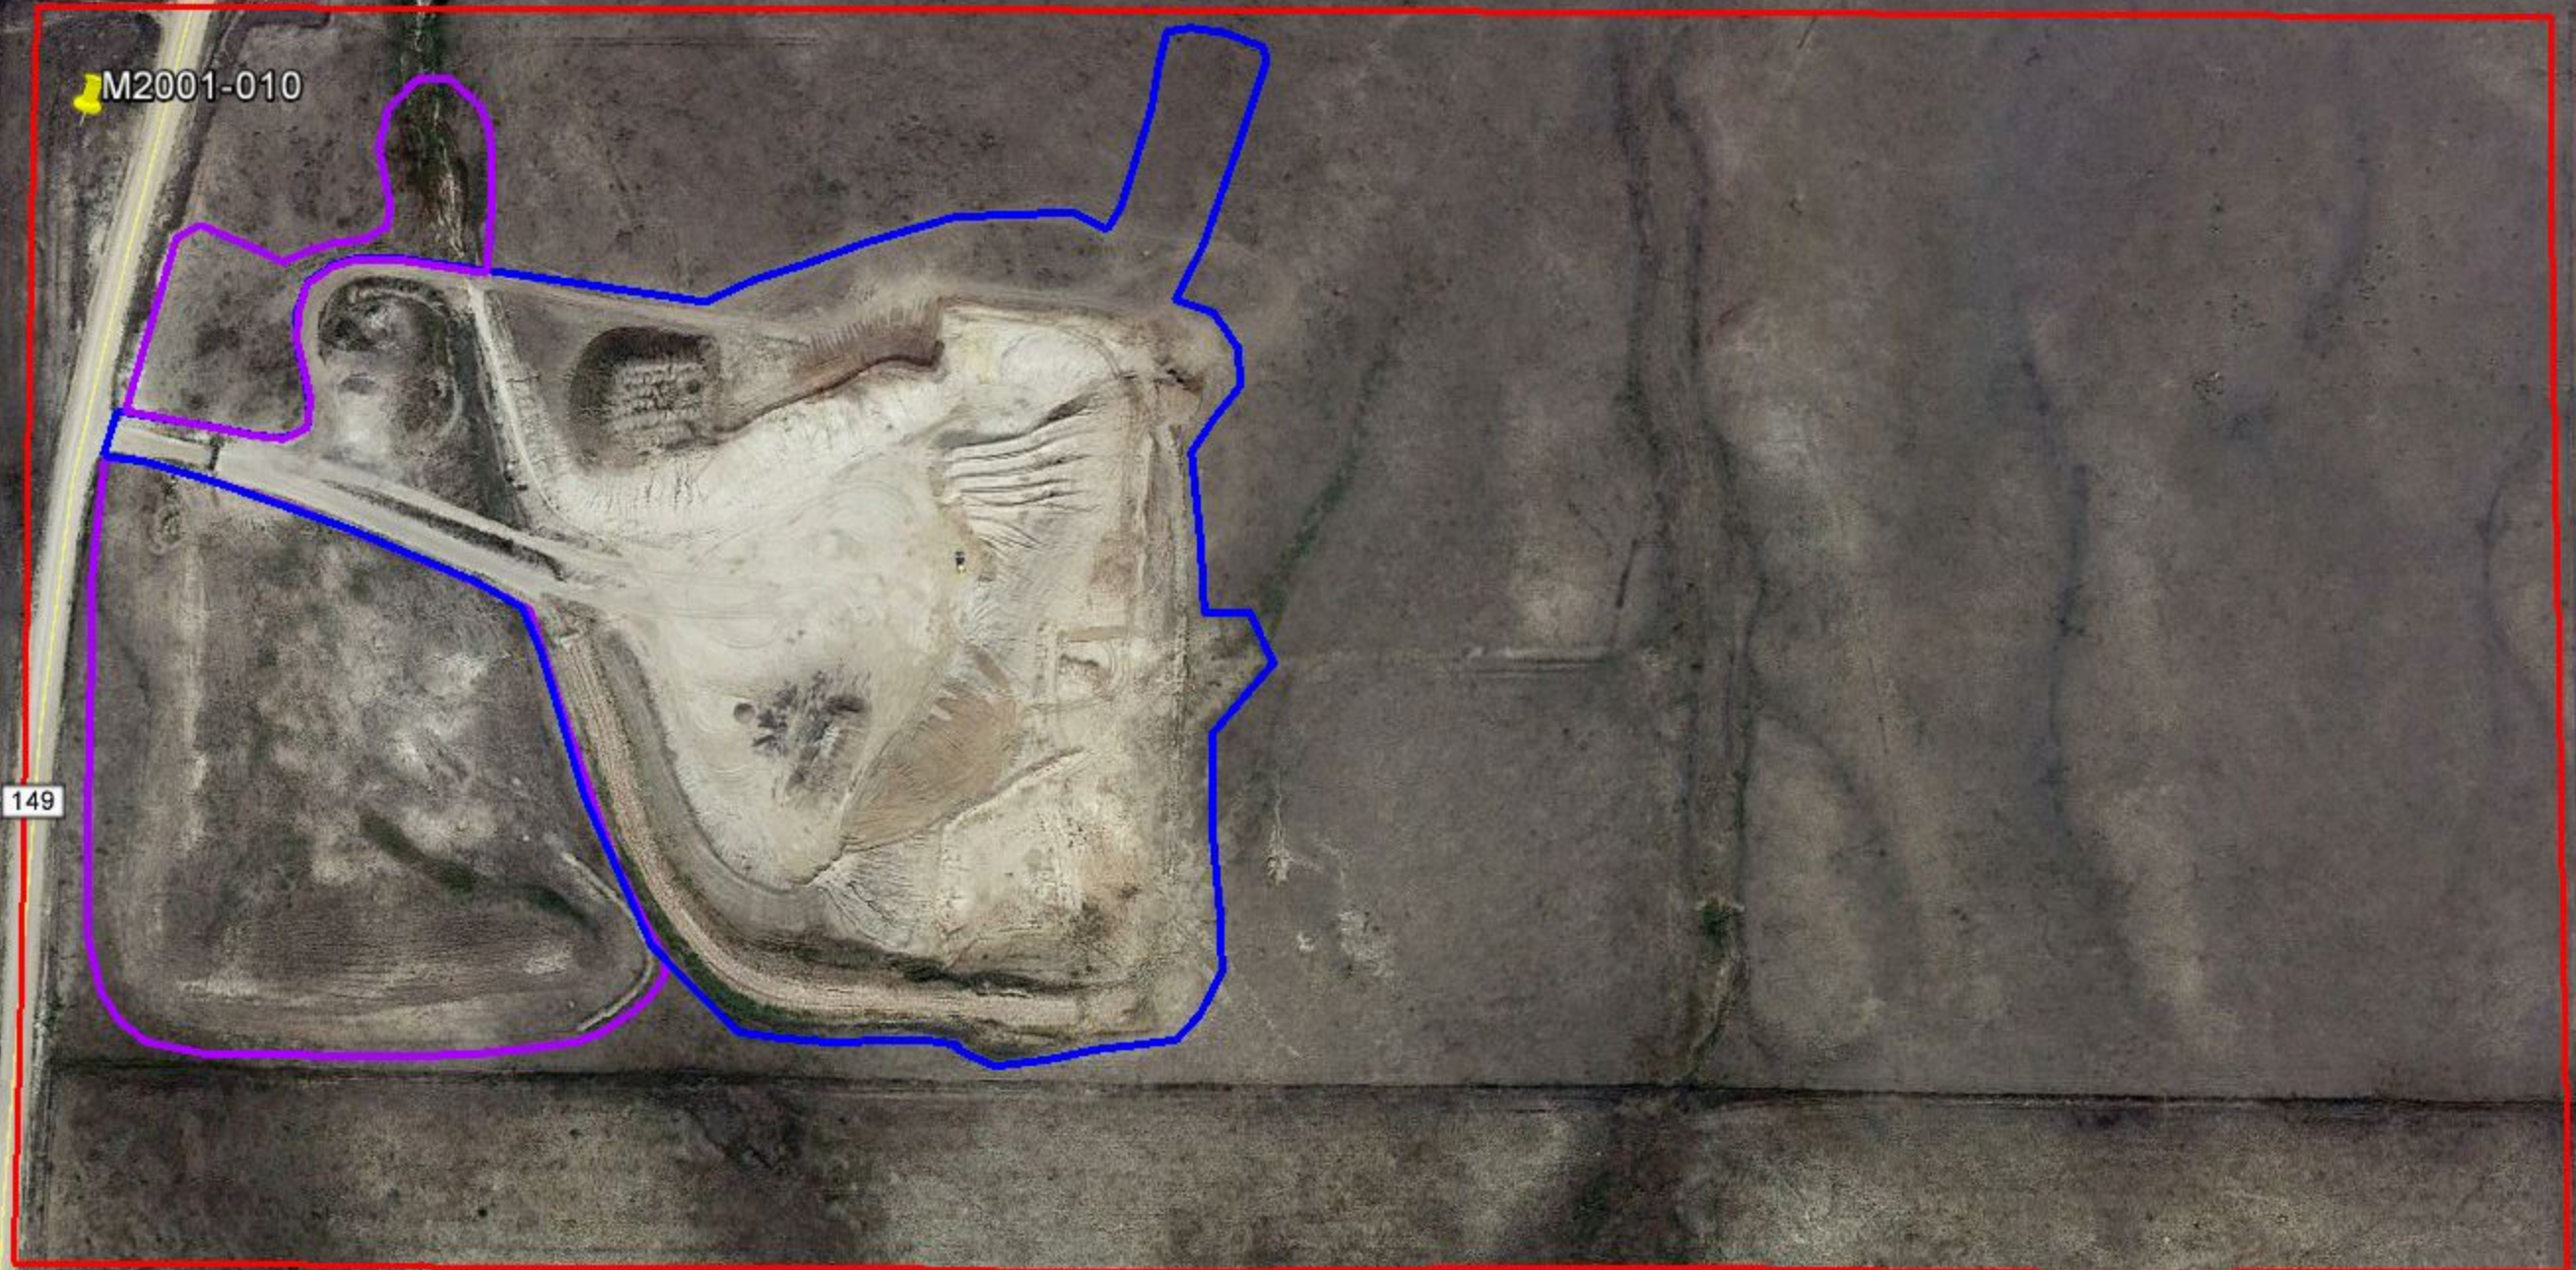
## M2001-010 / Allison Gravel Pit / Elbert County

The Division estimates the operation has disturbed a total of 22.62 acres, including the active pit area and associated drainage structure (15 acres) and the reclaimed areas located west of the active pit (7.62 acres). This amount of disturbance is compliant with the approved maximum disturbance at any time of 40 acres. The operator appears to be following the approved mining plan, including reclaiming disturbed land as the operation moves eastward.

Purple Outline = 7.62 acres = Reclaimed areas (1.22 acres N of haul road + 6.4 acres S of haul road)

Blue Outline = 15 acres = Disturbed area used in active operation (area for NE stormwater drainage approximated)
