MINERALS PROGRAM INSPECTION REPORT

MINE NAME: Dill Pit	MINE/PROSPECTING ID#: M-2009-077	MINERAL: Borrow material for construction, gravel and sand	COUNTY: Elbert
INSPECTION TYPE: Monitoring	INSPECTOR(S): Amy Eschberger	INSP. DATE: February 17, 2016	INSP. TIME: 14:00
OPERATOR: Tracy and Ed Grimes	OPERATOR REPRESENTATIVE: Ed Grimes	TYPE OF OPERATION: 110c - Construction Limited Impact	
REASON FOR INSPECTION: Normal I&E Program	BOND CALCULATION TYPE: Complete Bond	BOND AMOUNT: \$18,700.00	
DATE OF COMPLAINT: NA	POST INSP. CONTACTS: None	JOINT INSP. AGENCY: None	
WEATHER: Clear	INSPECTOR'S SIGNATURE:

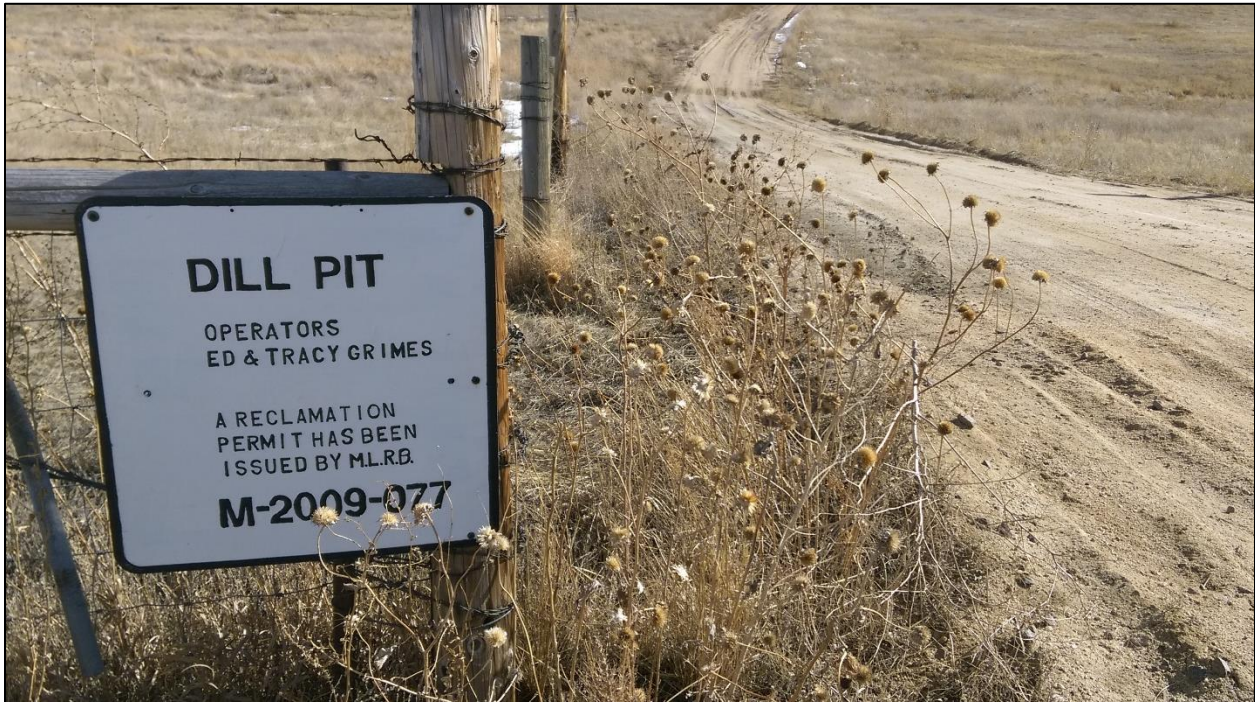
At the time of the inspection, it was partly cloudy and windy with some snow cover remaining. A proper permit sign was posted at the main site entrance off of US-24 (**Photo 1**). The permit boundary was delineated with posts. The active pit was located in the northern half of the permit area (see enclosed Google Earth image of disturbed area). Mined walls were present along the northern, western, and southern edges of the permit area, and have been graded to mostly 4H:1V or flatter (**Photos 2-5**). The edge of excavation ranges from approximately 65 to 75 feet from the edge of Co Rd 189, which is compliant with the permit condition of 39 feet. A small fresh cut, approximately 20 feet in length, was present near the southern edge of the pit, daylighting to the north (**see Photo 5**). Portions of sand stockpiles remained on the pit floor (**Photo 6**). Salvaged topsoil was bermed along the western edge of the pit above the mined wall, and appeared to be stable with vegetative cover (**Photo 7**). Two small test ditches were present south of the active pit.

Photo 1. View of permit sign posted at main site entrance off of US-24, access road to pit at right.

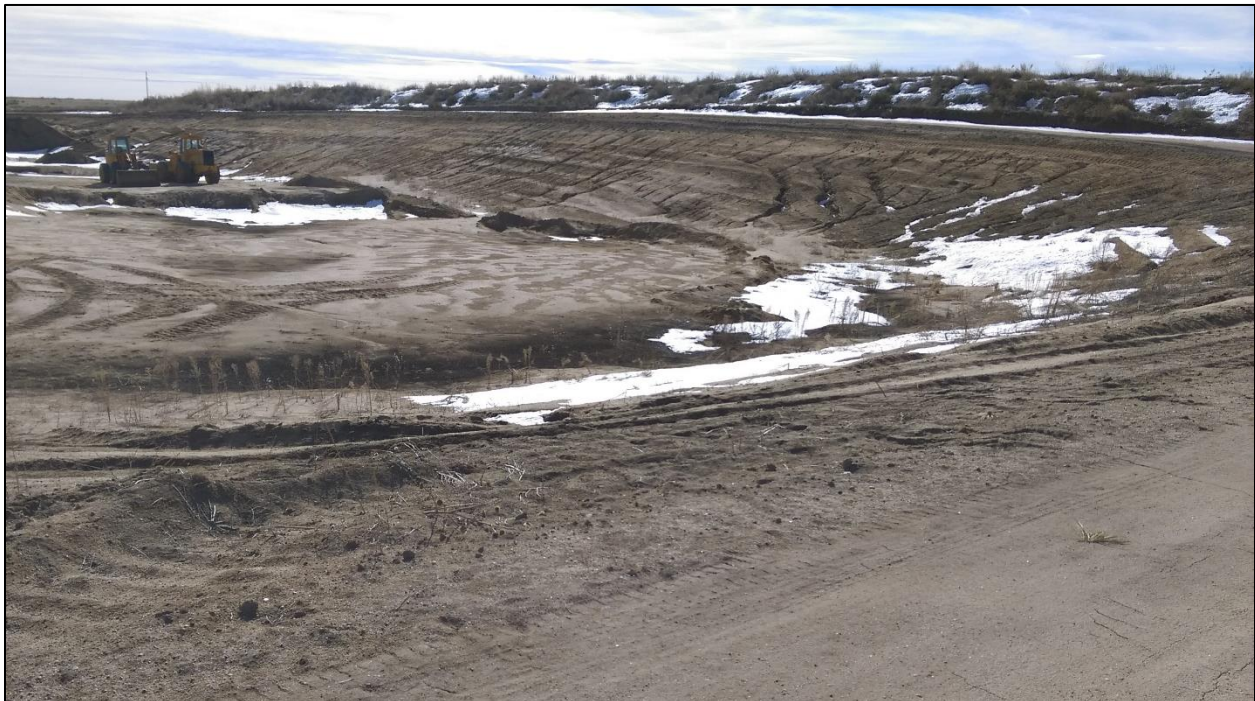
Photo 2. View looking southwest from northern edge of active pit, showing western mined wall graded to approximately 4H:1V slope. Note topsoil bermed along top of mined wall.

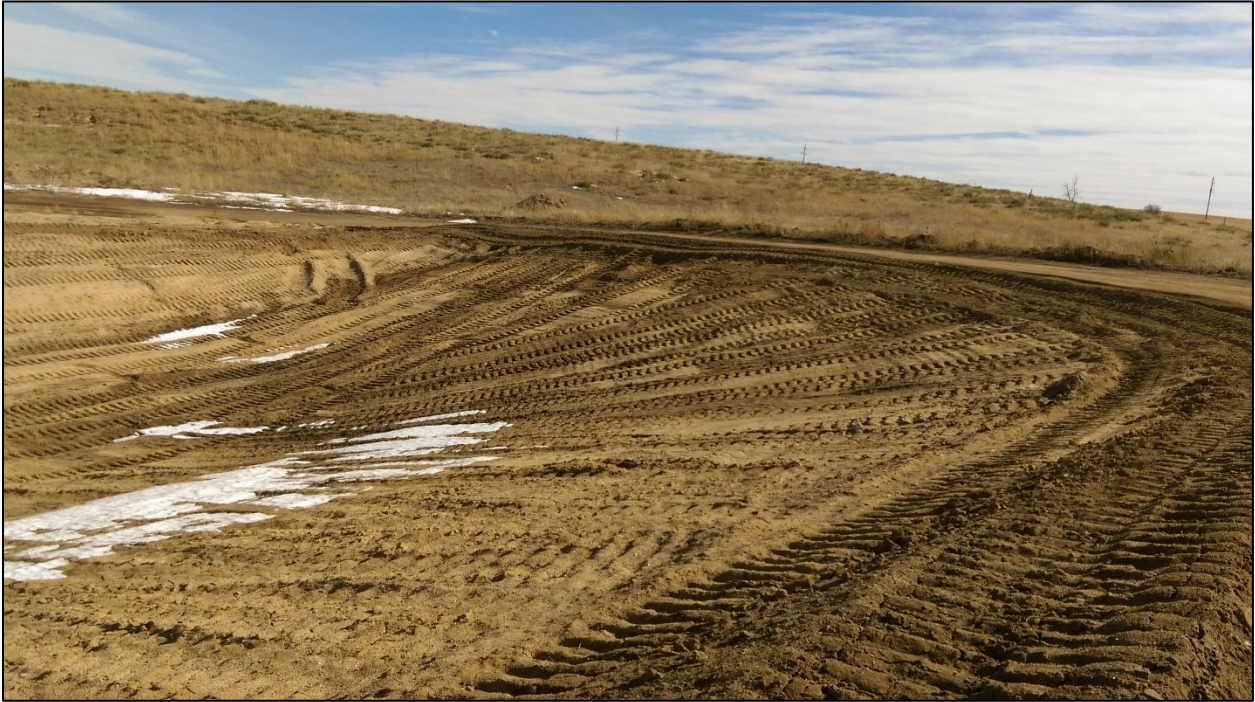
Photo 3. View looking southeast from western edge of active pit, showing southern mined wall graded to approximately 4H:1V slope.

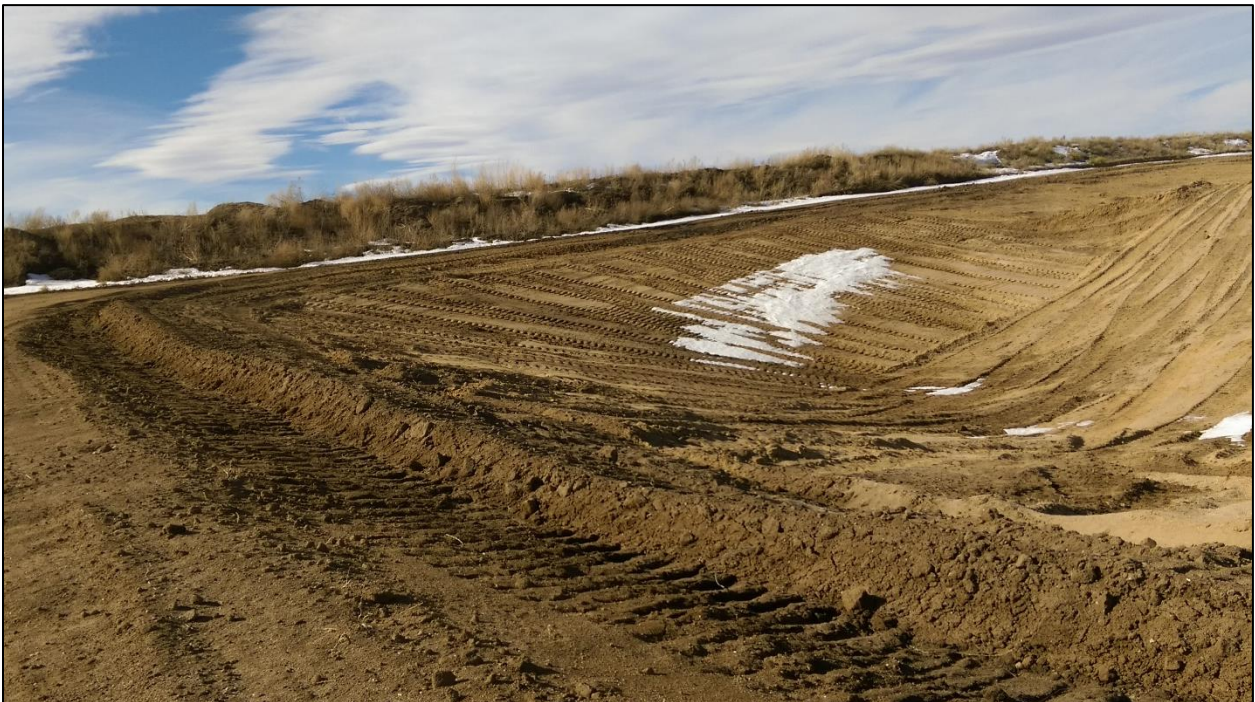
Photo 4. View looking northwest from southern edge of active pit, showing southwestern mined wall graded to approximately 4H:1V slope. Note topsoil bermed along top of mined wall.

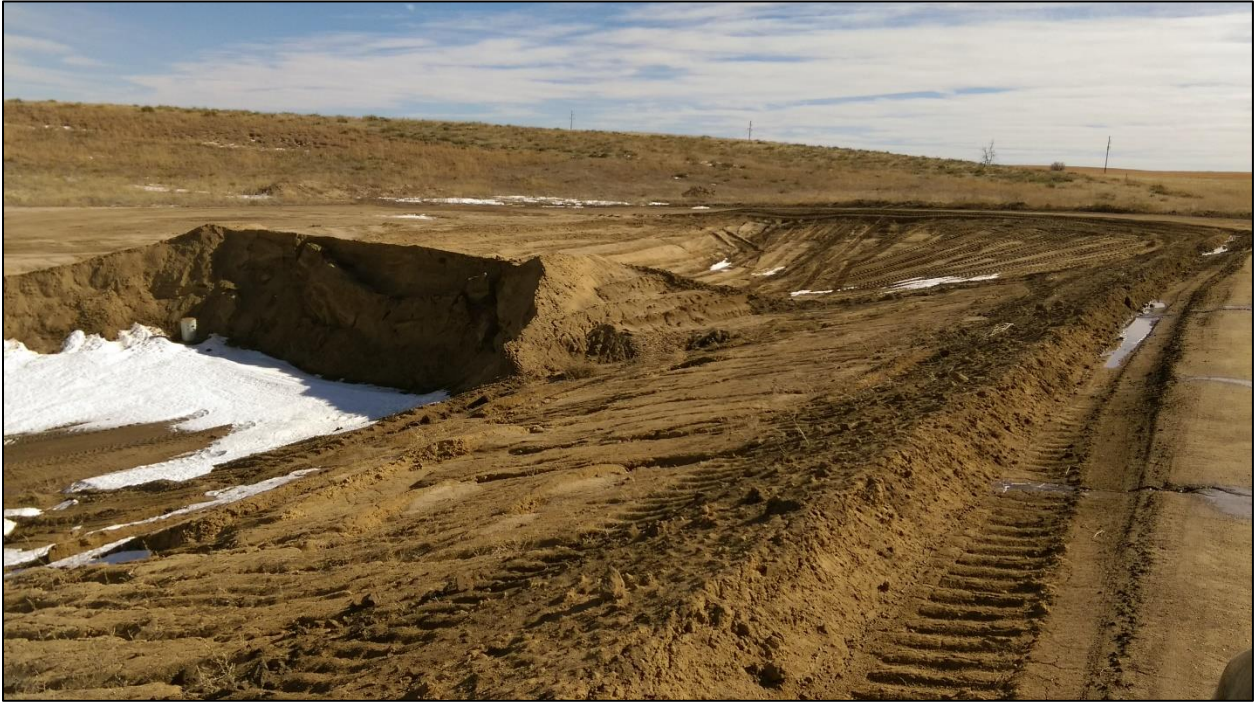
Photo 5. View looking southeast from western edge of active pit, showing western and southern mined walls graded to approximately 4H:1V slope. Note small fresh cut at left.

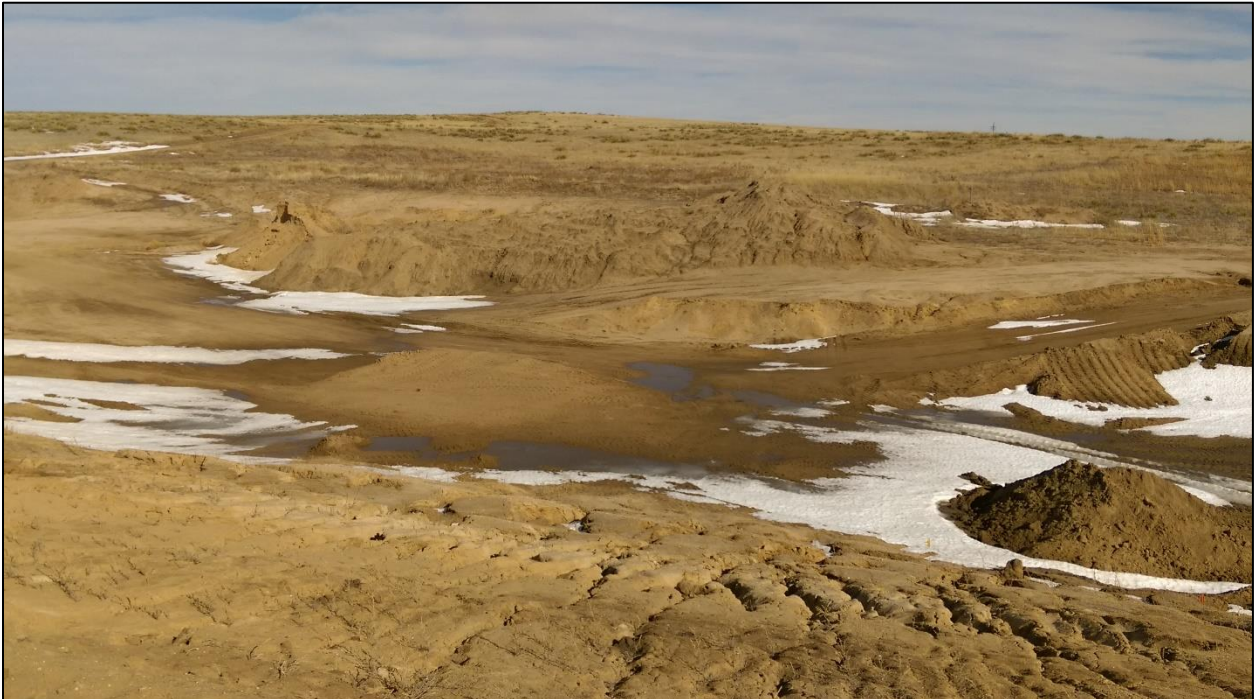
Photo 6. View looking east from western edge of active pit, showing sand stockpiled on pit floor.

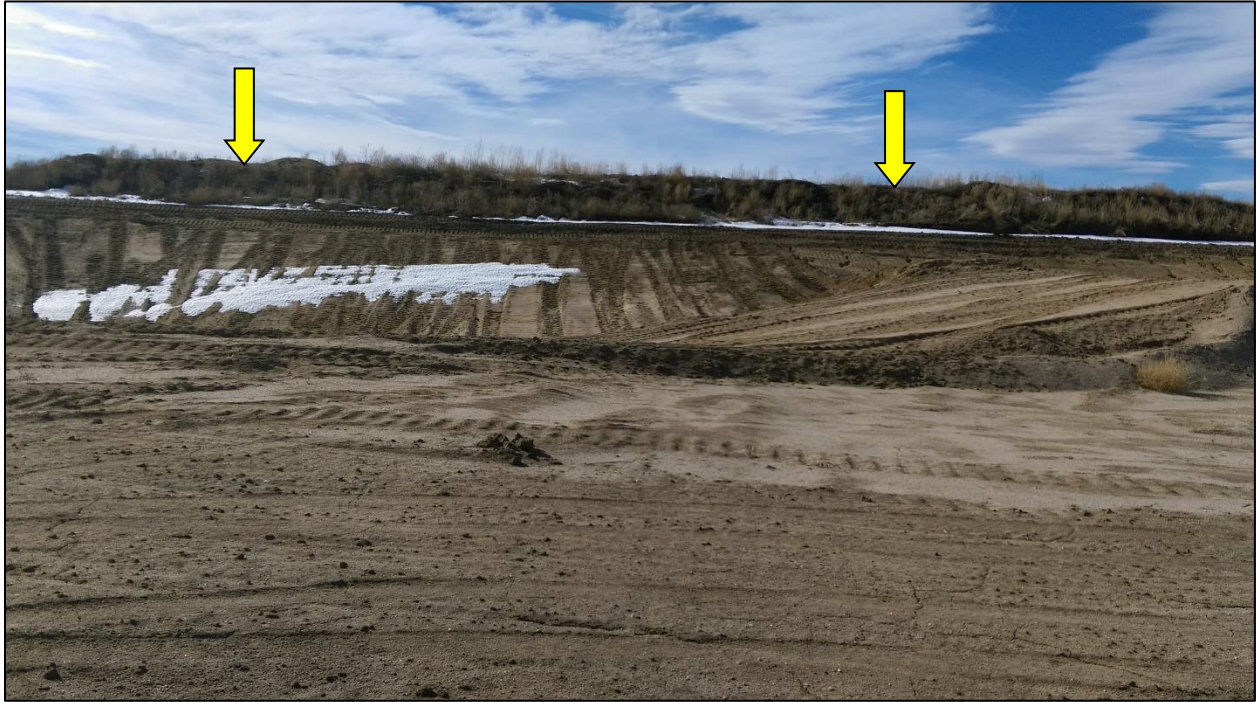
Photo 7. View looking west from eastern edge of active pit, showing topsoil bermed along top of western mined wall (indicated with arrows), stable with vegetative cover.

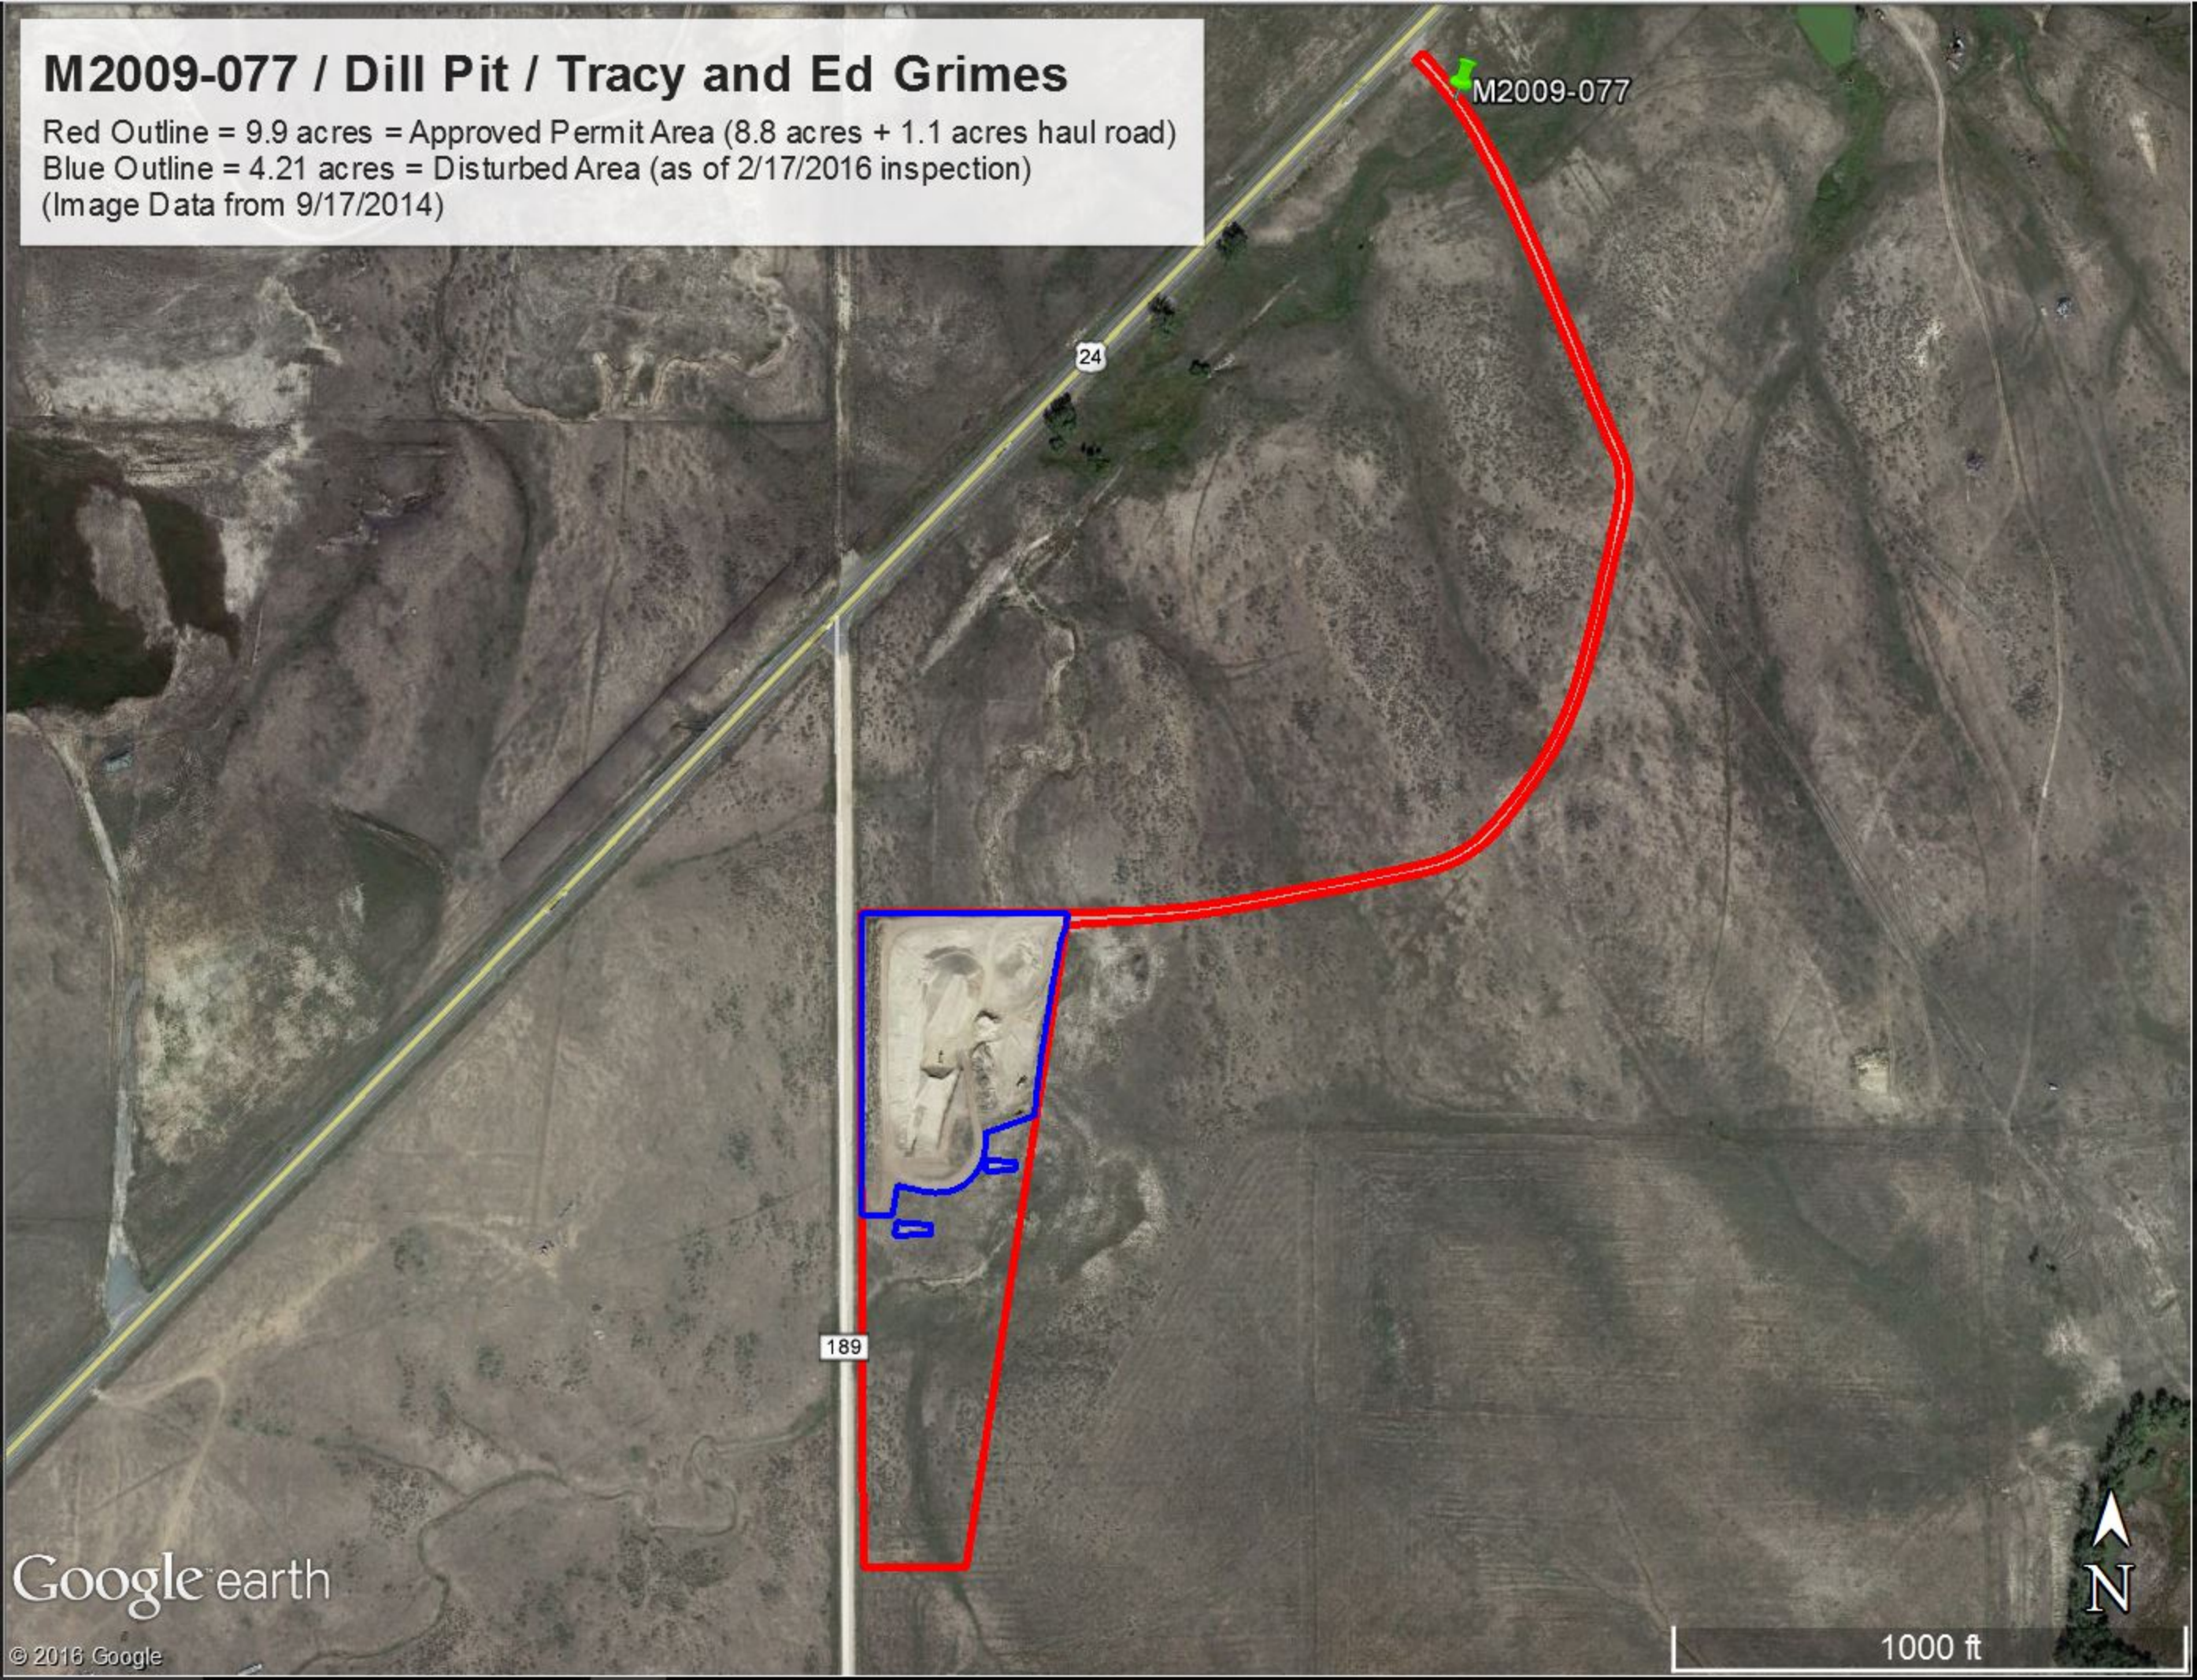
M2009-077 / Dill Pit / Tracy and Ed Grimes

Red Outline = 9.9 acres = Approved Permit Area (8.8 acres + 1.1 acres haul road)
Blue Outline = 4.21 acres = Disturbed Area (as of 2/17/2016 inspection)
(Image Data from 9/17/2014)

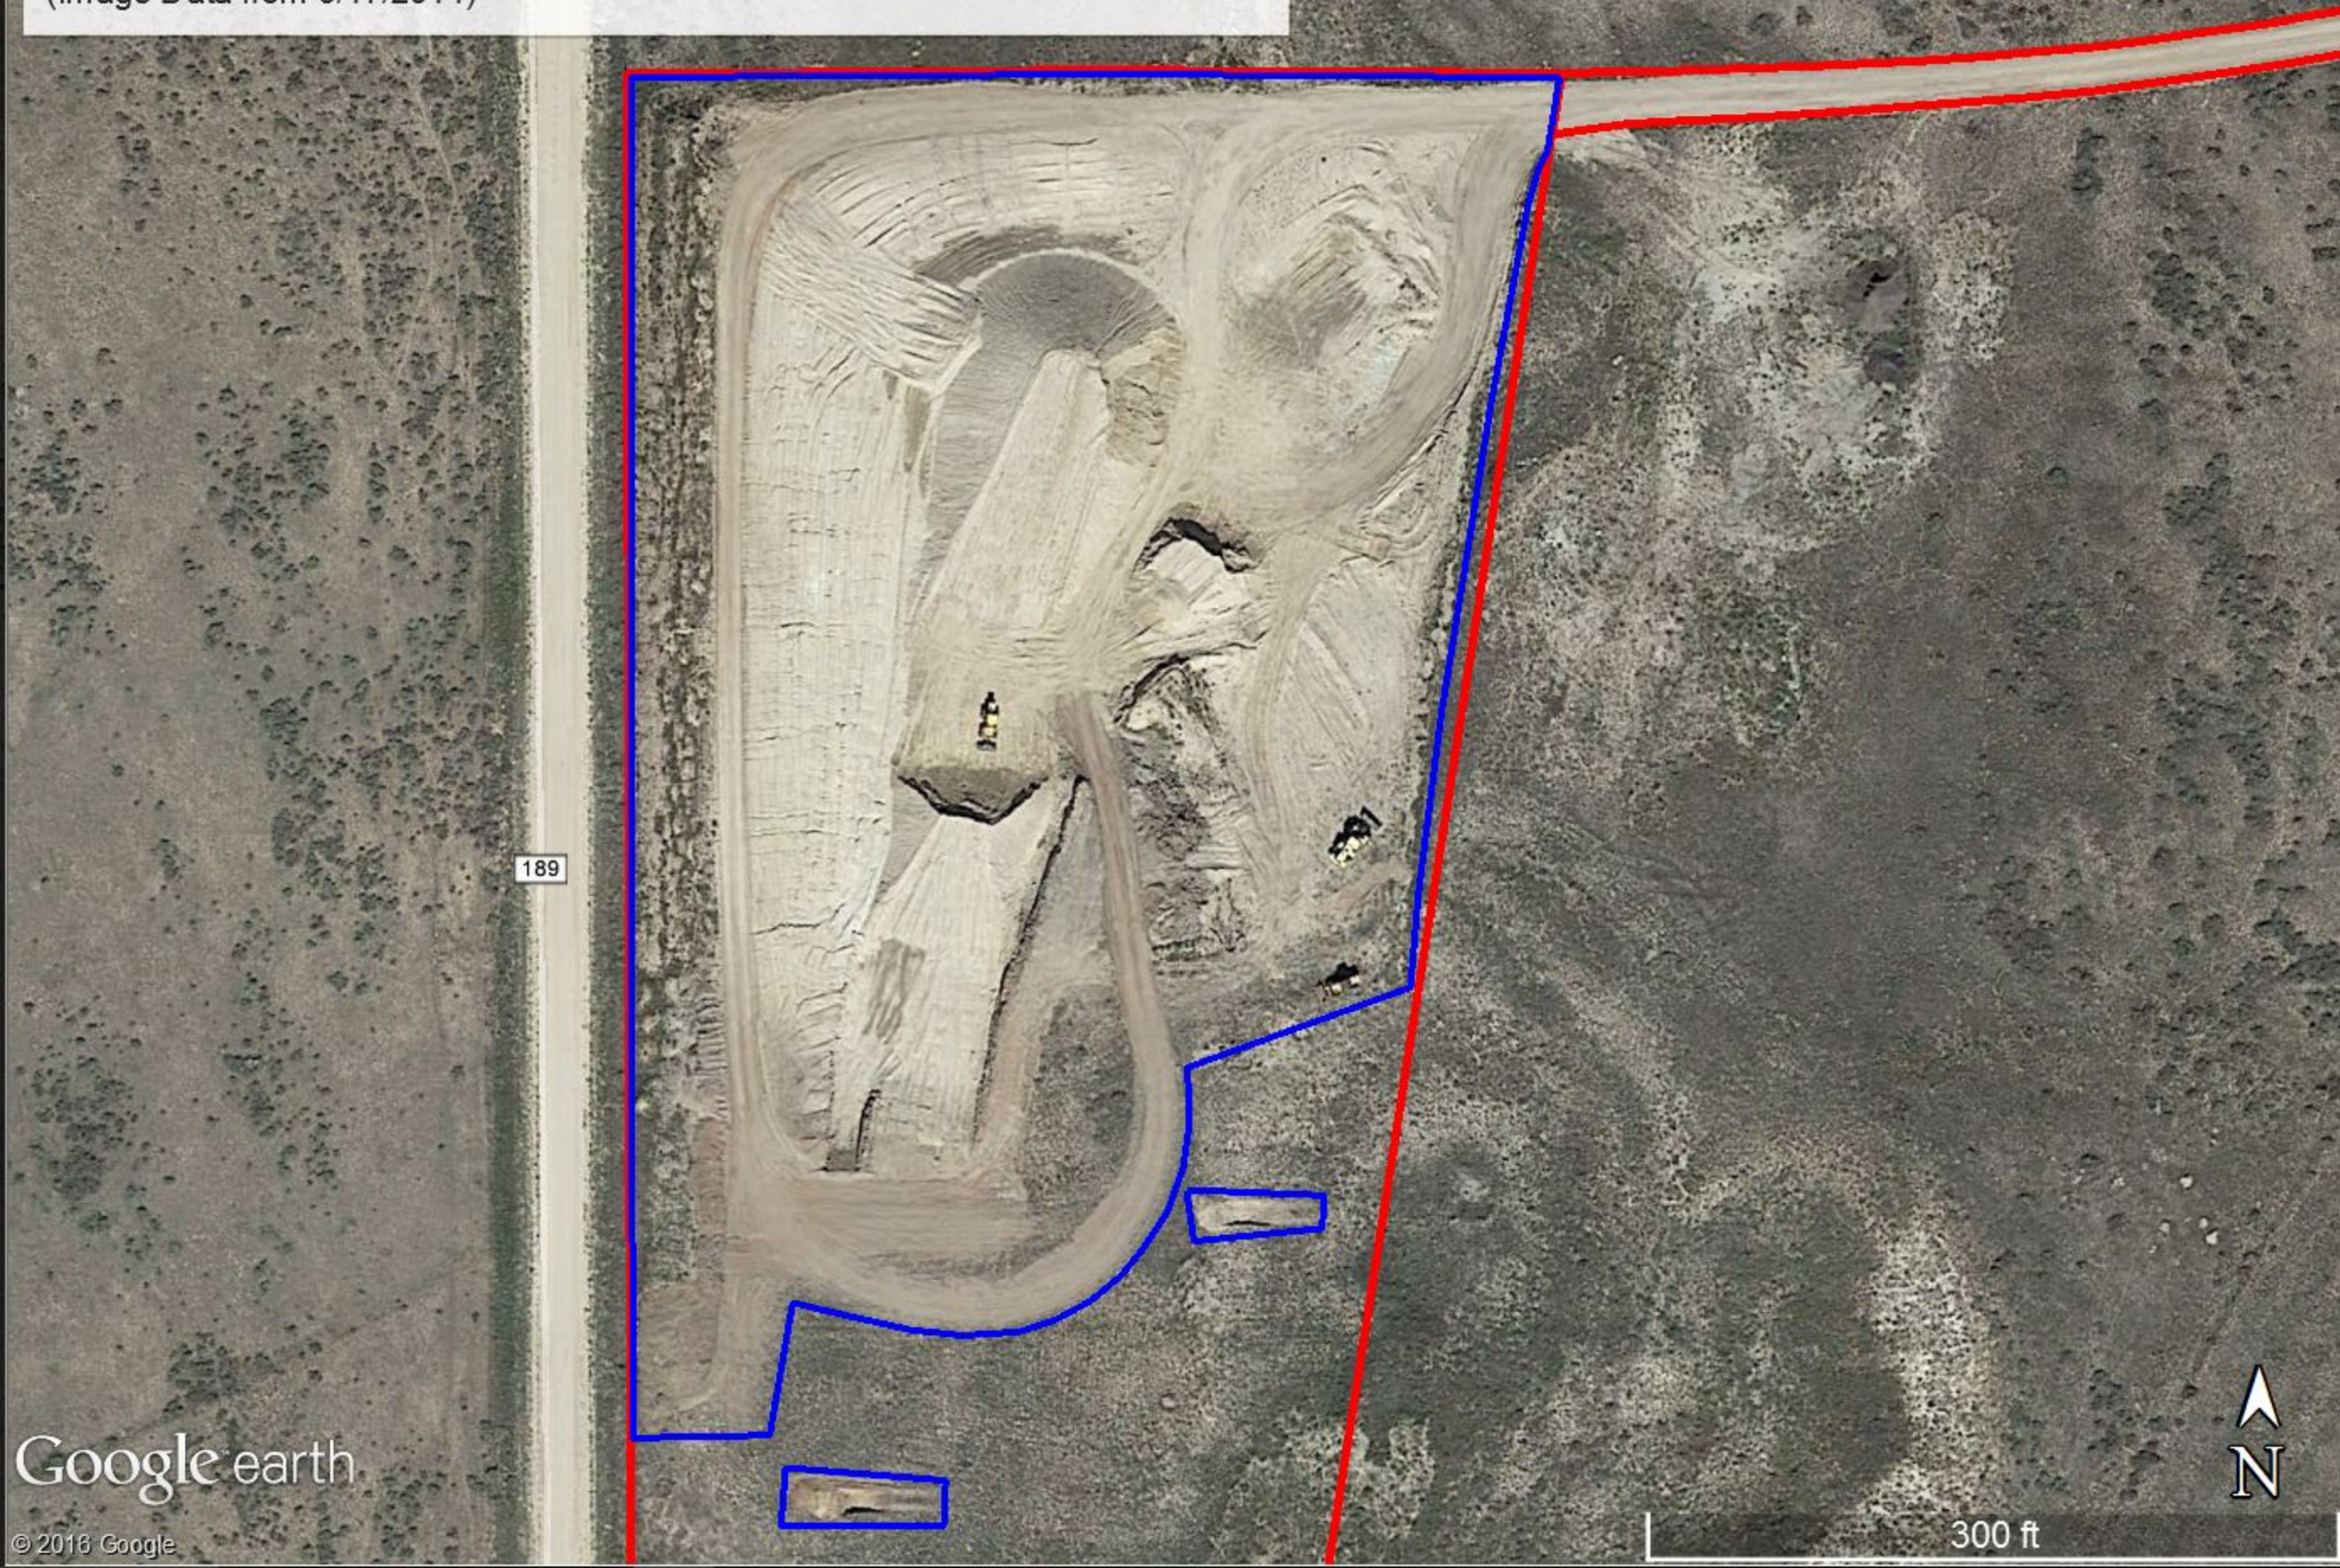
M2009-077 / Dill Pit / Tracy and Ed Grimes

Red Outline = 9.9 acres = Approved Permit Area (8.8 acres + 1.1 acres haul road)

Blue Outline = 4.21 acres = Disturbed Area (as of 2/17/2016 inspection)
