**COLORADO**Division of Reclamation,
Mining and Safety

MINERALS PROGRAM INSPECTION REPORT**PHONE: (303) 866-3567**

MINE NAME: Rothe Sand & Gravel Pit	MINE/PROSPECTING ID#: M-1995-017	MINERAL: Sand and gravel	COUNTY: Logan
INSPECTION TYPE: Monitoring	INSPECTOR(S): Jared L. Ebert	INSP. DATE: December 19, 2016	INSP. TIME: 11:45
OPERATOR: City of Sterling	OPERATOR REPRESENTATIVE: Donald J. Saling and George Good	TYPE OF OPERATION: 110c - Construction Limited Impact

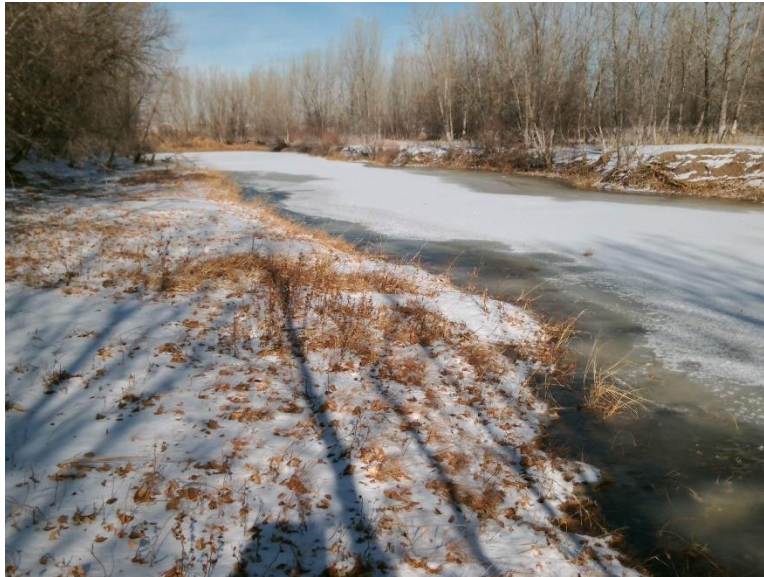
PROBLEM/POSSIBLE VIOLATION: Problem: Two pits with exposed ground water have been created at this site. This is cited as a problem for failure to follow the approved reclamation plan pursuant to C.R.S. 34-32.5-116 (1). The operator must follow the approved reclamation plan or provide sufficient information to describe or identify how the operator intends to conduct reclamation.

Two pits contain exposed ground water at the site. The approved mining and reclamation plan does not allow for long term exposed ground water. This issue is cited as a problem at the beginning of this report.

At the northern end of the permit area, two small open water pits have been created. The affected land surrounding the pits are vegetated with grasses and trees. The side slopes of the pits vary in angle. However, portions of the pit slopes above and likely below the water line appear to have a steep 1:1 or 2:1 angle. The operator will need to grade the pit slopes to a 3:1 angle both 5 feet above and 10 feet below the waterline in accordance with Rule 3.1.5(7). Mr. Salang indicated that the City of Sterling would like to create a park/recreation area within the permit area. The City plans to expand the eastern most pond and connect the two ponds in the middle. Mr. Saling provided me a map at the inspection that depicts their proposed plan. This map is included at the end of this report as an attachment. It was discussed with Mr. Saling that they would need to file an Amendment to their current permit to revise their mining and reclamation plan to account for this proposed activity. At this time, the site have not been reclaimed in accordance with the approved reclamation plan, this issue is cited as a problem at the beginning of this report.

Figure 1. Western most pond, south end looking north.

CORRECTIVE ACTIONS: The operator shall submit an Amendment to the permit, with the required \$827 amendment fee, to update and clarify the current approved reclamation plan to reflect existing and proposed

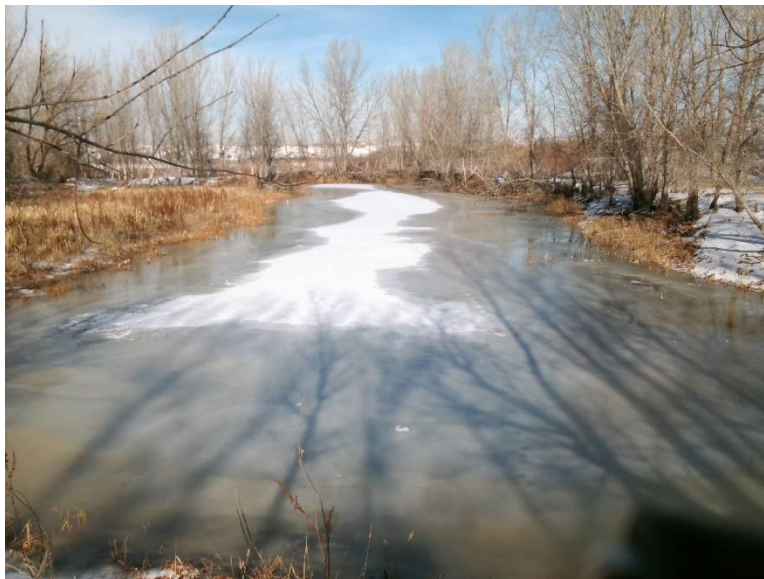
Figure 2. Eastern most pond, south end looking north.

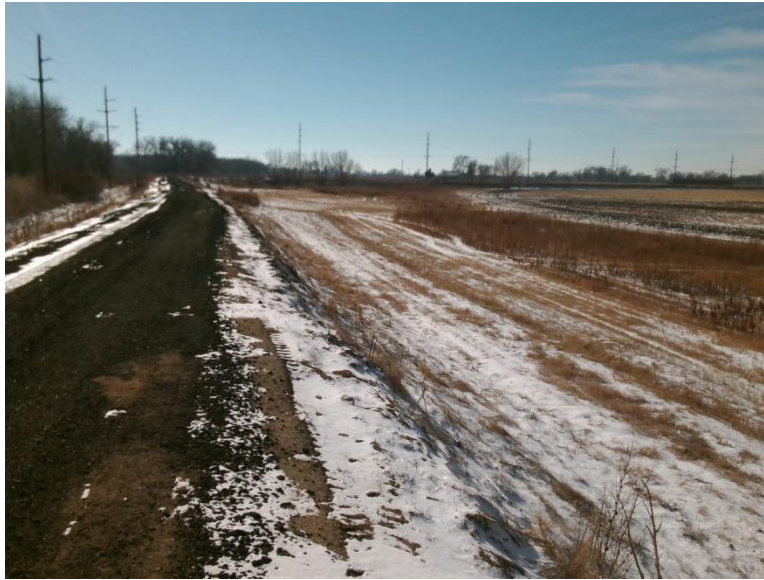
The southern end of the permit area has been graded to blend in with the surrounding area and has been revegetated.

The reclaimed area is vegetated with grasses, forbs and trees. The area appears stable.

Figure 3. From the south end of the ponds looking south at the southern permit area.
