**MINERALS PROGRAM INSPECTION REPORT**  
**PHONE: (303) 866-3567**

<b>MINE NAME:</b> Ute Mine	<b>MINE/PROSPECTING ID#:</b> M-1979-221	<b>MINERAL:</b> Clay (general)	<b>COUNTY:</b> Douglas
<b>INSPECTION TYPE:</b> Monitoring	<b>INSPECTOR(S):</b> Peter S. Hays	<b>INSP. DATE:</b> December 29, 2016	<b>INSP. TIME:</b> 10:30
<b>OPERATOR:</b> General Shale Brick, Inc.	<b>OPERATOR REPRESENTATIVE:</b> Jason McGraw	<b>TYPE OF OPERATION:</b> 112c - Construction Regular Operation	
<b>REASON FOR INSPECTION:</b> Normal I&E Program	<b>BOND CALCULATION TYPE:</b> Partial Bond	<b>BOND AMOUNT:</b> \$39,000.00	
<b>DATE OF COMPLAINT:</b> NA	<b>POST INSP. CONTACTS:</b> None	<b>JOINT INSP. AGENCY:</b> None	
<b>WEATHER:</b> Clear	<b>INSPECTOR'S SIGNATURE:</b>

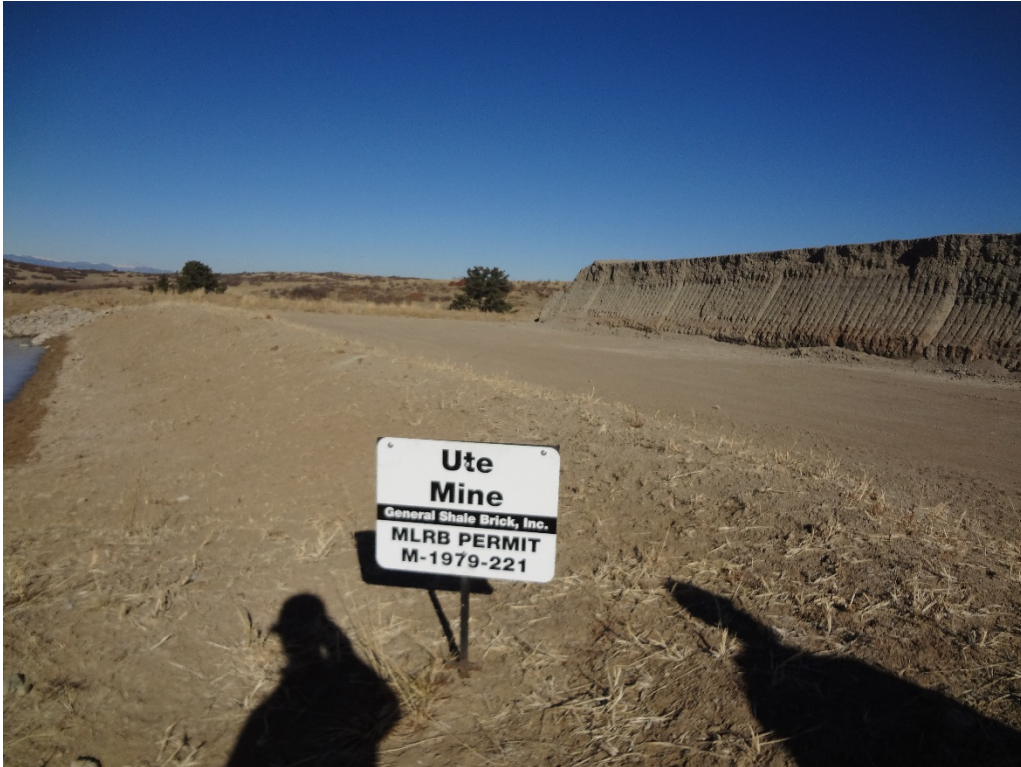
The Division currently holds a financial warranty in the amount of \$39,000.00, which appears adequate based on this inspection. The mine sign and boundary markers were observed as required by Rule 3.1.12. All mining disturbance was contained within the permit boundary. The site is permitted for 38.78 acres according to the Division's records. The Operator's annual report map indicates a permit boundary of 42.36 acres. The Division approved an acreage reduction request (AR-01) in 2005. It appears the Division did not correctly calculate the revised permit acreage. The Division believes the correct permit acreage is 42.37, based on the information submitted with the 2005 acreage reduction request. The permit file will be updated by the Division.

Ute Mine sign

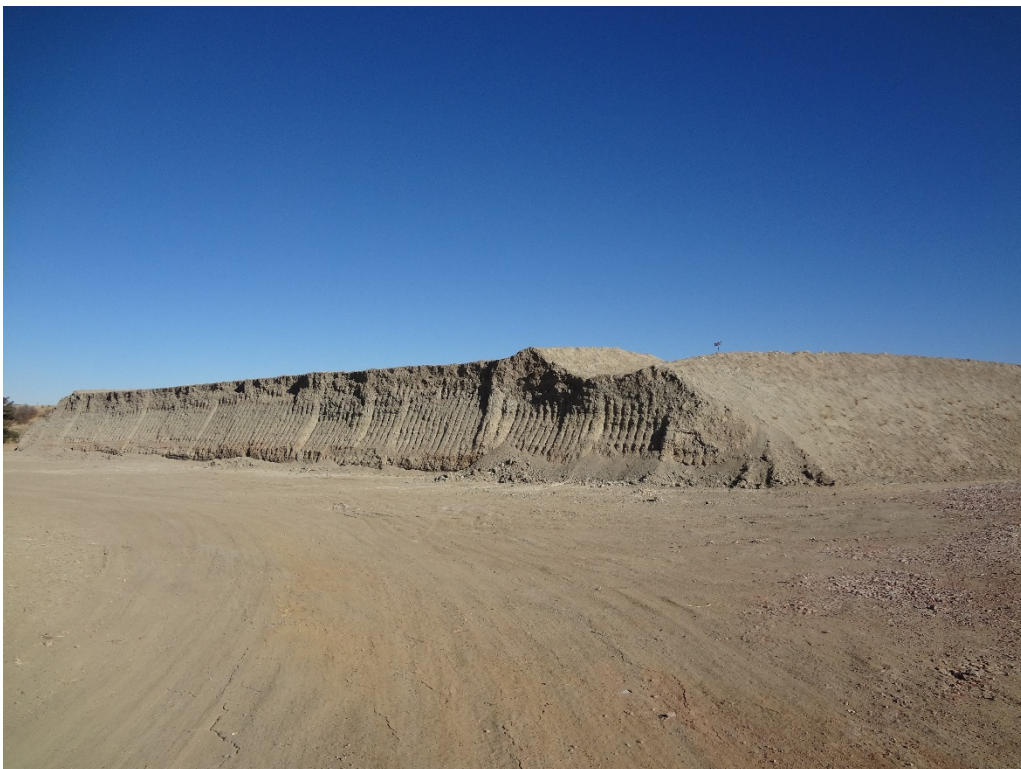
View of stockpile from southwest corner of pad looking northeast

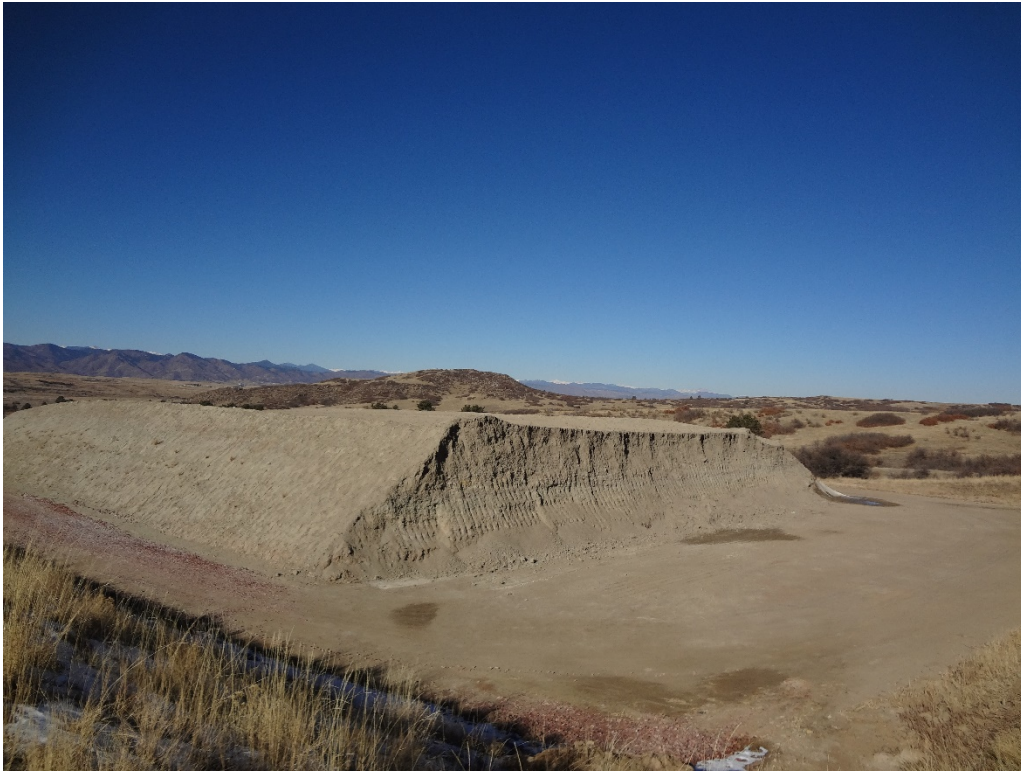
View of stockpile from southeast corner of pad looking northwest

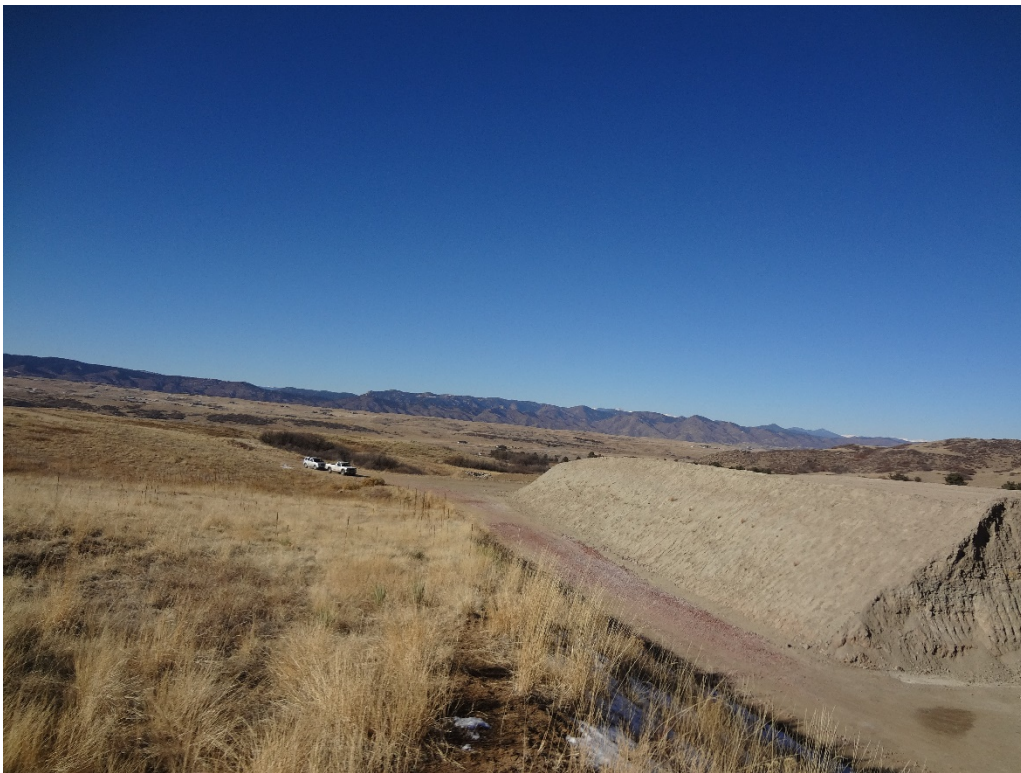
View of stockpile from southeast corner of pad looking west

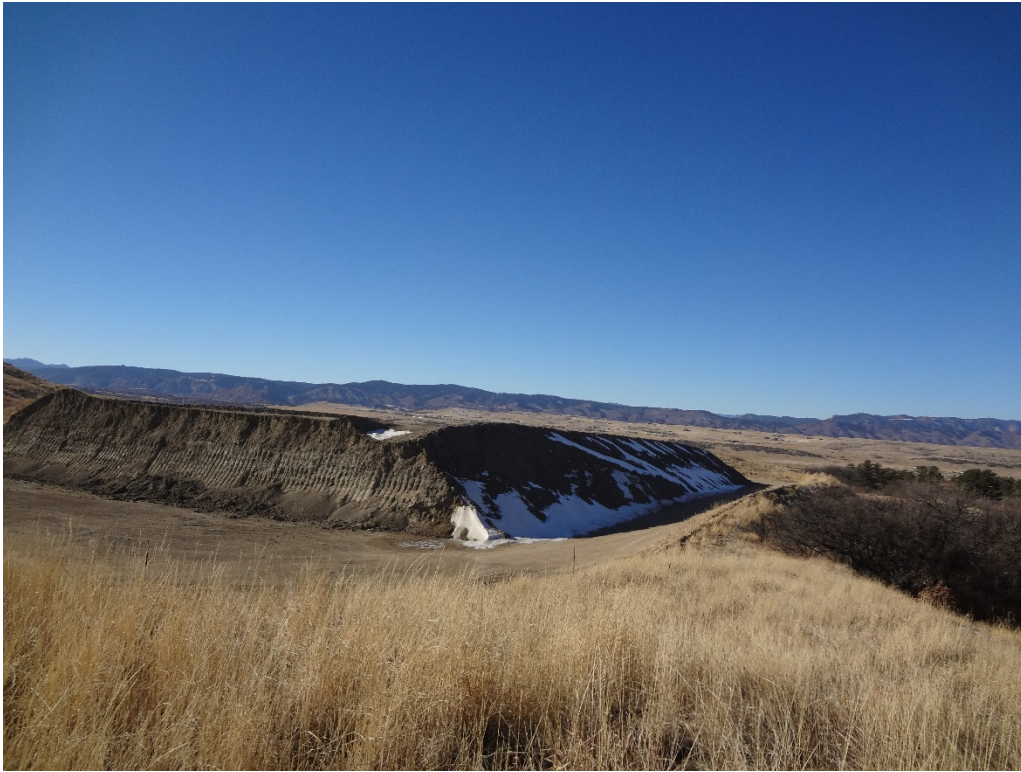
View of stockpile from northeast corner of pad looking southwest

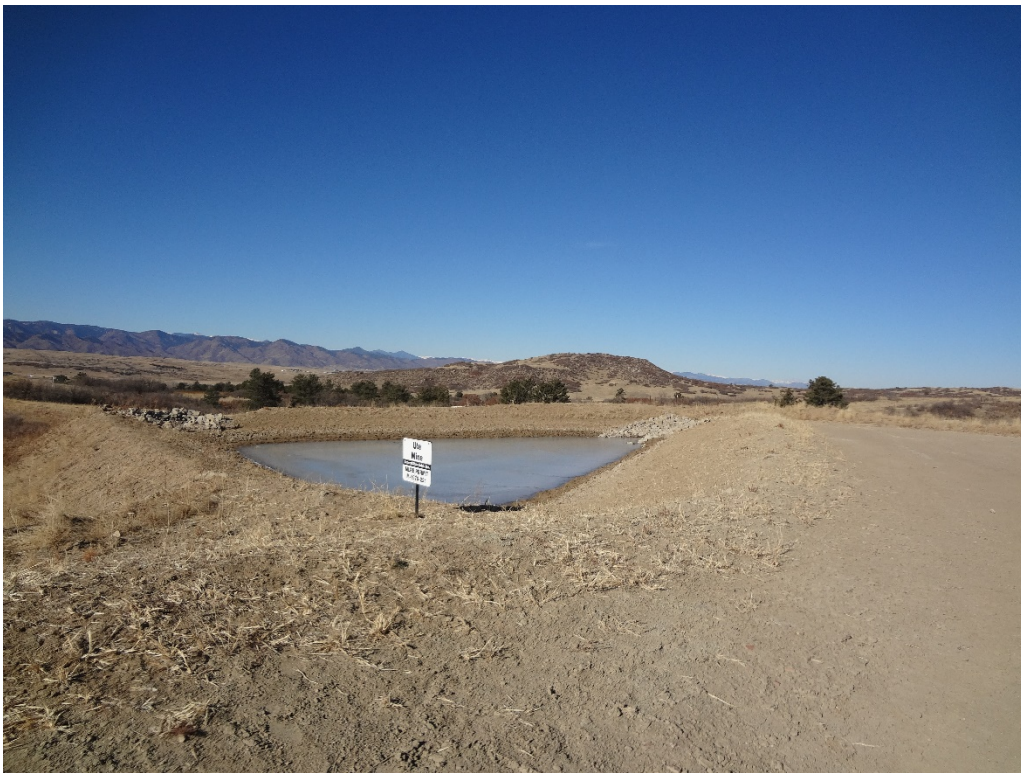
Final reclamation of the leased portion of the site is ongoing as mentioned above. The backfilled mine area has been seeded and mulched recently. The topsoil stockpile located in the northeast corner of the site was well vegetated. One small erosion gully was noted on the north side of the topsoil stockpile during the inspection. The Division recommends the Operator stabilize the erosion feature to prevent additional erosion of the stockpile. The stormwater pond in the southwest corner of the pad area contained water.

View of stormwater detention pond in southwest corner of stockpile pad

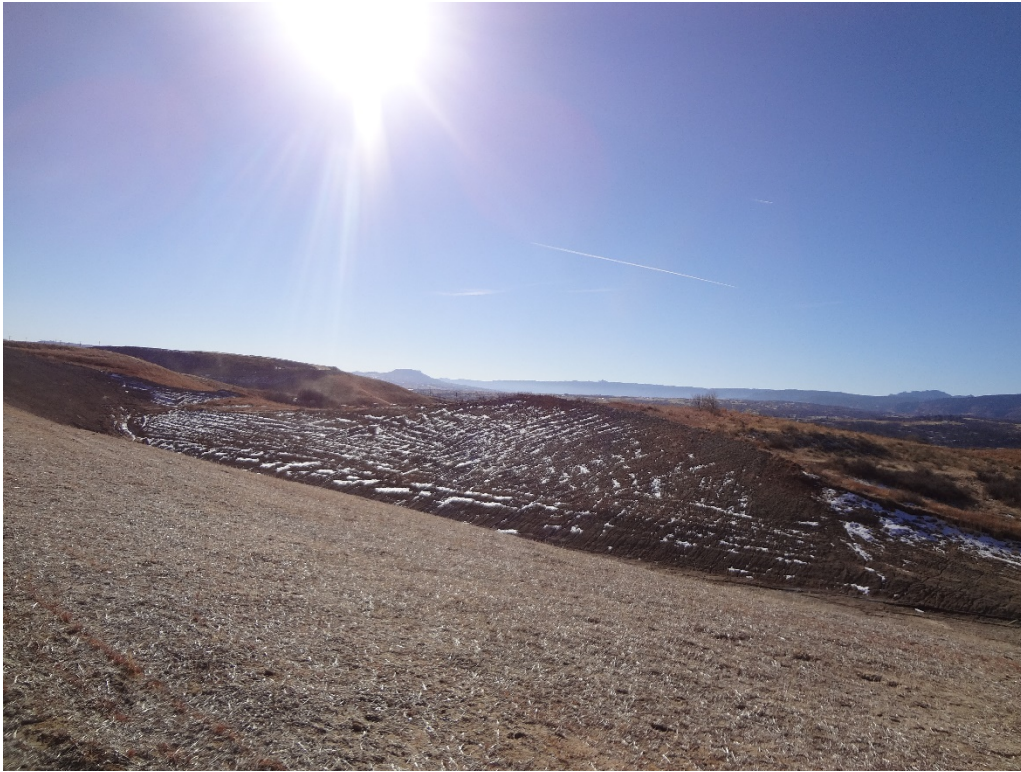
View of mine face looking south (foreground is backfilled leased pit area)

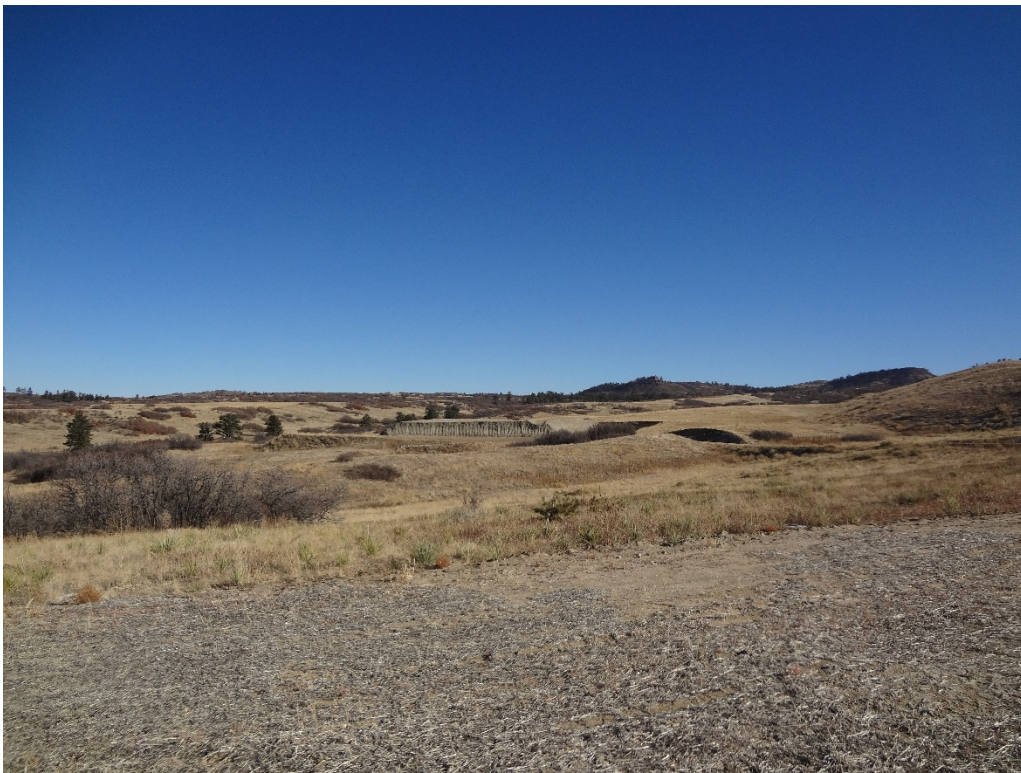
View of stockpile from the backfilled leased pit area
