**MINERALS PROGRAM INSPECTION REPORT****PHONE: (303) 866-3567**

<b>MINE NAME:</b> Pioneer Mine	<b>MINE/PROSPECTING ID#:</b> M-1977-252	<b>MINERAL:</b> Clay (general)	<b>COUNTY:</b> Douglas
<b>INSPECTION TYPE:</b> Monitoring	<b>INSPECTOR(S):</b> Peter S. Hays	<b>INSP. DATE:</b> December 29, 2016	<b>INSP. TIME:</b> 09:30
<b>OPERATOR:</b> General Shale Brick, Inc.	<b>OPERATOR REPRESENTATIVE:</b> Jason McGraw	<b>TYPE OF OPERATION:</b> 112c - Construction Regular Operation	
<b>REASON FOR INSPECTION:</b> Normal I&E Program	<b>BOND CALCULATION TYPE:</b> Partial Bond	<b>BOND AMOUNT:</b> \$91,243.00	
<b>DATE OF COMPLAINT:</b> NA	<b>POST INSP. CONTACTS:</b> None	<b>JOINT INSP. AGENCY:</b> None	
<b>WEATHER:</b> Clear	<b>INSPECTOR'S SIGNATURE:</b>

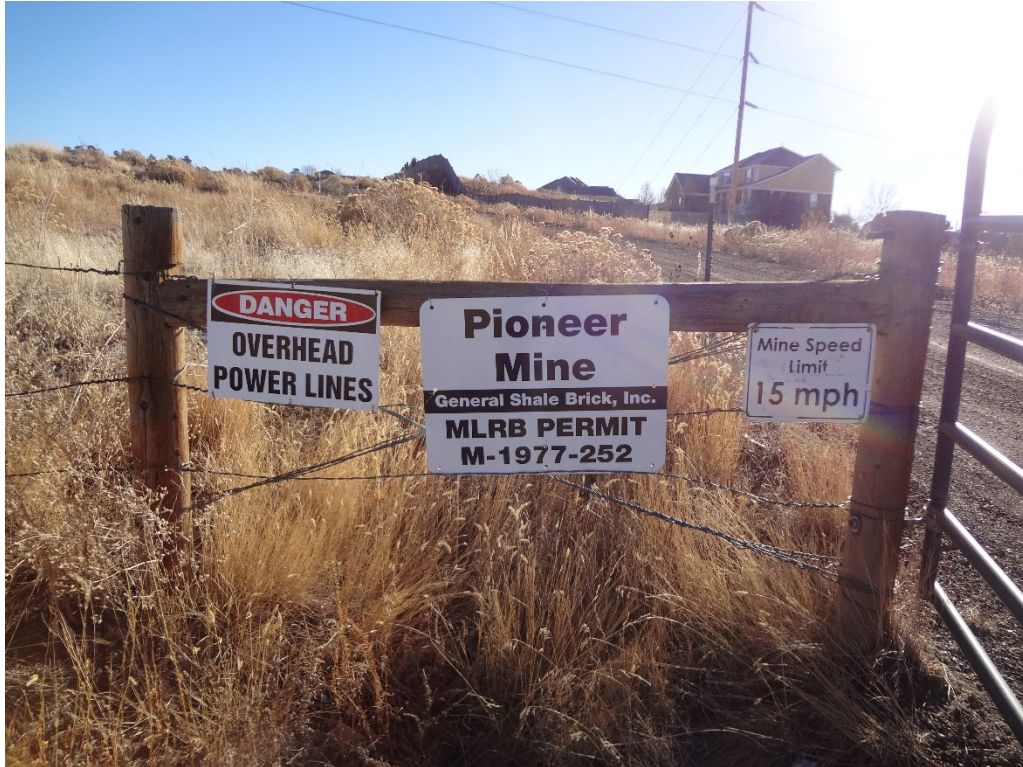
The Division currently holds a financial warranty in the amount of \$91,243.00, which appears adequate based on this inspection. The mine sign and boundary markers were observed as required by Rule 3.1.12. All mining disturbance was contained within the permit boundary. The site is permitted for 34.0 acres in accordance with technical revision no. 2 (TR-02) approved by the Division on October 11, 2000. The Operator's annual report indicates the site is permitted for 31.6 acres with a 27.8 acre disturbance area.

Pioneer Mine sign

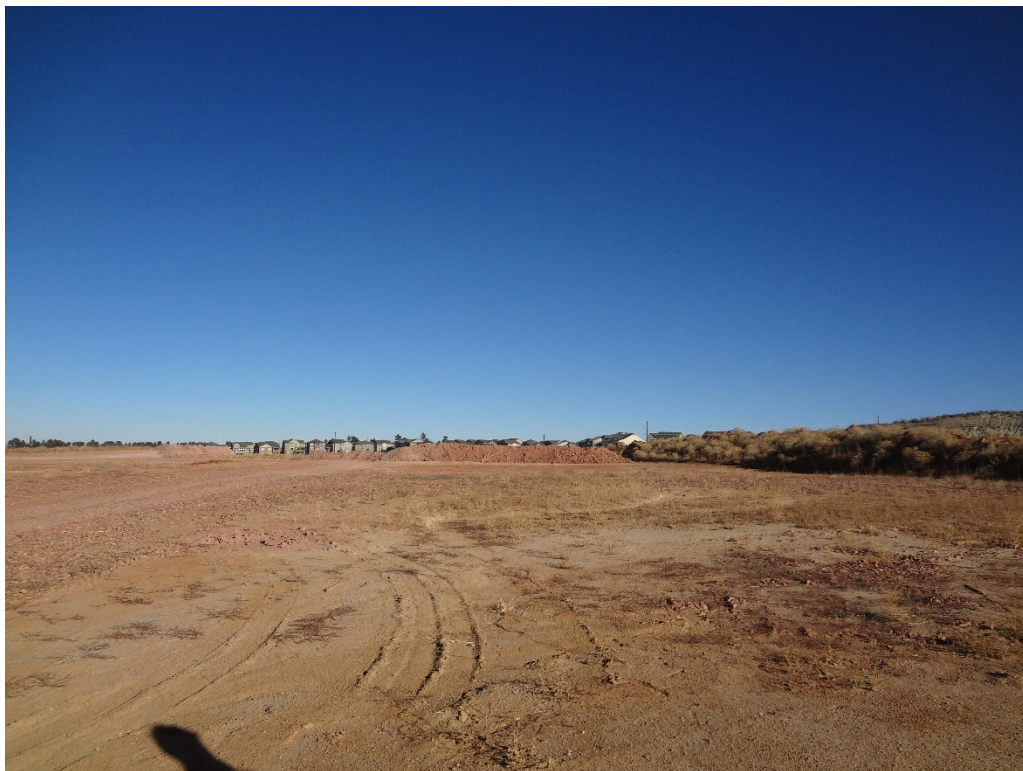
View of stockpile area from south end of pad looking north

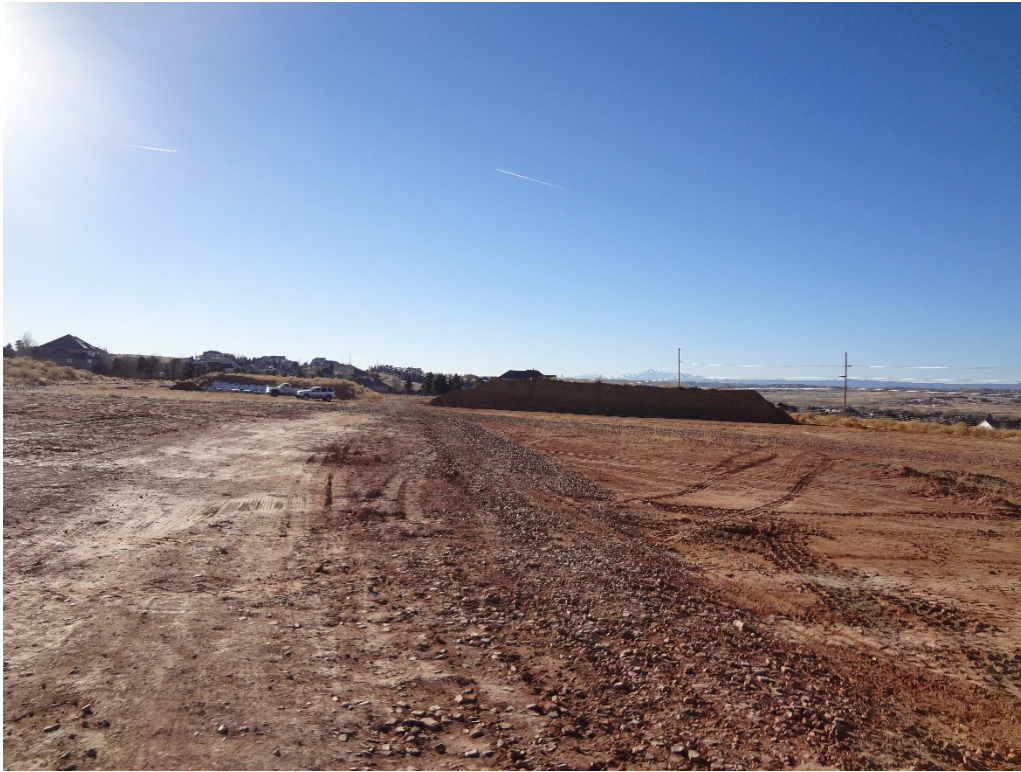
View of stockpile area from north end of pad looking south

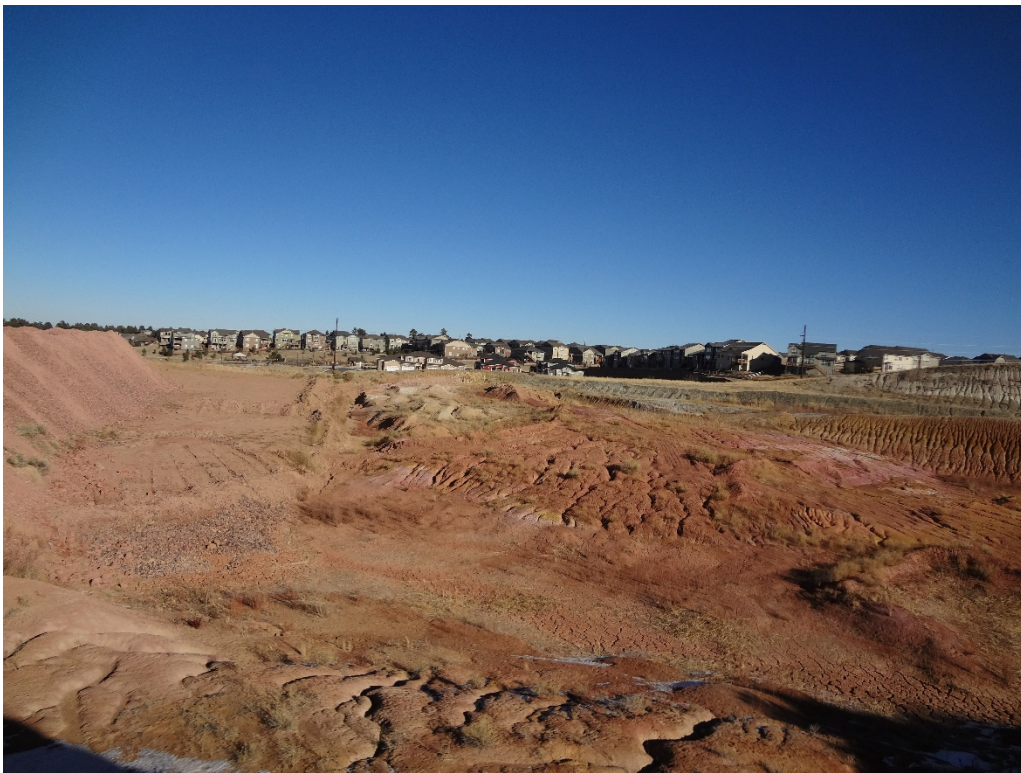
View of pit from north end of pad looking north

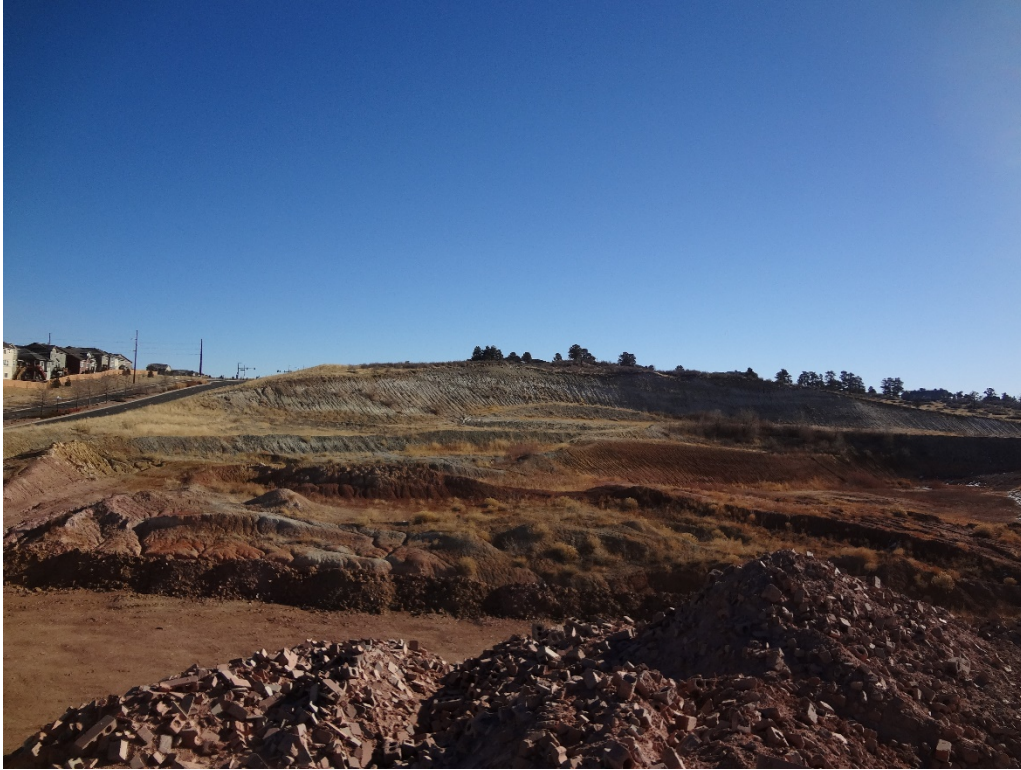
View of pit from the northwest corner of the site looking east

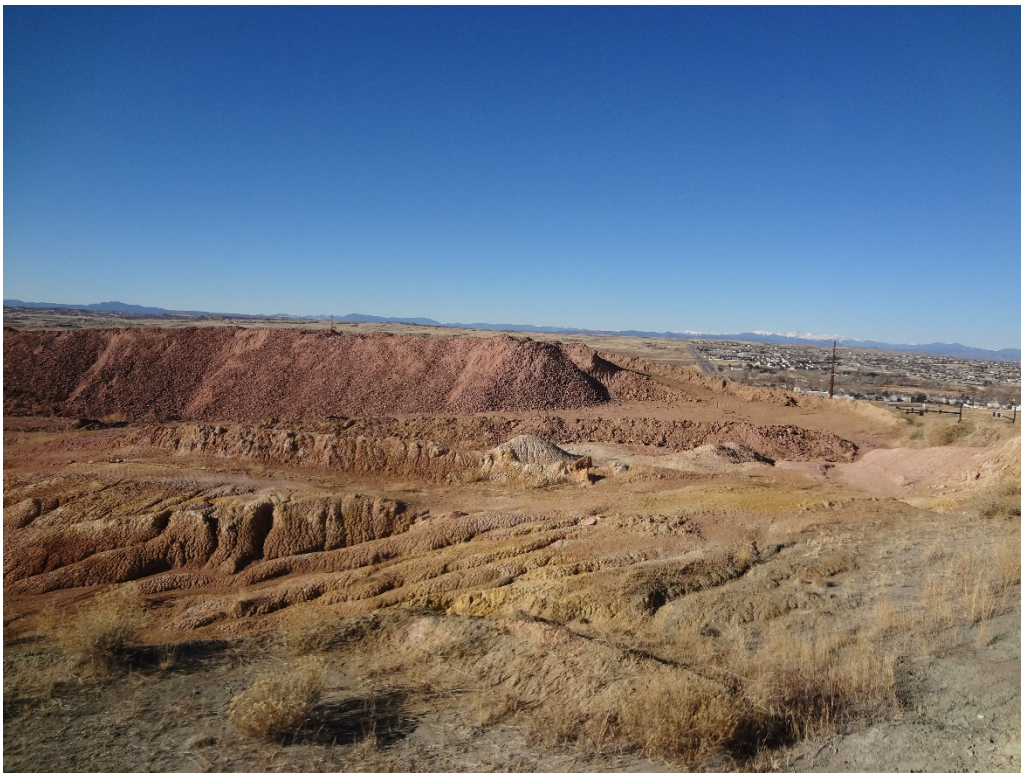
View of pit from the northeast corner of the site looking west

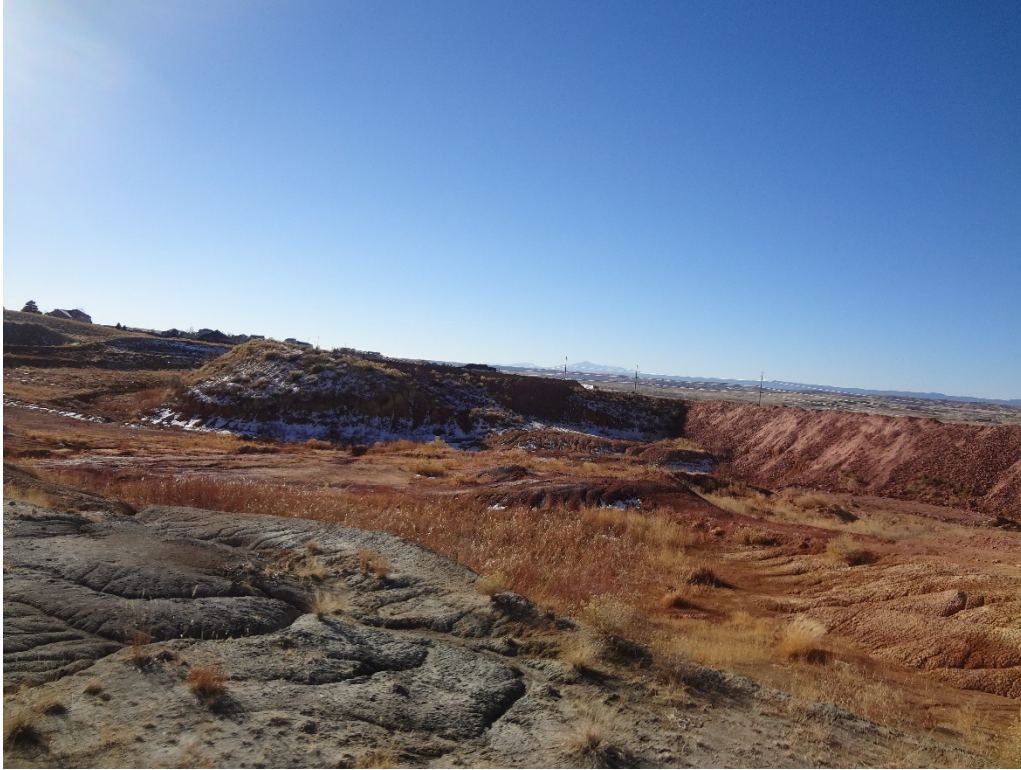
View of pit from the northeast corner of the site looking southeast

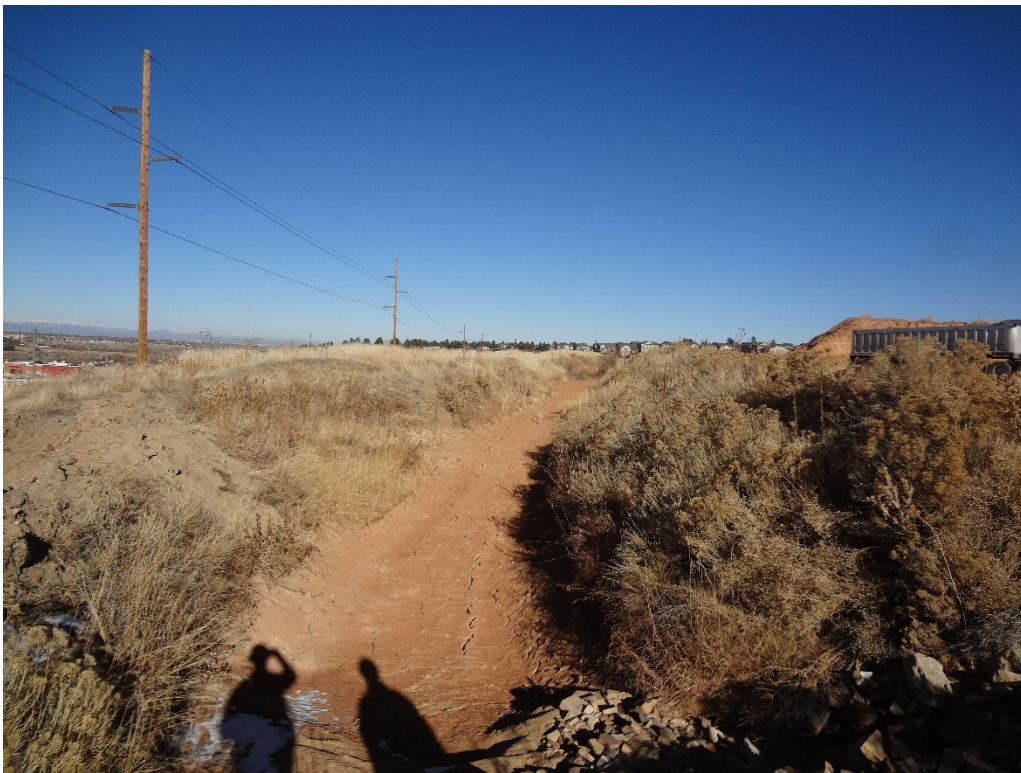
No final reclamation activities have started at the site. A large topsoil stockpile is located along the west side of the site between the access road and the mine area. A stormwater detention pond is located between the topsoil stockpile and the mine pad.

View of stormwater pond located between stockpile pad and topsoil berm
