**COLORADO**Division of Reclamation,  
Mining and Safety

**MINERALS PROGRAM INSPECTION REPORT****PHONE: (303) 866-3567**

<b>MINE NAME:</b> Hogback Mine	<b>MINE/PROSPECTING ID#:</b> M-1980-245	<b>MINERAL:</b> Clay (general)	<b>COUNTY:</b> Douglas
<b>INSPECTION TYPE:</b> Monitoring	<b>INSPECTOR(S):</b> Peter S. Hays	<b>INSP. DATE:</b> December 29, 2016	<b>INSP. TIME:</b> 12:30
<b>OPERATOR:</b> General Shale Brick, Inc.	<b>OPERATOR REPRESENTATIVE:</b> Jason McGraw	<b>TYPE OF OPERATION:</b> 112c - Construction Regular Operation

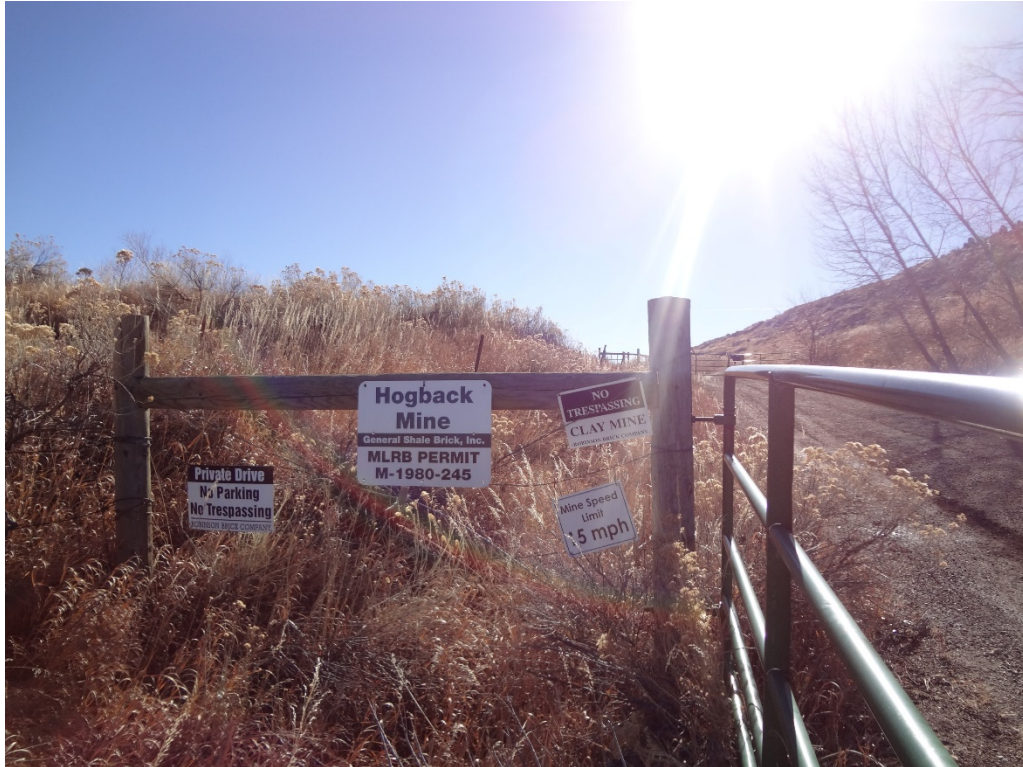
Hogback Mine sign

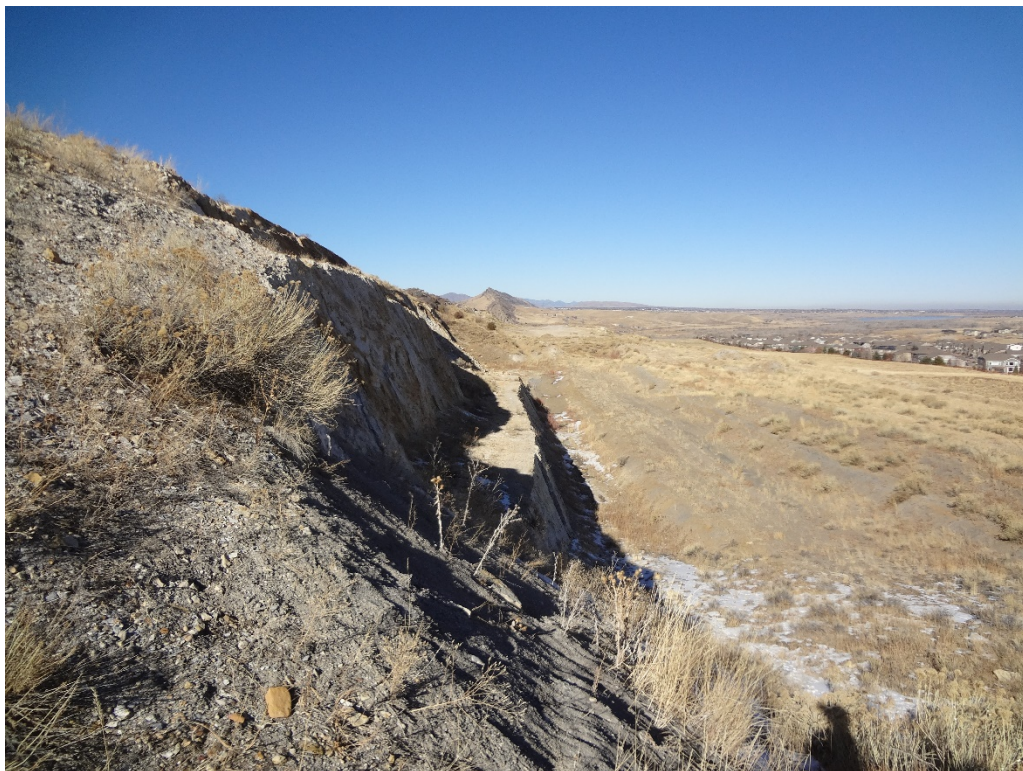
View of lower clay deposits in north mining area looking south

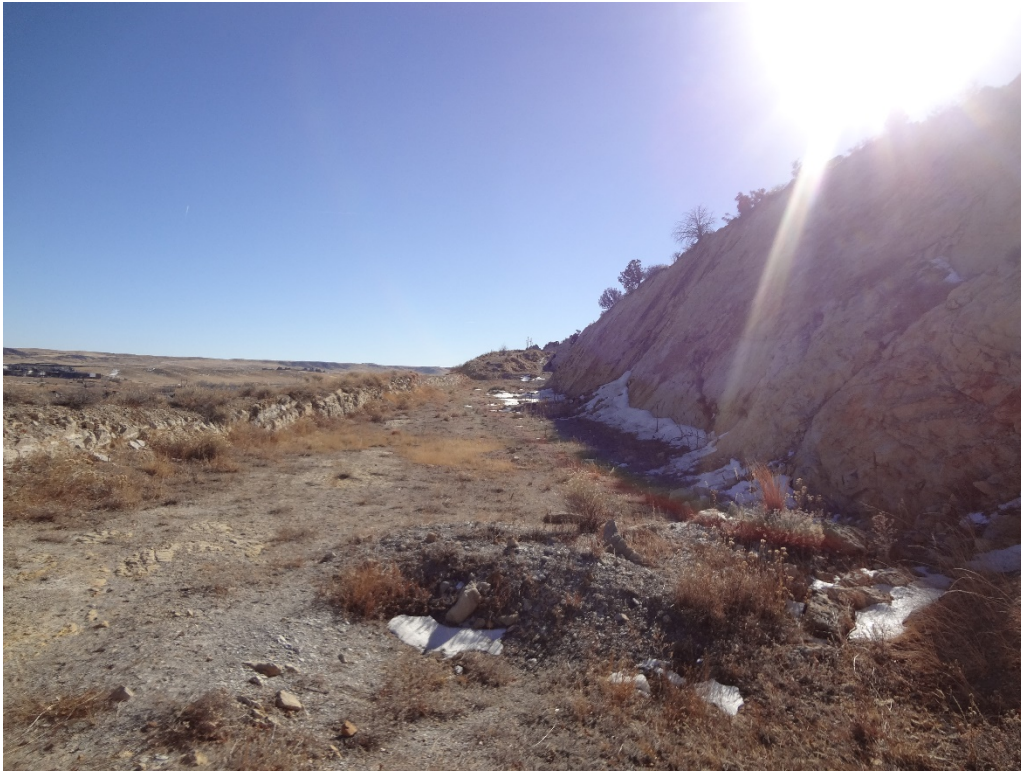
View of upper clay deposits in north mining area looking north

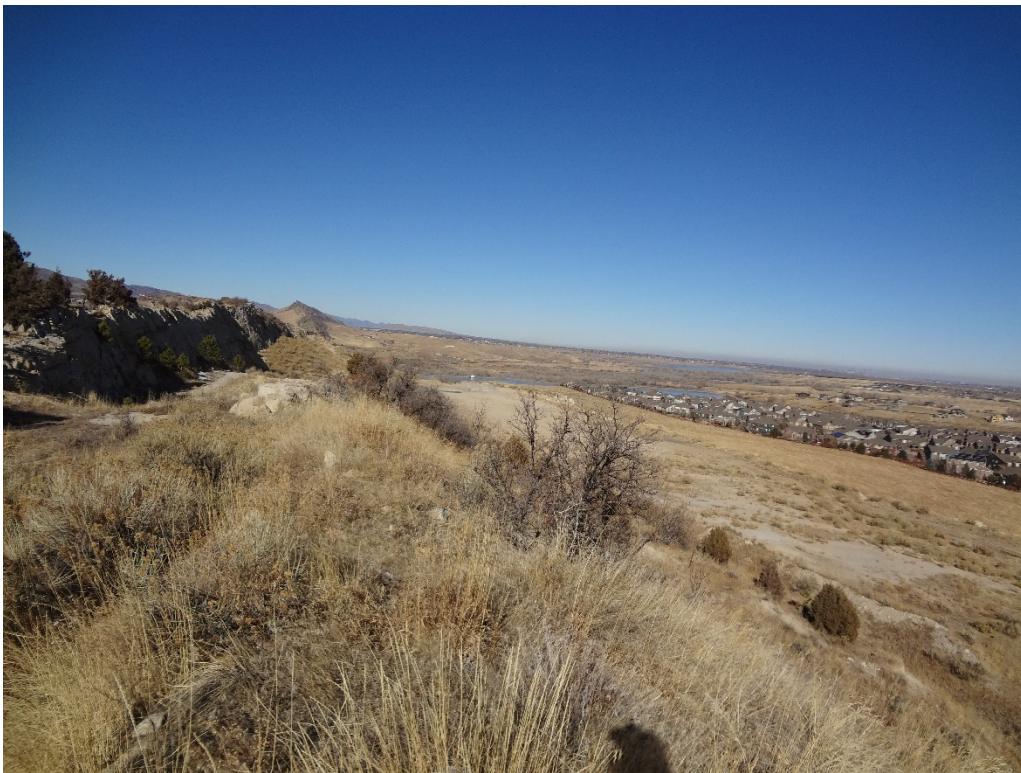
View of stockpile area from the north mining area looking south

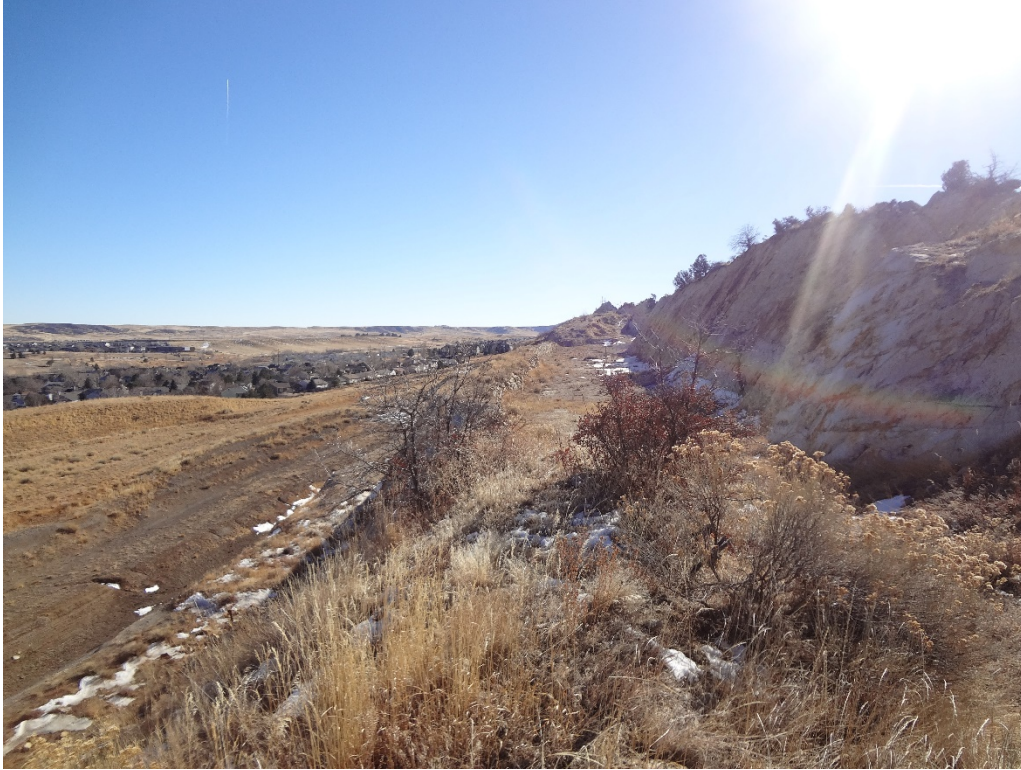
View of upper clay deposits in north mining area looking south
