Locatable Minerals Site Inspection
U.S. Department of the Interior
Bureau of Land Management
Royal Gorge Field Office

| Date:8/22/2016 Time:10:20-10:40 a.m. Weather: Partly cloudy Inspection Purpose: Annual inspection | Project Name: Destiny Mine Case Number: COC-73930 Operator:Astemborski Location:Fairplay, CO |

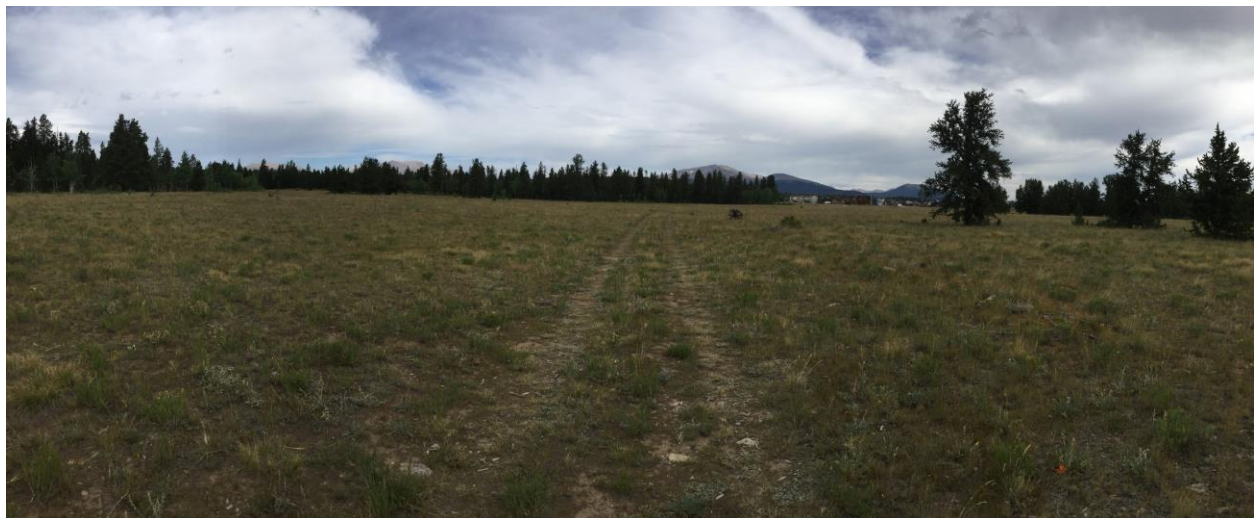
Photo 1: Partially regrown two track heading north across claim from access gate

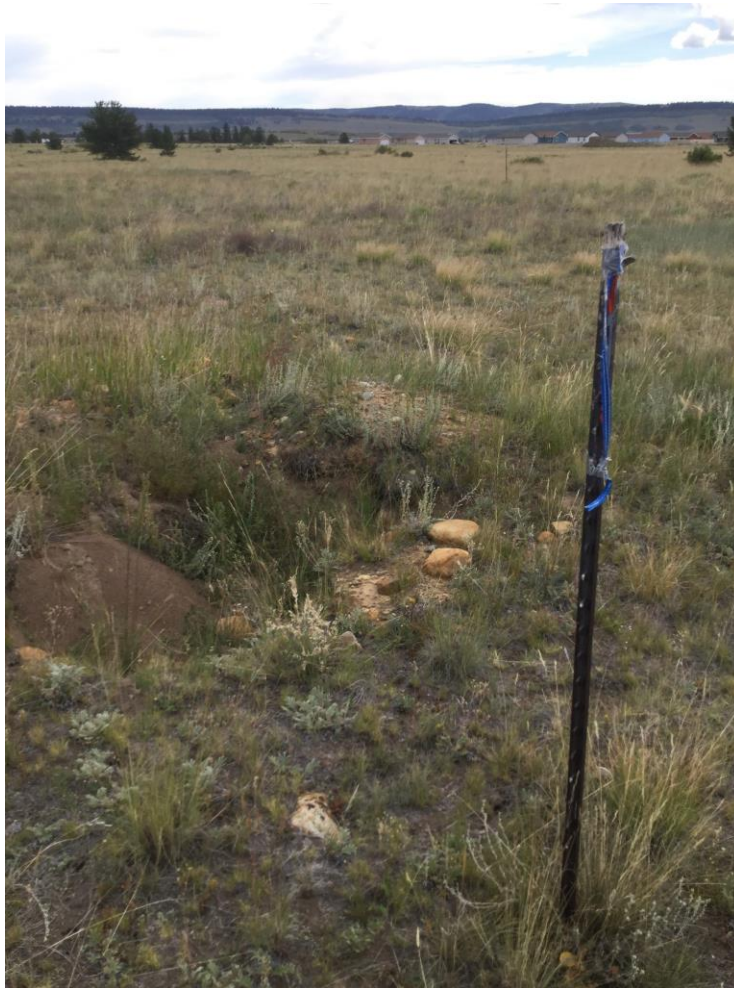
| <p align="center"><u>General Safety Conditions</u></p> <p><input type="checkbox"/> Temporary Fencing</p> <p><input type="checkbox"/> Flagging</p> <p><input type="checkbox"/> Signage (mine site, direction of travel, etc.)</p> <p><input type="checkbox"/> Does it appear that the mining is conducted in a</p> | <p><input type="checkbox"/> N/A</p> <div style="border: 1px solid black; padding: 5px;">One small, fairly shallow pit seen with no flagging or fencing</div> |

Photo 2: T-bar post near shallow pit. No label on post.

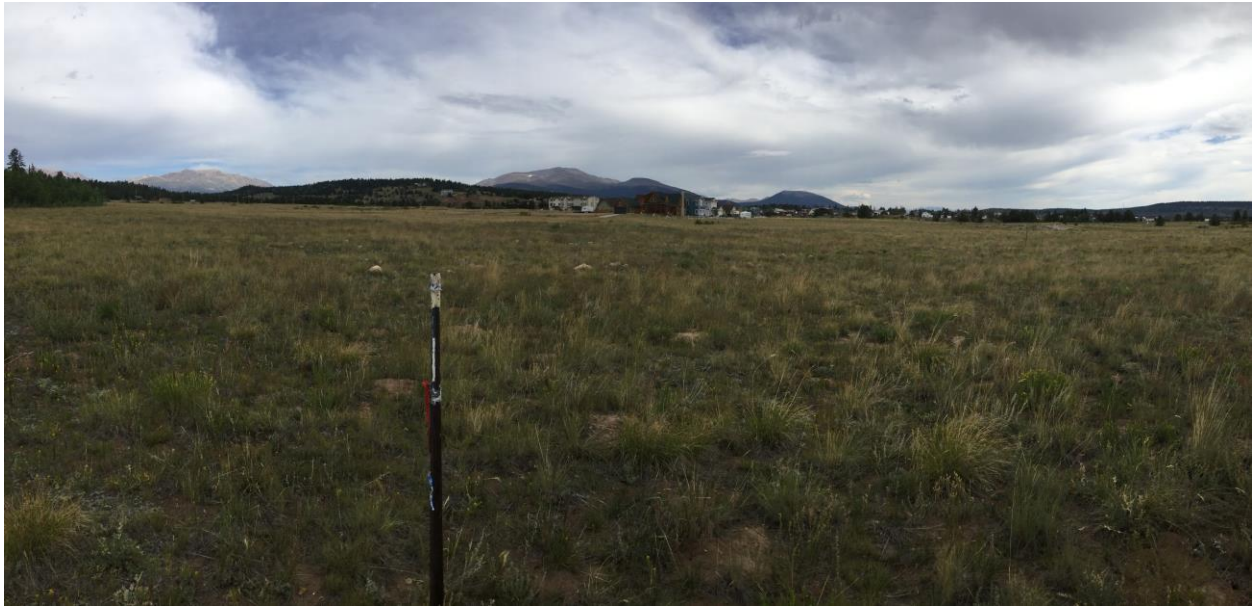
| <u>Claim Markers</u> <input type="checkbox"/> Claim Signs <input type="checkbox"/> Corners <input type="checkbox"/> Discovery Post | <div style="border: 1px solid black; padding: 5px;"><input type="checkbox"/> N/A No claim signs or corners seen. DRMS sign present in previous inspections was missing. Several green t-bar posts on northeast side of claim appeared to have flags and may have been marking utilities.</div> |

Photo 3: Post, possibly marking utilities. Looking north towards Tristan Loop houses.

| <p>Actions to be taken by the Operator</p> <p>Operators should read this report carefully because it may require corrective action and/or response to the BLM in order to avoid consideration of possible enforcement action.</p> | <p>Operator should consider clear signage and investigate location/condition of DRMS sign</p> |

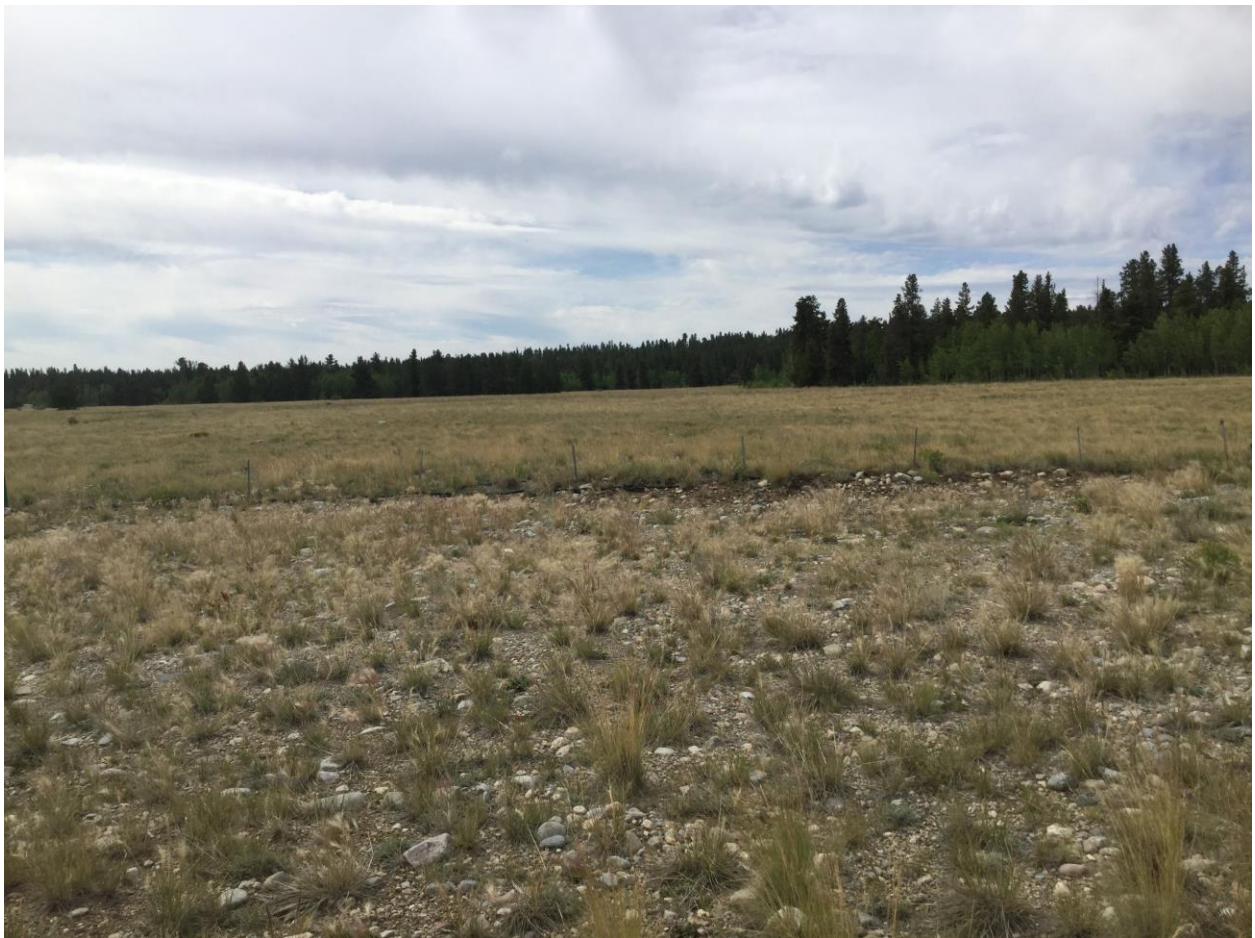
Photo 4: Taken from Tristan Loop, looking ~south. Fence seems to indicate edge of development.
