**Locatable Minerals Site Inspection**  
**U.S. Department of the Interior**  
**Bureau of Land Management**  
**Royal Gorge Field Office**

Date:9/02/2016 Time:10:20-10:30 a.m. Weather: Partly cloudy Inspection Purpose: Annual inspection	Project Name: Destiny Mine Case Number: COC-73930 Operator:Astemborski Location:Fairplay, CO
<b>Attendees</b> BLM: William Jenkins, Kelsey Zabrusky Operator(s): Other(s):	Project Status:Active Project Type:3809-PoO for gold placer; 3600-Pending contract for sand & gravel Occupancy: Concurrent
<b>General Compliance</b> Compliance with the filed Plan of Operations, and 43 CFR 3809 (in particular the performance standards outlined in 3809.420).	In general, the operation is in compliance with the Plan on file with BLM. <input checked="" type="checkbox"/> <b>Yes</b> <input type="checkbox"/> <b>No</b> <input type="checkbox"/> <b>N/A</b> <div style="border: 1px solid black; height: 40px; margin-top: 5px;"></div> In general, the operation and disturbances on site coincide with the method of prospecting, mining, and access described in the Plan of Operations. <input checked="" type="checkbox"/> <b>Yes</b> <input type="checkbox"/> <b>No</b> <input type="che

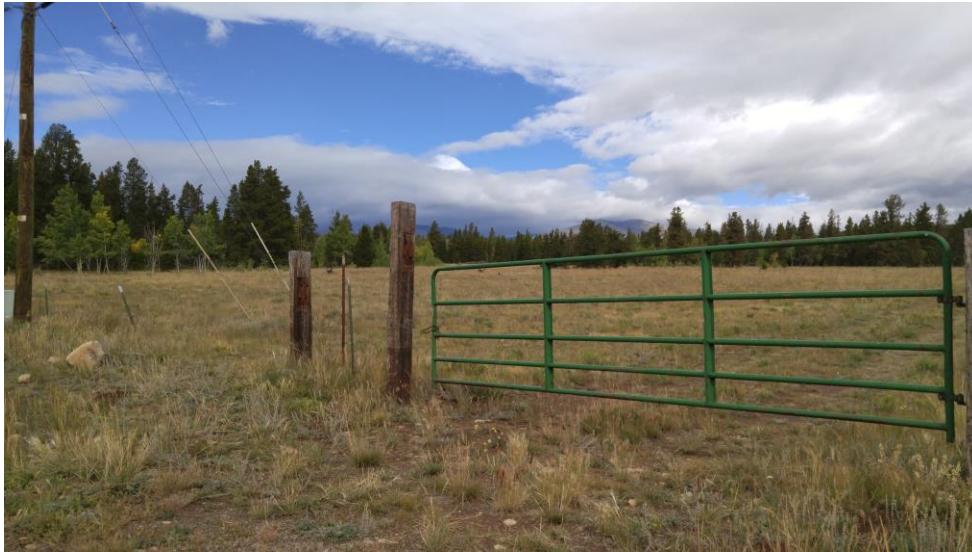
Photo 1: Access gate looking northwest.

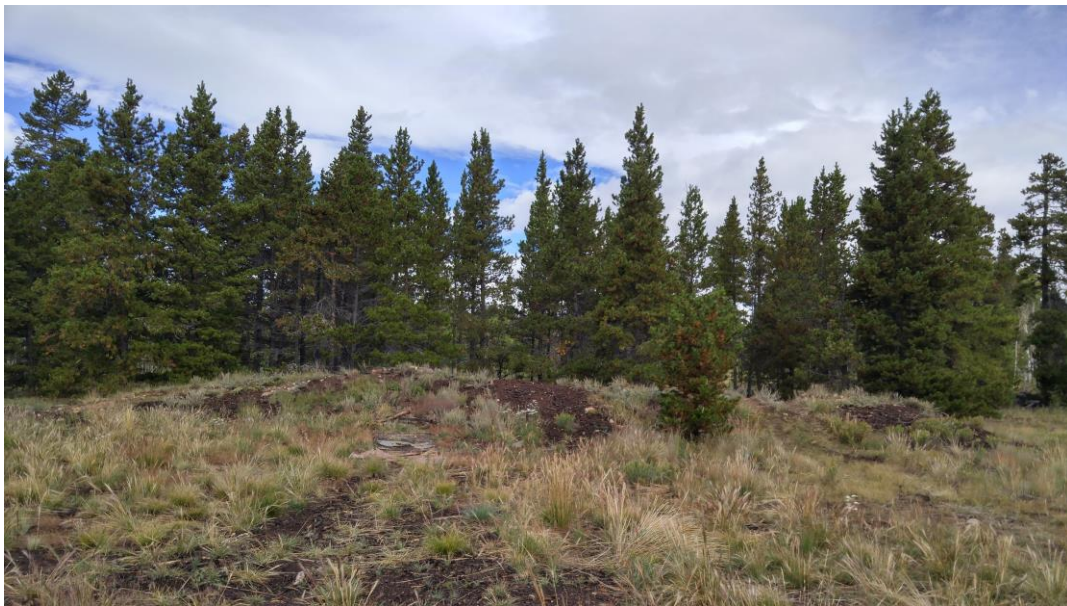
Photo 2: Wood chip pile next to trees, northwest of gate.

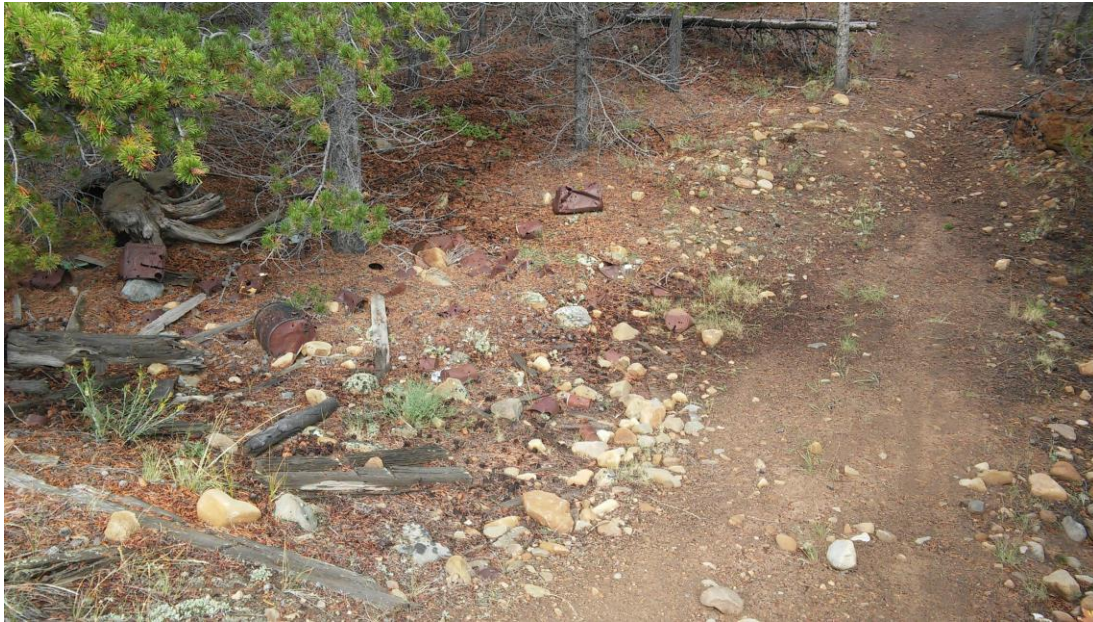
<u><b>Site Conditions</b></u> <input type="checkbox"/> Housekeeping <input type="checkbox"/> Access (clear, bermed, signed, accurate with Plan?) <input type="checkbox"/> Acreage (disturbance per plan? site secured per plan?)	<div style="border: 1px solid black; padding: 5px;">Metal cans and debris behind woodchip pile to the northwest of the gate, not associated with mining activity. Access from gate on south side is clear, not signed. Little to no disturbance seen</div>
<u><b>Claim Markers</b></u> <input type="checkbox"/> Claim Signs <input type="checkbox"/> Corners <input type="checkbox"/> Discovery Post	<input type="checkbox"/> <b>N/A</b> <div style="border: 1px solid black; padding: 5px;">No claim signs or corners seen. DRMS sign present in previous inspections was missing. Several green t-bar posts on northeast side of claim appeared to have flags and may have been marking utilities.</div>

Photo 3: Area behind woodchip pile with metal debris and possible atv tracks

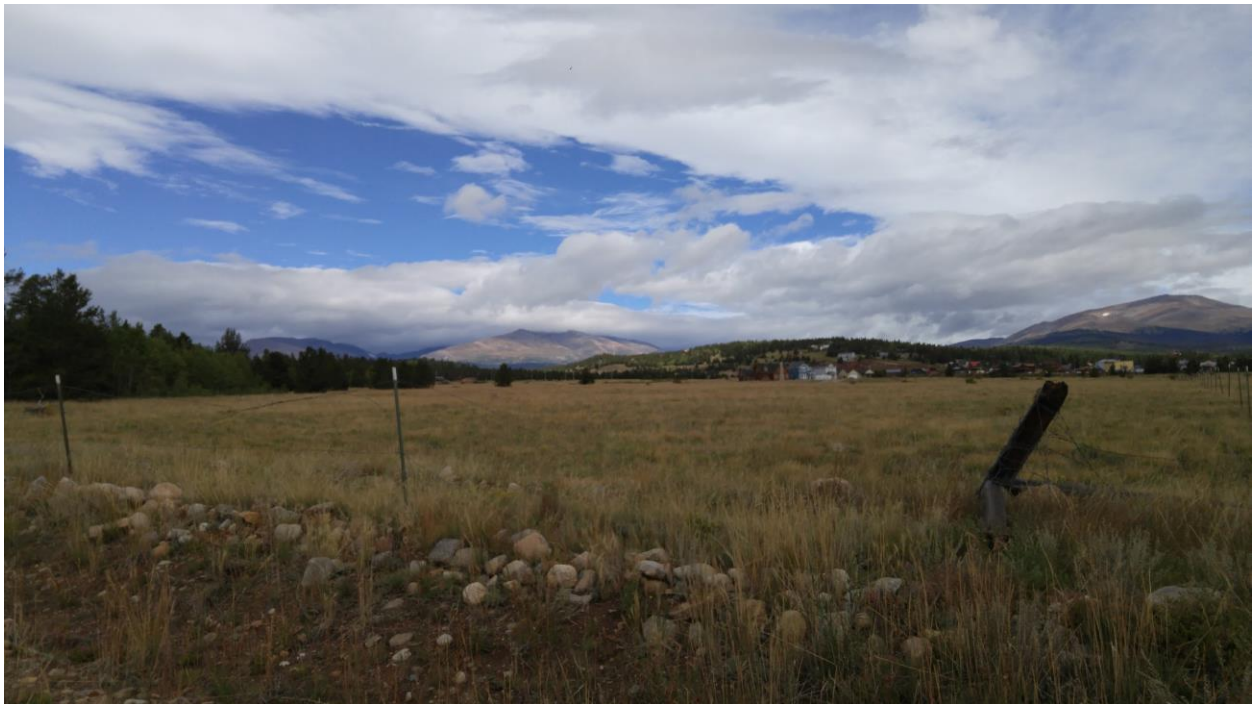
Photo 4: Taken from Thompson Park road looking north across claim.
