**COLORADO**Division of Reclamation,
Mining and Safety

MINERALS PROGRAM INSPECTION REPORT**PHONE: (303) 866-3567**

MINE NAME: Freund Pit	MINE/PROSPECTING ID#: M-1985-003	MINERAL: Sand and gravel	COUNTY: Elbert
INSPECTION TYPE: Monitoring	INSPECTOR(S): Amy Eschberger	INSP. DATE: February 18, 2016	INSP. TIME: 11:00
OPERATOR: Running Creek Ranch	OPERATOR REPRESENTATIVE: Joseph Freund, Jr.	TYPE OF OPERATION: 112c - Construction Regular Operation

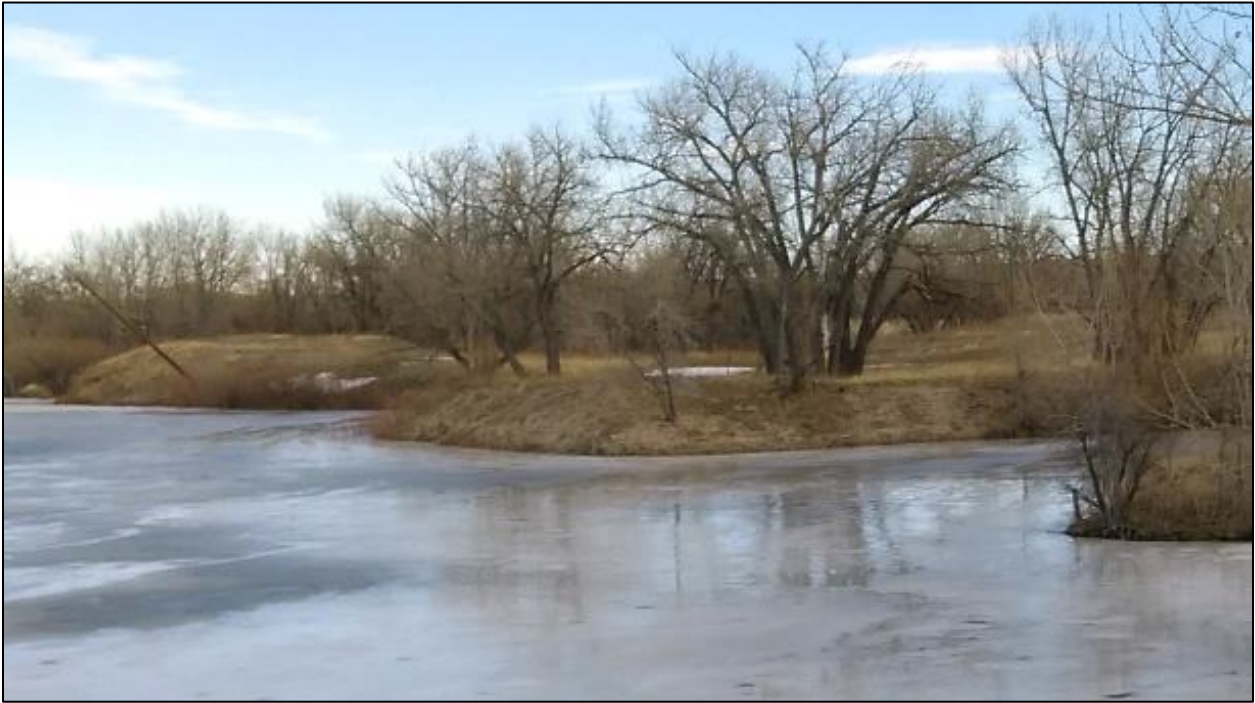
Photo 1. View looking northeast at portion of eastern shoreline, showing slope gradients of at or near 1H:1V.

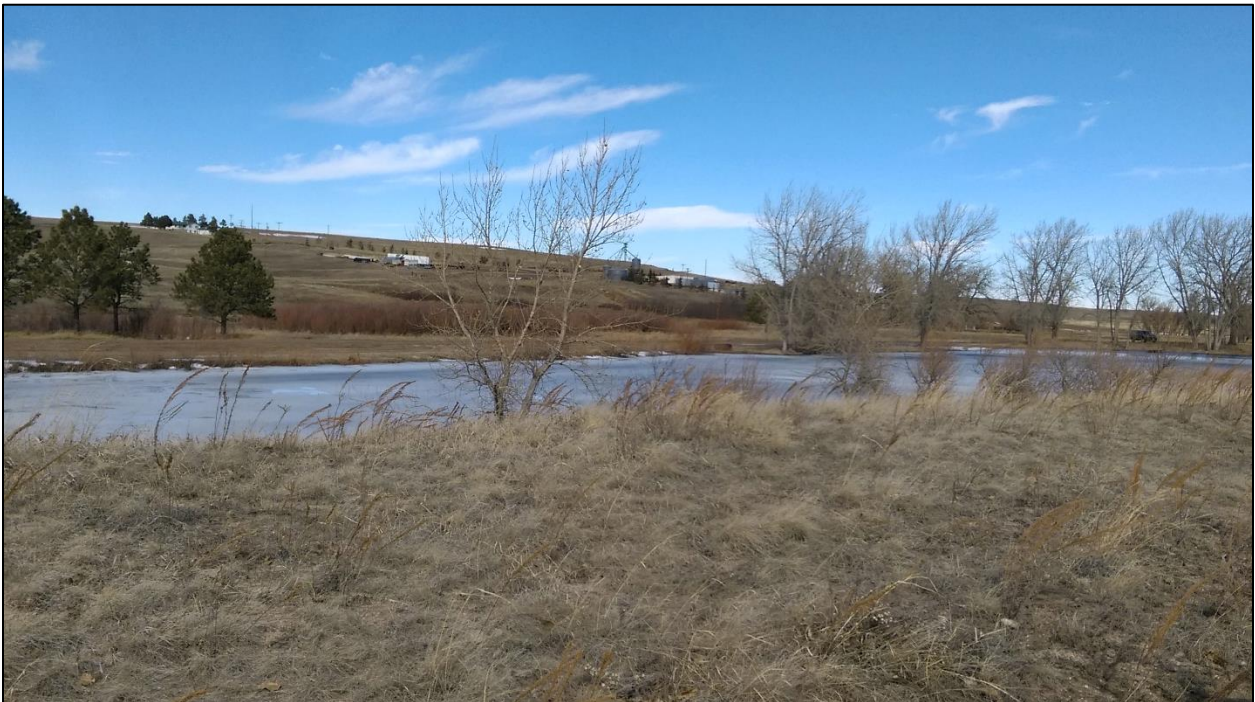
Photo 2. View looking northwest, showing vegetative cover present along eastern pond shoreline (foreground), including native grasses and some trees (mainly cottonwoods and willows).

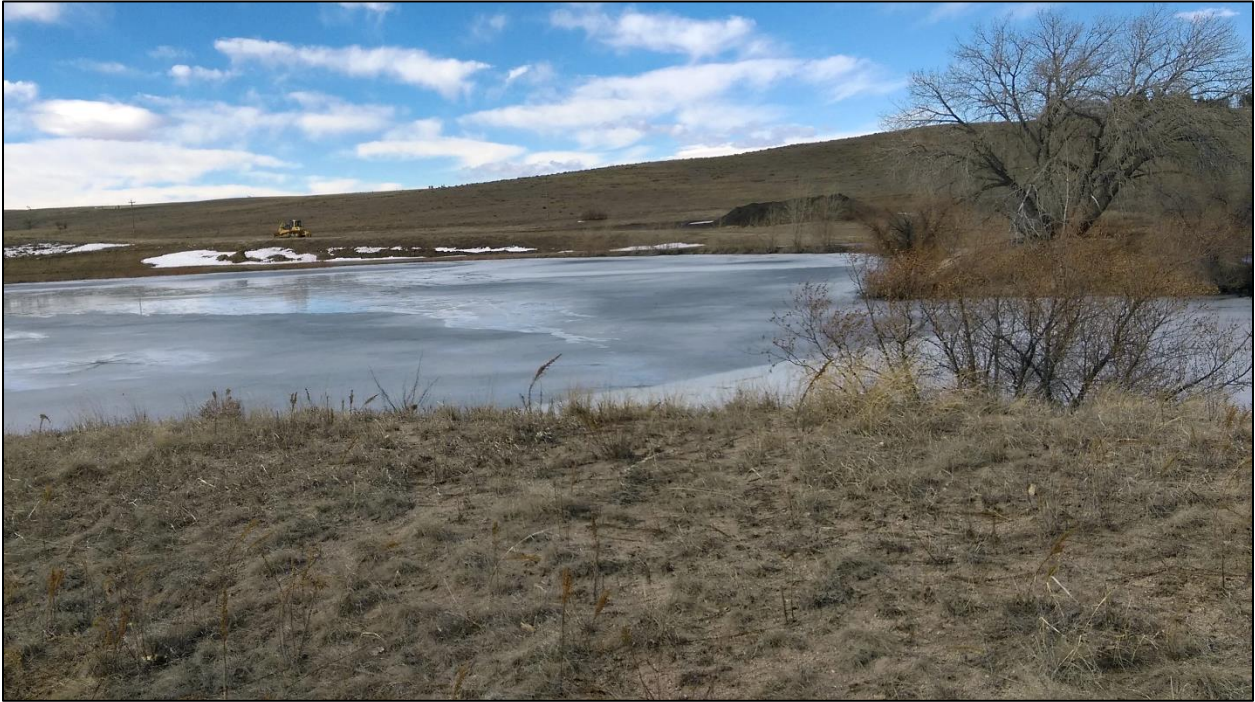
Photo 3. View looking west, showing vegetative cover present along eastern pond shoreline (foreground), including native grasses and some trees (mainly cottonwoods and willows). Looking toward extraction area located on other side of pond.

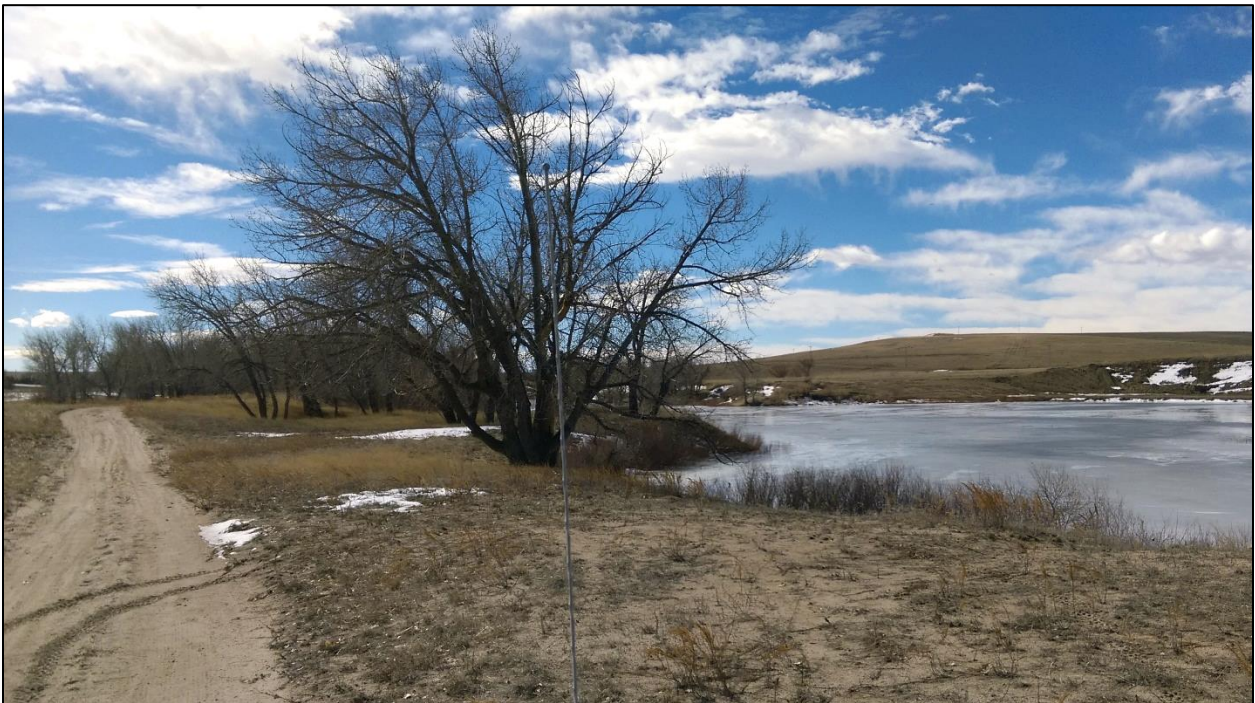
Photo 4. View looking south, showing vegetative cover present along eastern pond shoreline (foreground), including native grasses and some trees (mainly cottonwoods and willows).

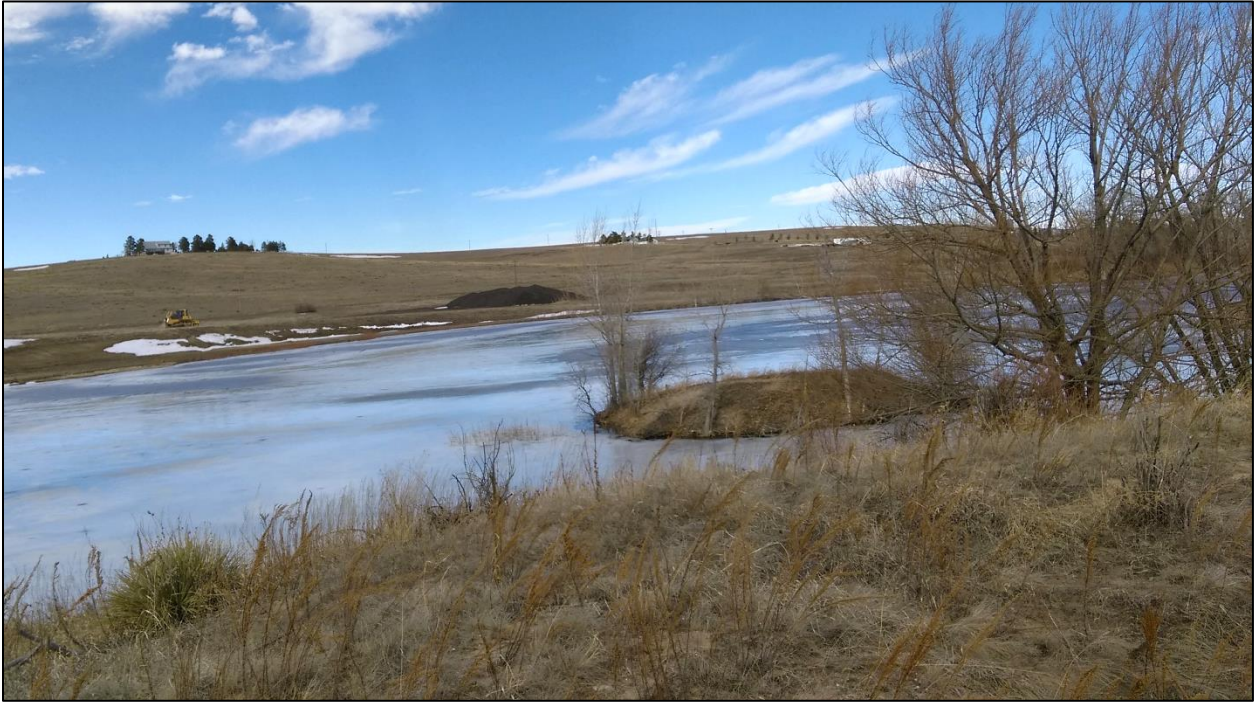
Photo 5. View looking northwest, showing vegetative cover present along eastern pond shoreline (foreground), including native grasses and some trees (mainly cottonwoods and willows). Note small island present in pond (shown at center, right).

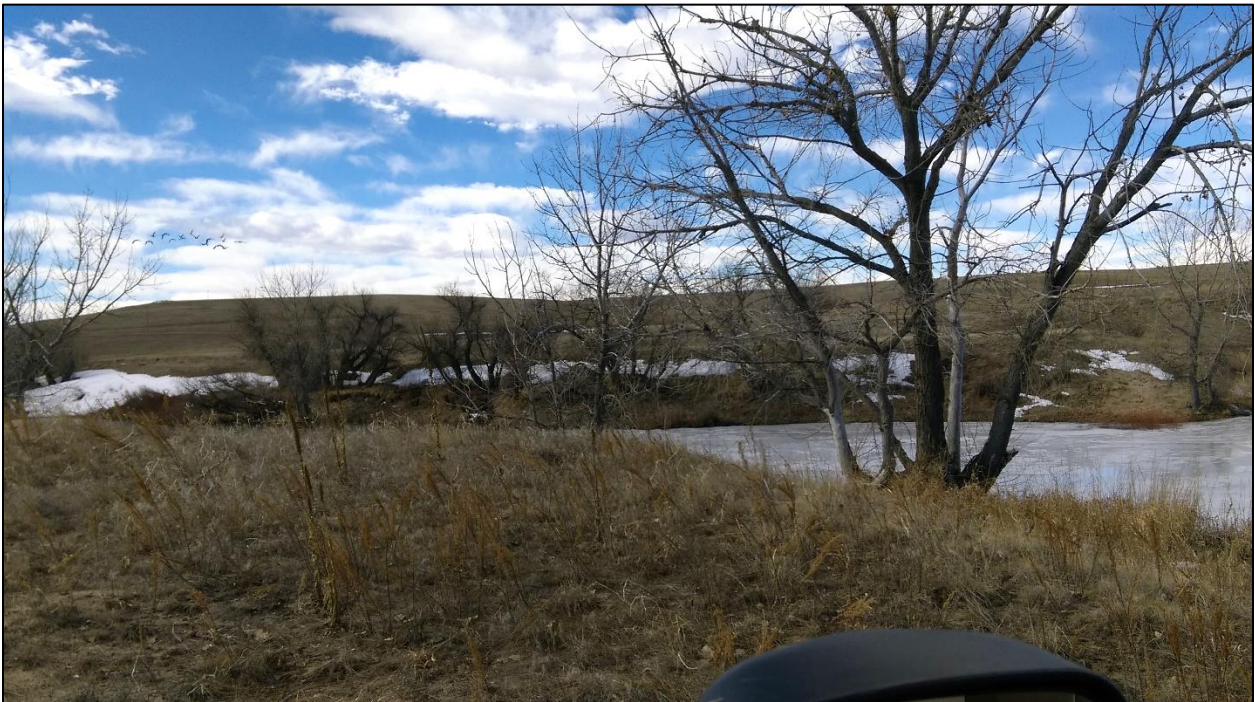
Photo 6. View looking west, showing vegetative cover present along eastern pond shoreline (foreground), including native grasses and some trees (mainly cottonwoods and willows).

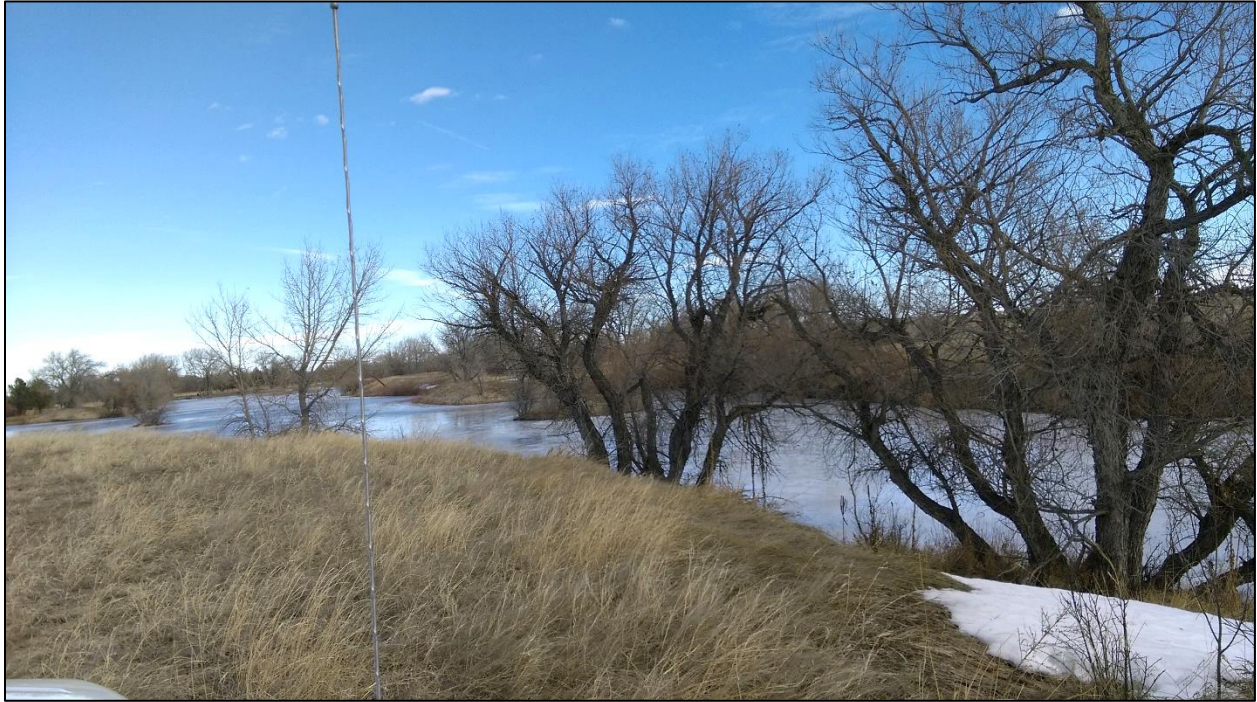
Photo 7. View looking northeast, showing vegetative cover present along southern pond shoreline (foreground), including native grasses and some trees (mainly cottonwoods and willows).

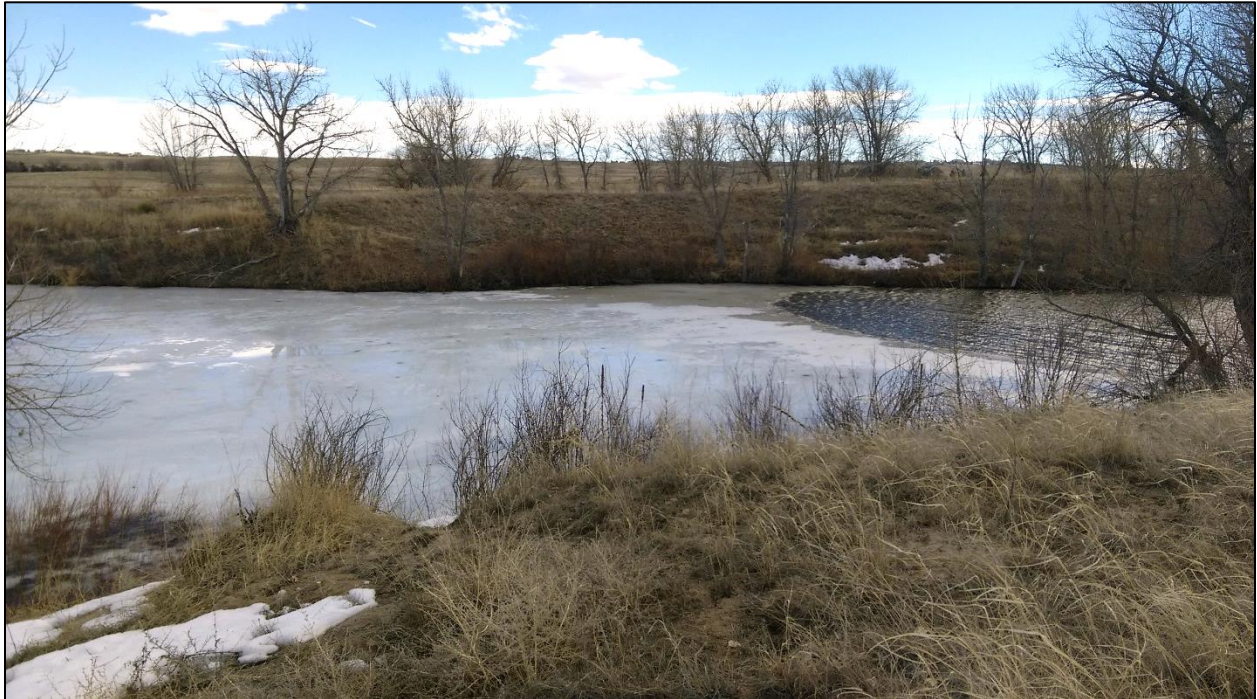
Photo 8. View looking east, showing vegetative cover present along southern pond shoreline (foreground and background), including native grasses and some trees (mainly cottonwoods and willows).

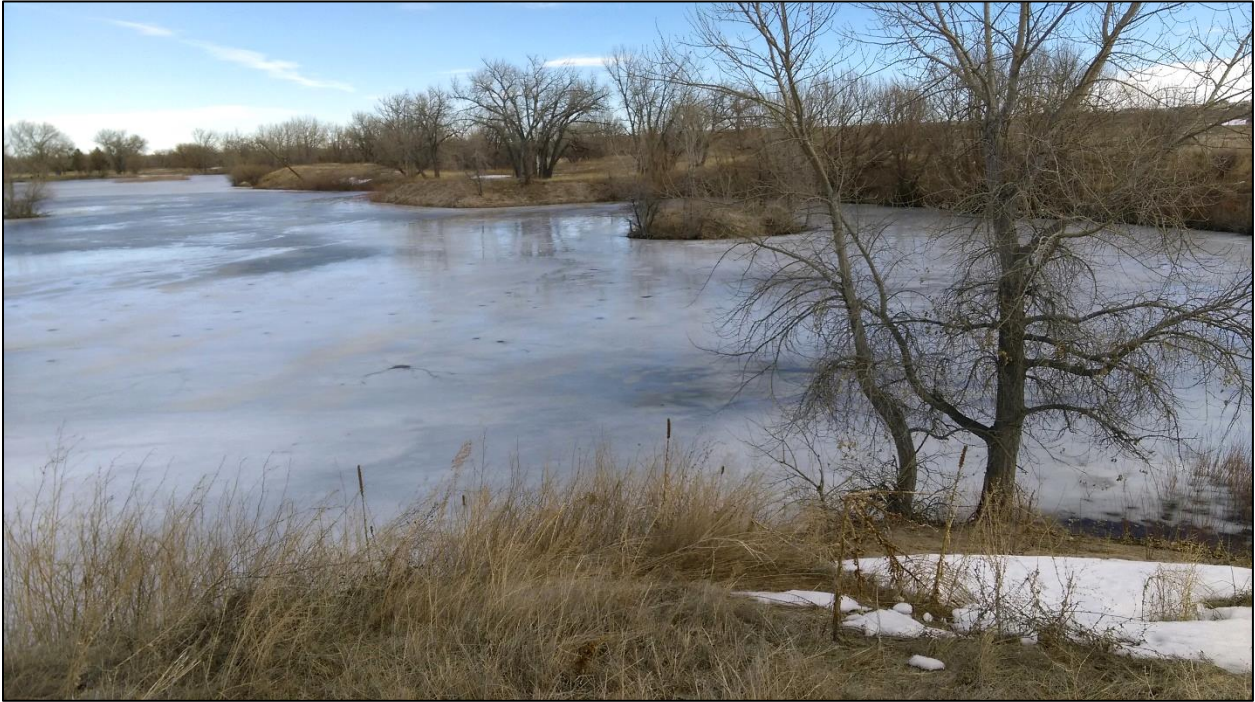
Photo 9. View looking northeast, showing vegetative cover present along southern pond shoreline (foreground), including native grasses and some trees (mainly cottonwoods and willows). Note small island present in pond (shown at center, right).

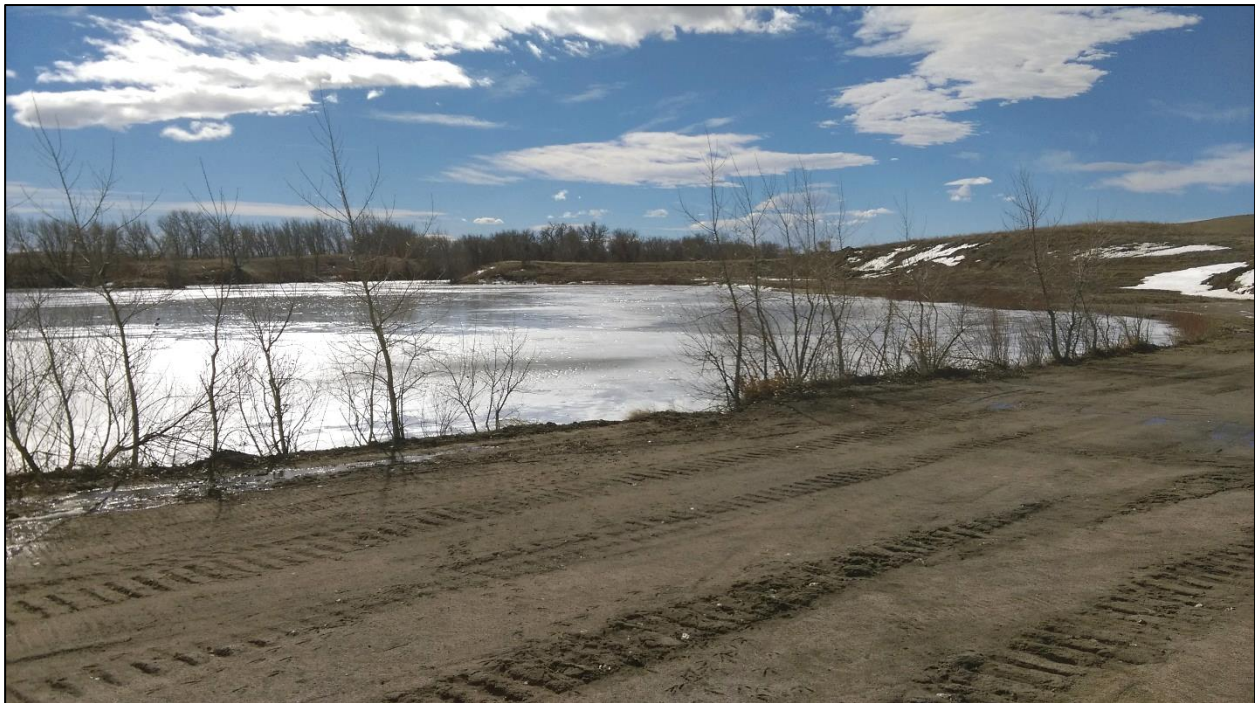
The Division estimates the current pond to be approximately 10.25 acres in size (10.5 acres total minus 0.25 acre for islands present in the pond). This means the operation has expanded the pre-existing 7 acre pond by approximately 3.25 acres. The total amount of exposed groundwater is compliant with the maximum exposure of 27 acres allowed by the approved augmentation plan for the site (mentioned above). The eastern and southern pond banks appear to be steeper than the approved 3H:1V slope gradient. Some portions appear to have slopes at or near 1H:1V (**Photo 1**). As the Division has noted in previous inspection reports, all pond shorelines will need to be graded to the approved slope gradient of 3H:1V or flatter for final reclamation. The Division understands the eastern pond shoreline was created prior to the site being permitted (and prior to 1980). However, the shoreline is included in the approved permit area, and therefore, must be reclaimed in accordance with the approved reclamation plan. All but the more recently created western pond shoreline have a good establishment of native grasses and trees (mainly willows and cottonwoods) that appear to have volunteered into these areas (**Photos 2-9**). This vegetative cover appears to be effectively controlling erosion of the pond slopes at this time. The western shoreline has slope gradients ranging from 3H:1V to nearly flat, with some native grasses and willows volunteering across this side of the pond (**Photo 10**).

Photo 10. View looking south at portion of western shoreline, showing slope gradients of near flat.

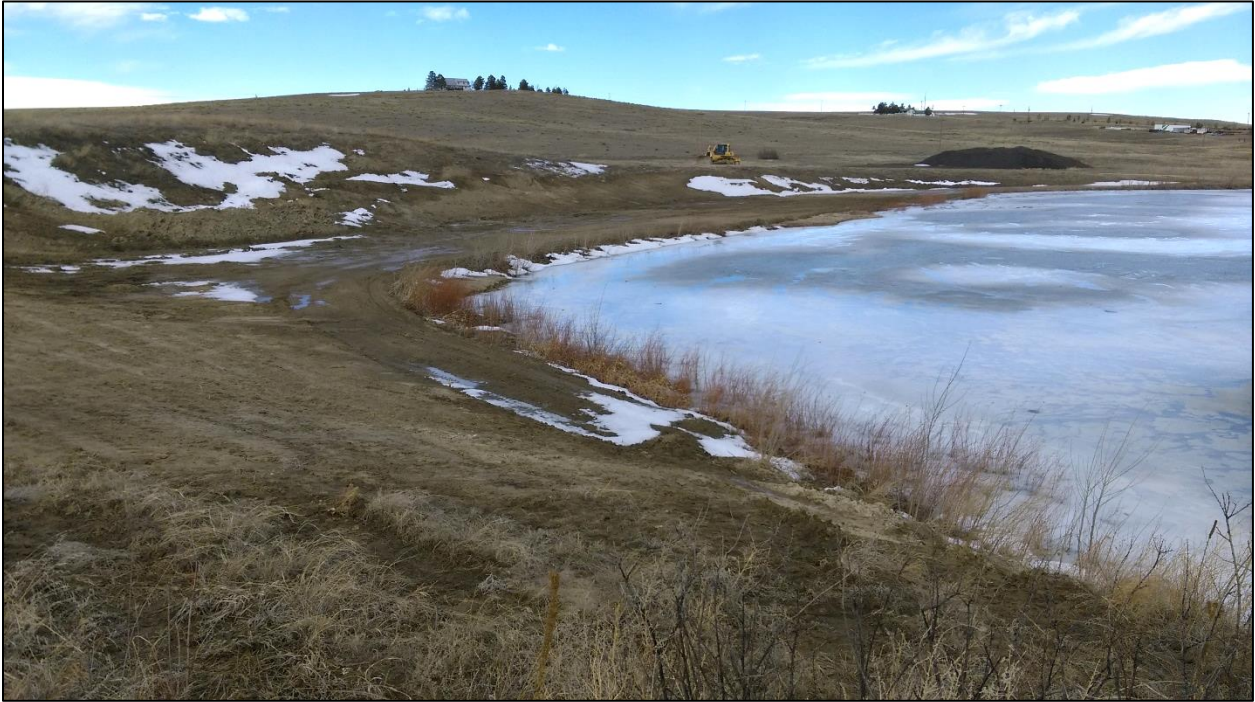
The most recent excavation area located west of the pond (**Photos 11 and 12**) is approximately 5 acres in size, and includes a stripped area, a topsoil stockpile, and a milled asphalt stockpile. Mr. Freund said the operation had mined down to a clay layer in this area and stopped. Therefore, the operation may not continue to expand the pond in this area, but mine the sand and gravel on top of the clay layer, then reclaim the disturbed land. The salvaged topsoil is stored along the western edge of the excavation area, and appears to be stable with good grass cover (**Photo 13**). The stockpile of milled asphalt is stored at the northwestern corner of the area, north of the haul road (**Photo 14**). A problem was cited for this stockpile in the Division's April 4, 2007 inspection report, requiring the operator to give more details about the stockpile and its intended use. The Division was concerned the stockpile would be used for backfill in the pond. The operator submitted a letter on October 31, 2007 which explained that the stockpile is used strictly for road maintenance on the ranch and would not be buried on site or used as backfill for the pond. At the time, the operator estimated the stockpile to be approximately 3,000 CY in volume. According to historic aerial images of the site available in Google Earth, the current stockpile is slightly smaller than it was in 2007, but appears to fluctuate in size throughout the years as it is added to and used.

Photo 11. View looking northwest at southern portion of most recent excavation area located just west of pond. Note shoreline slope gradients at 3H:1V to near flat.

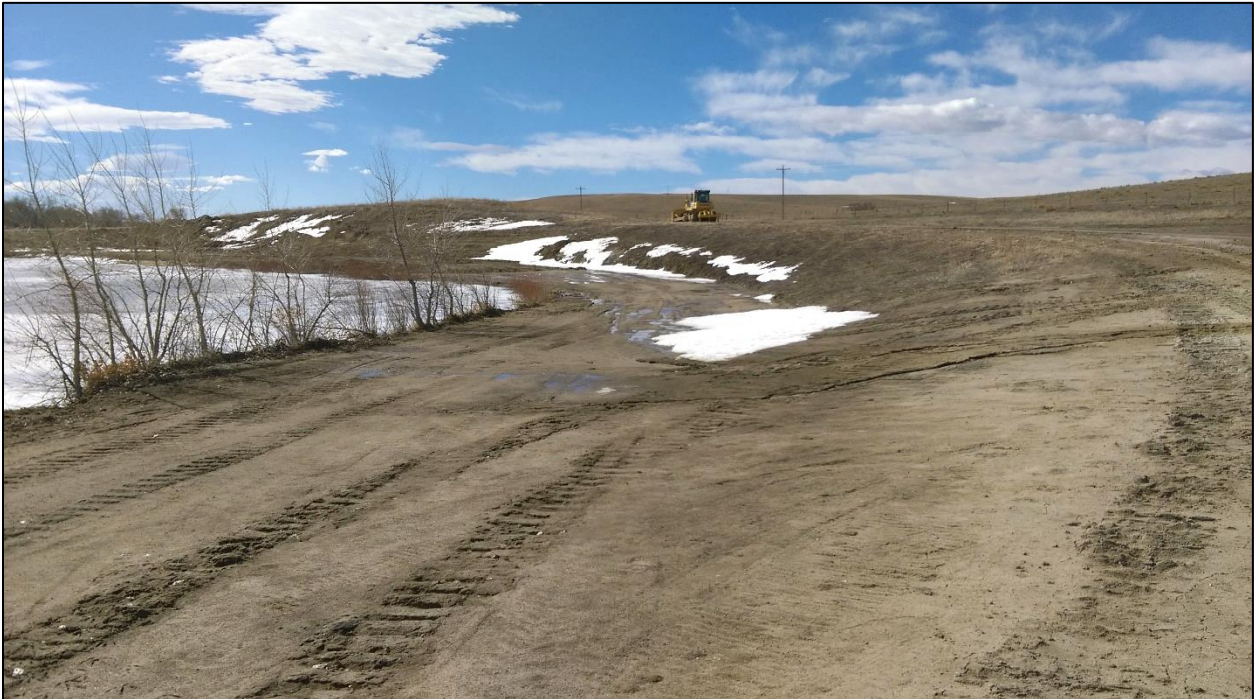
Photo 12. View looking southwest at northern portion of most recent excavation area located just west of pond. Note shoreline slope gradients at 3H:1V to near flat.

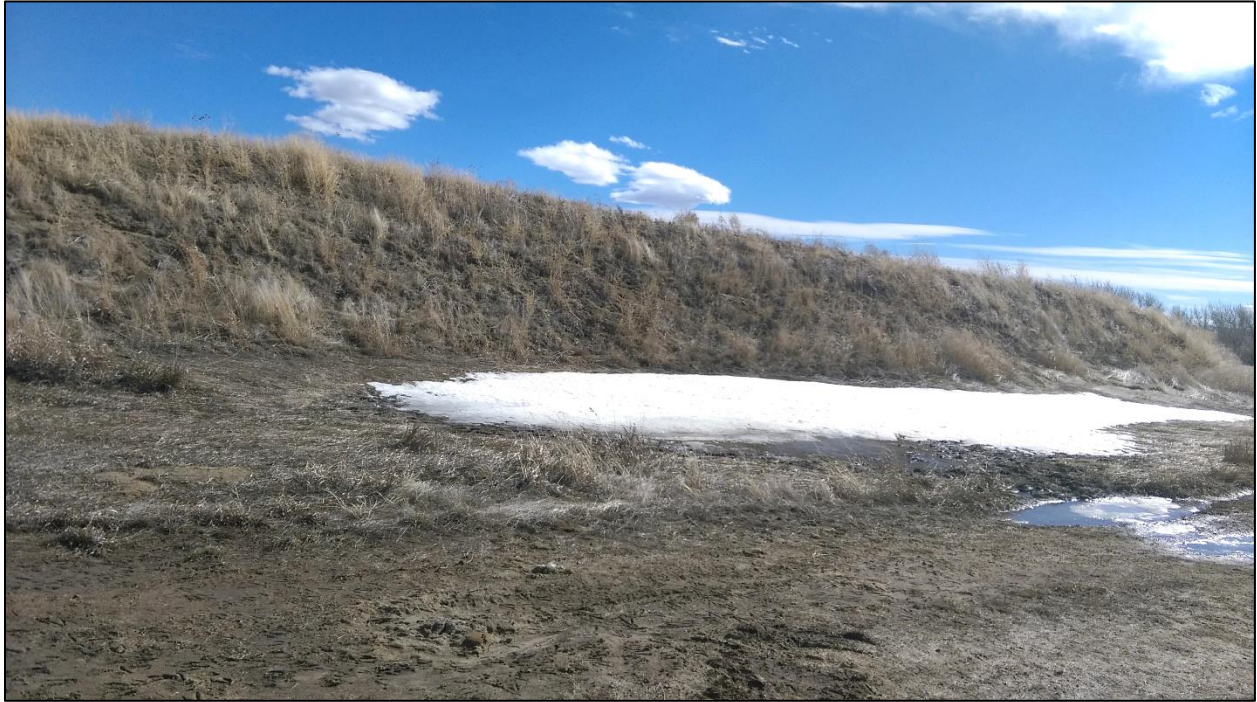
Photo 13. View of topsoil stockpile stored at western edge of most recent excavation area located just west of pond. Note stockpile appears to be stable with good grass cover.

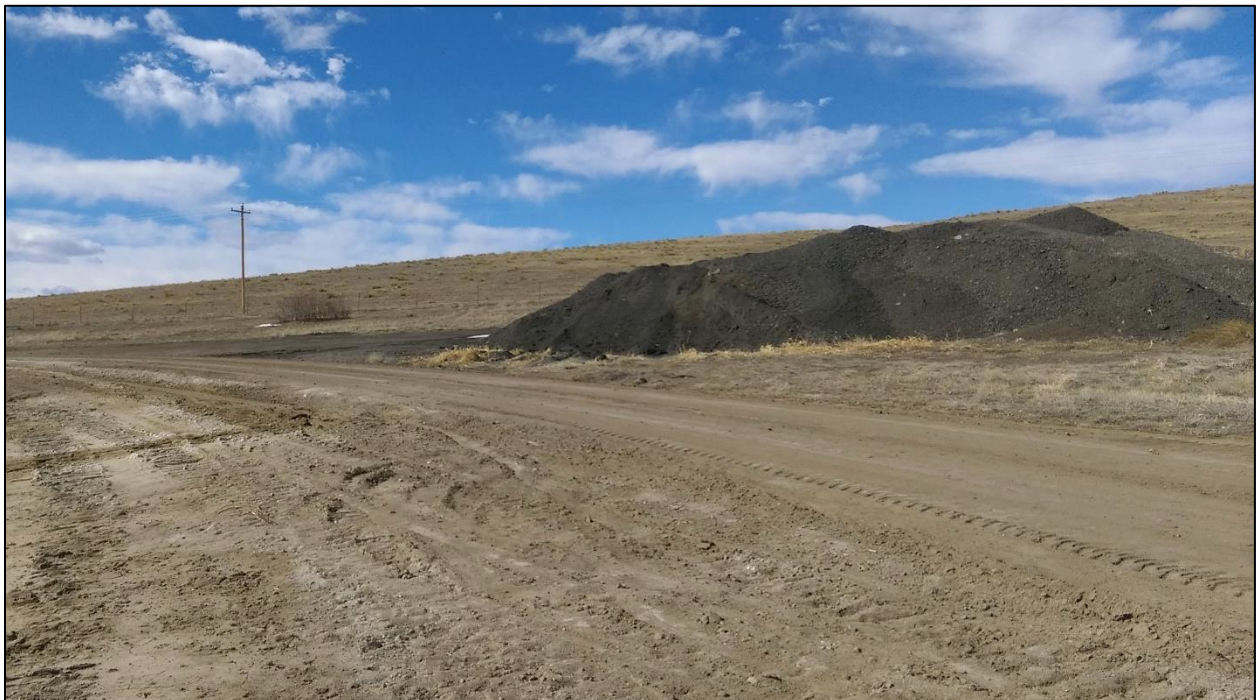
Photo 14. View of milled asphalt stockpile stored at northwestern corner of most recent excavation area located just west of pond.

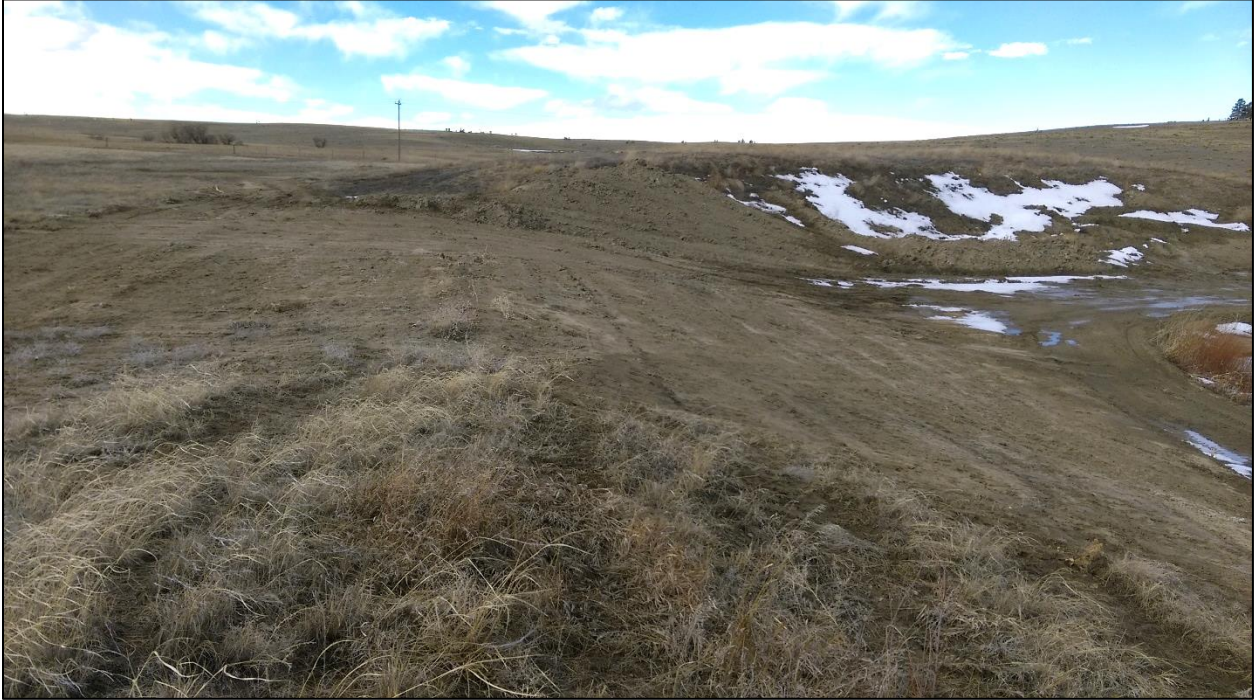
Photo 15. View looking west across southern portion of most recent excavation area located west of pond, showing recent grading to repair stormwater damage along slope.

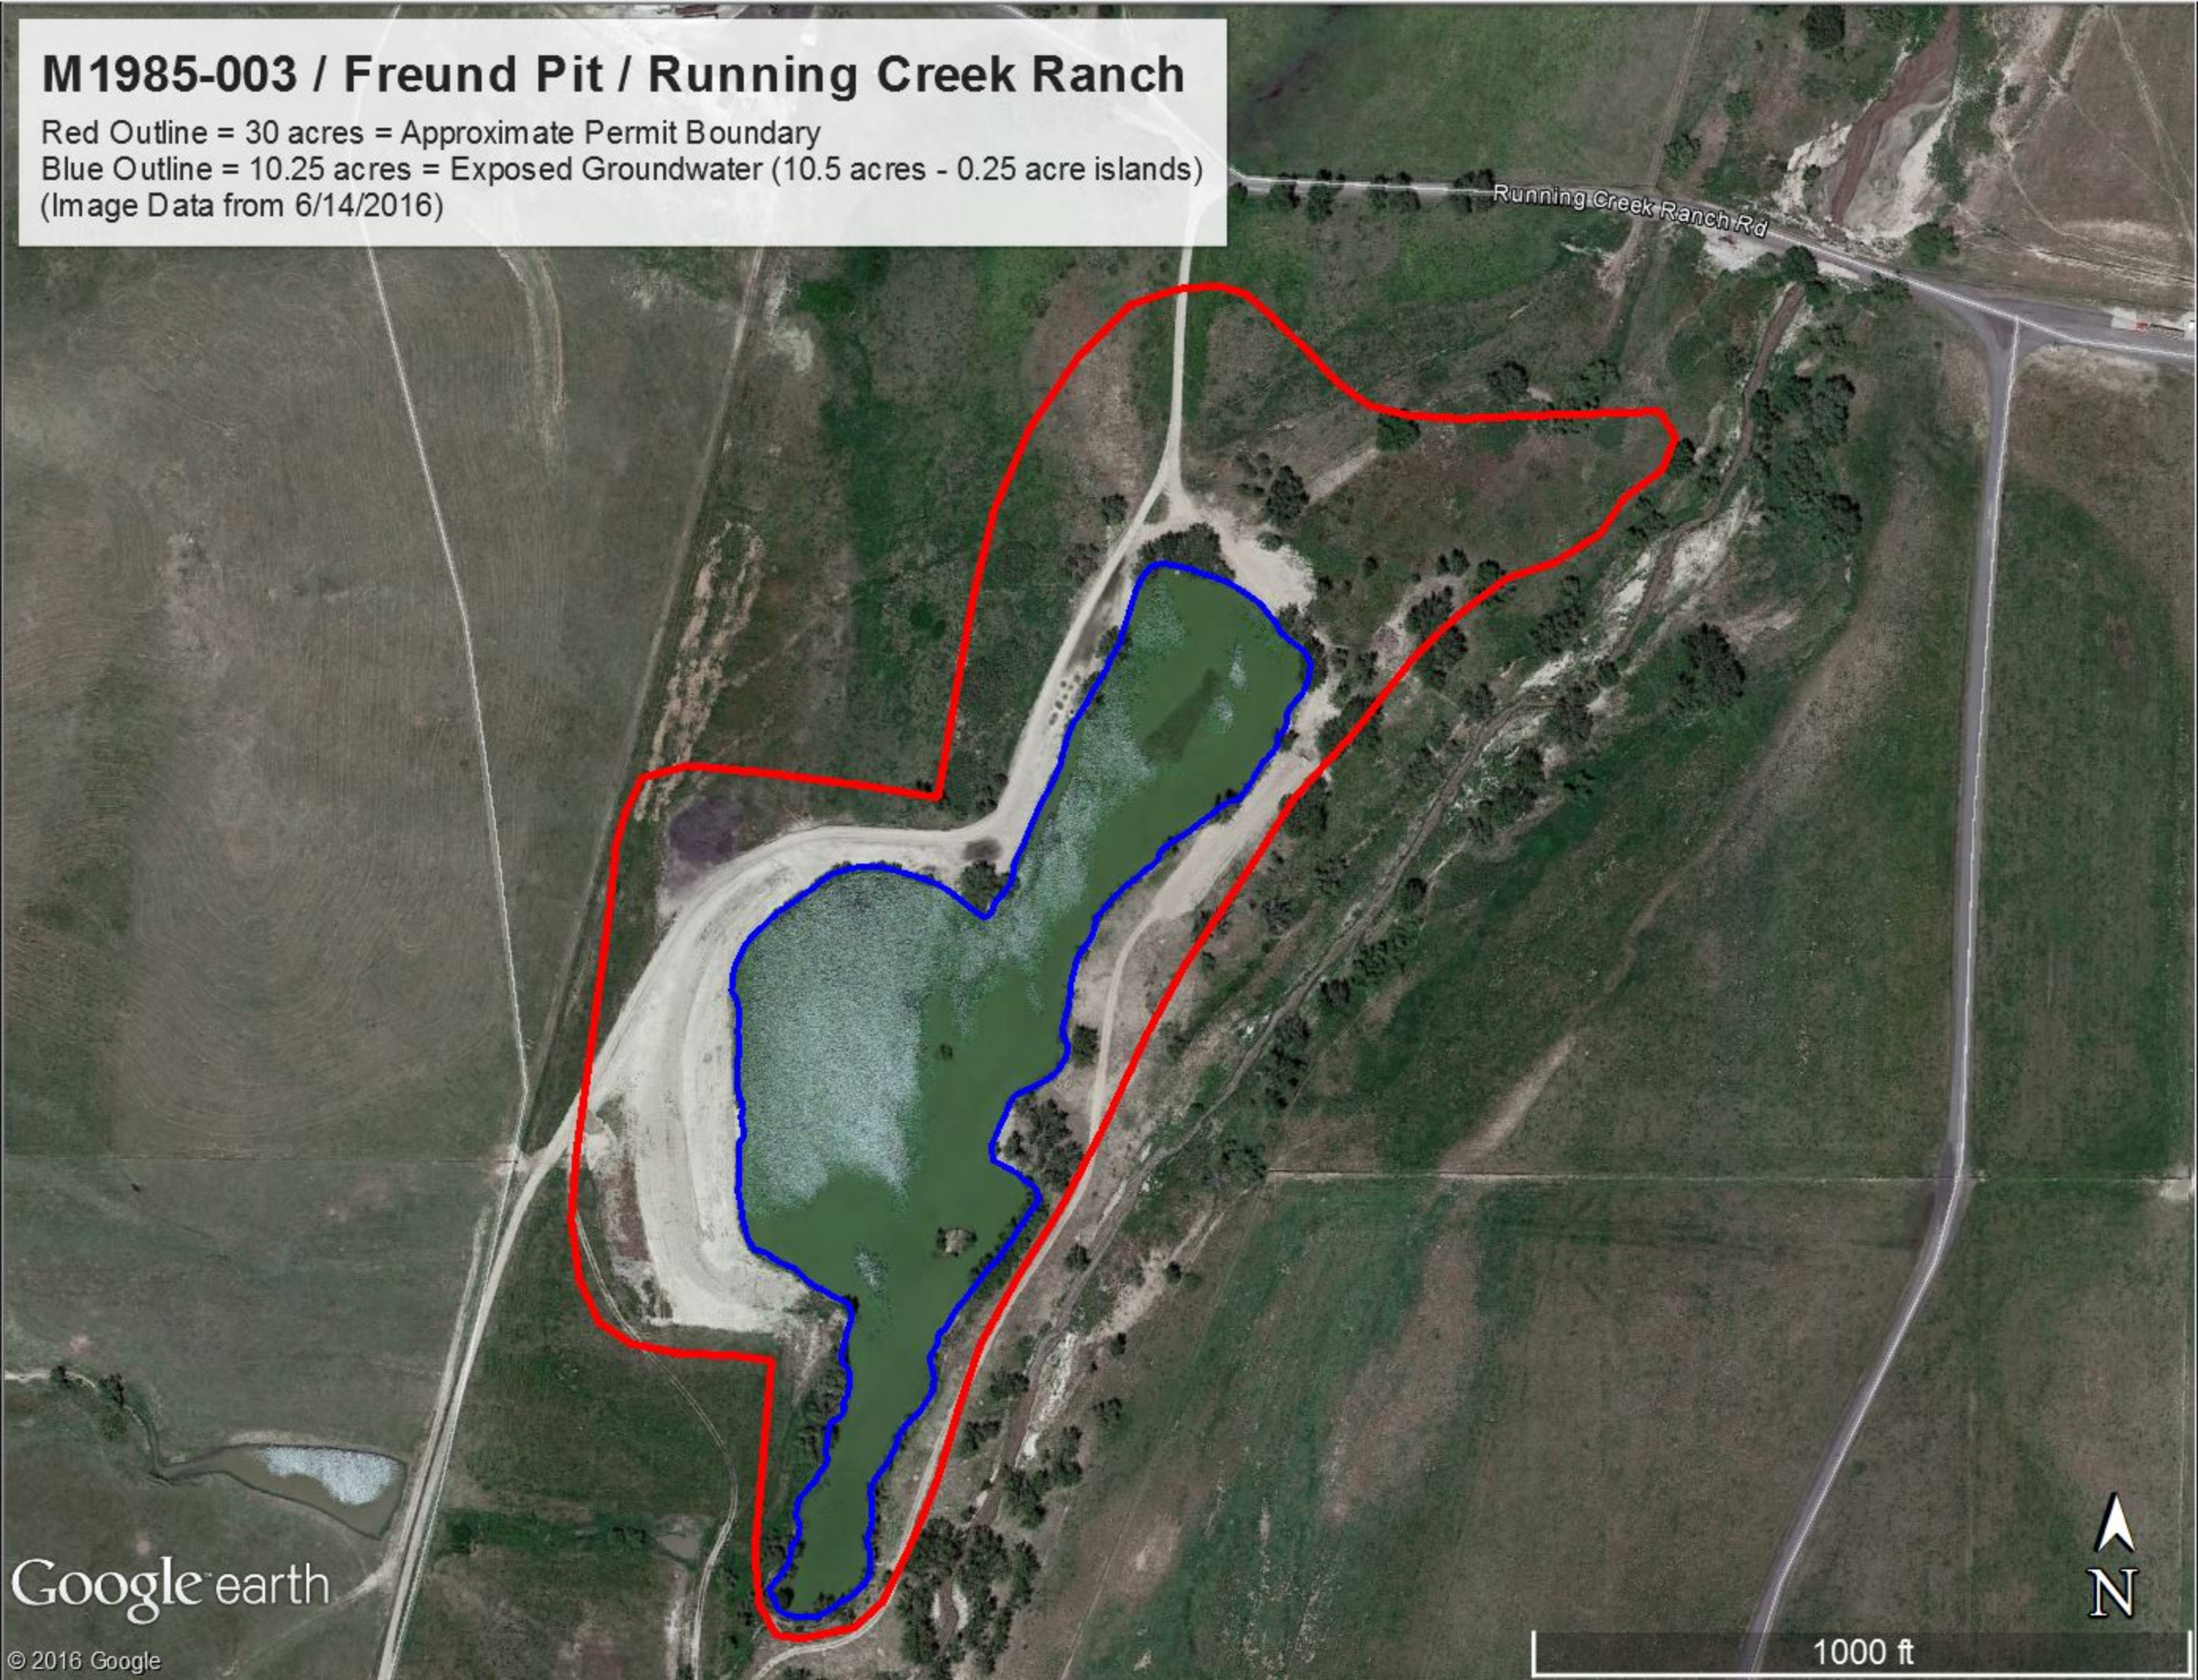
M1985-003 / Freund Pit / Running Creek Ranch

Red Outline = 30 acres = Approximate Permit Boundary
Blue Outline = 10.25 acres = Exposed Groundwater (10.5 acres - 0.25 acre islands)
(Image Data from 6/14/2016)

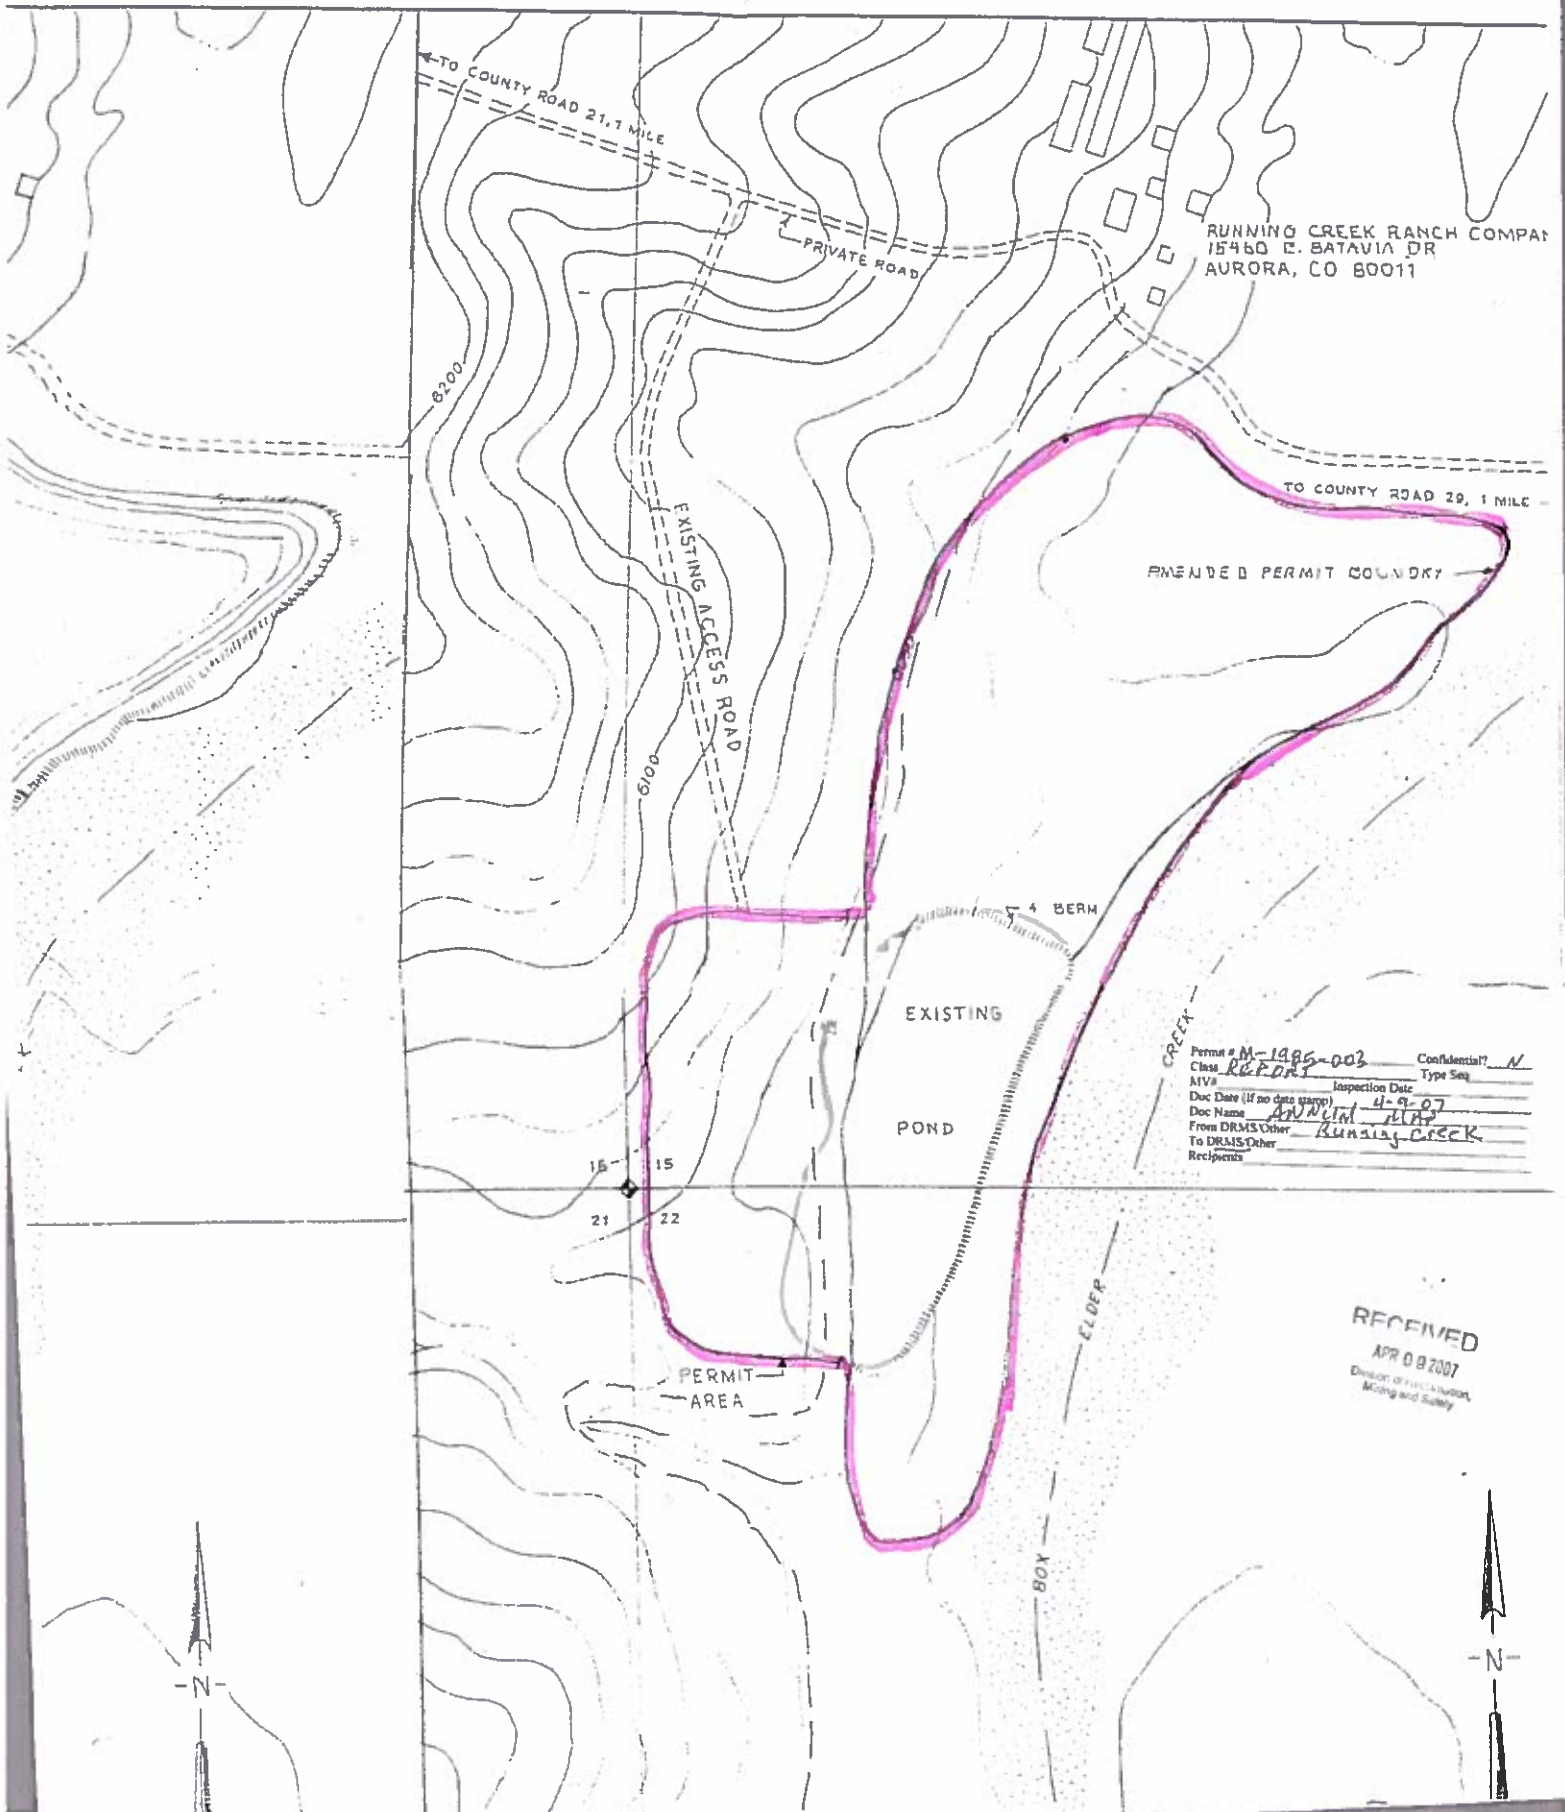
M1985-003 / Freund Pit
Pink Outline = 112c Permit Boundary

PROBLEM: The affected area boundary markers are missing or incorrectly placed. This is a problem for failure to maintain boundary markers around the affected area as required by Construction Materials Rule 3.1.12(2).

At the time of the inspection, it was sunny and cool, with some snow cover remaining on the ground. A permit sign was posted at the gated entrance to the site off of Co Rd 29. The private access road is not indicated to be part of the approved permit area, but a "pre-existing ranch road not significantly improved for the mining operation". The 112c permit area approved in the 1988 Conversion application is curved in shape, and appears to include the existing 7 acre pond, forms a somewhat rectangular shaped area just west of the pond, and includes a larger area to the north of the pond but south of the access road. During the inspection, the Division could not locate any markers that properly delineate the approved permit boundary. Mr. Freund indicated the permit boundary is delineated by fencelines and ranch roads in the area. There is a ranch road that circles the perimeter of the pond and property fencelines present to the west and south of the permit area. However, in reviewing aerial images of the site available in Google Earth, the fencelines and ranch roads do not delineate the approved permit boundary. The enclosed Google Earth image of the site shows the approximate location of the approved permit boundary as shown on the permit maps submitted with the 1988 Conversion application (see enclosed permit map showing 112c permit boundary). It appears the most recent excavation area located west of

the pond is very close to the western permit boundary, meaning the operation could very likely cause offsite damage if the boundary is not properly delineated on the ground, as required. Pursuant to Rule 3.1.12(2), the boundaries of the affected area must be marked by monuments or other markers that are clearly visible and adequate to delineate such boundaries. A problem is cited in this report (see page 1) for failure to maintain boundary markers around the affected area. The operator will need to conduct a survey and replace the boundary markers in the correct locations. The operator shall submit to the Division by the corrective action due date photographs of the markers once they are placed, and a site map showing the approved permit boundary which indicates the locations where photographs were taken.

CORRECTIVE ACTIONS: The operator shall conduct a survey and replace the boundary markers in the correct locations. The operator shall provide proof to the Division that this has been done by the corrective action date. Proof shall be submitted as photographs of boundary markers along with a site map showing the approved permit boundary that indicates the locations where corresponding photographs were taken.
