Re: M-1980-244 Cresson Project – 2015 Arequa Gulch VLF Annual Geotechnical Inspection Report.

RE: 2015 Annual Arequa Gulch Valley Leach Facility Inspection
Cripple Creek & Victor Gold Mining Company
Cresson Project
Victor, Teller County, Colorado

CLIENT CRIPPLE CREEK & VICTOR GOLD MINING COMPANY	
PROJECT		2015 ANNUAL AREQUA GULCH VLF INSPECTION	
TITLE		PHOTO LOG	
		FILENAME 106.001.008F	REVISION 0
		FIGURE NO. 1	REVISION 0

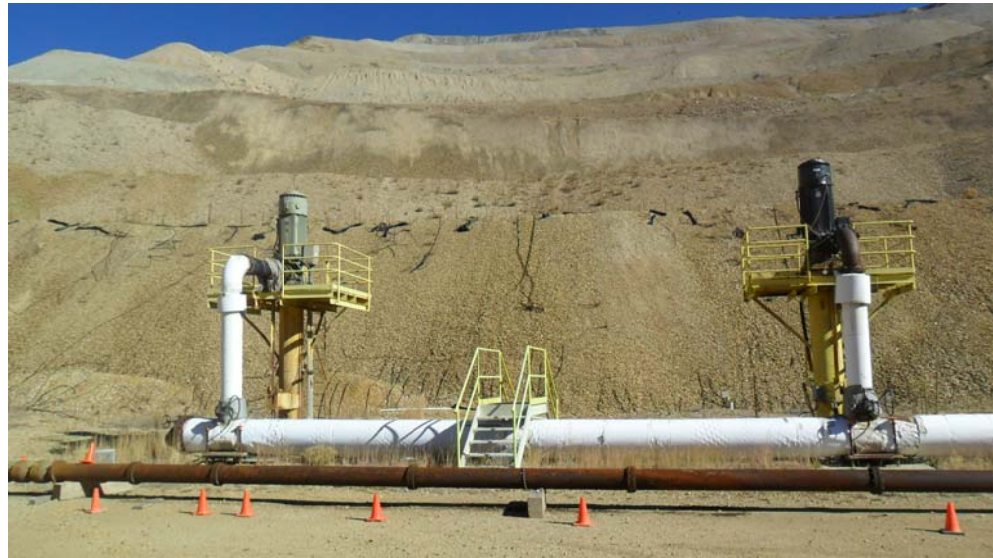
The ore slopes within the AG-VLF were observed to be stable. NewFields did not observe signs of slope slumping (other than minor surficial slips due to bench grading activities and slopes under active leach), seepage faces or evidence of perched water zones, surface cracking, or any other signs of any unstable slope movements, i.e. surface tension cracks at the slope crest or bulging at the toe of the slopes. Above the PSSA Risers, the ore set back appears to be adequate, and the slope above the risers appears dry and stable.

PHOTO 1: NEAR PHASE II PSSA RISERS

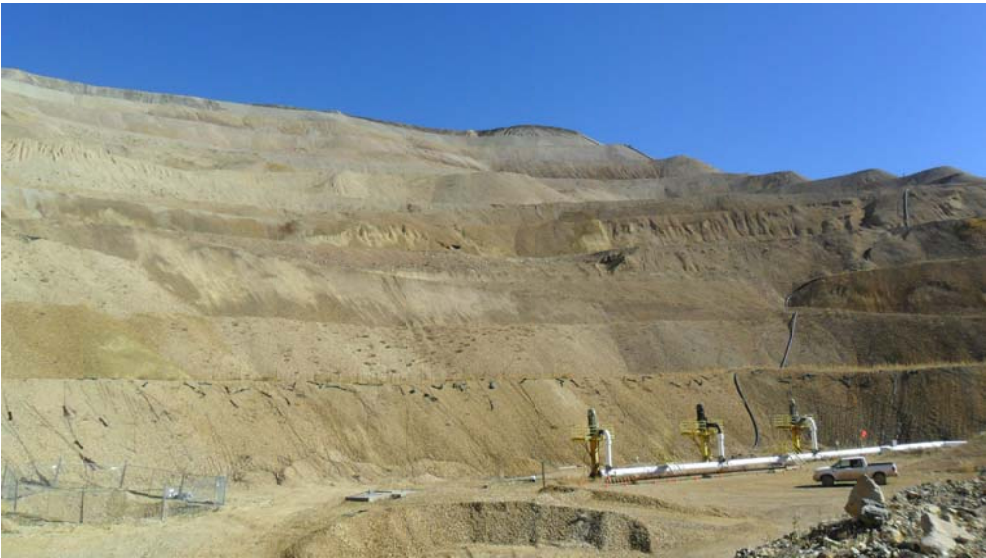
PHOTO 2: VLF SIDE-SLOPE LOOKING
SOUTHEAST AT THE VLF SLOPE NEAR
PHASE II PSSA RISERS

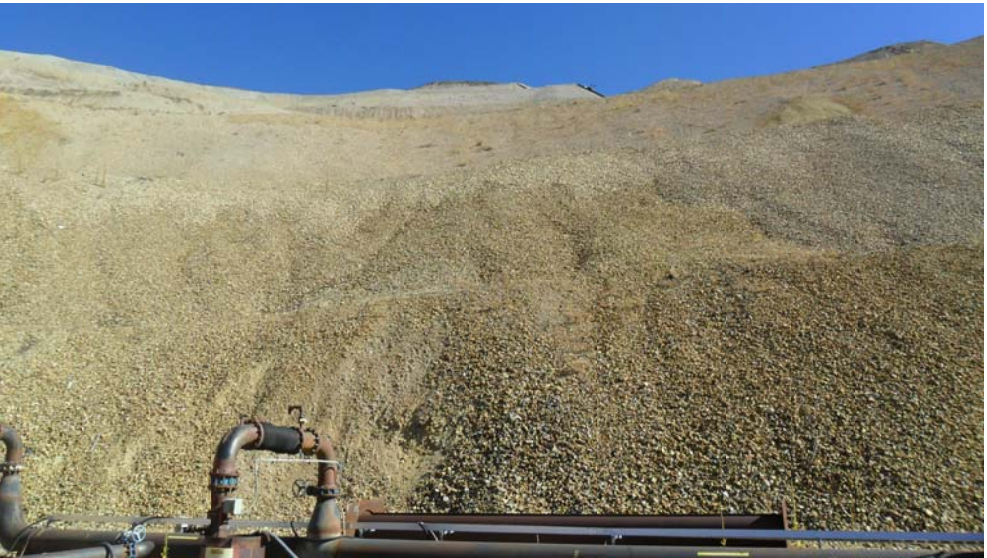
PHOTO 3: PHASE 1 PSSA RISERS

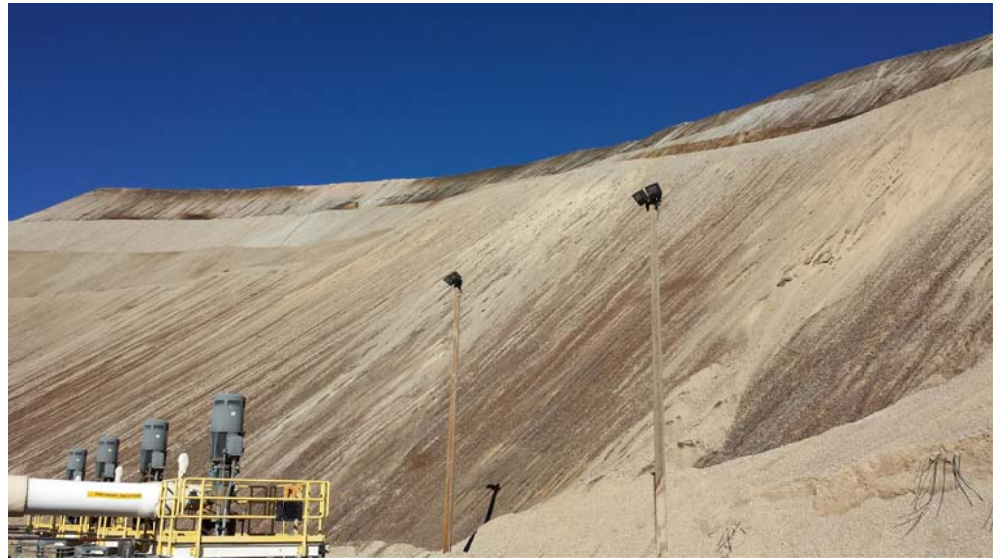
PHOTO 4: LEACHING ON SIDE-SLOPES
ABOVE THE PHASE 5 PSSA RISERS

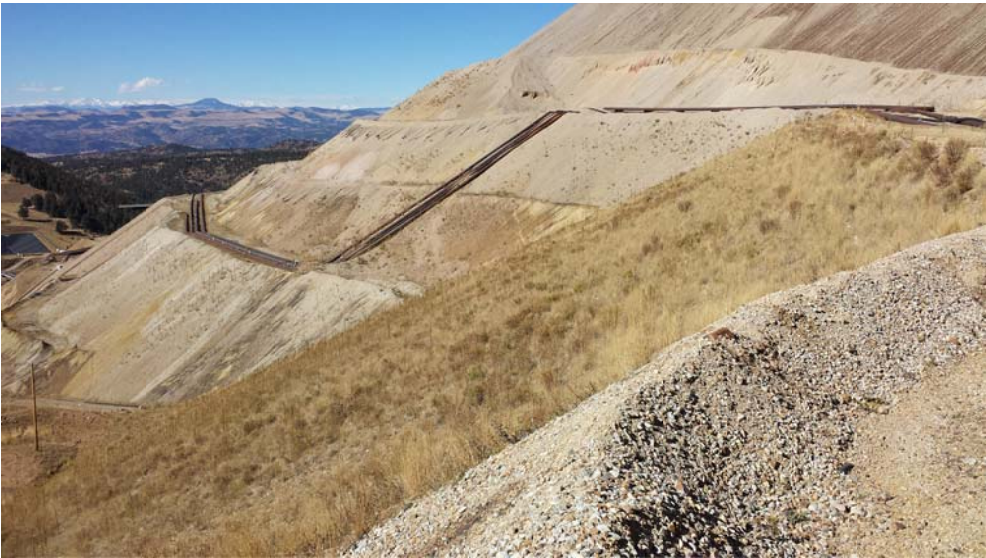
PHOTO 5: PHASE 1 SLOPE, THE PHOTO WAS
TAKEN FROM PHASE 5 EMBANKMENT

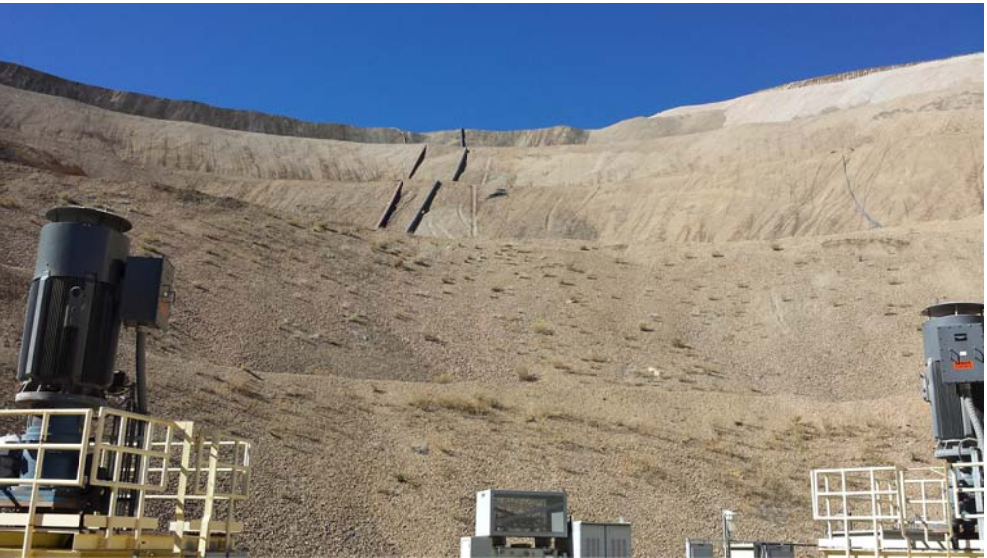
PHOTO 6: PHASE 4 PSSA RISERS

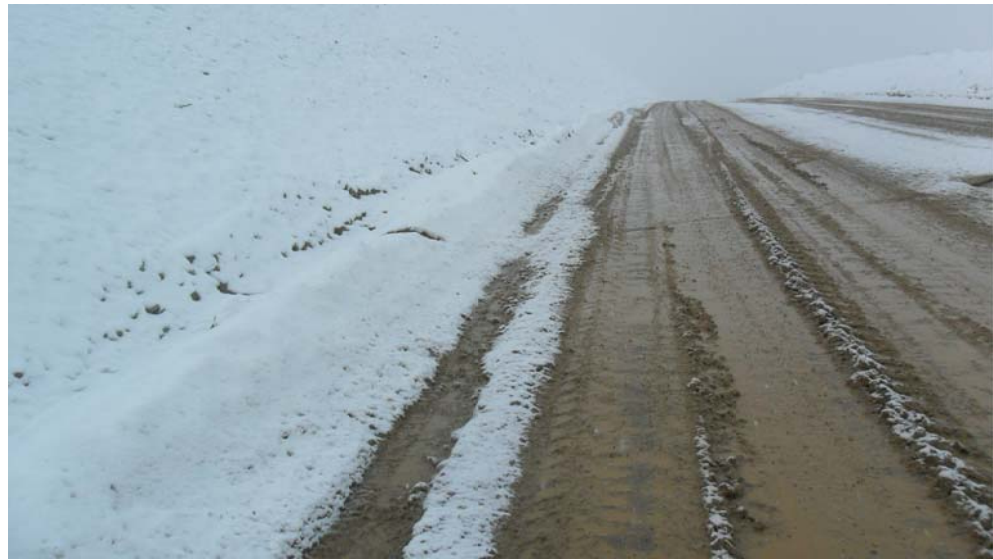
been placed immediately above the haul road. The cracks are oriented semi-orthogonally to the centerline of the haul road and are subparallel to one another. A series of 5 cracks were observed while on site during the October 22, 2015 site visit.

Crack monitoring data was reviewed in Eric Munroe's (Geotechnical site lead) office while on site and no significant movement was discernable. Observations made in the field are in agreeance with the data. No vertical displacement across cracks was observed. Based on field observations and available monitoring data, cracking in the haul road appears to be the result of settlement in the pad immediately adjacent to the road and the lateral displacement that has occurred as part of the settlement. In our opinion these cracks are not indicative of instability.

PHOTO 7: LOOKING WEST AT SETTLEMENT
CRACK

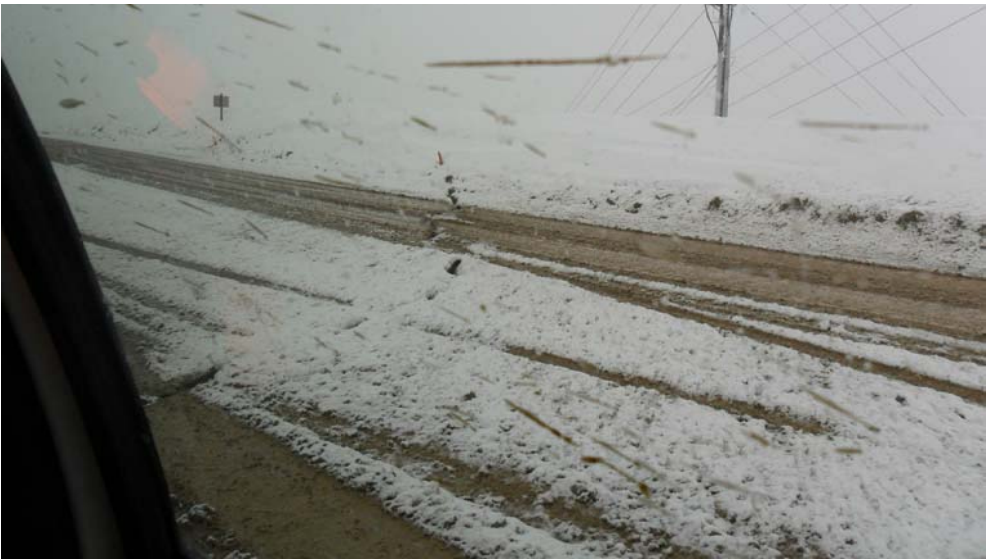
PHOTO 8: LOOKING NORTH AT SETTLEMENT CRACK

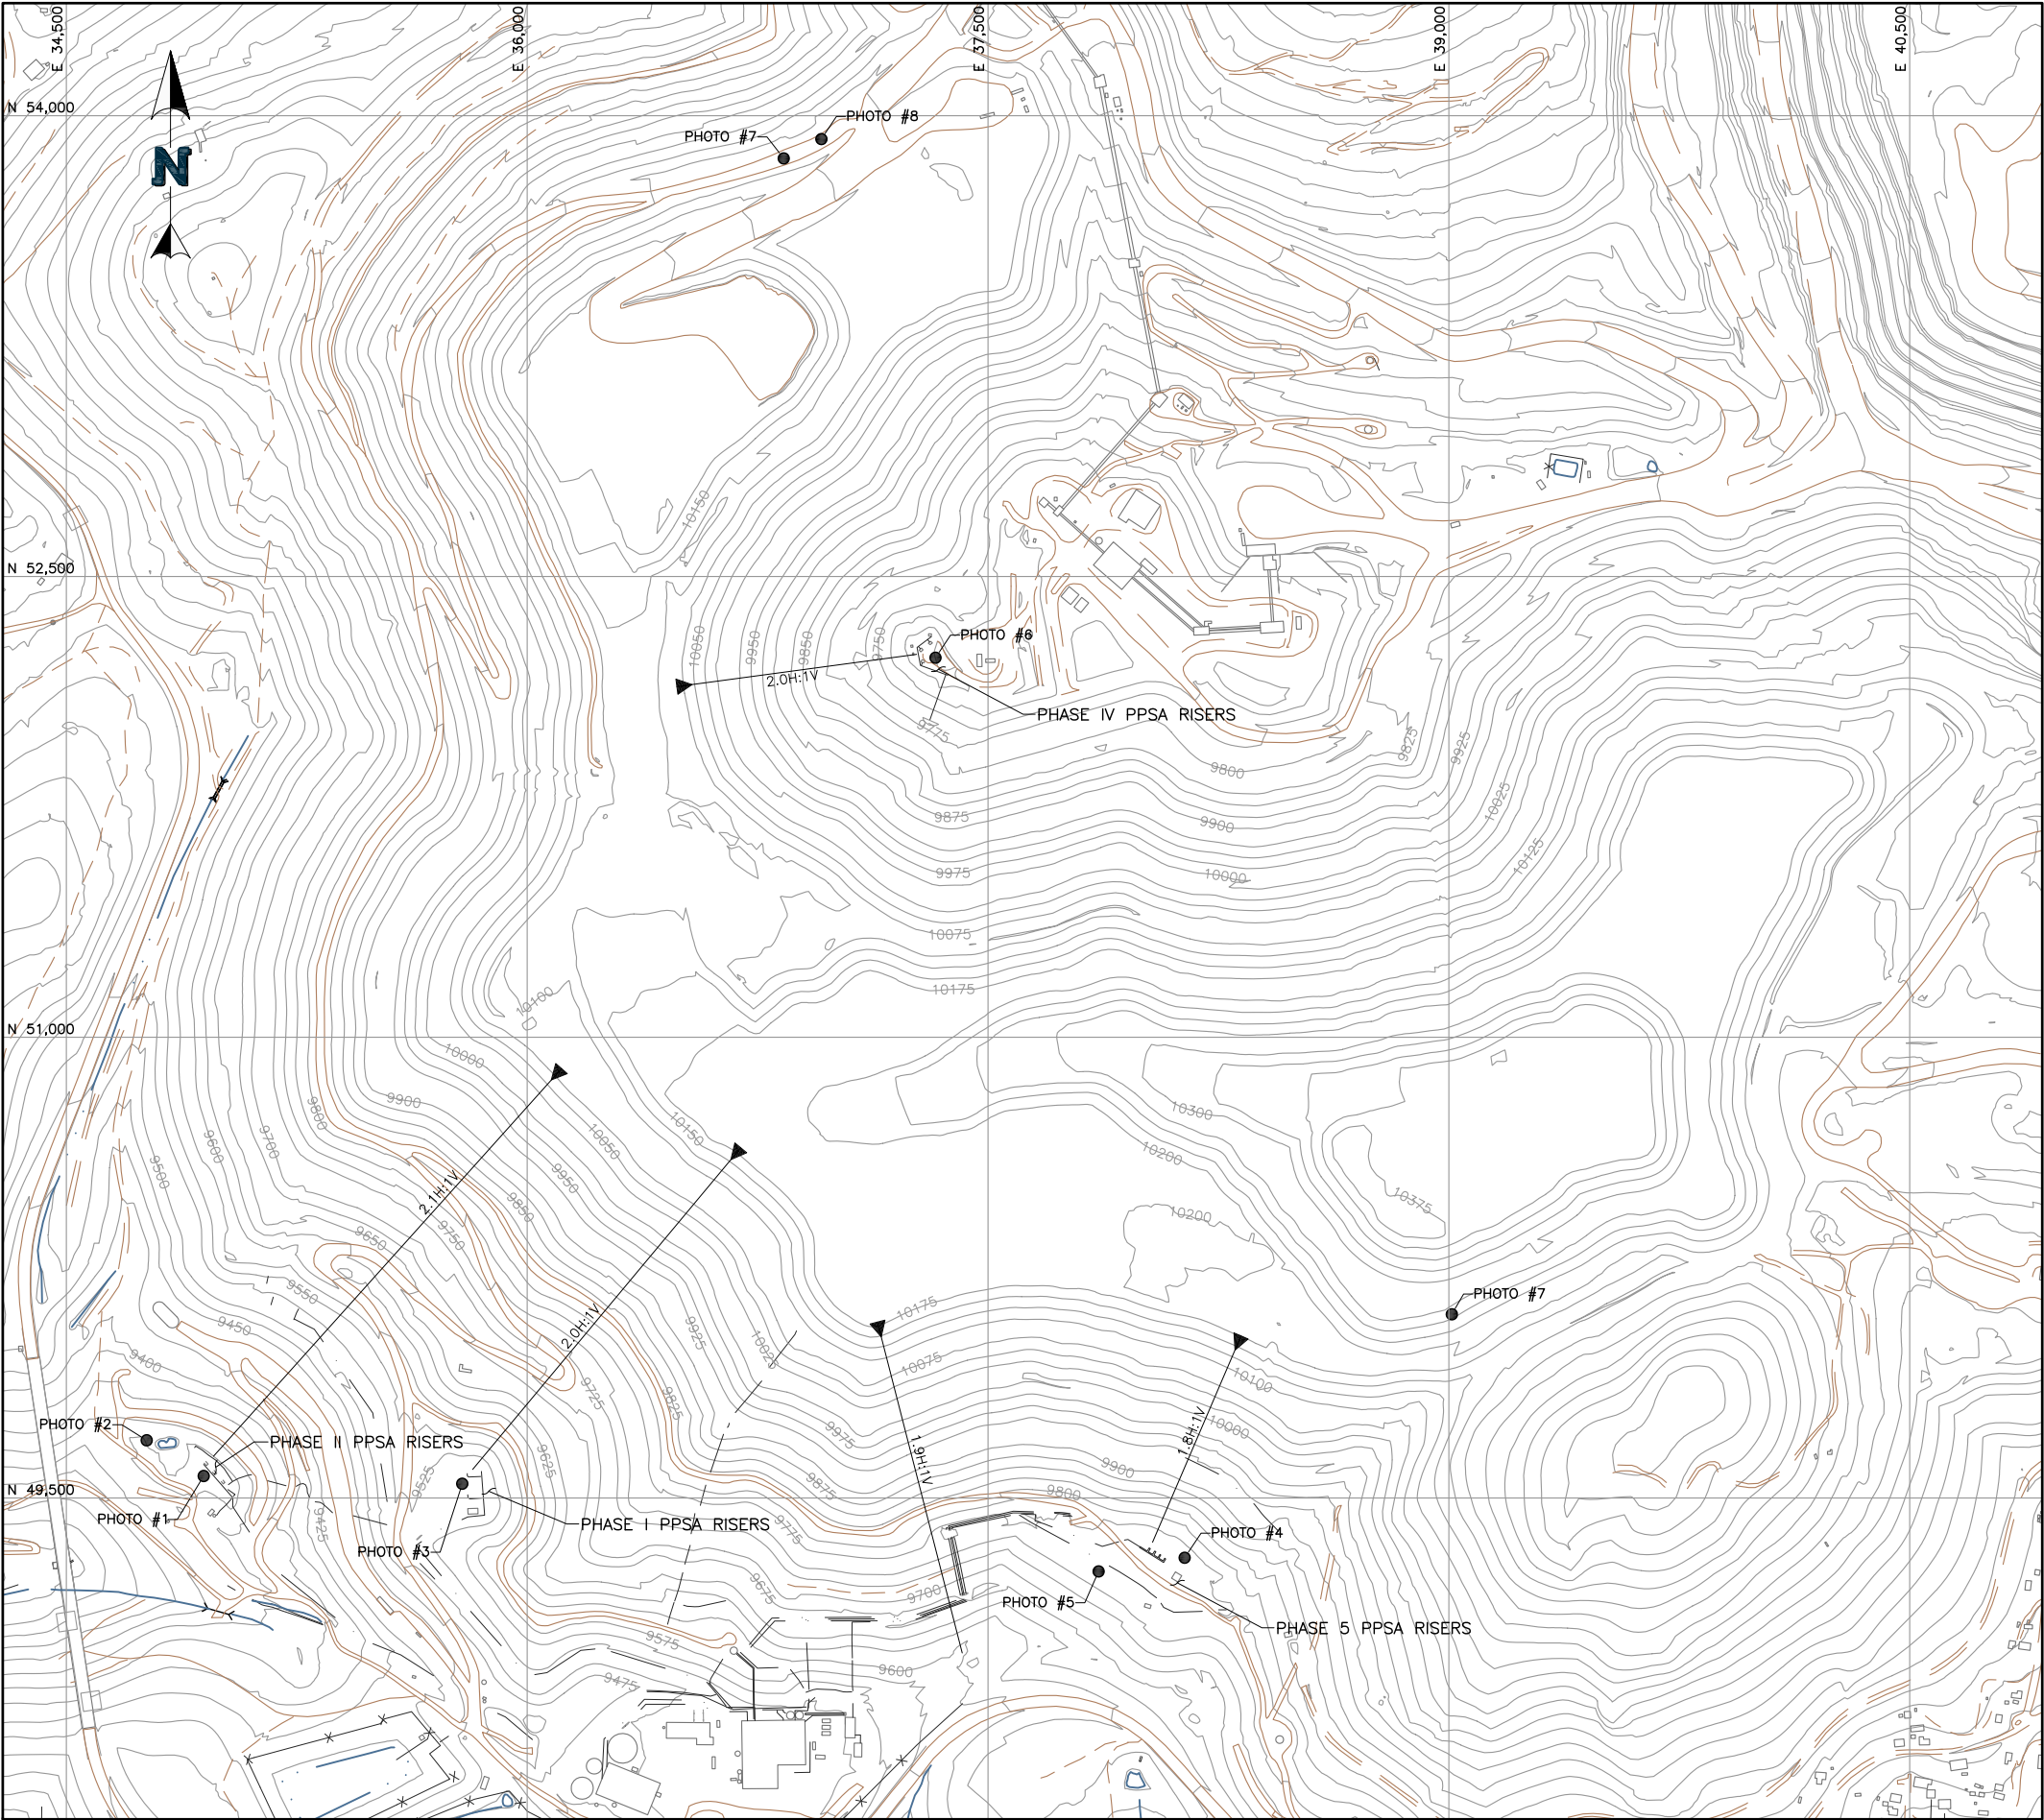
CLIENT CRIPPLE CREEK & VICTOR GOLD MINING COMPANY	
PROJECT		2015 ANNUAL AREQUA GULCH VLF INSPECTION	
TITLE		FILENAME	
		106.001.006F	
CURRENT TOPOGRAPHY		FIGURE NO.	REVISION
		2	0

Utilizing the Flyover Topography for the 2014 and 2015, NewFields developed AutoCAD Civil3d surfaces for both years. NewFields compared the side-slopes and pad development looking for differences between the two surfaces. The most significant change was the addition of the lift within the Phases 4 and 5 limits. The ultimate height increased by approximately 100', bring the maximum elevation of the AG-VLF to 10395' above sea level. Generally, all the side slopes remained unchanged from the previous year and the access road on the side of the VLF show signs of road maintenance performed by CC&V.

NewFields analyzed the side slopes of the 2015 flyover AG-VLF surface, and found the ore slopes between the benches ranged between 1.3H: 1V, the designed angle of repose for the ore, and 2:1 around the perimeter of the VLF. The composite slope of the VLF, measured from the base of the facility to the top crest, varied between 1.8H: 1V to 2.1H: 1V. These slopes are flatter than the recommended design slopes of 1.6H: 1V and 2.0H: 1V as described in the letter from Dr. John Lupo with AMEC Earth and Environmental, dated February 5, 2010; regarding Phase 5 PSSA Ore Slopes. In the letter, Dr. Lupo amends the design slopes to those cited above based on a flatter Phase 5 PSSA pond bottom than was originally envisaged in the design submittal.

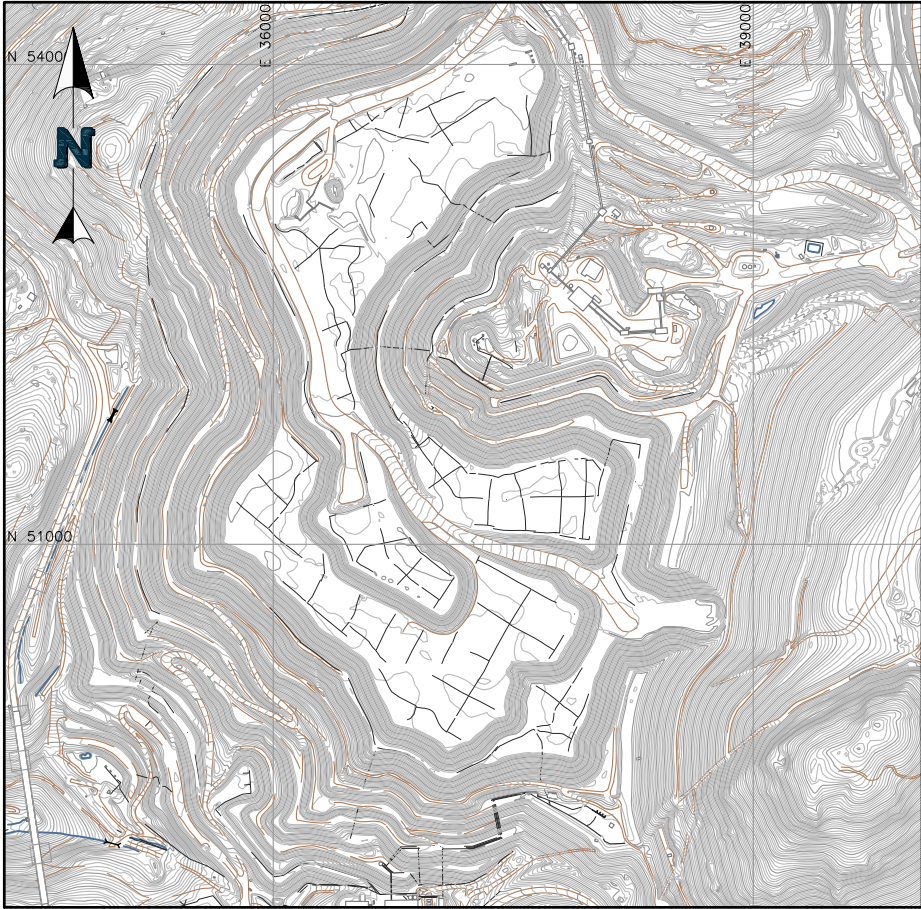
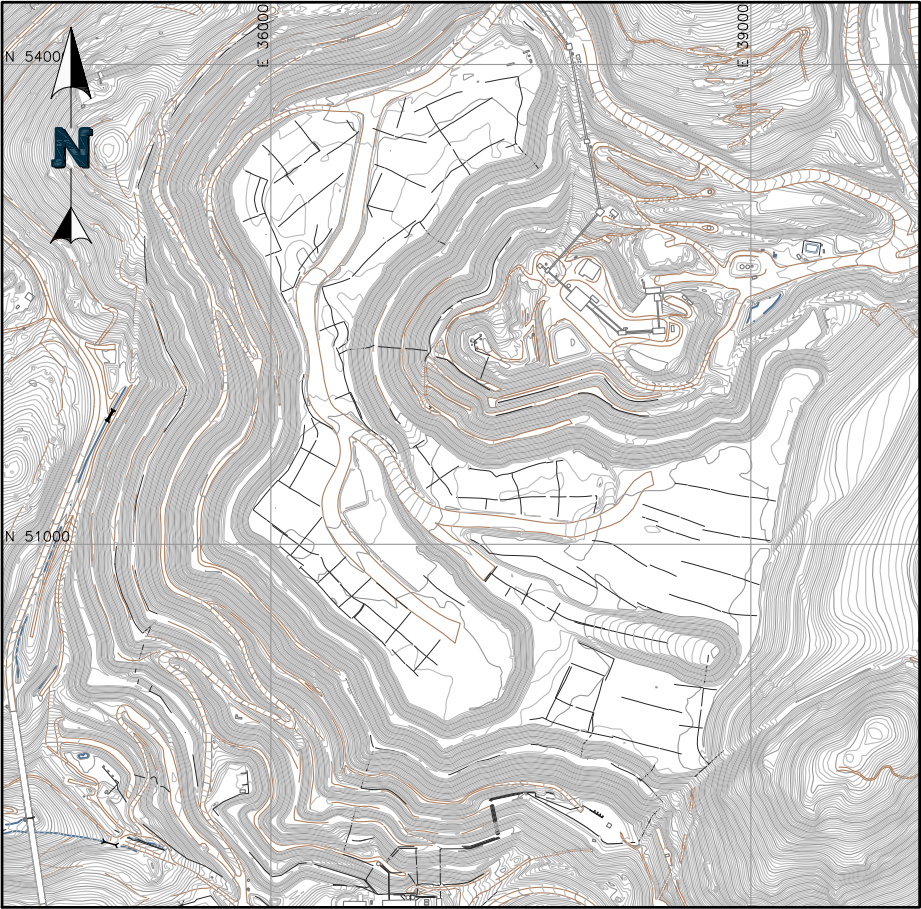
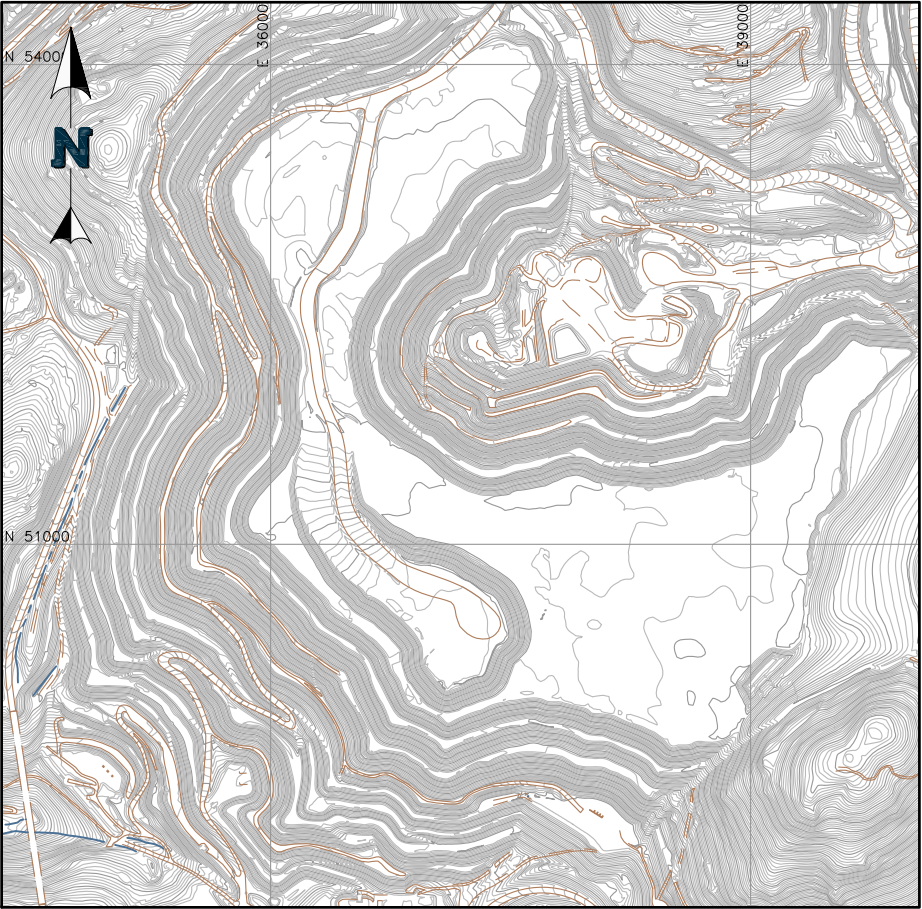
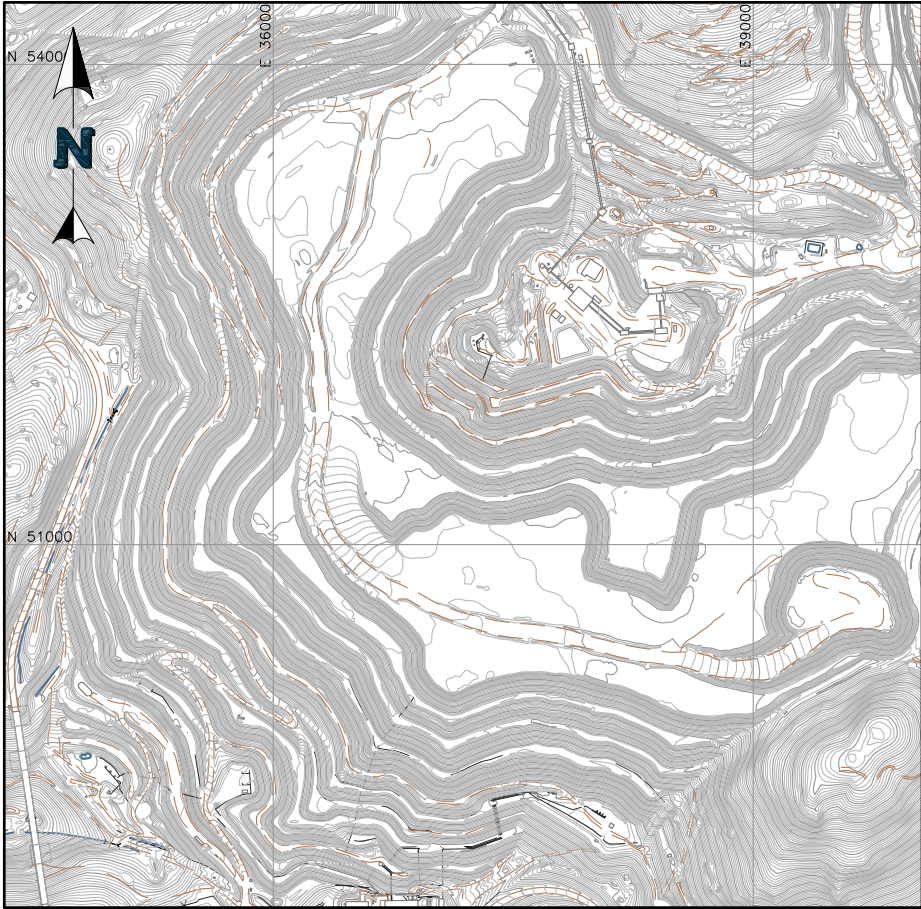
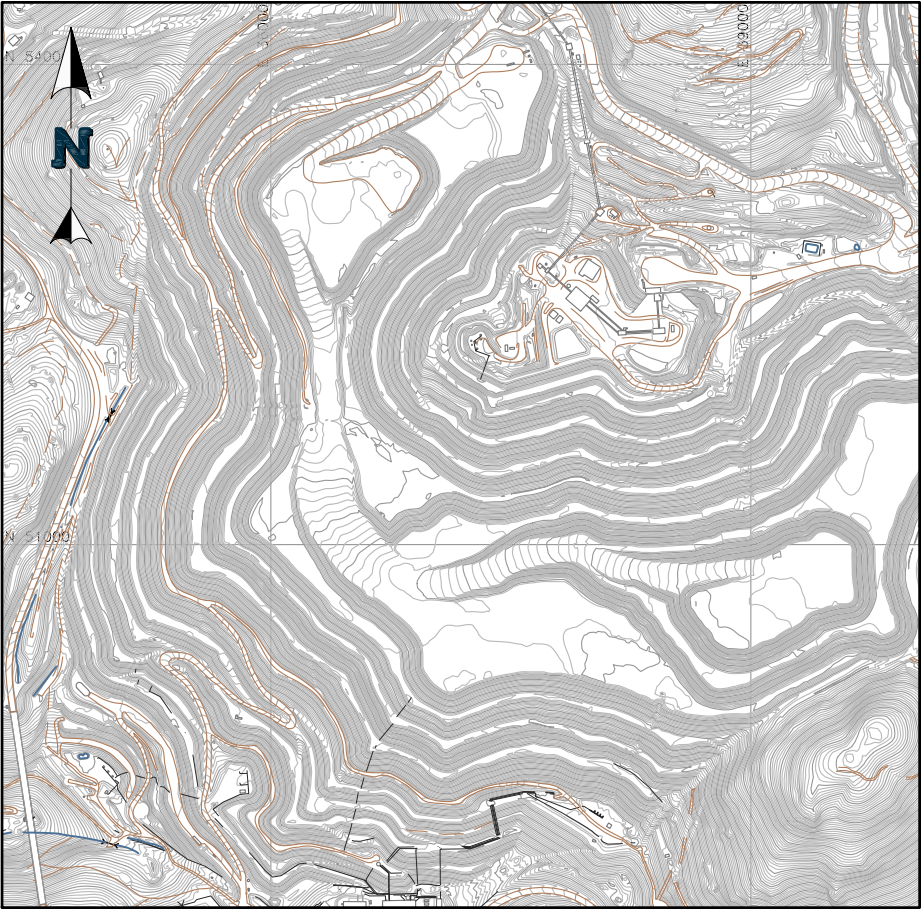
CLIENT CRIPPLE CREEK & VICTOR GOLD MINING COMPANY	
PROJECT		2015 ANNUAL AREQUA GULCH VLF INSPECTION	
TITLE		ANNUAL FLYOVER TOPOGRAPHY	
		COMPARISON OF AREQUA GULCH VLF	
		FILENAME	
		106.001.007F	
		FIGURE NO.	REVISION
		3	0

Additionally, to show the development of the AG-VLF over the previous 5 years, NewFields created Figure 3. This figure shows that the pad continues to be stable and shows no signs of movement.
