**COLORADO**Division of Reclamation,
Mining and Safety

MINERALS PROGRAM INSPECTION REPORT**PHONE: (303) 866-3567**

MINE NAME: AZCO Pit	MINE/PROSPECTING ID#: M-2004-029	MINERAL: Sand and gravel	COUNTY: Fremont
INSPECTION TYPE: Monitoring	INSPECTOR(S): Timothy A. Cazier	INSP. DATE: September 15, 2015	INSP. TIME: 13:30
OPERATOR: AZCO Construction, Inc.	OPERATOR REPRESENTATIVE: None	TYPE OF OPERATION: 110c - Construction Limited Impact	
REASON FOR INSPECTION: Normal I&E Program	BOND CALCULATION TYPE: Partial Bond	BOND AMOUNT: \$17,500.00	
DATE OF COMPLAINT: NA	POST INSP. CONTACTS: None	JOINT INSP. AGENCY: None	
WEATHER: Cloudy	INSPECTOR'S SIGNATURE:

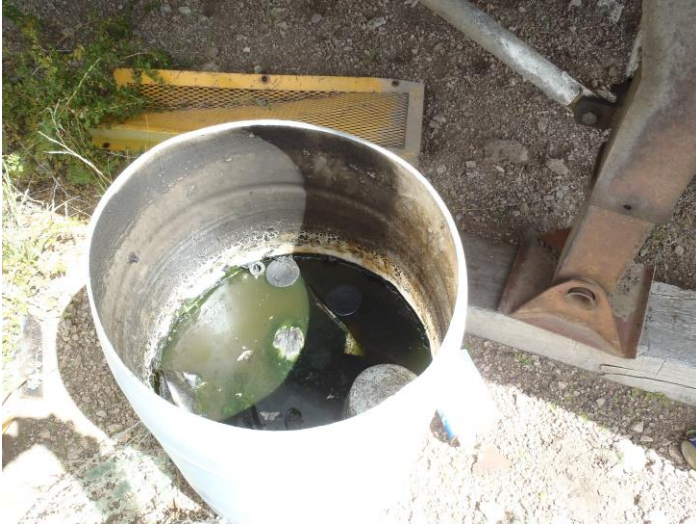
Fish and Wildlife: Open drums containing liquid could be a wildlife attractant. The observed containers (see **Photo 1**) should be covered and sealed.

Photo #1 – Open Drum

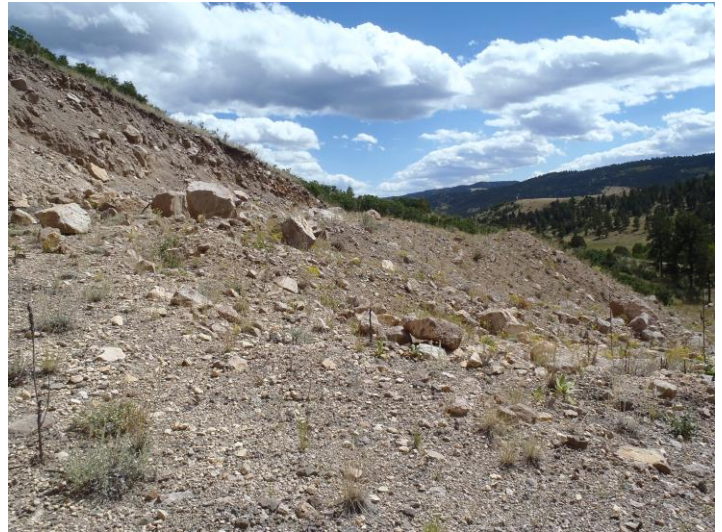
Gen. Compliance with Mine Plan: The operation appeared to be in compliance with the approved mine plan. Google Earth was used to measure the disturbed area, which was estimated to be approximately 2.25 acres. High walls were estimated to vary between 20 and 30 feet in high and appeared stable (see **Photo 2**).

Photo #2 – Highwall

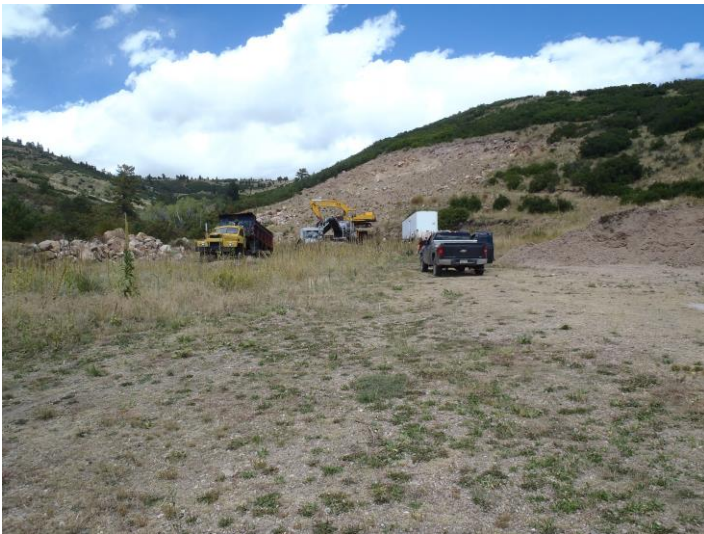
Processing Waste: A stockpile of oversized rock was observed on the north side and what might be a product stockpile or squeegee was observed on the south side (see **Photo 3**).

Support Facilities On-site: A screen plant, crusher, excavator, and dump truck were observed on site (see **Photo 3**).

Photo #3 – Processing facilities, Oversize rock & product piles

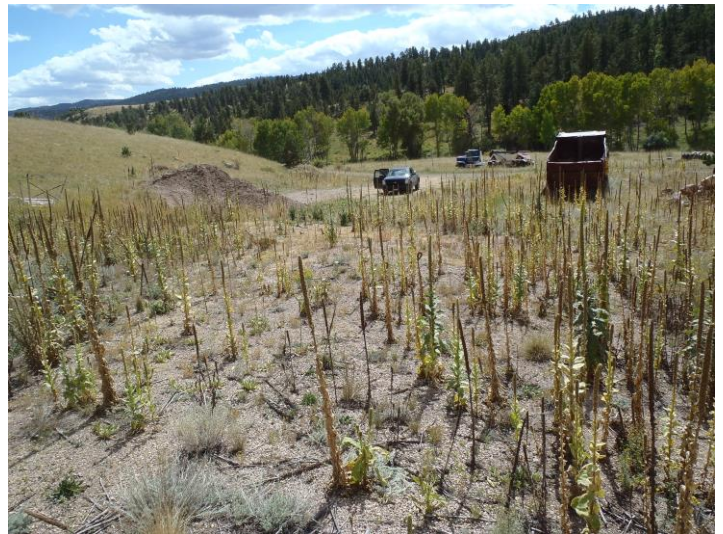
Revegetation: A large amount of Common Mullein was observed (see **Photo 4**). This is a noxious weed List C species, so it was not cited as a problem. However, the Operator should implement a weed control program to reduce the number of mullein plants on site.

Photo #4 – Common Mullein
