MINERALS PROGRAM INSPECTION REPORT
PHONE: (303) 866-3567

MINE NAME: Tallahassee Pit	MINE/PROSPECTING ID#: M-1999-003	MINERAL: Sand and gravel	COUNTY: Fremont
INSPECTION TYPE: Monitoring	INSPECTOR(S): Timothy A. Cazier	INSP. DATE: September 15, 2015	INSP. TIME: 14:40
OPERATOR: Seifert Construction dba Seifert Enterprises, LLC	OPERATOR REPRESENTATIVE: None	TYPE OF OPERATION: 110c - Construction Limited Impact	
REASON FOR INSPECTION: Normal I&E Program	BOND CALCULATION TYPE: Partial Bond	BOND AMOUNT: \$34,685.00	
DATE OF COMPLAINT: NA	POST INSP. CONTACTS: None	JOINT INSP. AGENCY: None	
WEATHER: Cloudy	INSPECTOR'S SIGNATURE:

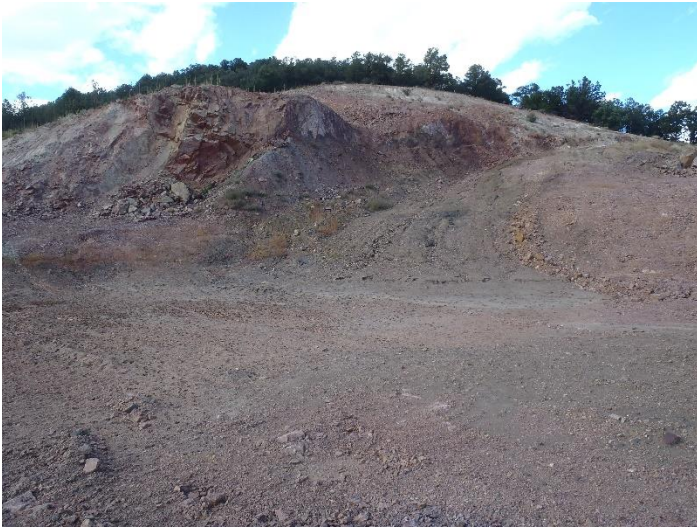
Gen. Compliance with Mine Plan: The operation appeared to be in compliance with the approved mine plan. Google Earth was used to measure the disturbed area, which was estimated to be approximately 6.5 acres. High walls were estimated to be approximately 30 feet in height and appeared stable (see **Photo 1**).

Photo #1 – Highwall

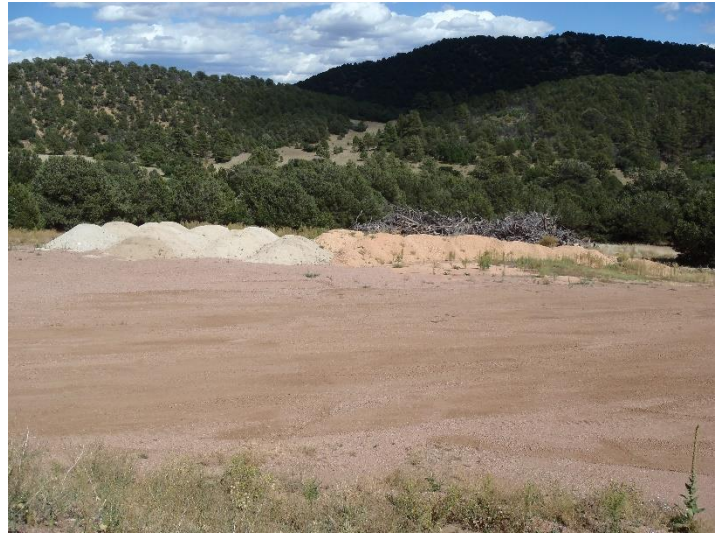
Processing Waste: Two stockpiles of clayey material were observed on the north end of the site (see **Photo 2**). Mr. Beach indicated this material was from a local foundation excavation and would be blended with the mined material and used for road base. The Operator should be aware this material cannot be used for backfill on the mine site without a technical revision (TR) which would include a certificate of inert fill. The Division expects this material will be removed by the next regular monitoring inspection.

Photo #2 – Clay stockpiles from foundation excavation

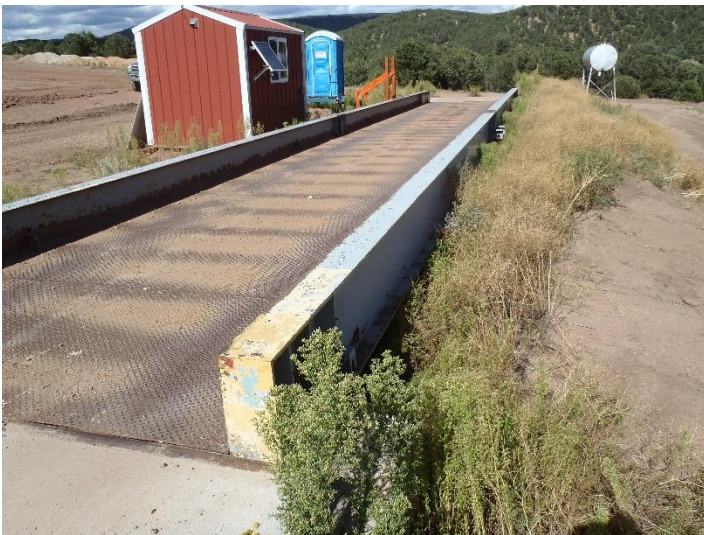
Support Facilities On-site: A D8 dozer, backhoe (loaded on a flatbed trailer), truck scale, scale house, and an AST were observed on site (see **Photo 3**).

Photo #3 – Support facilities

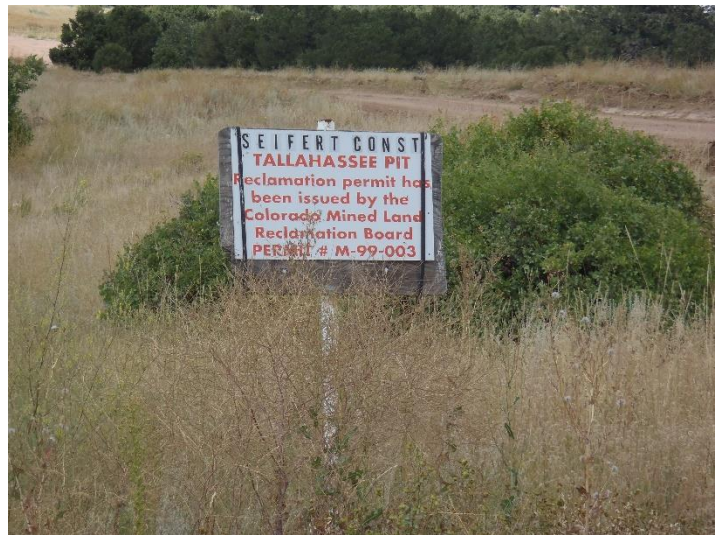
Signs and Markers: The permit sign was properly posted (see **Photo 4**) and barbed wire fence appeared to mark the permit boundary.

Photo #4 – Permit sign
