MINERALS PROGRAM INSPECTION REPORT

MINE NAME: South 40 Quarry	MINE/PROSPECTING ID#: M-1990-016	MINERAL: Surface Moss Rock	COUNTY: Fremont
INSPECTION TYPE: Monitoring	INSPECTOR(S): Timothy A. Cazier	INSP. DATE: September 30, 2015	INSP. TIME: 9:30
OPERATOR: High Plains Stone Company	OPERATOR REPRESENTATIVE: Debbie Wagner	TYPE OF OPERATION: 110c - Construction Limited Impact	
REASON FOR INSPECTION: Normal I&E Program	BOND CALCULATION TYPE: Partial Bond	BOND AMOUNT: \$2000.00	
DATE OF COMPLAINT: NA	POST INSP. CONTACTS: Phil Courtney	JOINT INSP. AGENCY: State Land Board	
WEATHER: Cloudy	INSPECTOR'S SIGNATURE:

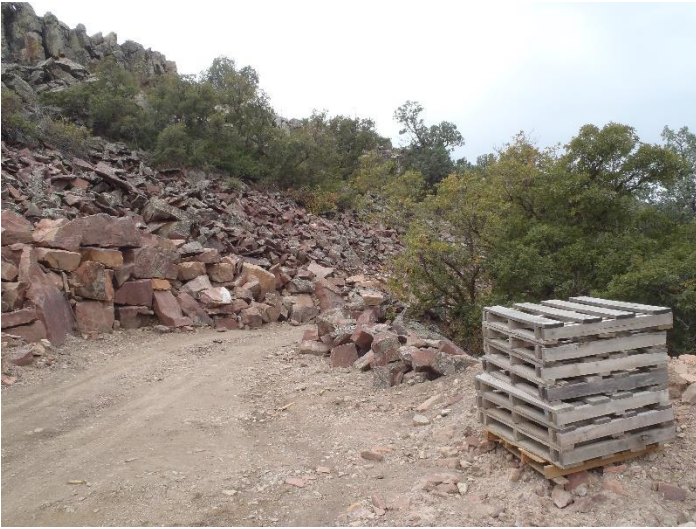
Gen. Compliance with Mine Plan: The operation appeared to be in compliance with the approved mine plan. Google Earth was used to measure the disturbed area, which was estimated to be less than one acre. High walls were estimated to be approximately 10 to 12 feet in height and appeared stable (see **Photo 1**).

Photo #1 – Typical highwall

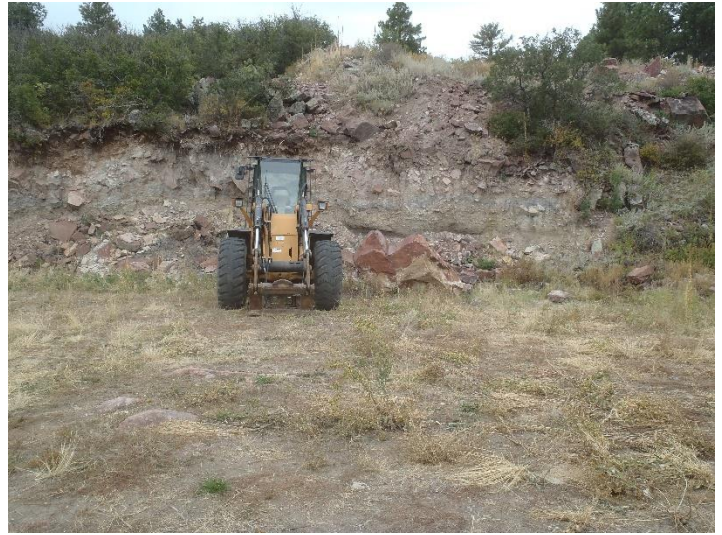
Support Facilities On-site: A loader (see **Photo 2**) and crane (see **Photo 3**) were observed on site.

Photo #2 – Site loader

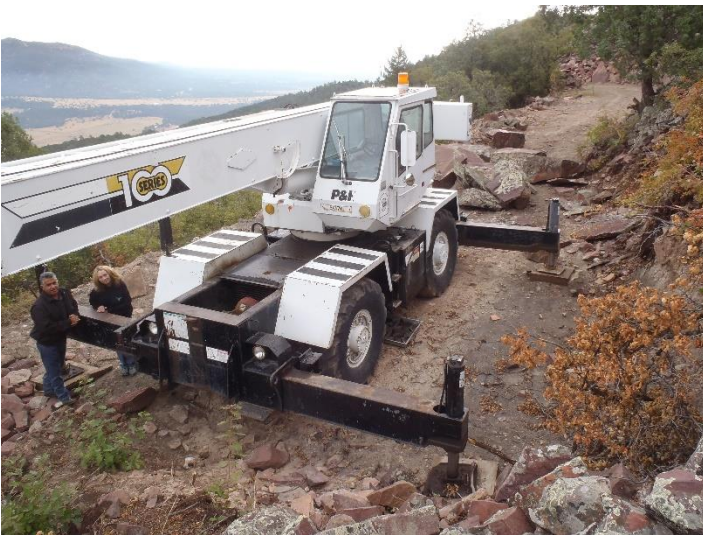
Photo #3 – Site crane, active mining area

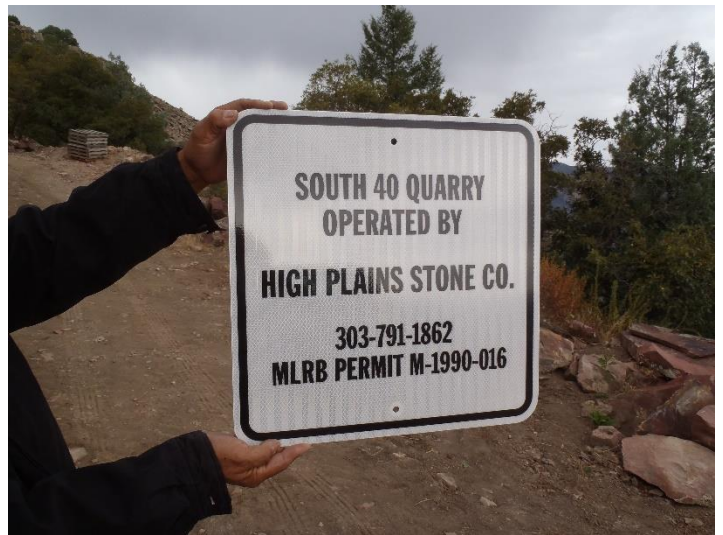
Signs and Markers: A new permit sign (see **Photo 4**) was brought to the site by the Operator and was to be properly posted after the inspection. Ms. Wagner indicated she would work on better delineating the permit boundaries and submit a technical revision to better define the permit boundary and request intermittent status if the plan is to operate less than 180 days per year.

Photo #4 – Permit sign
