MINERALS PROGRAM INSPECTION REPORT**PHONE: (303) 866-3567**

MINE NAME: J&J Stone Pit #1	MINE/PROSPECTING ID#: M-2011-004	MINERAL: Sandstone (silica, stone, quartzite)	COUNTY: Fremont
INSPECTION TYPE: Monitoring	INSPECTOR(S): Timothy A. Cazier	INSP. DATE: September 30, 2015	INSP. TIME: 12:50
OPERATOR: KrauthCo Inc	OPERATOR REPRESENTATIVE: Mike Krauth	TYPE OF OPERATION: 112c - Construction Regular Operation	
REASON FOR INSPECTION: Normal I&E Program	BOND CALCULATION TYPE: Partial Bond	BOND AMOUNT: \$5,608.00	
DATE OF COMPLAINT: NA	POST INSP. CONTACTS: None	JOINT INSP. AGENCY: None	
WEATHER: Cloudy	INSPECTOR'S SIGNATURE:

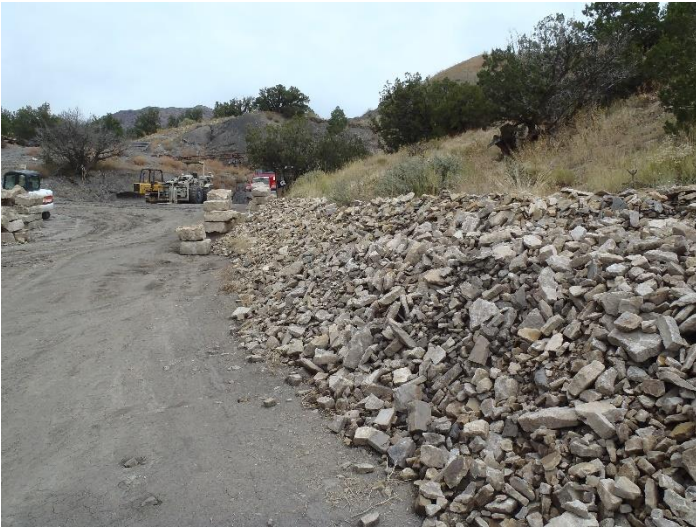
Backfilling and Grading: Riprap material had been used to stabilize cut banks in the storage yard (see **Photo 1**).

Photo #1 – Riprap material

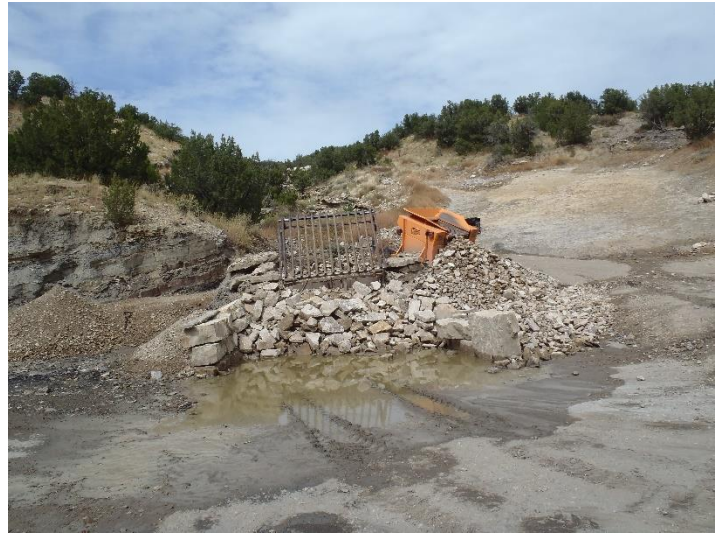
Hydrologic Balance: No standing water was observed in the pit and no exposed groundwater was observed. We discussed protecting the adjacent unnamed drainage (see **Photo 2**) and that some energy dissipation structure may be required in the future. Mr. Krauth pointed out the site sediment pond (see **Photo 3**) downgradient of the access road.

Photo #2 – Unnamed drainage upgradient of sediment pond

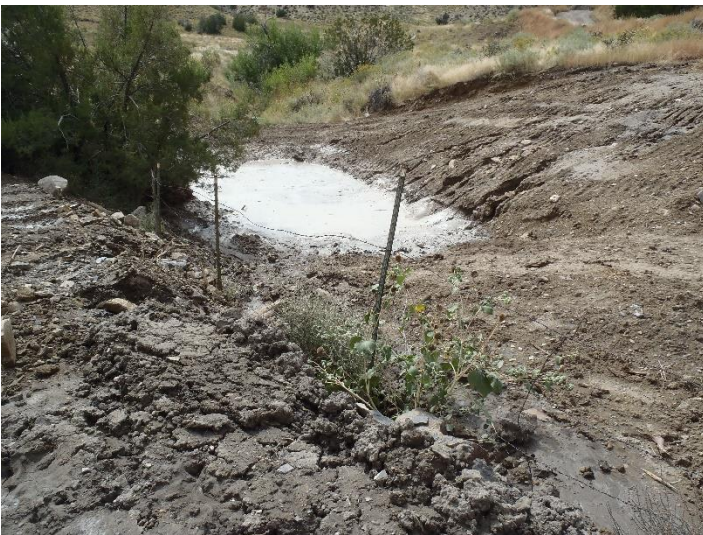
Storm Water MGT Plan: No oil or fuel spills observed. Site sediment pond appeared adequate.

Photo #3 – Site sediment pond

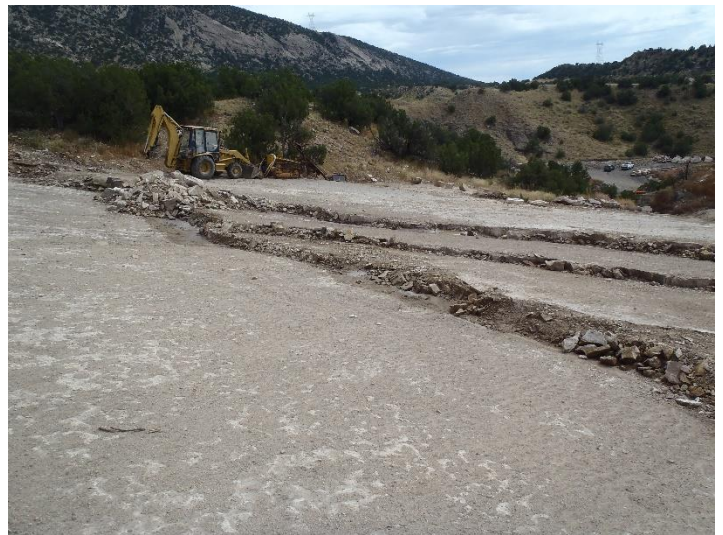
Gen. Compliance with Mine Plan: The operation appeared to be in compliance with the approved mine plan. Google Earth was used to measure the disturbed area, which was estimated to be approximately 0.84 acres as shown in **Figure 1**. The current working face consists of exposed sandstone (see **Photo 4**) which is fractured in layers using expanding clay in boreholes.

Photo #4 – Active working face

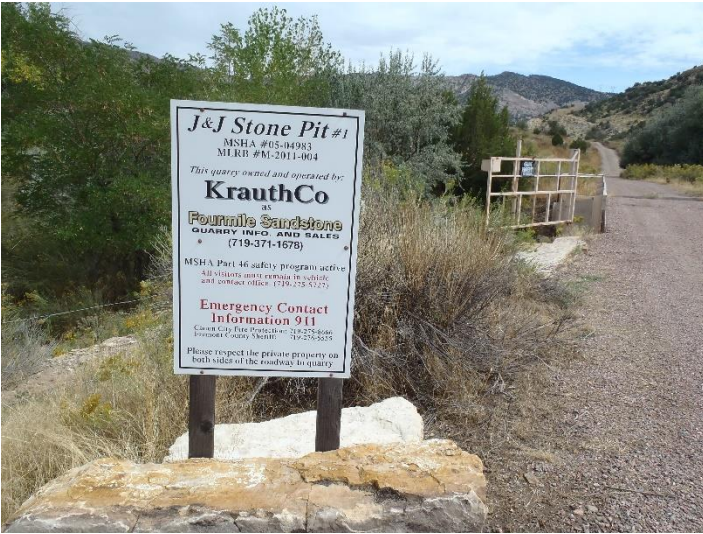
Signs and Markers: The permit sign was properly posted (see **Photo 5**) and boundary markers were observed to delineate the permit boundary (see **Photo 6**).

Photo #5 – Permit sign

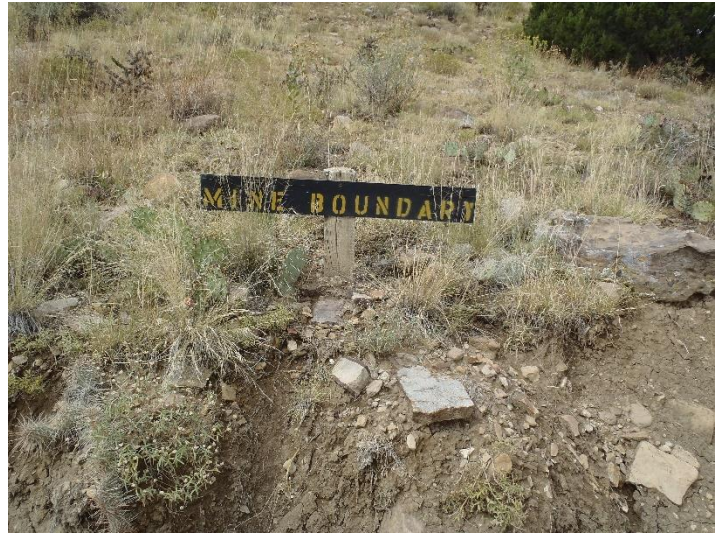
Photo #6 – Typical permit boundary sign
