MINERALS PROGRAM INSPECTION REPORT
PHONE: (303) 866-3567

MINE NAME: Bad Boys Pit	MINE/PROSPECTING ID#: M-1996-081	MINERAL: Turquoise	COUNTY: Teller
INSPECTION TYPE: Monitoring	INSPECTOR(S): Timothy A. Cazier	INSP. DATE: October 20, 2015	INSP. TIME: 11:25
OPERATOR: Bad Boys of Cripple Creek Mining Co. Inc.	OPERATOR REPRESENTATIVE: David Graham	TYPE OF OPERATION: 110(2) - Hard Rock Limited Impact	
REASON FOR INSPECTION: Normal I&E Program	BOND CALCULATION TYPE: Partial Bond	BOND AMOUNT: \$3,700.00	
DATE OF COMPLAINT: NA	POST INSP. CONTACTS: None	JOINT INSP. AGENCY: None	
WEATHER: Cloudy	INSPECTOR'S SIGNATURE:

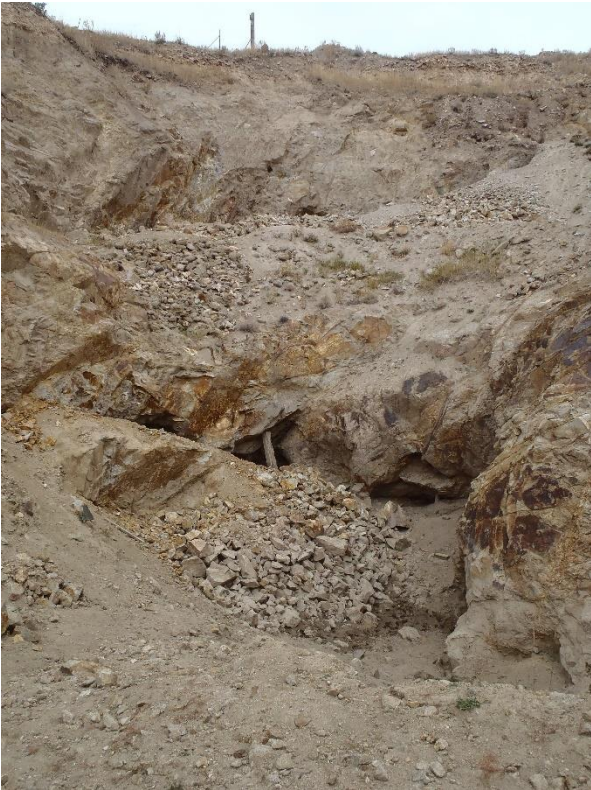
Gen. Compliance with Mine Plan: The operation appeared to be in compliance with the approved mine plan. Google Earth was used to measure the disturbed area, which was estimated to be less than an acre. High walls were estimated to be approximately 60 feet in height (with two benches) and appeared stable (see **Photo 1**). The Division could not find a reference in the permit allowing the "dog holes" observed in portions of the highwall (see **Photo 2**). If this practice is to continue, a revision to the permit is required to demonstrate these holes will not impact stability of the highwall.

Photo #1 – Highwall (with 2 benches)

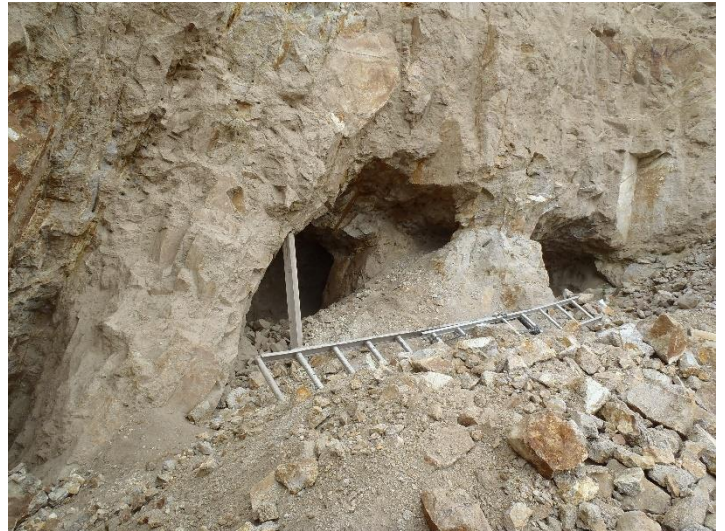
Photo #2 – Highwall “dog holes”

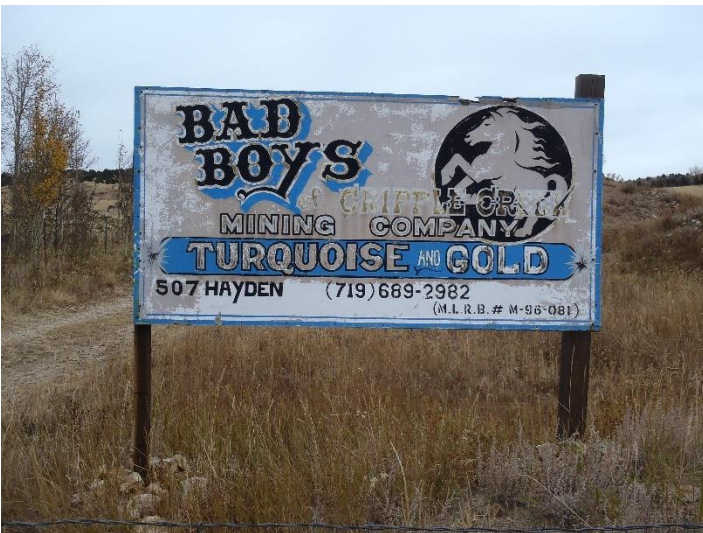
Signs and Markers: The permit sign was properly posted (see **Photo 3**) and a fence appeared to mark the permit boundary.

Photo #3 – Permit sign

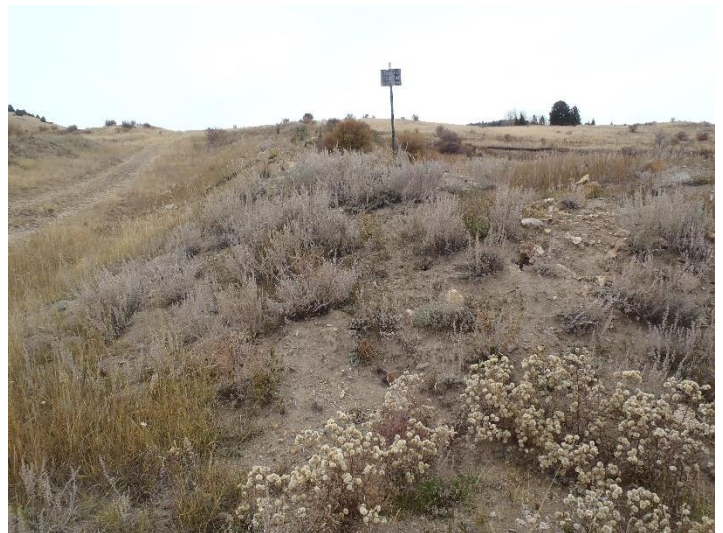
Topsoil: The topsoil stockpile was located northwest of the highwall and labeled (see **Photo 4**).

Photo #4 – Topsoil stockpile
