MINERALS PROGRAM INSPECTION REPORT

MINE NAME: Florence Pit	MINE/PROSPECTING ID#: M-2001-070	MINERAL: Turquoise	COUNTY: Teller
INSPECTION TYPE: Monitoring	INSPECTOR(S): Timothy A. Cazier	INSP. DATE: October 20, 2015	INSP. TIME: 12:35
OPERATOR: Wallace F. Burtis	OPERATOR REPRESENTATIVE: None	TYPE OF OPERATION: 110(2) - Hard Rock Limited Impact	
REASON FOR INSPECTION: Normal I&E Program	BOND CALCULATION TYPE: Partial Bond	BOND AMOUNT: \$1,000.00	
DATE OF COMPLAINT: NA	POST INSP. CONTACTS: None	JOINT INSP. AGENCY: None	
WEATHER: Cloudy	INSPECTOR'S SIGNATURE:

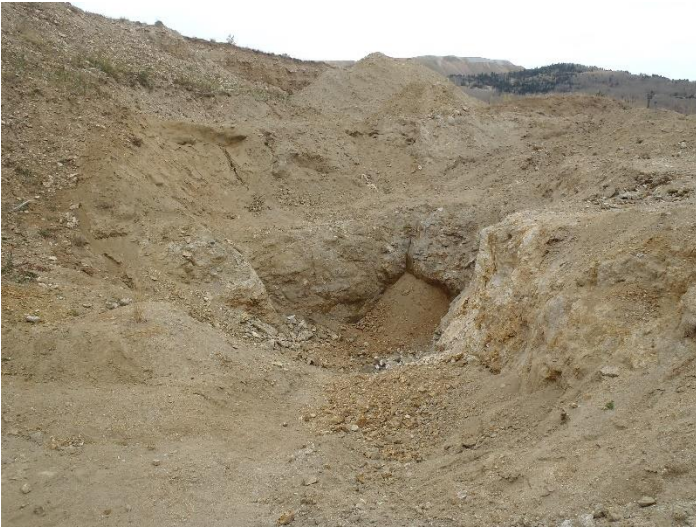
Gen. Compliance with Mine Plan: The operation appeared to be in compliance with the approved mine plan. The pit/trench (see **Photo 1**) is likely little changed since the previous inspection.

Photo #1 – Open pit/trench

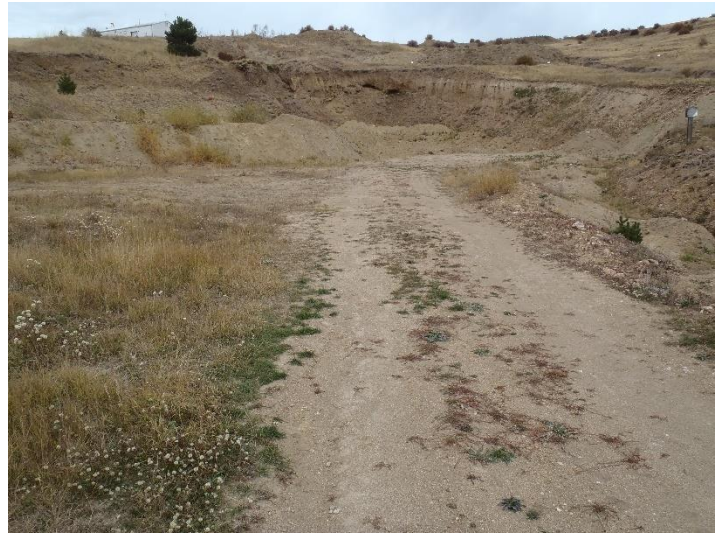
Roads: The access road (see **Photo 2**) did not appear to be a source of sediment that could be tracked offsite.

Photo #2 – Access road – looking north

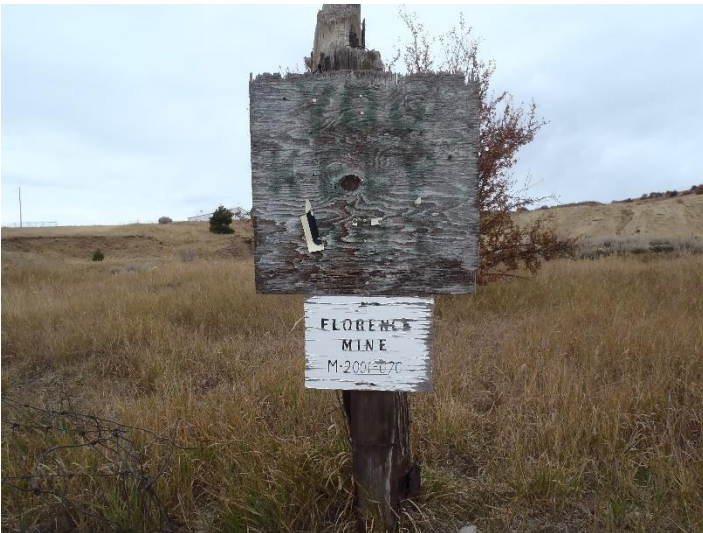
Signs and Markers: The permit sign was properly posted (see **Photo 3**) and a combination of markers (see **Photo 4**) and a fence appeared to mark the permit boundary.

Photo #3 – Permit sign

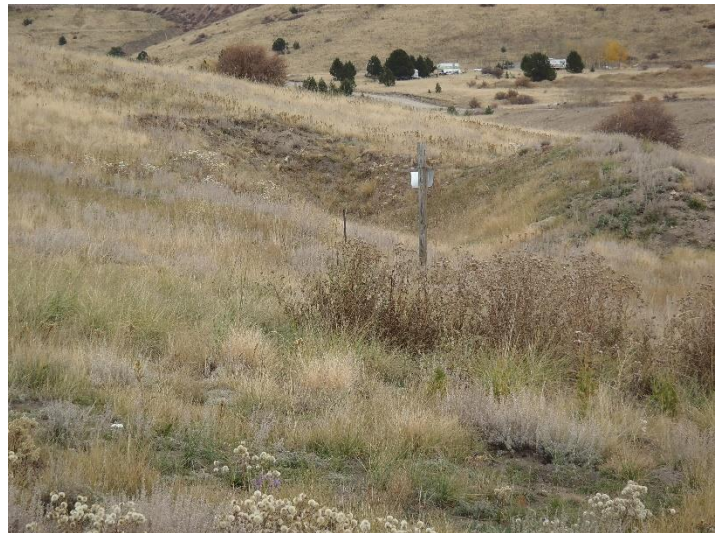
Photo #4 – Typical marker – looking east
