MINERALS PROGRAM INSPECTION REPORT
PHONE: (303) 866-3567

MINE NAME: Robinson Sons Gravel Pit No. 1	MINE/PROSPECTING ID#: M-2008-076	MINERAL: Sand and gravel; borrow material for construction	COUNTY: Las Animas
INSPECTION TYPE: Monitoring	INSPECTOR(S): Amy Eschberger, Wally Erickson	INSP. DATE: November 23, 2016	INSP. TIME: 09:30
OPERATOR: Robinson Sons Inc	OPERATOR REPRESENTATIVE: None	TYPE OF OPERATION: 112c - Construction Regular Operation	
REASON FOR INSPECTION: Priority	BOND CALCULATION TYPE: None	BOND AMOUNT: \$52,815.00	
DATE OF COMPLAINT: NA	POST INSP. CONTACTS: None	JOINT INSP. AGENCY: None	
WEATHER: Clear	INSPECTOR'S SIGNATURE:

SIGNATURE DATE: January 23, 2017

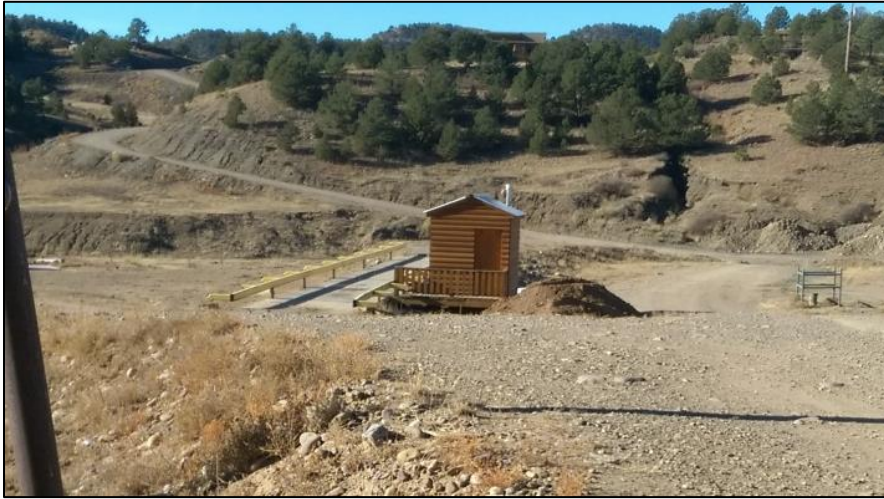
Photo 1. View looking west, showing scale house and associated road constructed off main access road.

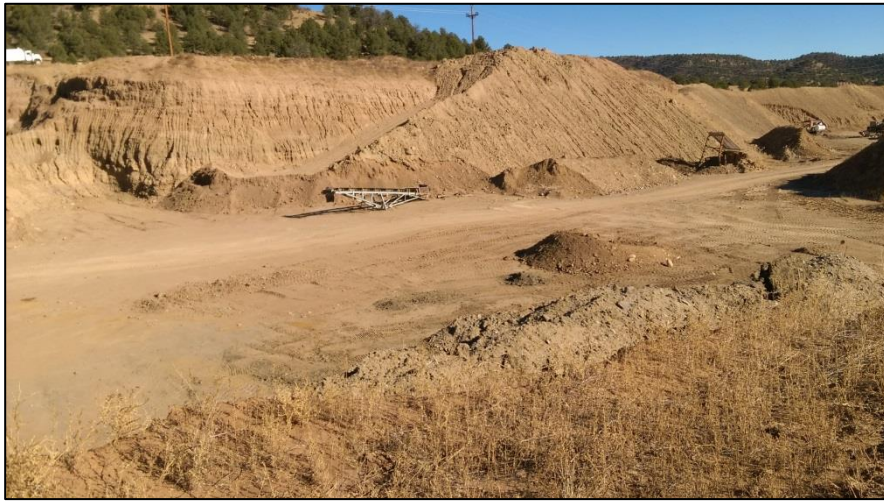
The current pit appears to be located mainly in mining phase one and three. Pit slopes ranged from near vertical to 1.5H:1V (Photos 2-7). Evidence of instability of the highwalls was limited to erosion occurring as surface drainage enters the pit area. Pursuant to Rules 3.1.5(3) and 3.1.6(3), the Operator is obligated to control erosion for all affected lands. Therefore, the operator shall work to maintain stability of the pit walls, including repairing any erosion before it compromises the stability of the pit highwalls. If the pit highwalls will be inactive for extended periods of time the Division recommends they should be graded to a 3H:1V configuration.

Photo 2. View of northern (south-facing) highwall in western portion of active pit. Slope gradients of approximately 0.5H:1V to 1.5H:1V.

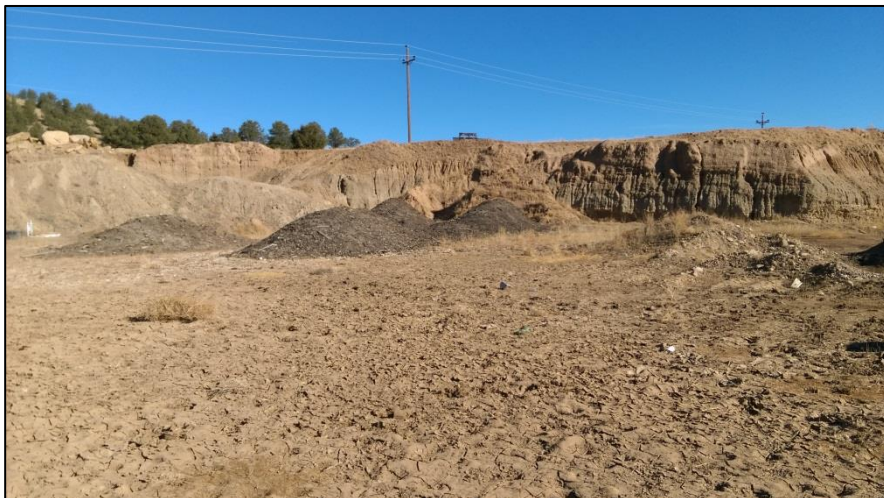
Photo 3. View of northern (south-facing) highwall in eastern portion of active pit. Slope gradients of approximately 0.5H:1V to 1.5H:1V.

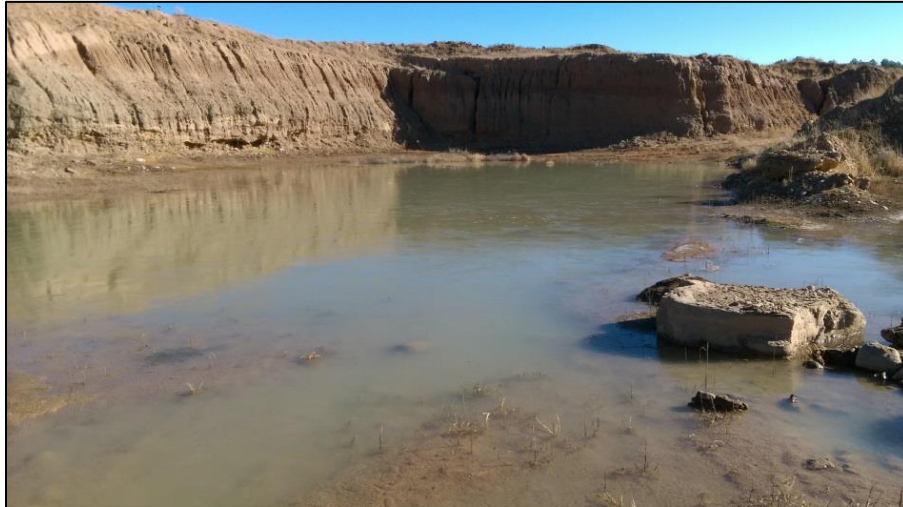
Photo 4. View of eastern (west-facing) highwall in eastern portion of active pit. Slope gradients of approximately 1H:1V. Note water retained in pit.

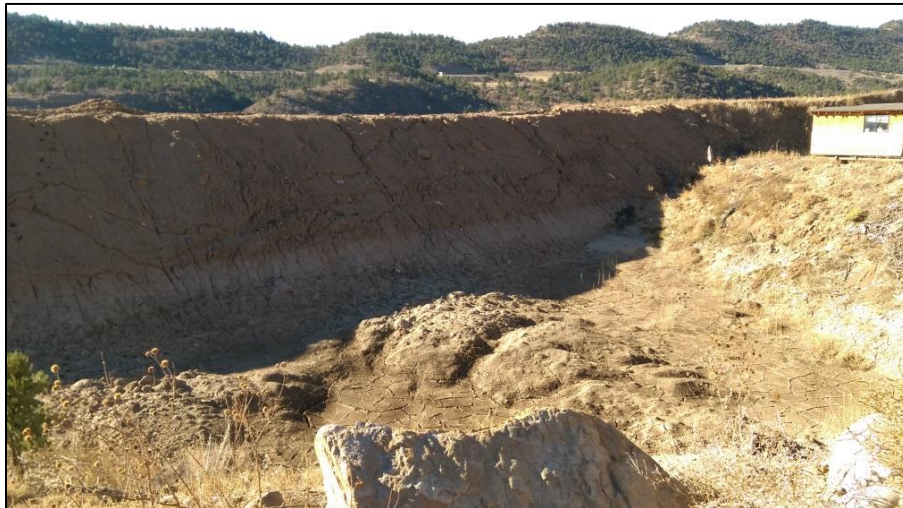
Photo 5. View of southern (north-facing) highwall in eastern portion of active pit. Slope gradients of approximately 0.5H:1V.

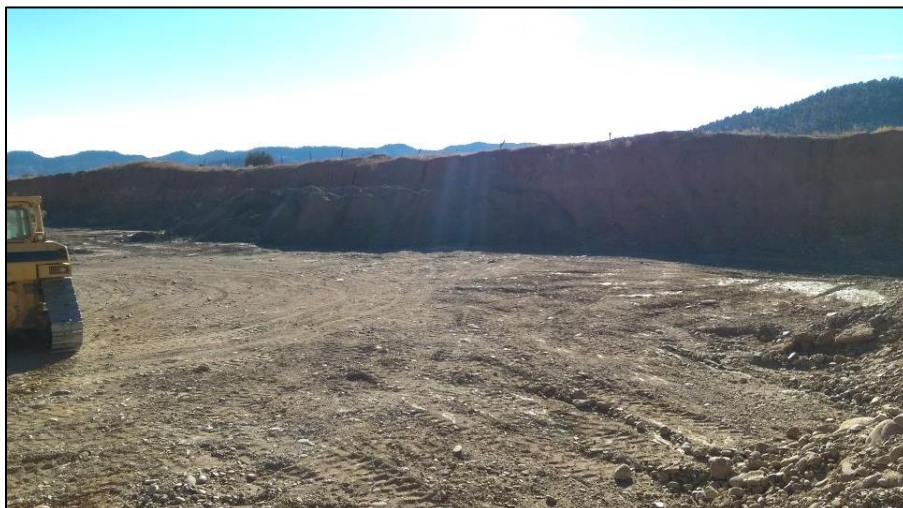
Photo 6. View of southern (north-facing) highwall in western portion of active pit. Slope gradients of approximately 0.5H:1V.

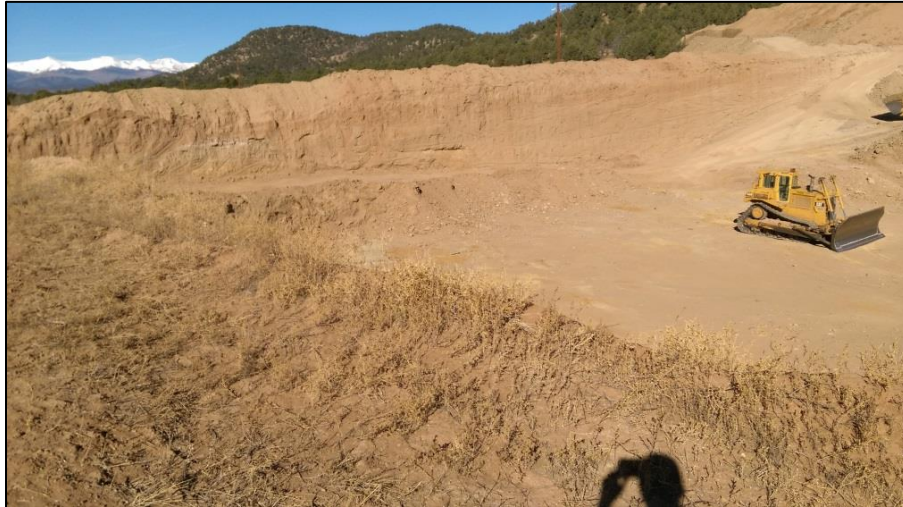
Photo 7. View of western (east-facing) highwall in western portion of active pit. Slope gradients of near vertical to approximately 0.5H:1V.

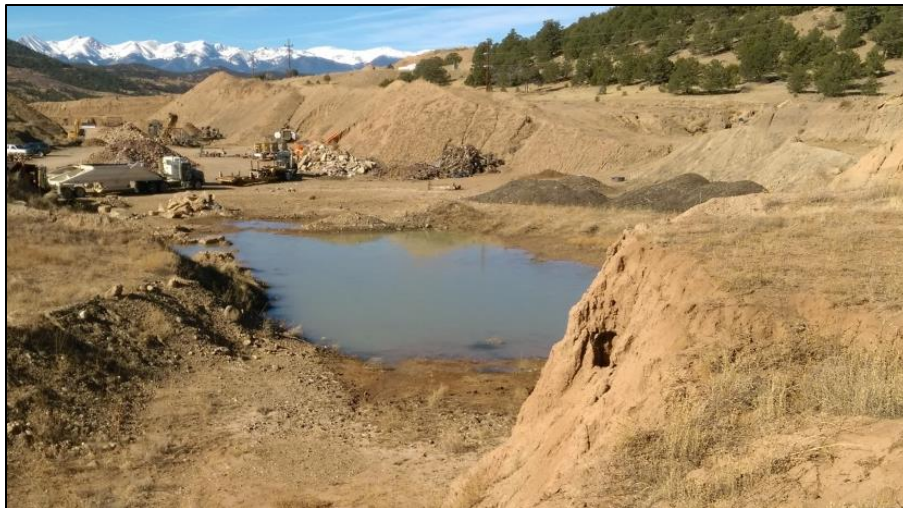
The eastern portion of the pit was impounding water (Photo 8; also shown in Photo 4), which the Division believes to be a temporary retention of stormwater due to the absence of wetlands vegetation. The Operator is advised the Division of Water Resources (DWR) requires all stormwater impounded on site must infiltrate into the ground or be released to the natural stream system within 72 hours. Otherwise, all work must cease until a substitute water supply plan or augmentation plan approved by water court is obtained.

Photo 8. View looking west, showing water retained in eastern portion of active pit.

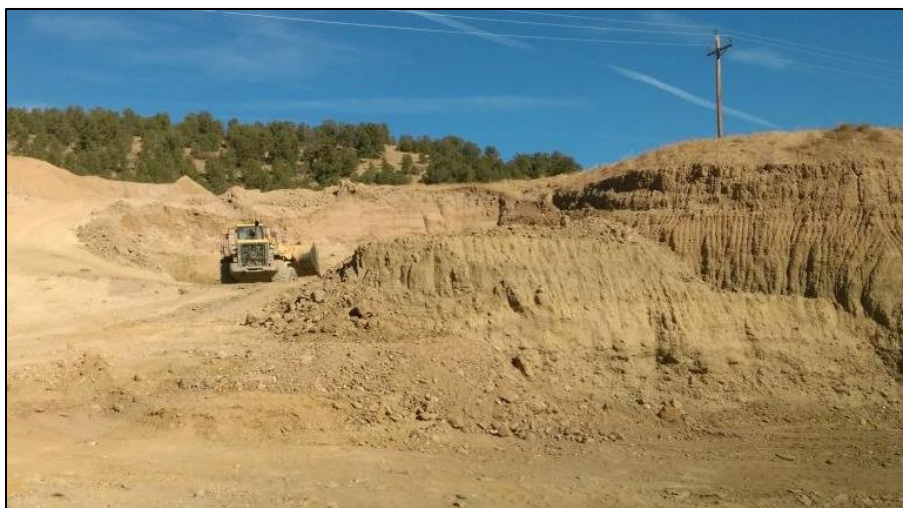
During the inspection, a front end loader was observed excavating overburden from the northwestern corner of the pit area (Photo 9) and hauling the material to a stockpile located west of the gas well pad (Photo 10). No other activities were observed. Overburden stockpiles were located along the edges of the active pit floor (Photos 11-13). Salvaged topsoil was stockpiled around the pit perimeter (Photo 14). Topsoil stockpiles exhibited vegetative cover sufficient to control erosion. Various stockpiles of processed material were located on the pit floor (Photos 15 and 16). Several trucks, various mining equipment, and a shed were also located on the pit floor (Photos 17-19). The Operator has stripped a small area just west of the active pit in preparation for advancing the pit westward. The topsoil salvaged from this area was stockpiled along the southern edge. Three small test pits have been excavated to the east of the active pit (Photos 20 and 21). The Division estimates the Operator has disturbed approximately 19.22 acres within the approved permit area (see enclosed Google Earth image 1).

Photo 9. View of loader extracting overburden from northwestern portion of active pit.

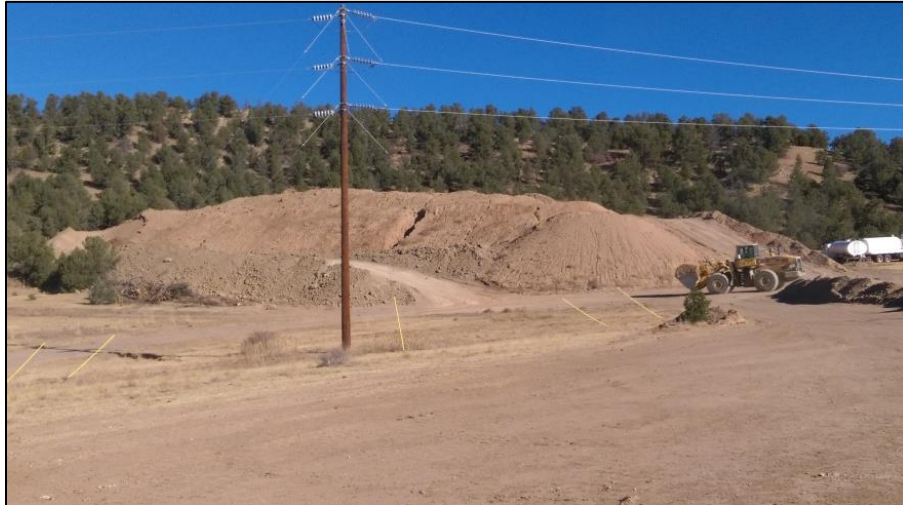
Photo 10. View of large overburden stockpile located northwest of active pit, west of gas well pad.

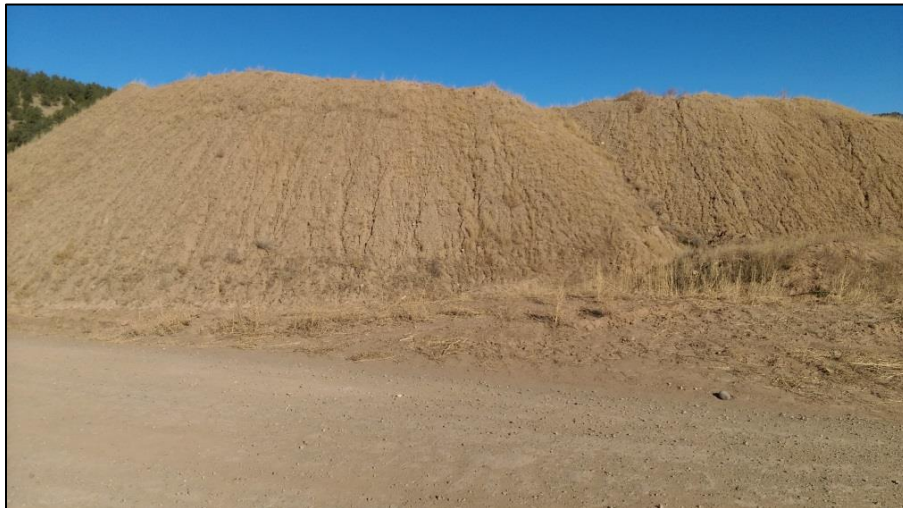
Photo 11. Close-up view of large overburden stockpile located northwest of active pit, west of gas well pad.

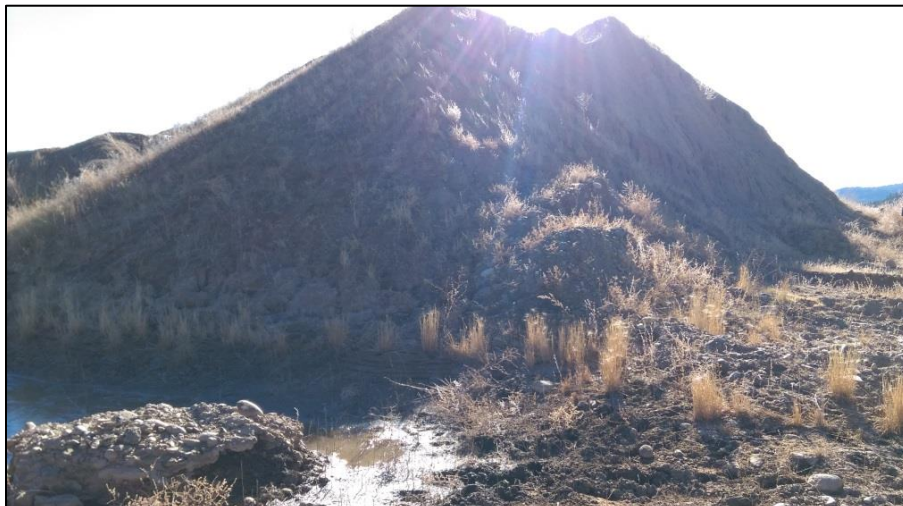
Photo 12. View of large overburden stockpile stored on pit floor in eastern portion of active pit.

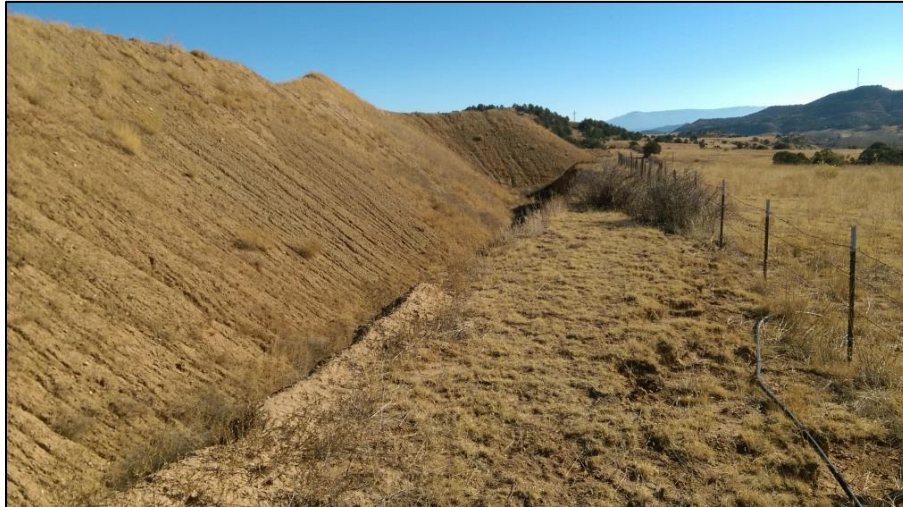
Photo 13. View of large overburden stockpile stored on pit floor adjacent to southern pit wall.

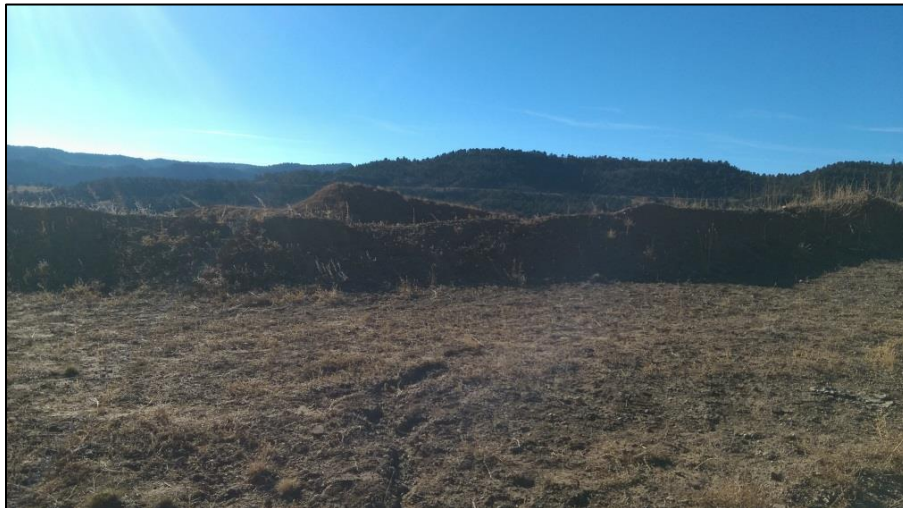
Photo 14. View of topsoil berm stored along top of northern pit wall.

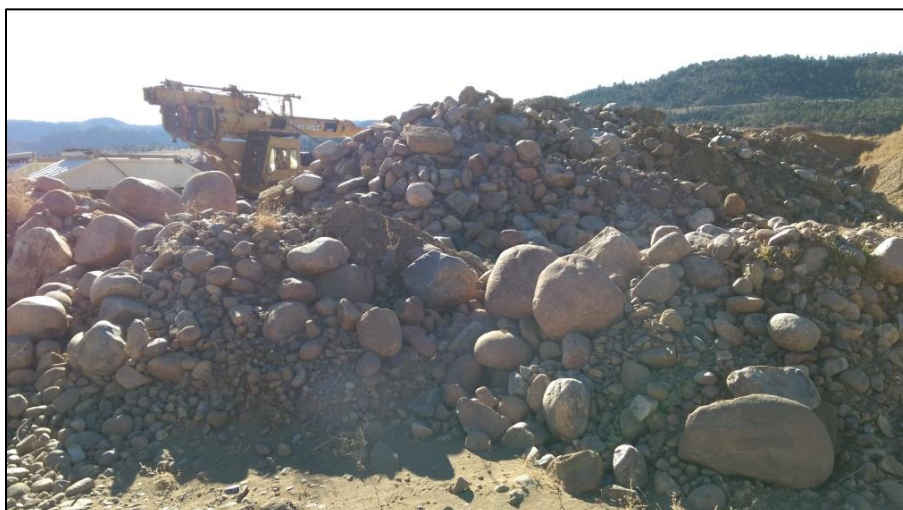
Photo 15. View of mined rocks stockpiled on pit floor.

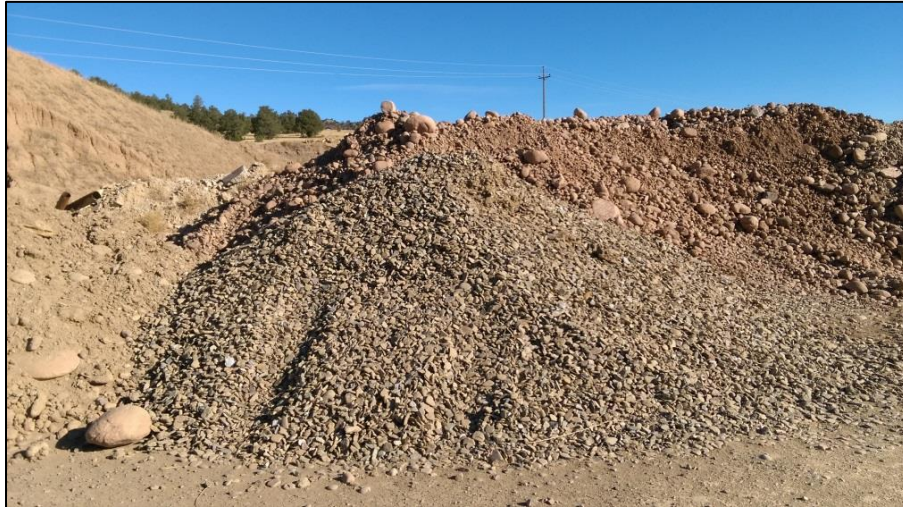
Photo 16. View of processed material stockpiled on pit floor.

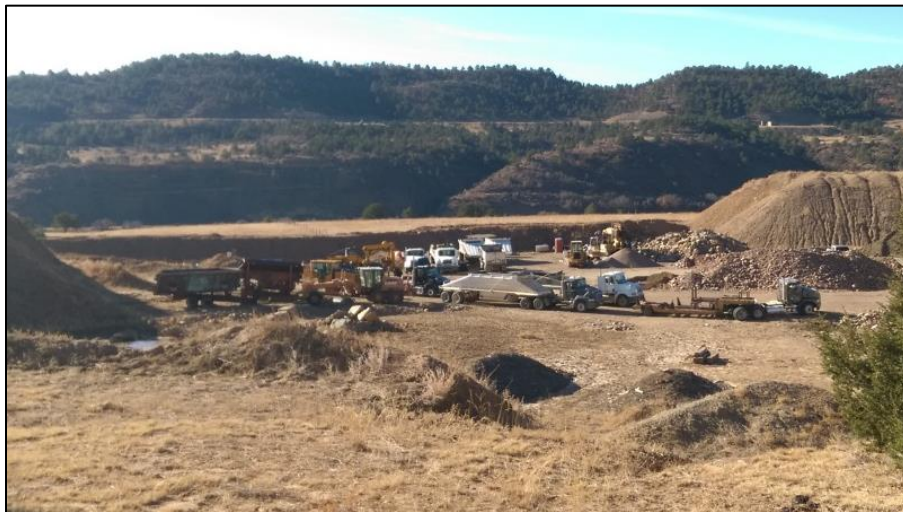
Photo 17. View looking south into active pit, showing several trucks and pieces of equipment stored on pit floor.

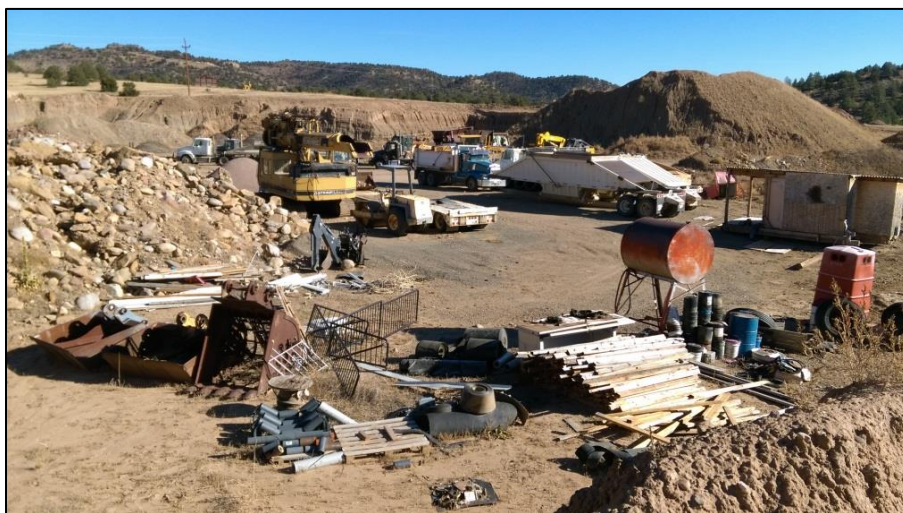
Photo 18. View of trucks, equipment, and small wooden shed (at right) stored on pit floor.

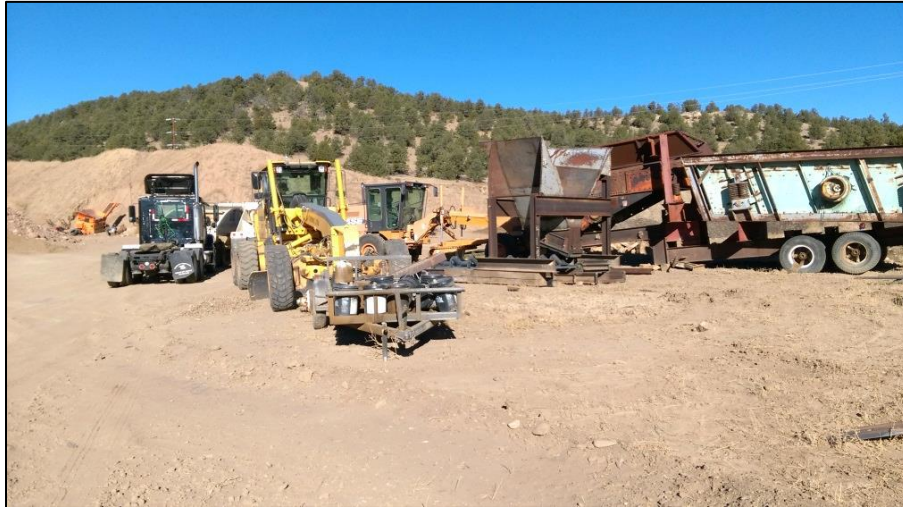
Photo 19. View of trucks and equipment stored on pit floor.

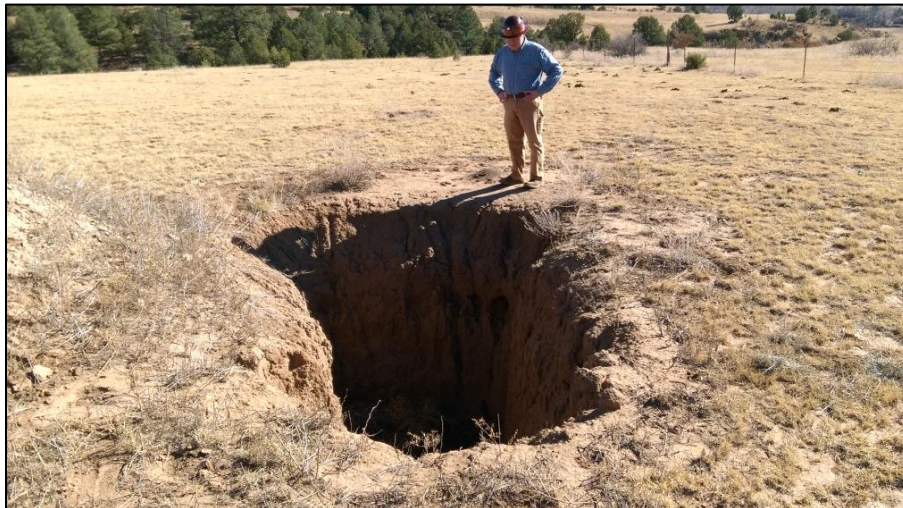
Photo 20. View of one of three small test pits excavated east of active pit, in mining phase 3 area.

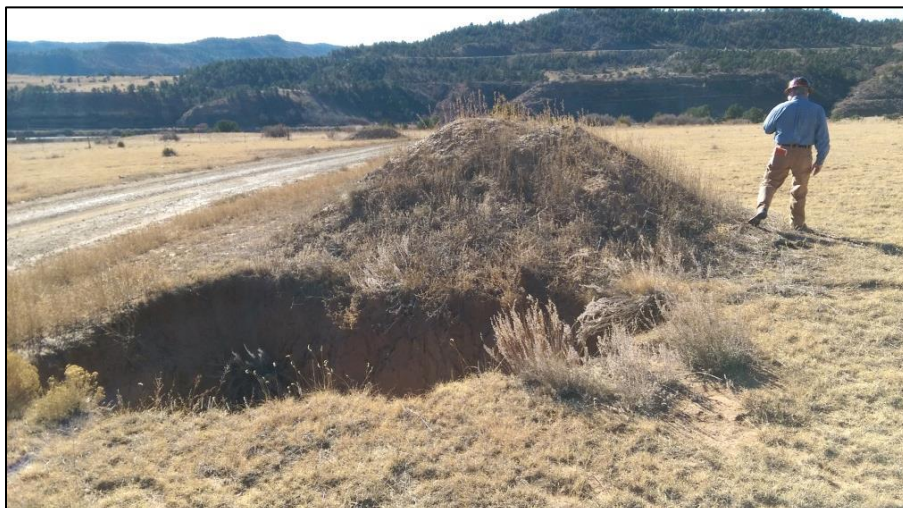
Photo 21. View of one of three small test pits excavated east of active pit, in mining phase 3 area. Located north of test pit shown in Photo 20.

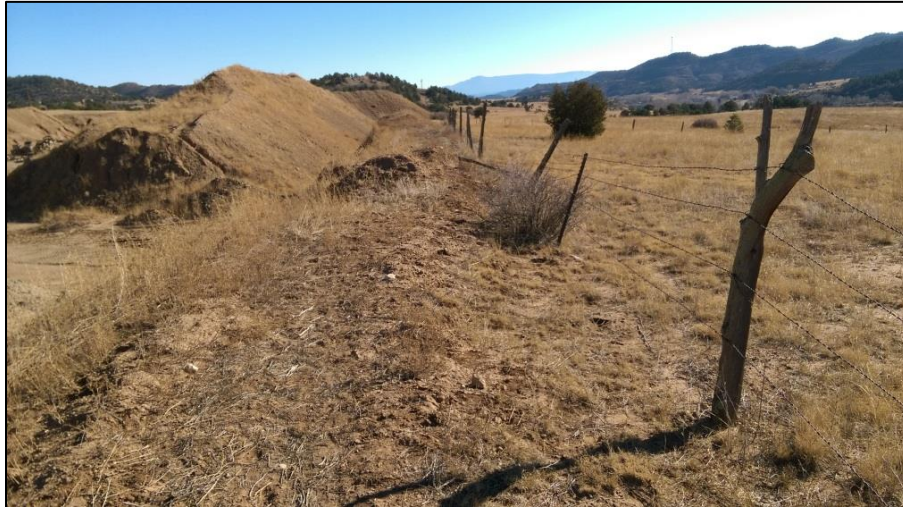
The Division inspected the fence referenced by Mr. Vigil. The fence is an old 4-string barbed wire fence with wooden posts (Photos 22 and 23). A few metal posts have been placed along the fence for added support. The fence runs roughly parallel to the section line (permit boundary) in the eastern portion of the site, but runs at an angle to the section line in the western portion of the site. Pit highwalls approach the fence to within 5-10 feet (Photo 24). On the enclosed Google Earth image 2, dated October 1, 2013, stockpiled material is clearly shown to be covering a portion of the southern fence line. On the enclosed Google Earth image 3, dated October 18, 2016, the stockpiled material appears to have been pushed north of the fence line. During the inspection, the Division confirmed the stockpiled material had been pushed north of the fence, the disturbed area graded, and the fence restored with new wire and metal posts (Photos 25 and 26). Observations made during the inspection and recorded in this report indicate the Operator has fulfilled Mr. Vigil's immediate concerns. However, the lands between the fence and section line, not owned by the Operator, are inappropriately included in the permit area due to the fact the Operator has not demonstrated a legal right to enter these lands. Therefore, the Division has found a problem with the permit records, pursuant to C.R.S. 34-32.5-112(1)(c)(IV) and Rules 6.4.14 and 6.3.7, and the Operator is required to either demonstrate his legal right to enter these lands, or submit an acreage reduction request to release these portions from the permit area. As clarified on page two of this report, the Division has imposed a 60-day deadline, due March 24, 2017, whereby the Operator must address the problem.

Photo 22. View looking east down southern edge of active pit, showing historic fence present just south of pit.

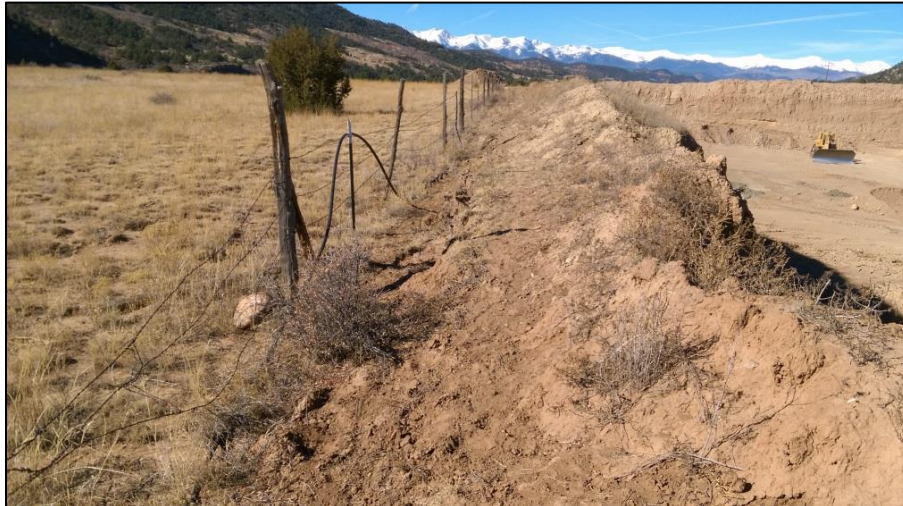
Photo 23. View looking west down southern edge of active pit, showing historic fence present just south of pit.

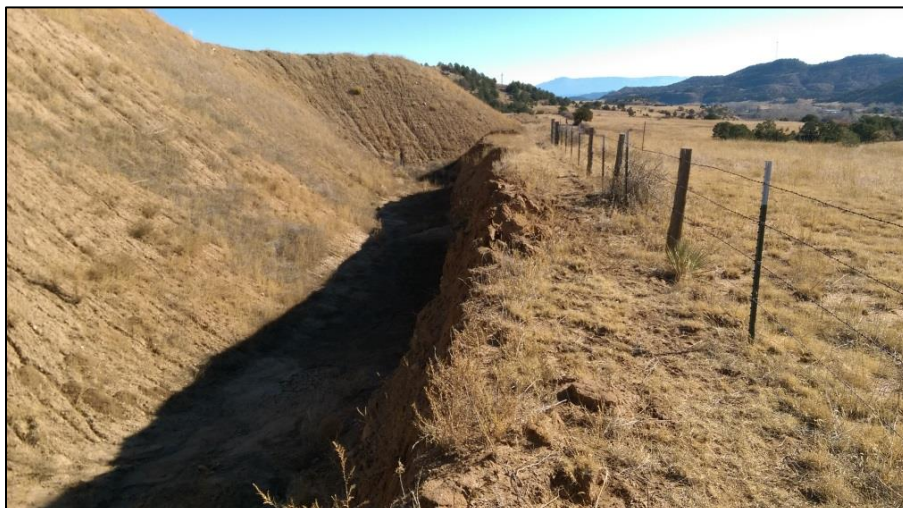
Photo 24. View looking east down southern edge of active pit, showing edge of pit wall within 5 feet of fenceline at this location.

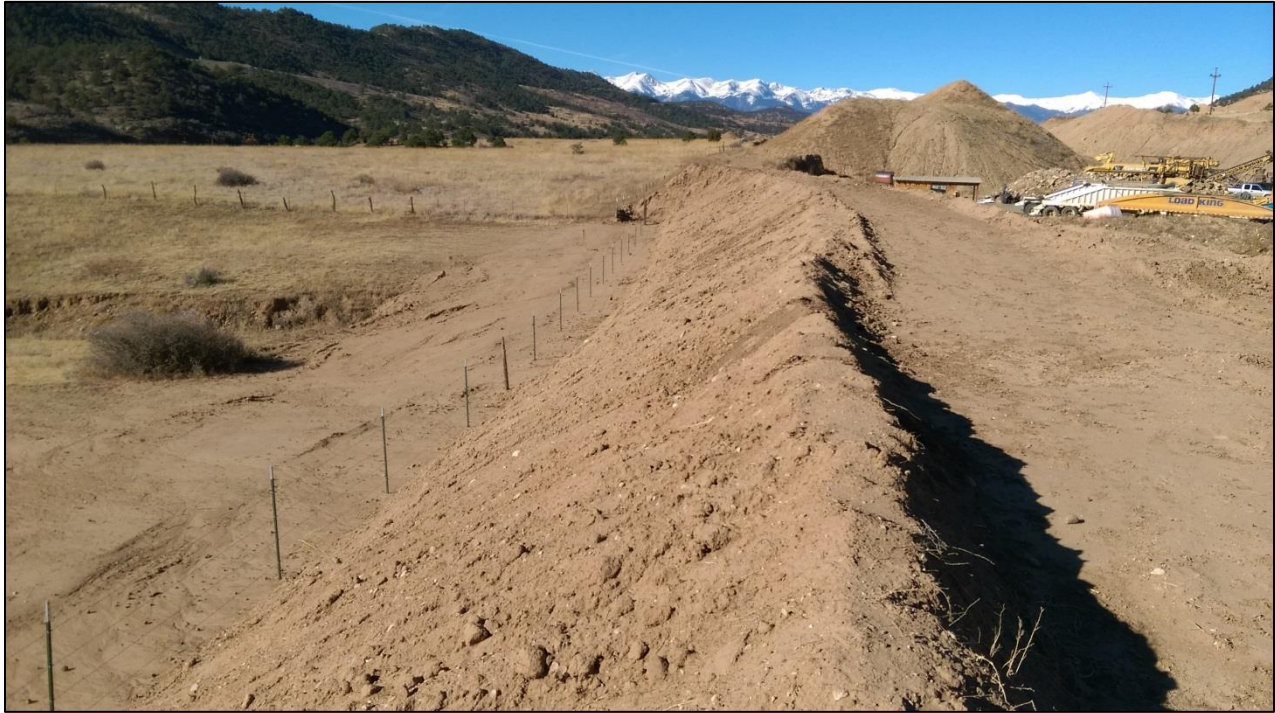
Photo 25. View looking west down southern edge of active pit, showing stockpile pushed back onto mine site, area graded, and fenceline rebuilt with new metal stakes and wire.

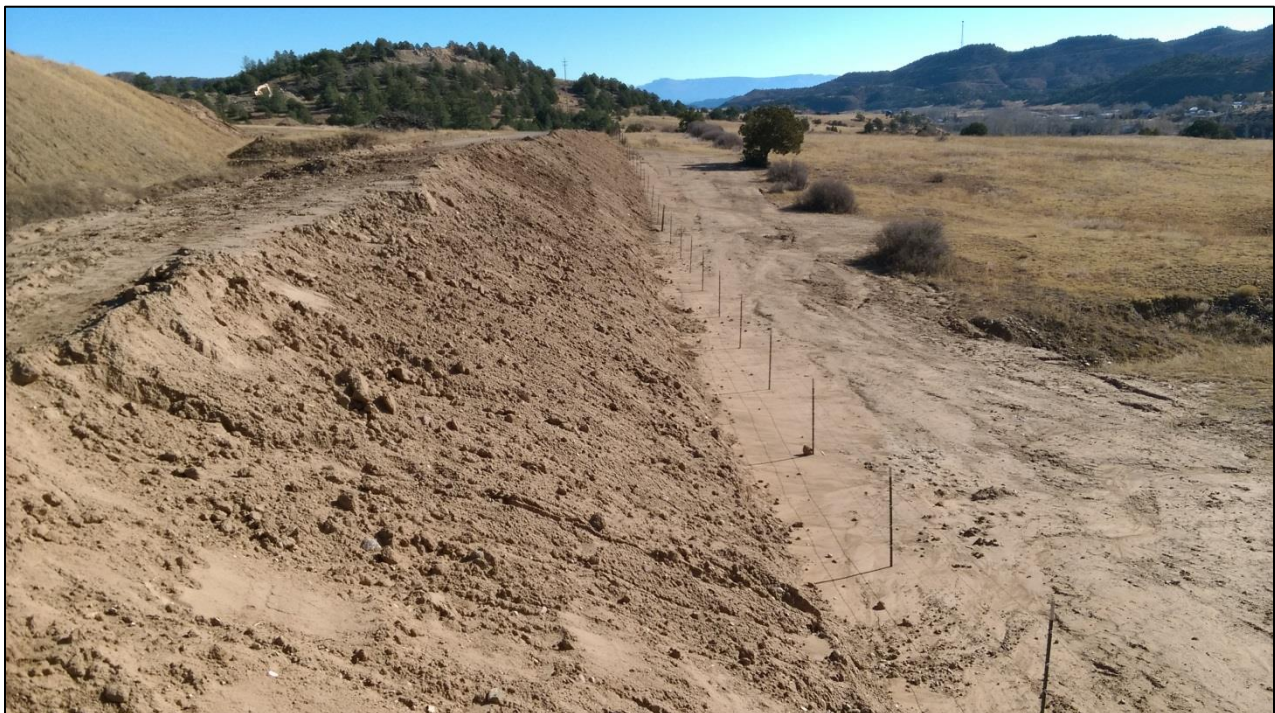
Photo 26. View looking east down southern edge of active pit, showing stockpile pushed back onto mine site, area graded, and fenceline rebuilt with new metal stakes and wire.

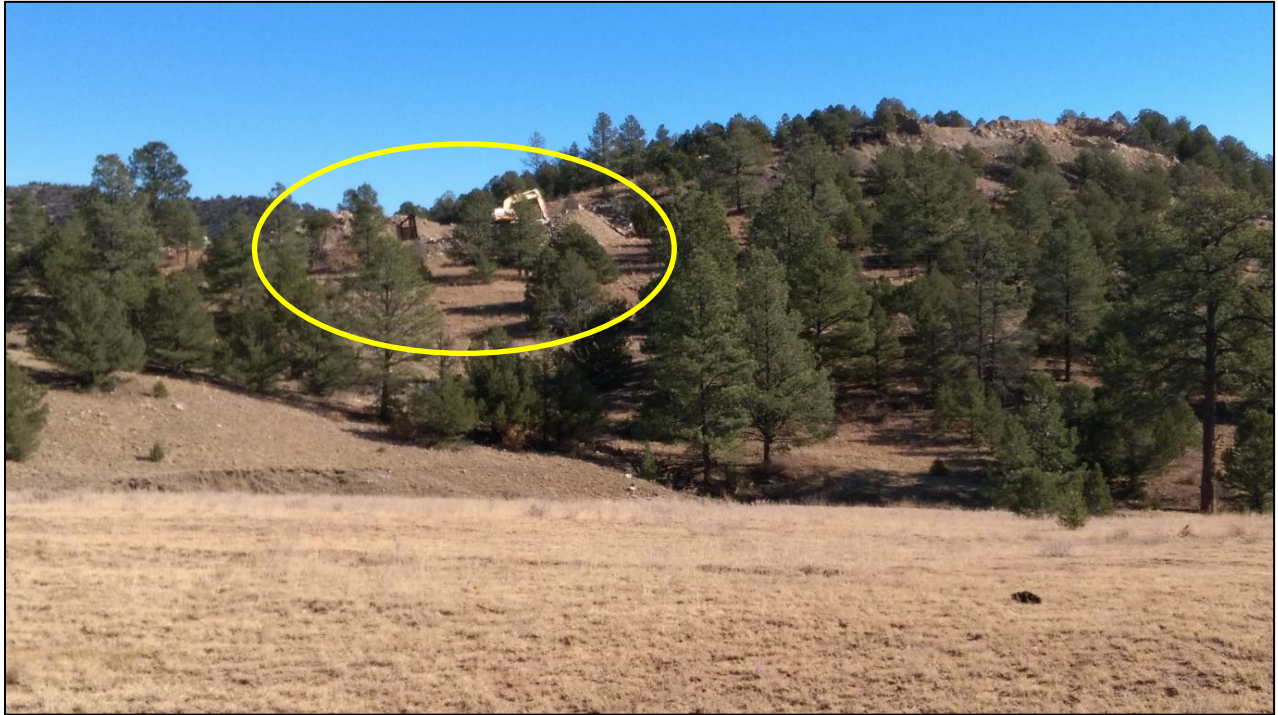
Photo 27. View looking east toward ridge located partially inside of permit area, showing mining equipment visible on side of ridge (circled).

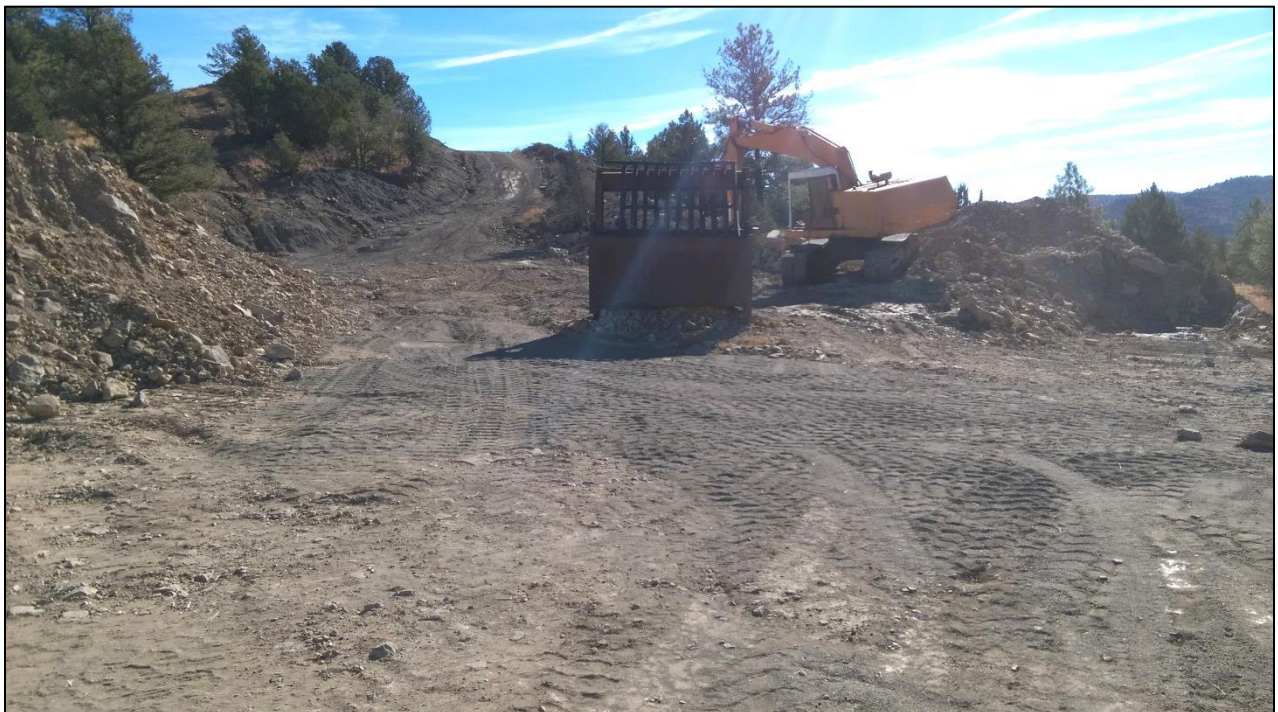
Photo 28. View of small stockpiling and processing area present on side of ridge. Note excavator, grizzly screen, and stockpiled material stored in area. This area is inside the approved permit boundary.

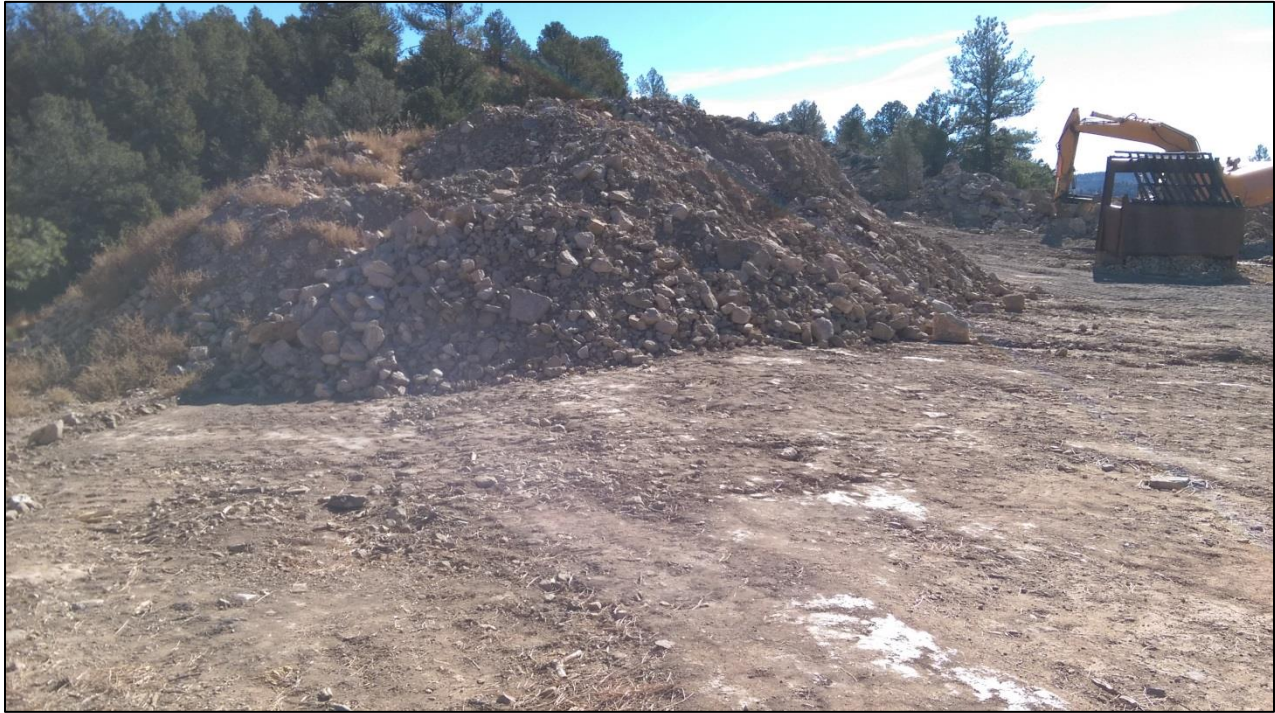
Photo 29. View of small stockpiling and processing area present on side of ridge. Note stockpiled material present in area. This area is inside the approved permit boundary.

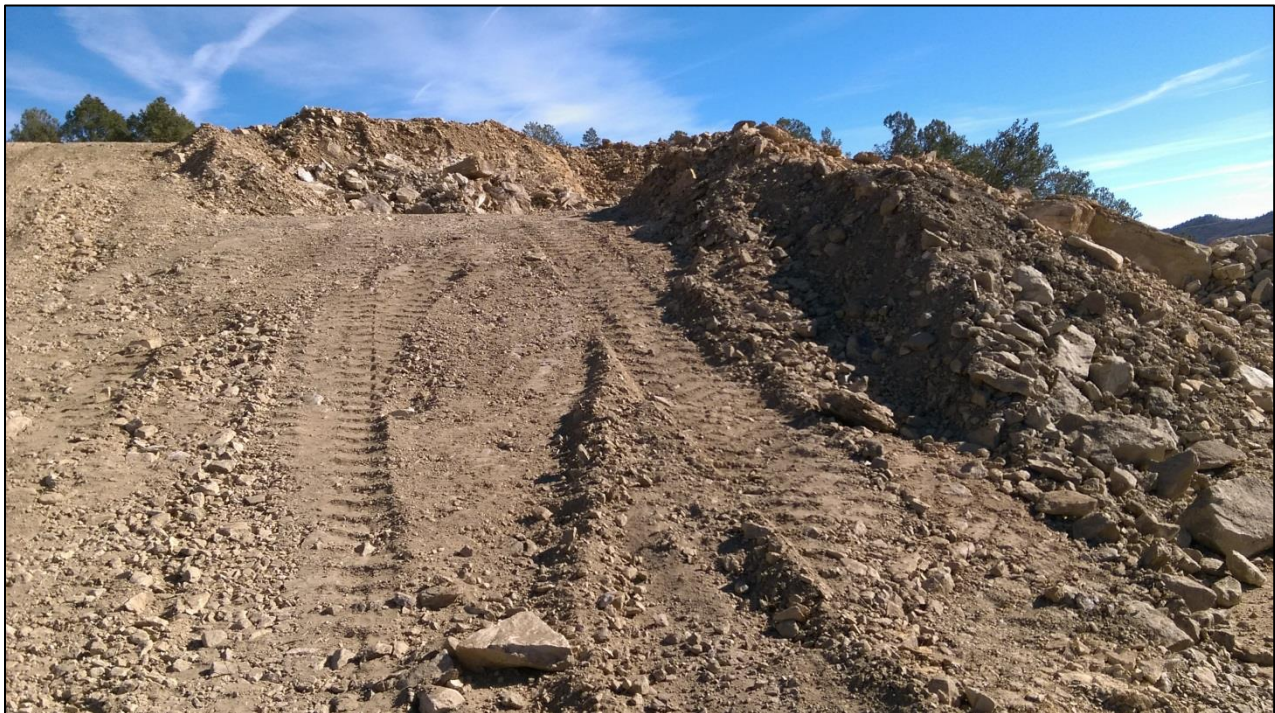
Off-Site Affected Lands at Ridge Area: At the top of the ridge located beyond the approved eastern boundary of affected lands, the Division observed approximately 0.9 acres of affected lands (Photos 30-33; Google Earth image 4).

Photo 30. View of excavation area at top of ridge. This area is outside of the approved permit boundary.

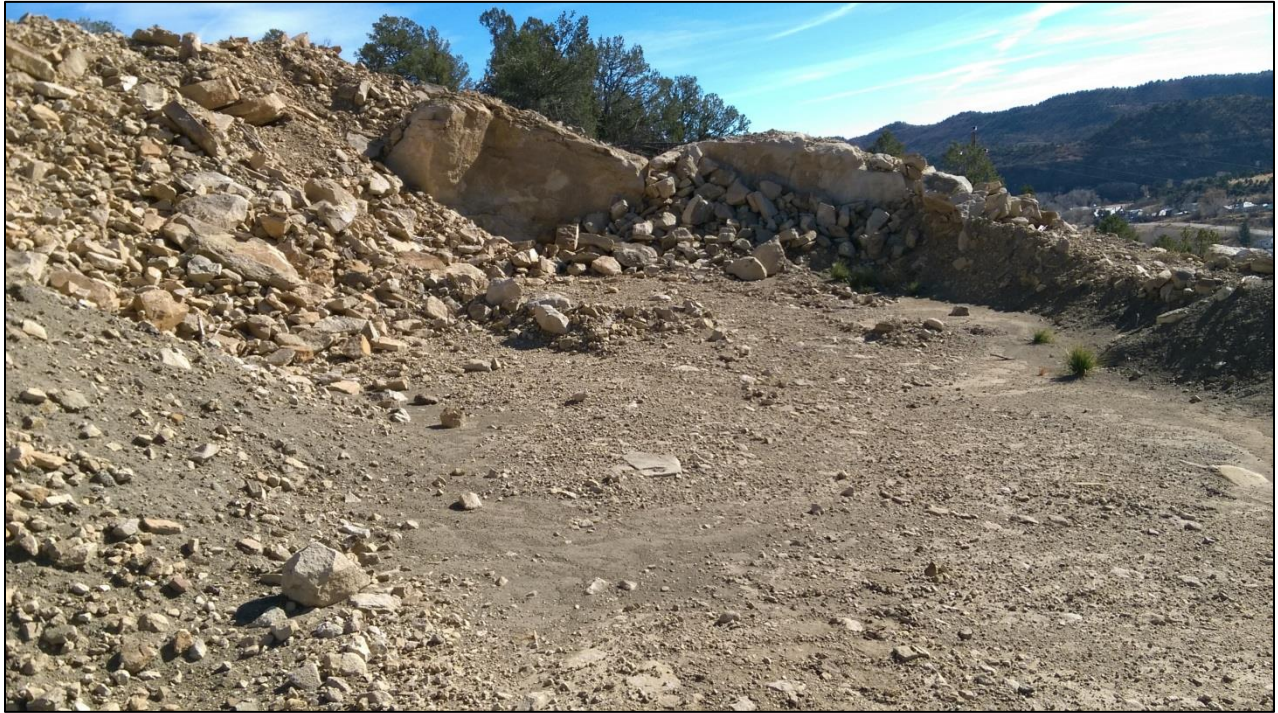
Photo 31. View of excavation area at top of ridge. This area is outside of the approved permit boundary.

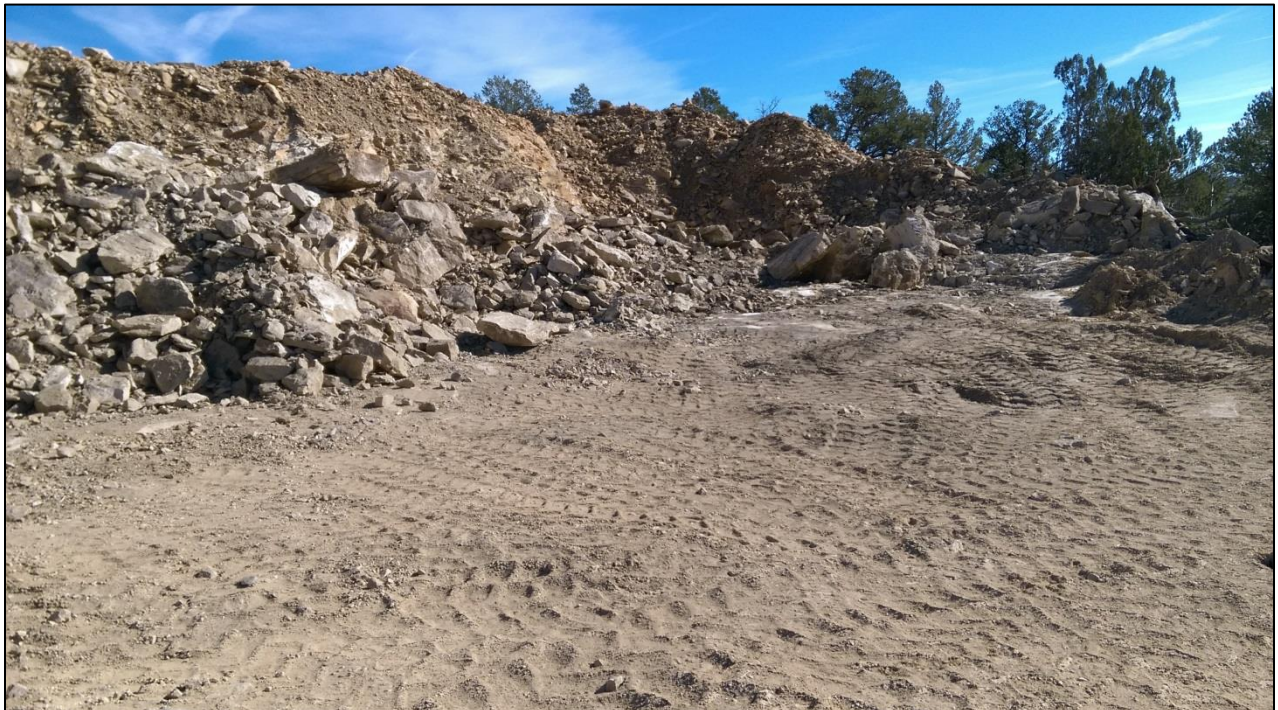
Photo 32. View of excavation area at top of ridge. This area is outside of the approved permit boundary.

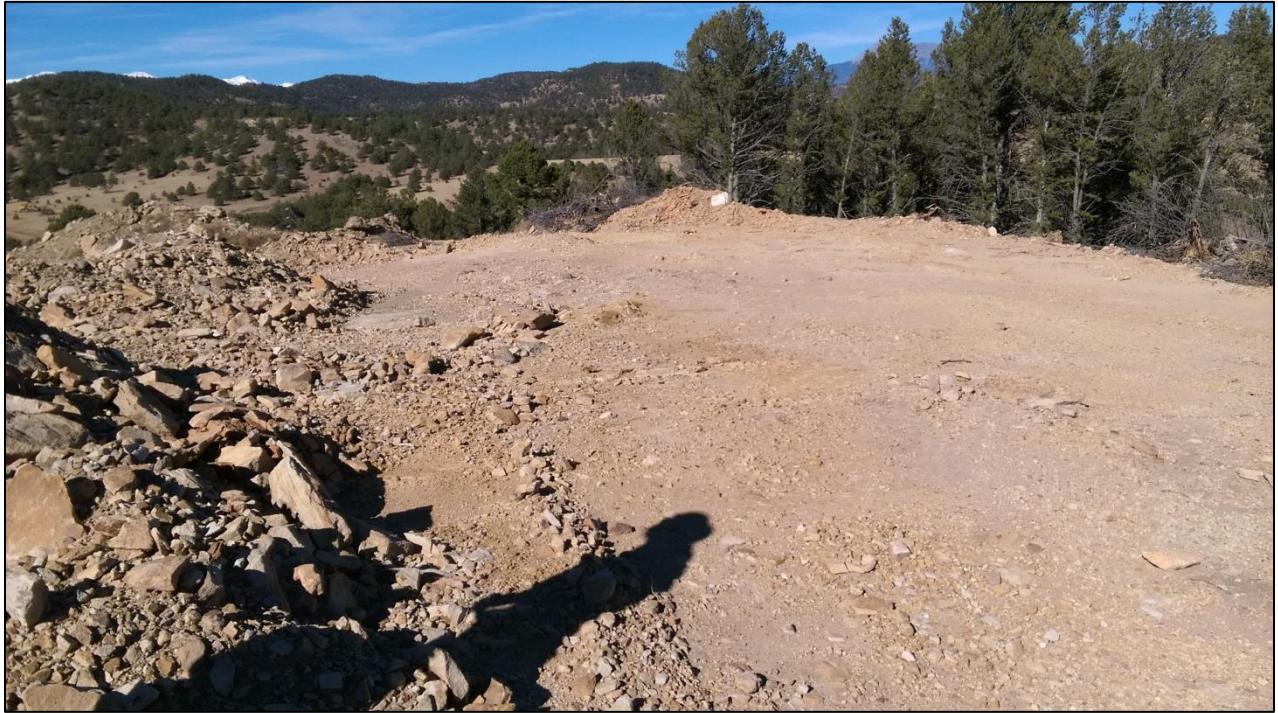
Photo 33. View of very top of ridge that has been mined and graded flat. This area is outside of the approved permit boundary.

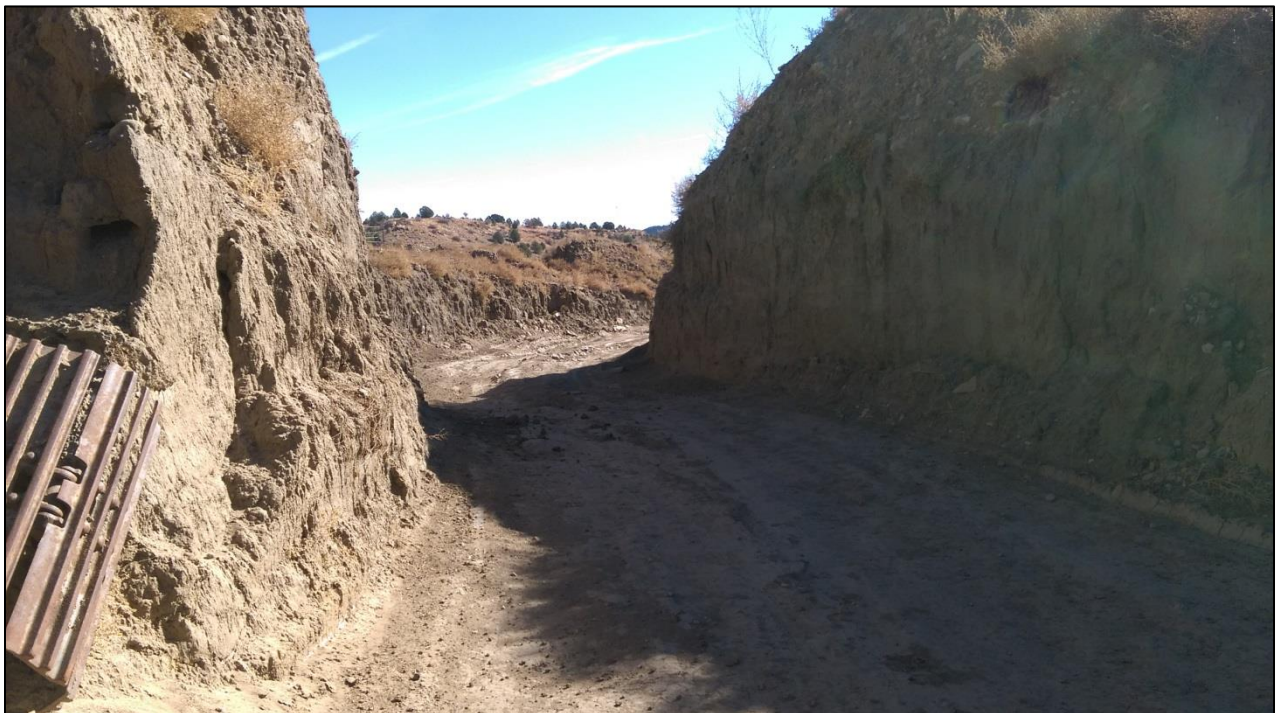
The illegal mining activity located upstream (north) of the mine access road (Photos 34-41) has captured the creek flow, diverting and retaining the creek flow, and has exposed alluvial groundwater. The diverted surface flow and exposed groundwater are routed back to the natural channel through a pair of culverts installed beneath the access road (Photo 42). The affected lands located beyond the affected land boundary and upstream (north) of the mine access road were estimated at 3.95 acres (see enclosed Google Earth image 5).

Photo 34. View looking south at dirt road constructed through ridge to access excavation area located north of main access road. This area is outside of the approved permit boundary.
