MINERALS PROGRAM INSPECTION REPORT
PHONE: (303) 866-3567

MINE NAME: Robinson Sons Gravel Pit No. 1	MINE/PROSPECTING ID#: M-2008-076	MINERAL: Sand and gravel; borrow material for construction	COUNTY: Las Animas
INSPECTION TYPE: Monitoring	INSPECTOR(S): Amy Eschberger, Wally Erickson	INSP. DATE: November 23, 2016	INSP. TIME: 09:30
OPERATOR: Robinson Sons Inc	OPERATOR REPRESENTATIVE: None	TYPE OF OPERATION: 112c - Construction Regular Operation	
REASON FOR INSPECTION: Priority	BOND CALCULATION TYPE: None	BOND AMOUNT: \$52,815.00	
DATE OF COMPLAINT: NA	POST INSP. CONTACTS: None	JOINT INSP. AGENCY: None	
WEATHER: Clear	INSPECTOR'S SIGNATURE:

SIGNATURE DATE: January 23, 2017

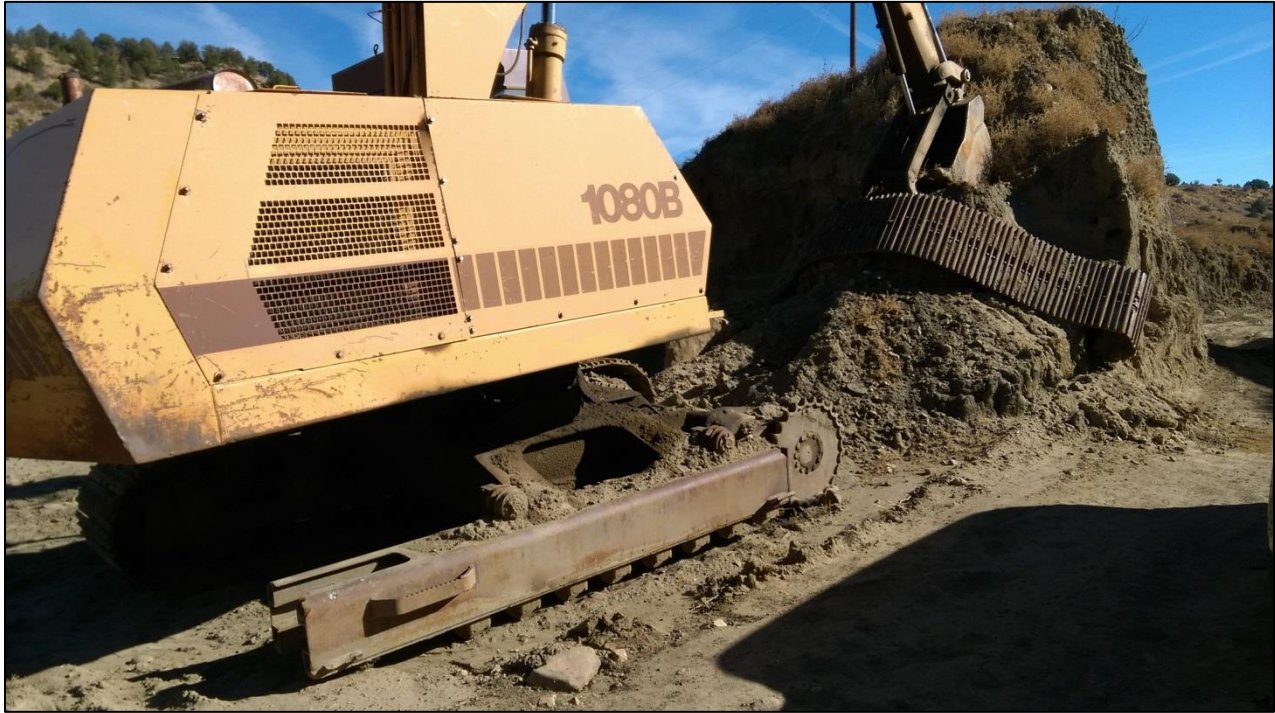
The illegal mining activity located upstream (north) of the mine access road (Photos 34-41) has captured the creek flow, diverting and retaining the creek flow, and has exposed alluvial groundwater. The diverted surface flow and exposed groundwater are routed back to the natural channel through a pair of culverts installed beneath the access road (Photo 42). The affected lands located beyond the affected land boundary and upstream (north) of the mine access road were estimated at 3.95 acres (see enclosed Google Earth image 5).

Photo 35. View of excavator present in excavation area located north of main access road. Note excavator lost track in mud while excavating. This area is outside of the approved permit boundary.

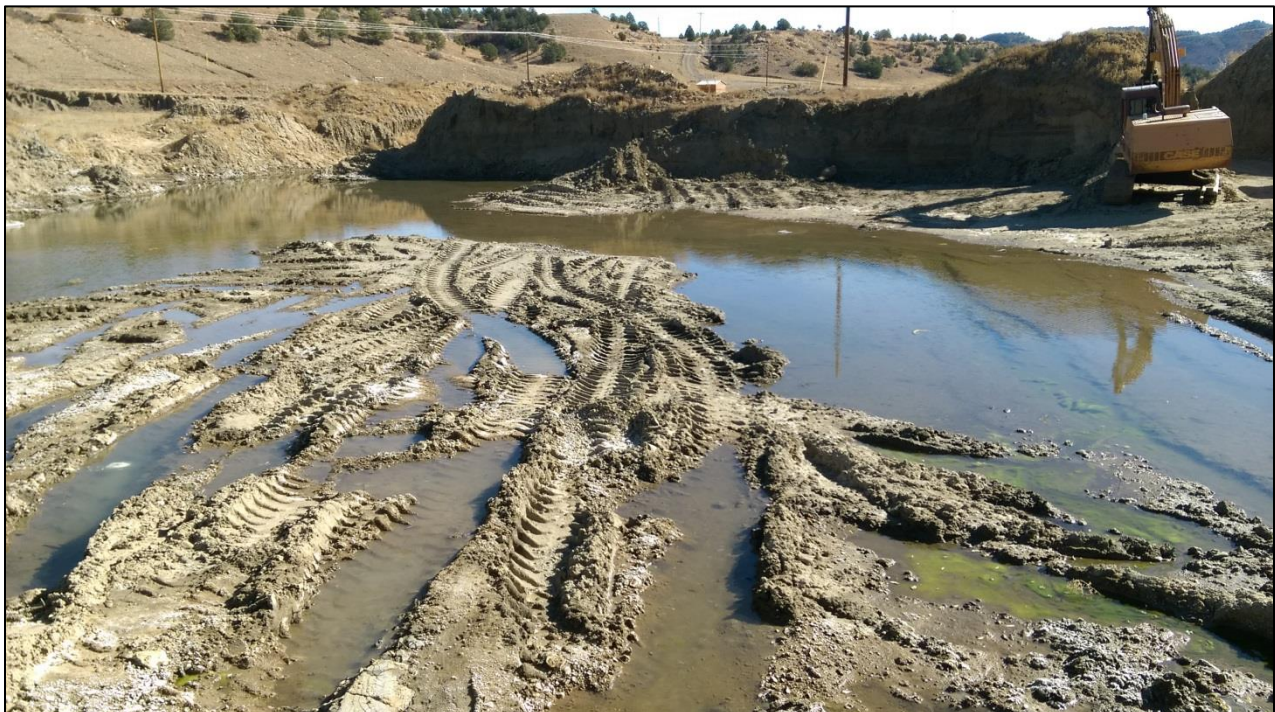
Photo 36. View of fresh loader tracks across floor of excavation area located north of main access road. Note water pooled up on excavated floor. This area is outside of the approved permit boundary.

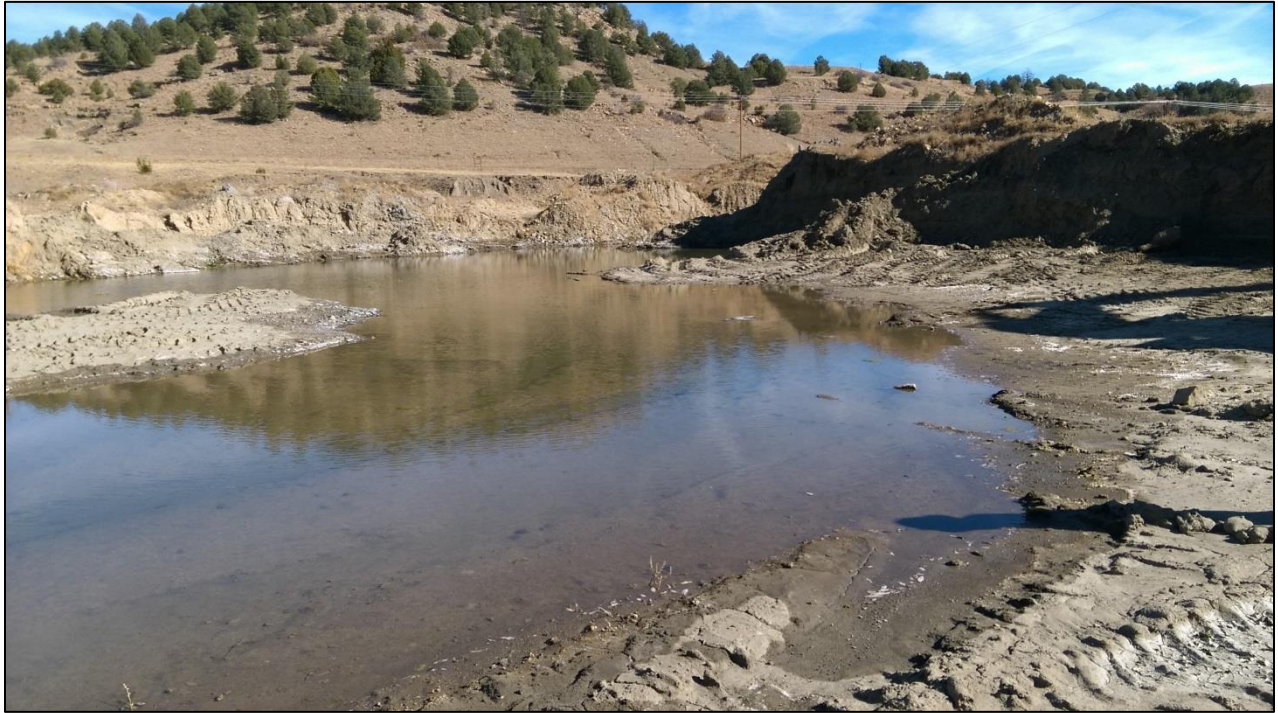
Photo 37. View of excavation area located north of main access road. Note water pooled up on excavated floor. This area is outside of the approved permit boundary.

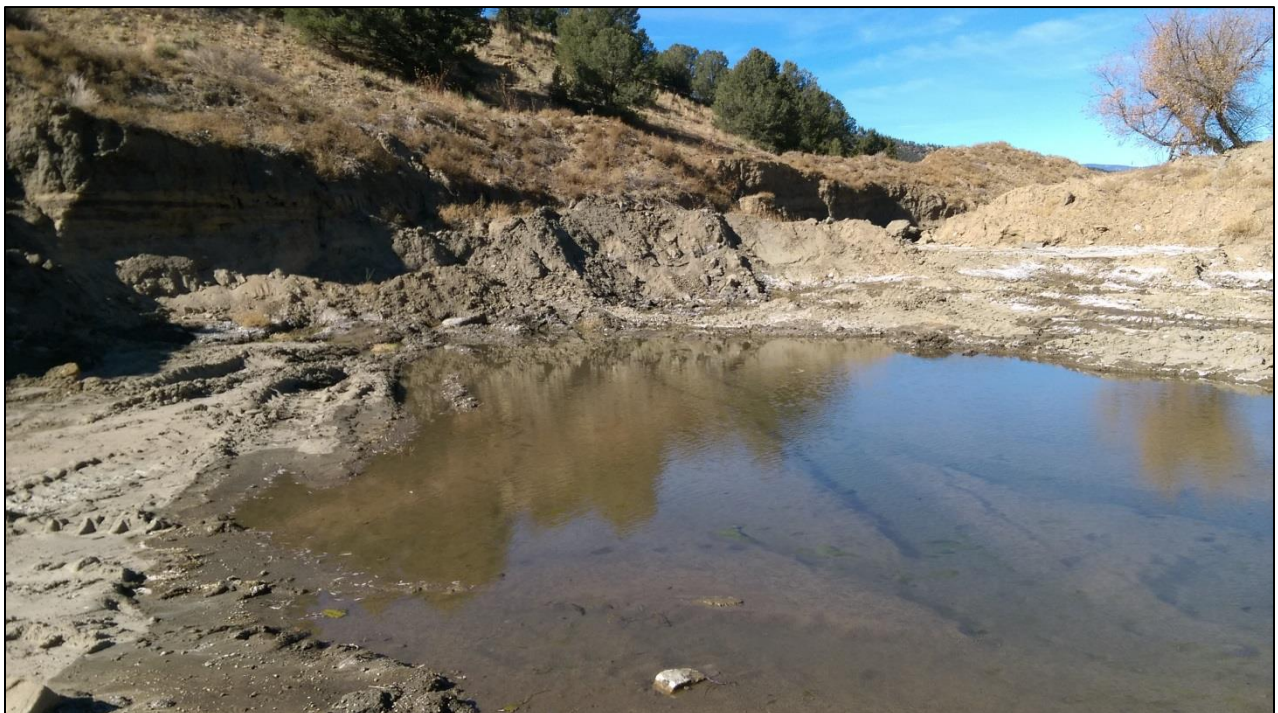
Photo 38. View of excavation area located north of main access road. Note material pushed to side of pit, and water pooled up on excavated floor. This area is outside of the approved permit boundary.

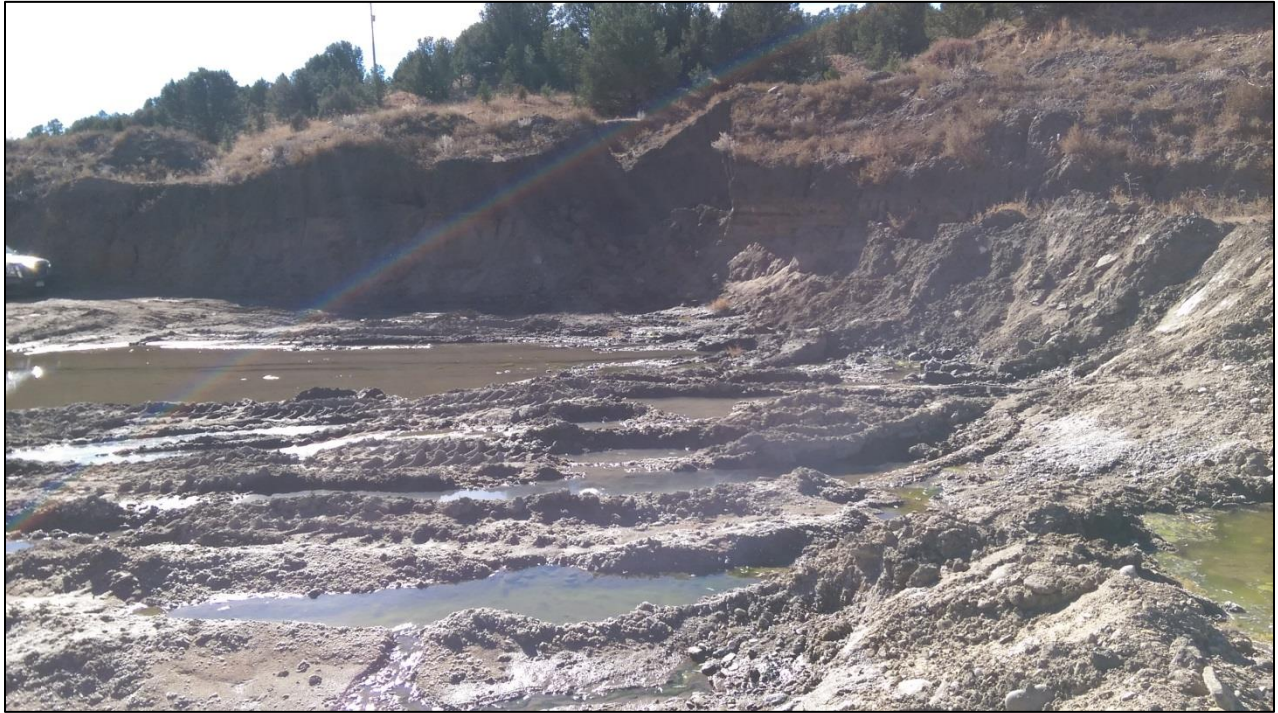
Photo 39. View of excavation area located north of main access road. Note material pushed to side of pit, and water pooled up on excavated floor. This area is outside of the approved permit boundary.

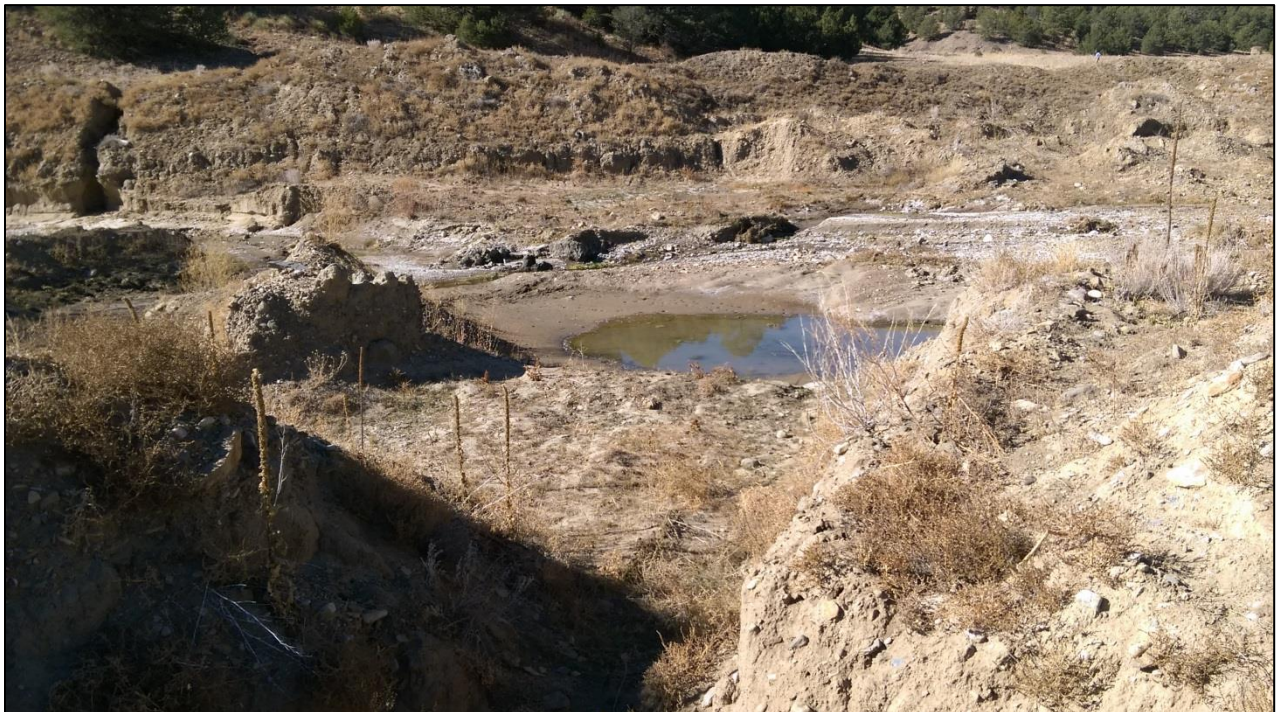
Photo 40. View of excavation area located north of main access road. Note water pooled up on excavated floor. This area is outside of the approved permit boundary.

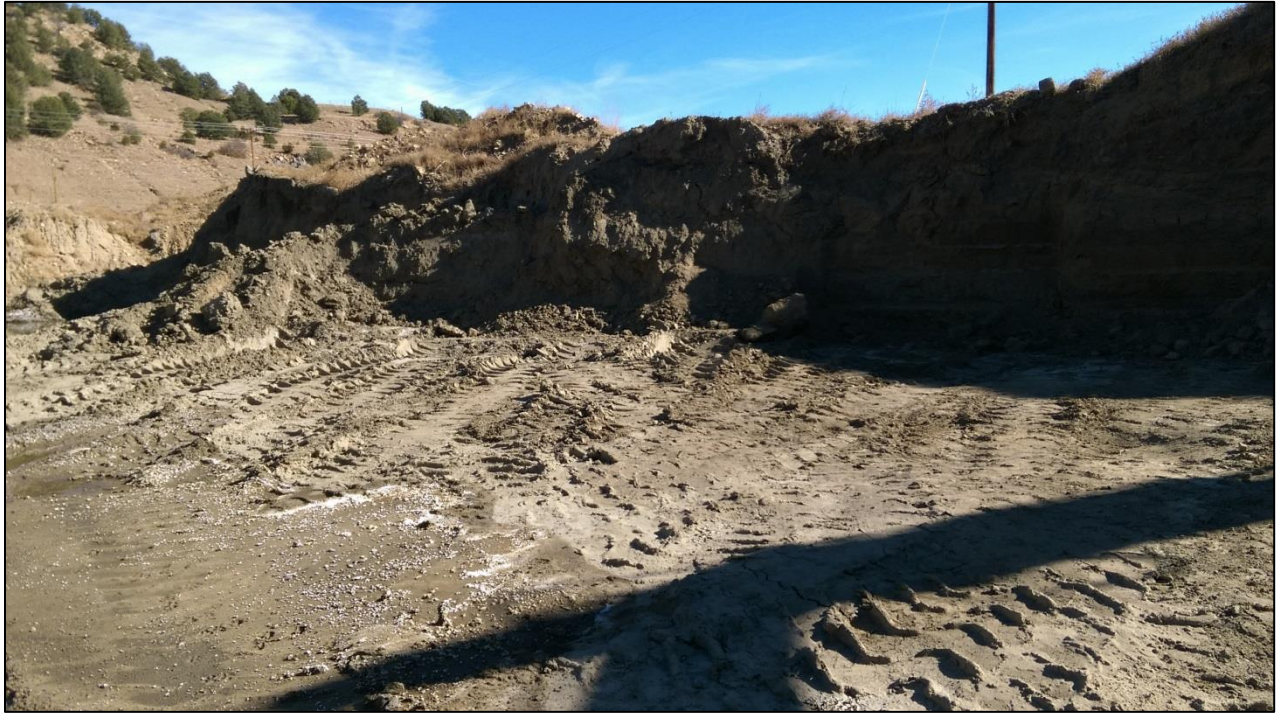
Photo 41. View of excavation area located north of main access road. Note ridge wall recently excavated. This area is outside of the approved permit boundary.

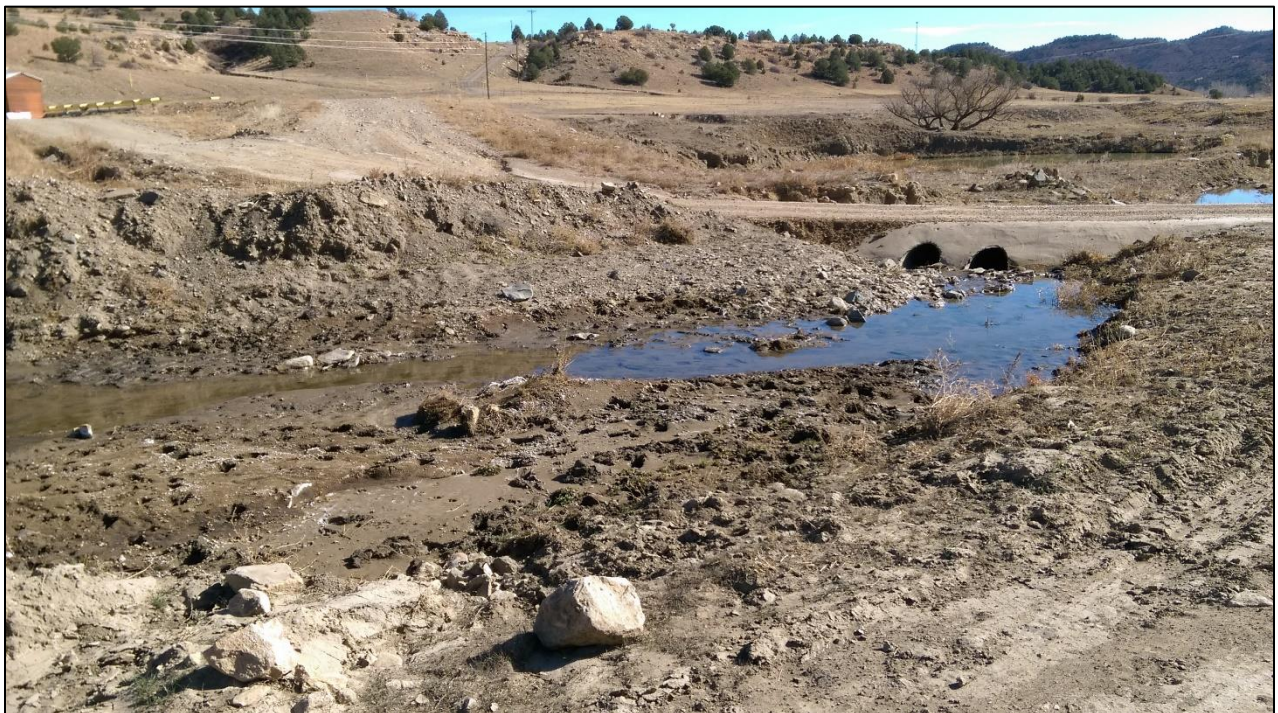
Photo 42. View looking south, showing creek flowing south/southeast from excavation area located north of access road, toward culverts installed under road, and into excavation area located south of road.

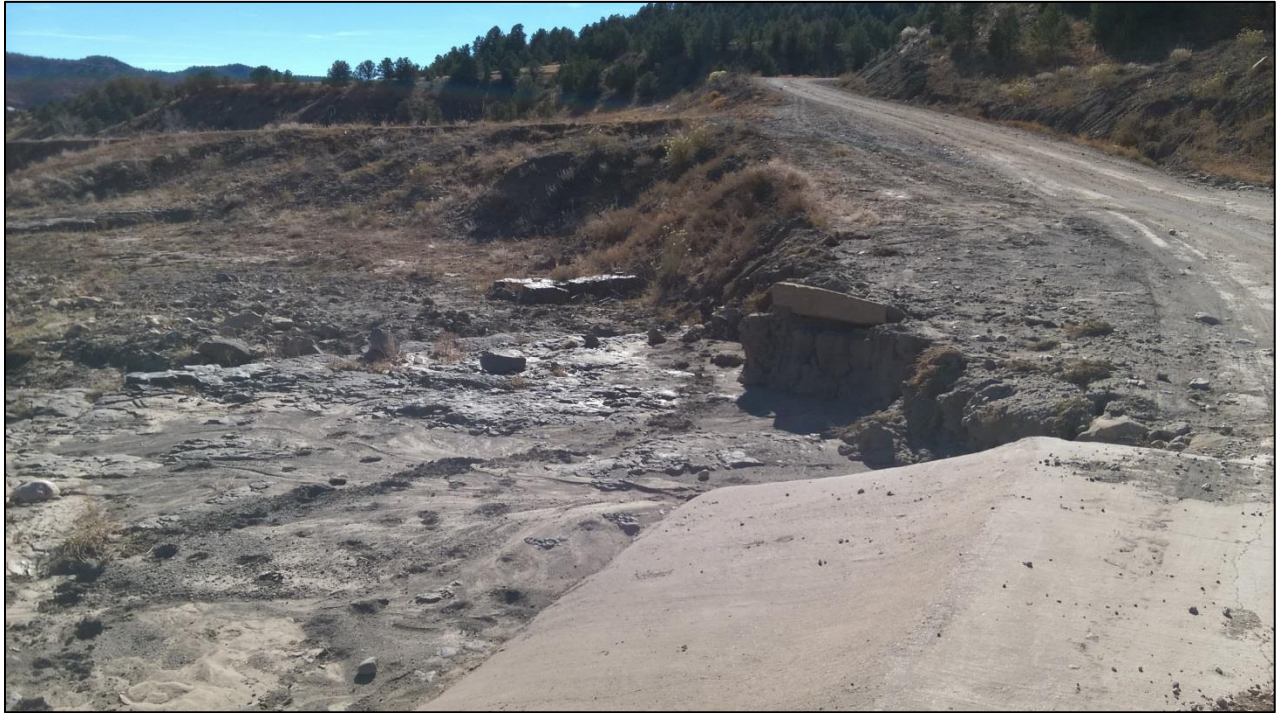
The illegal mining activity located downstream (south) of the mine access road was nearby and/or within the floodplain of the same unnamed creek (Photos 43-45). The Division's preliminary investigation indicates the excavation activity has exposed alluvial groundwater, as evidenced by the pond resulting from material extraction from the floodplain. The Division observed a truck scale and associated scale house and scale access ramps nearby (Photo 1). The truck scales and associated structures are defined as affected lands under Rule 1.1(3), but were

Photo 43. View looking southwest across northern portion of excavation area located south of main access road, in creek floodplain. Note main access road shown at right. This area is outside of the approved permit boundary.

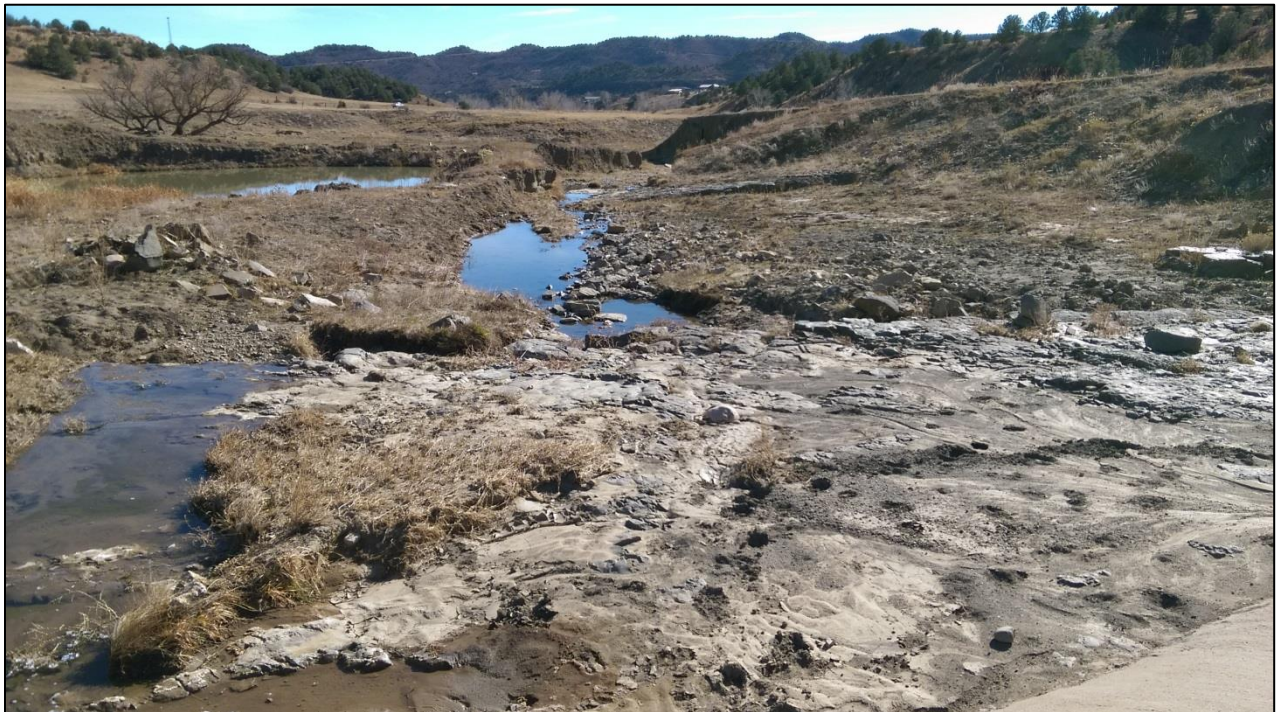
Photo 44. View looking south across excavation area located south of main access road, in creek floodplain. Note this area appears to be an older excavation than area to the north as grasses have volunteered into area. This area is outside of the approved permit boundary.

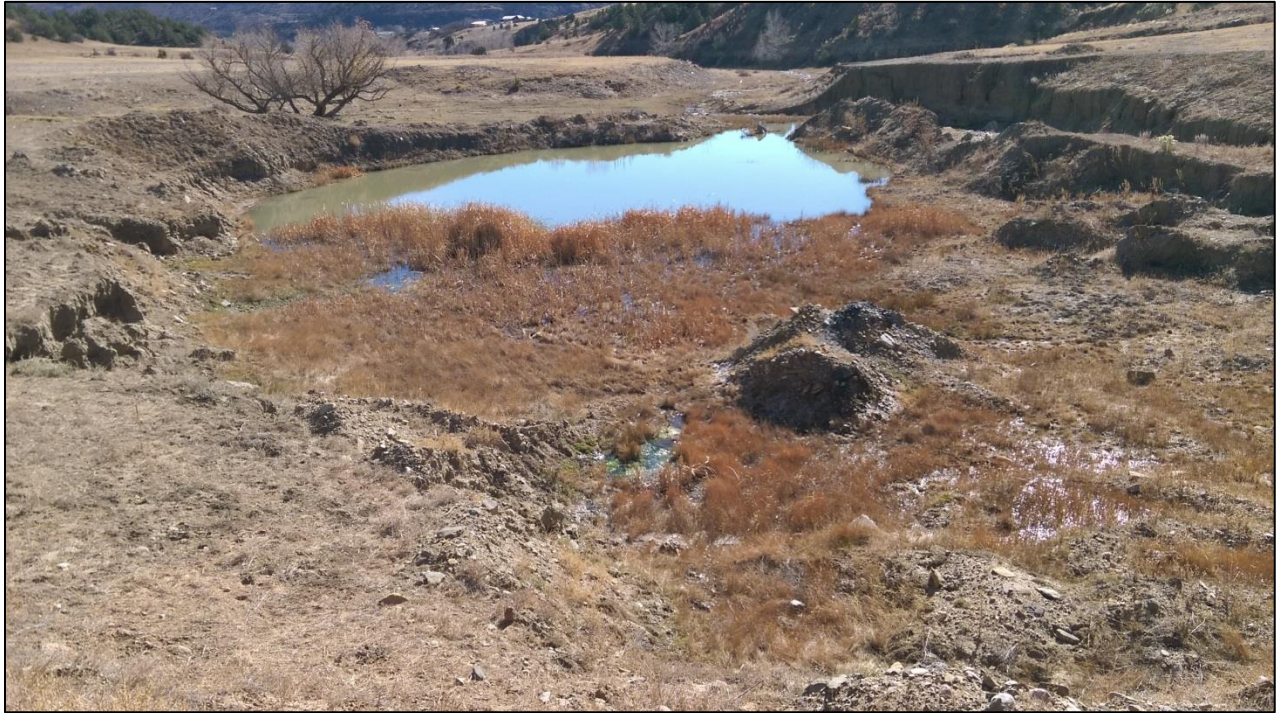
Photo 45. View looking southeast across excavation area located south of main access road, in creek floodplain. Note this area appears to be an older excavation than area to the north as grasses have volunteered into area. Also note water pooled up on excavated floor. This area is outside of the approved permit boundary.
