MINERALS PROGRAM INSPECTION REPORT
PHONE: (303) 866-3567

MINE NAME: Patty's Pit	MINE/PROSPECTING ID#: M-1998-103	MINERAL: Sand and gravel	COUNTY: Elbert
INSPECTION TYPE: Monitoring	INSPECTOR(S): Peter S. Hays	INSP. DATE: January 26, 2017	INSP. TIME: 11:00
OPERATOR: Town of Limon	OPERATOR REPRESENTATIVE: Ed Grimes	TYPE OF OPERATION: 110c - Construction Limited Impact	
REASON FOR INSPECTION: Normal I&E Program	BOND CALCULATION TYPE: None	BOND AMOUNT: \$0.00	
DATE OF COMPLAINT: NA	POST INSP. CONTACTS: None	JOINT INSP. AGENCY: None	
WEATHER: Clear	INSPECTOR'S SIGNATURE:

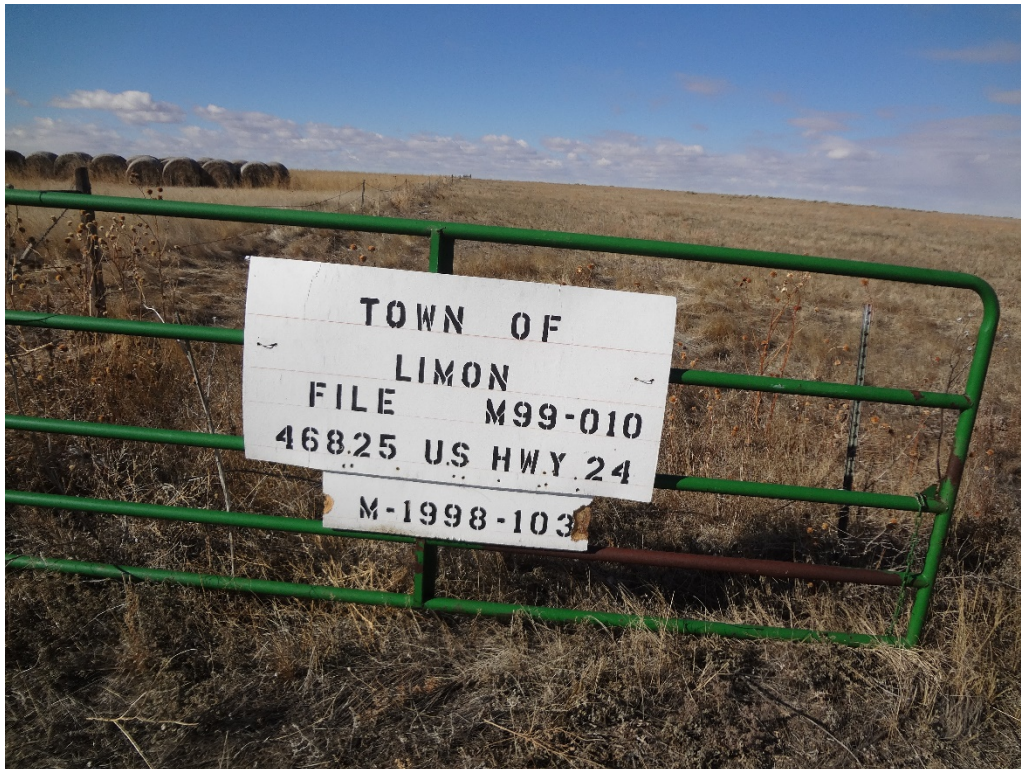
The required mine sign was observed on the entrance gate and the site boundaries were delineated with t-posts as required by Rule 3.1.12.

Patty's Pit mine sign

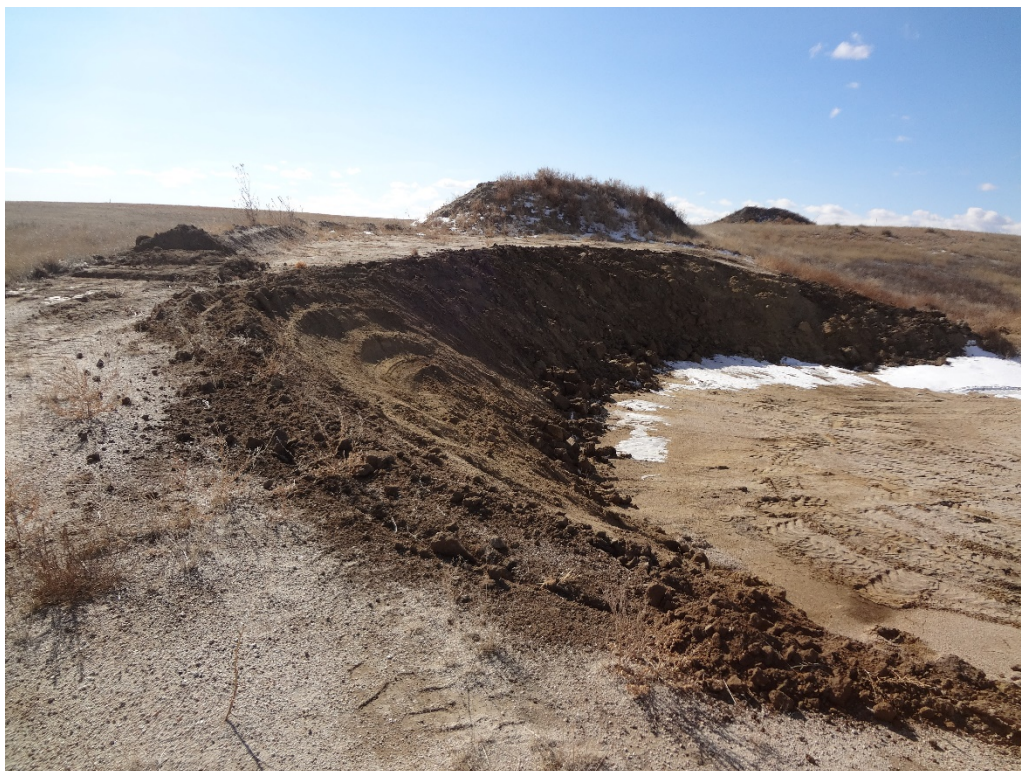
View of current highwall looking south

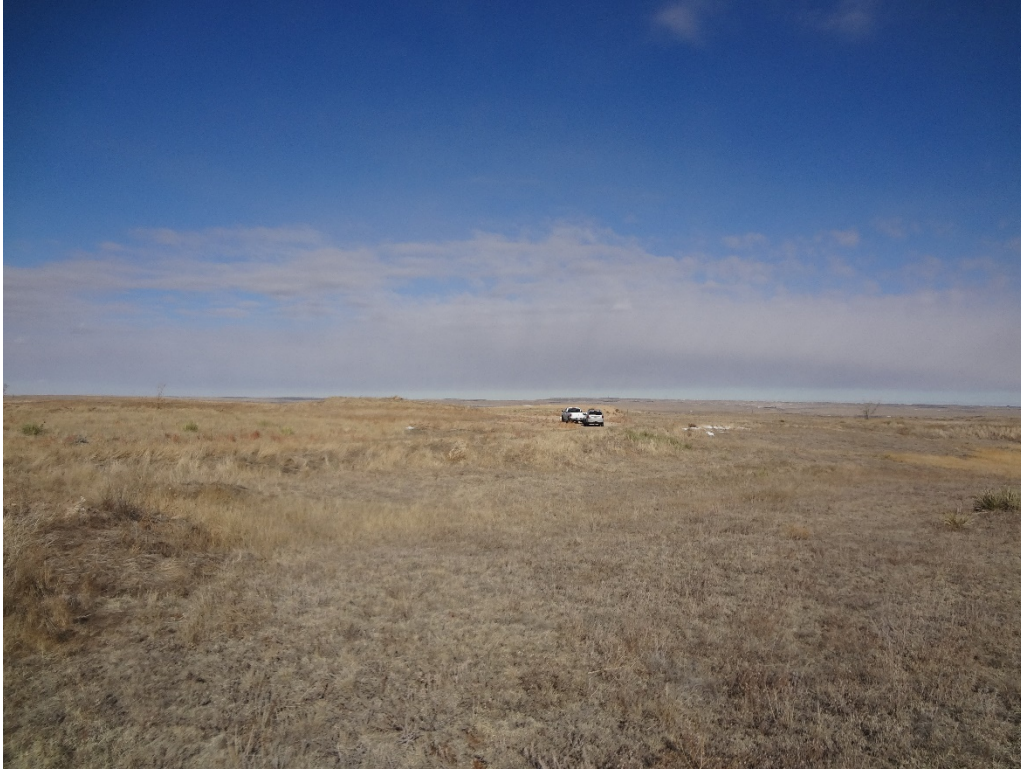
View from SE permit corner looking north

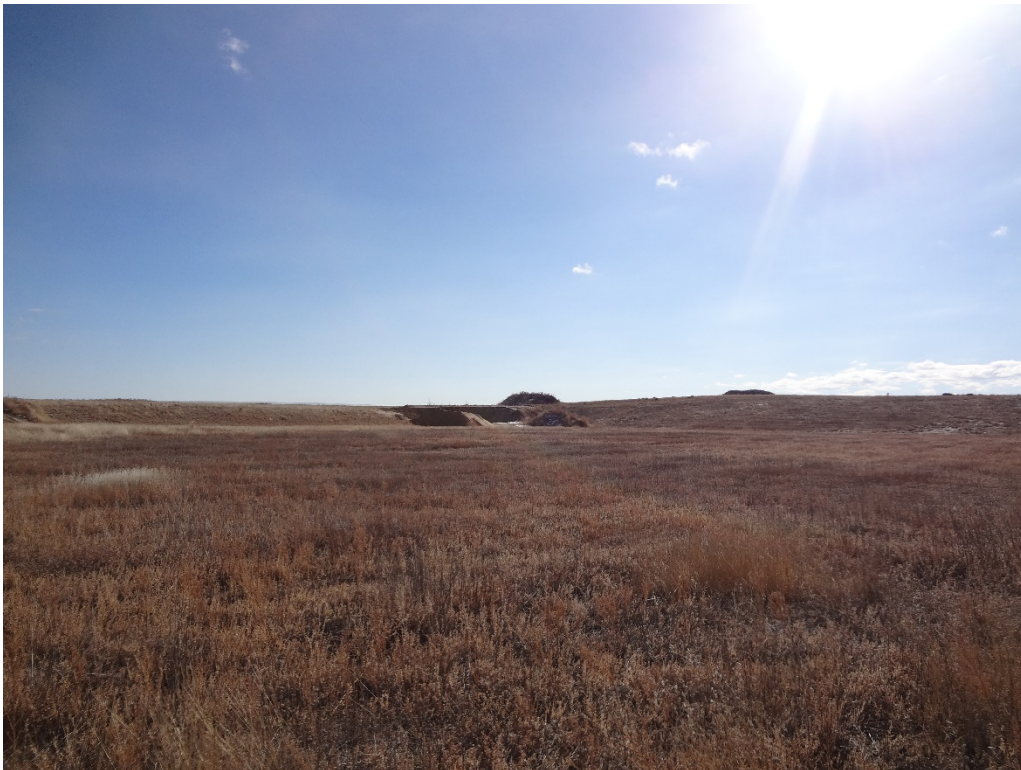
View of pit floor from NW corner of pit looking SE

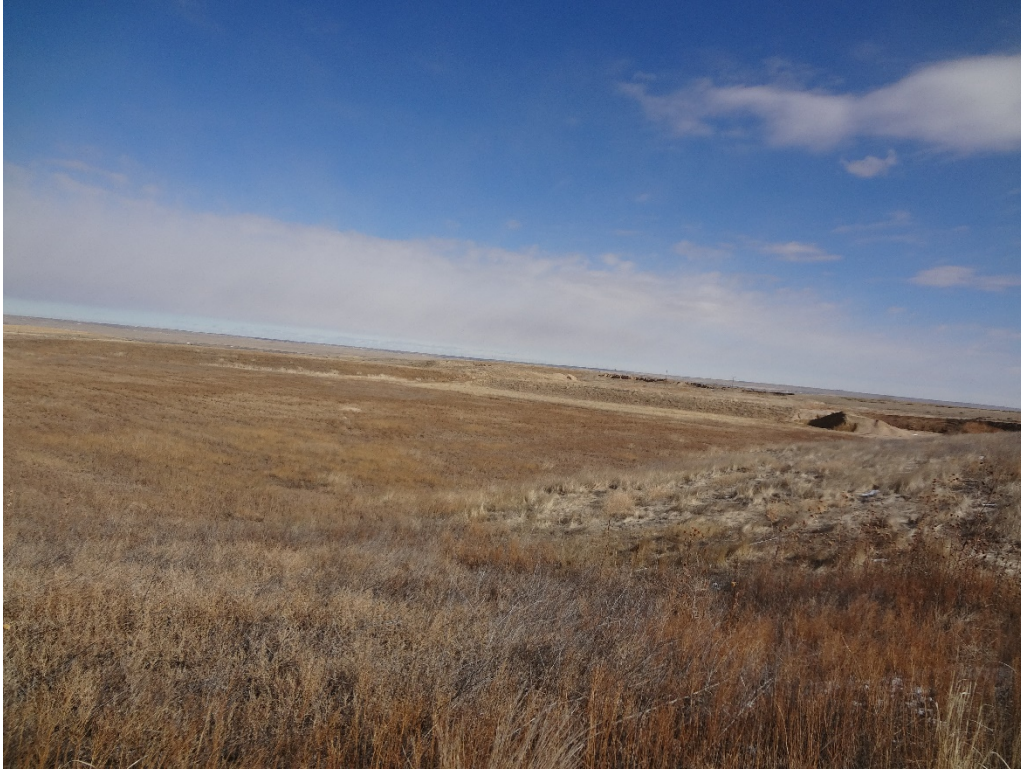
View of pit from SW corner looking NW

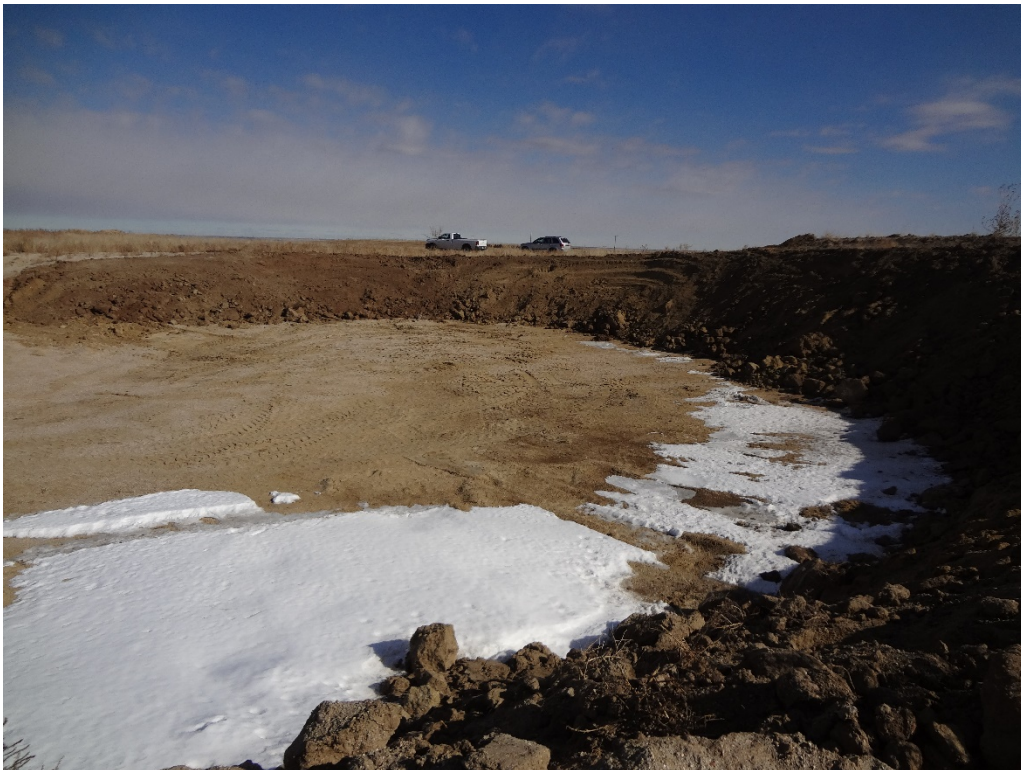
The site is permitted for 9.84 acres. The site was put into Temporary Cessation in 2013 by the Operator. The permit status was changed to active in 2015 at the request of the Operator. The site was active during 2016 with the removal of approximately 30 truckloads of pit run material from the southeast corner of the pit. The current highwall was estimated at eight feet in height and was temporarily sloped for stability. Mining excavation will continue to the east. No processing equipment was present at the site. The site was dry, no standing water was observed in the pit floor.

View of 2016 excavation area looking NE

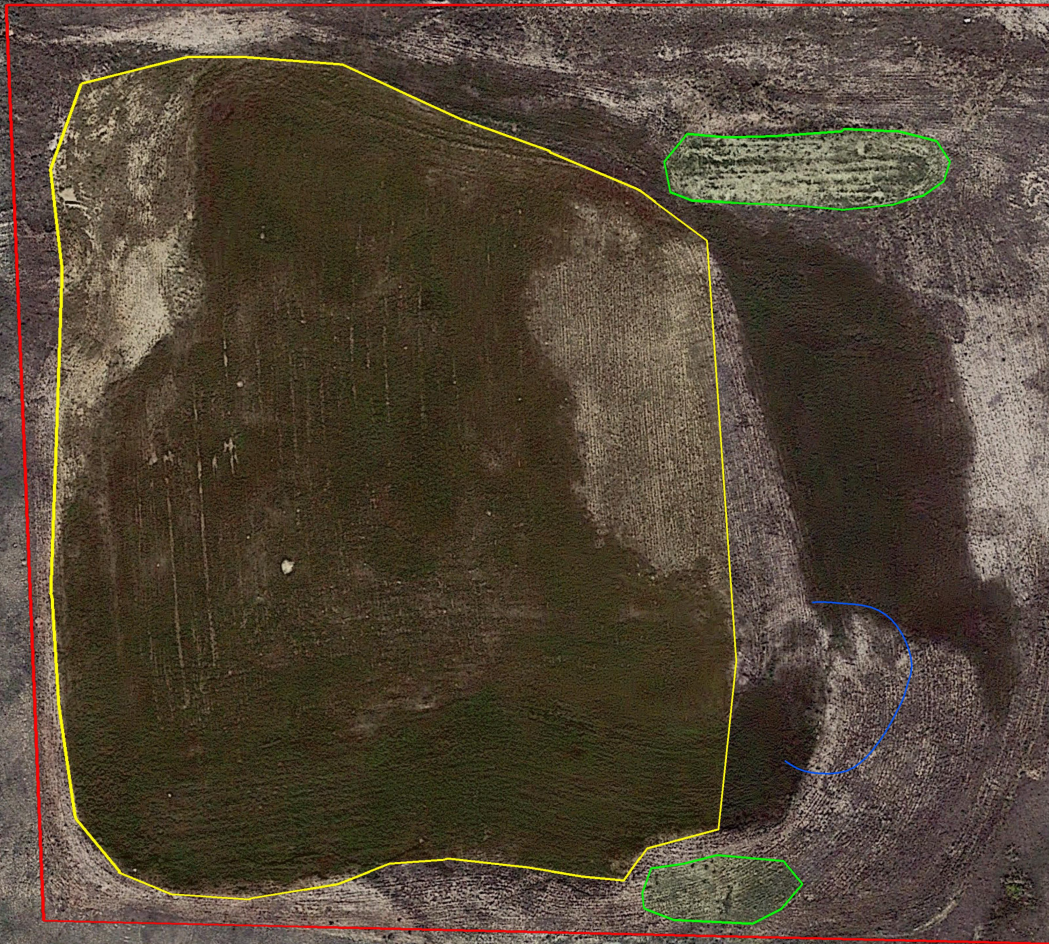
January 26, 2017 Inspection Map
M-1998-103

The site was GPS surveyed by the Division using a Trimble Juno 3B. The results of the survey indicated a permit boundary of 9.40 acres. A copy of the inspection map with the survey results is attached.
