MINERALS PROGRAM INSPECTION REPORT
PHONE: (303) 866-3567

| MINE NAME: Florence Sand & Gravel Pit | MINE/PROSPECTING ID#: M-1992-051 | MINERAL: Sand and gravel | COUNTY: Fremont |
| INSPECTION TYPE: Preoperation Inspection | INSPECTOR(S): Timothy A. Cazier | INSP. DATE: December 22, 2015 | INSP. TIME: 09:45 |

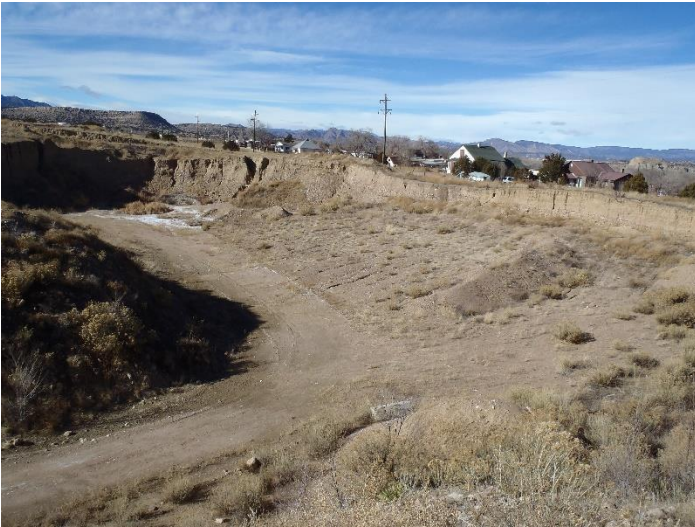
Backfilling and Grading: The northeast portion of the pit was visited (see **Photo 1**). It was agreed that the highwalls needed to be stabilized and flattened without excavating more material. Mr. Langston indicated they would bring backfill in from elsewhere on site.

Photo #1 – Northeast area requiring backfill

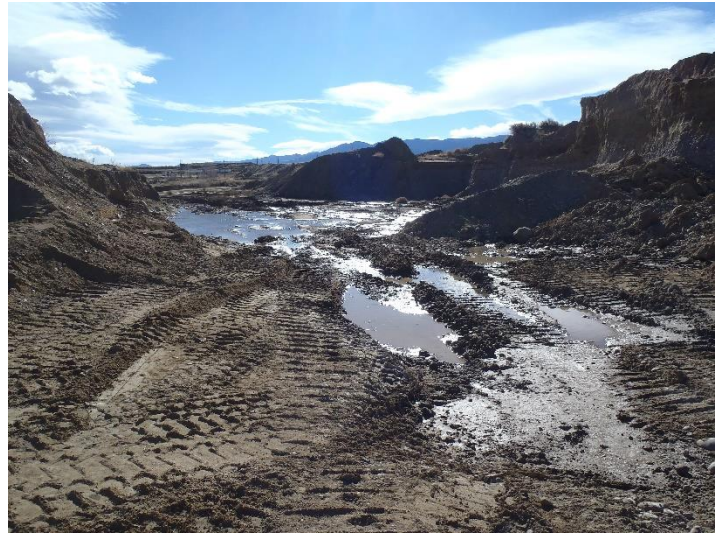
Hydrologic Balance: Some standing water was observed in the pit (see **Photo 2**). It was unclear if this was groundwater or captured stormwater. Mr. Langston committed to keeping the pit floor at least 2 feet above the normal high groundwater elevation as required.

Photo #2 – Standing water in pit

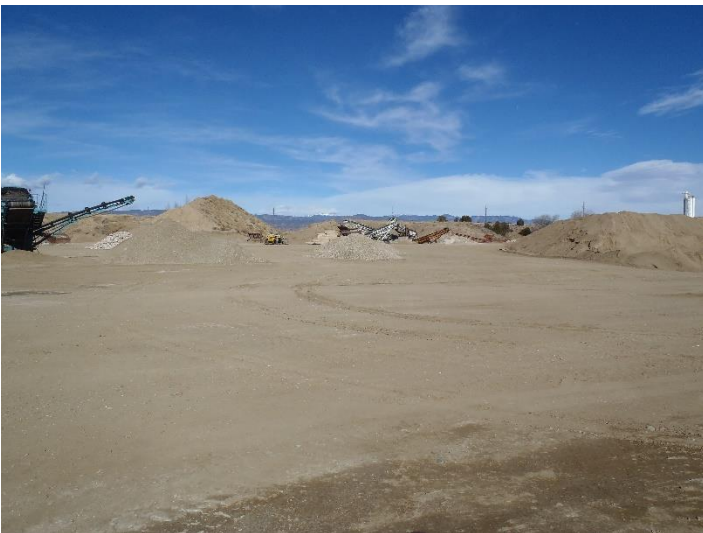
Support Facilities On-site: Several screens and conveyors were observed on site (see **Photo 3**).

Photo #3 – Conveyors, screens & product stockpiles

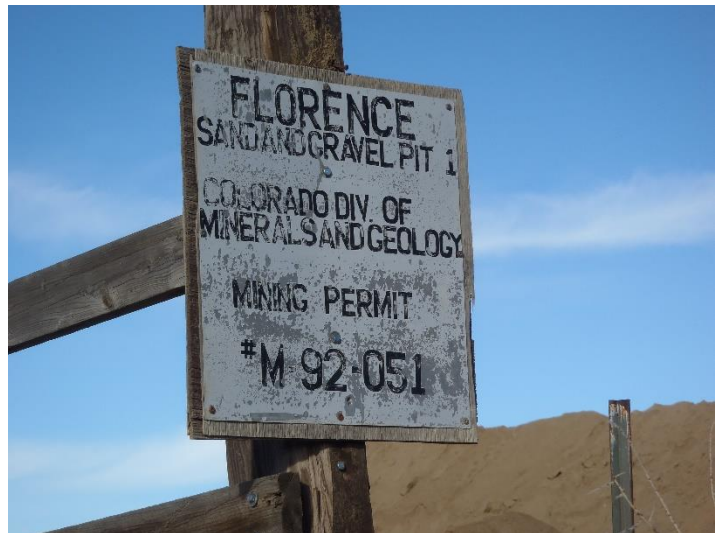
Signs and Markers: The permit sign was properly posted (see **Photo 4**) and boundary fences were observed on the north side (see **Photo 5**). An access road serves to delineate the south side (see **Photo 6**).

Photo #4 – Permit sign

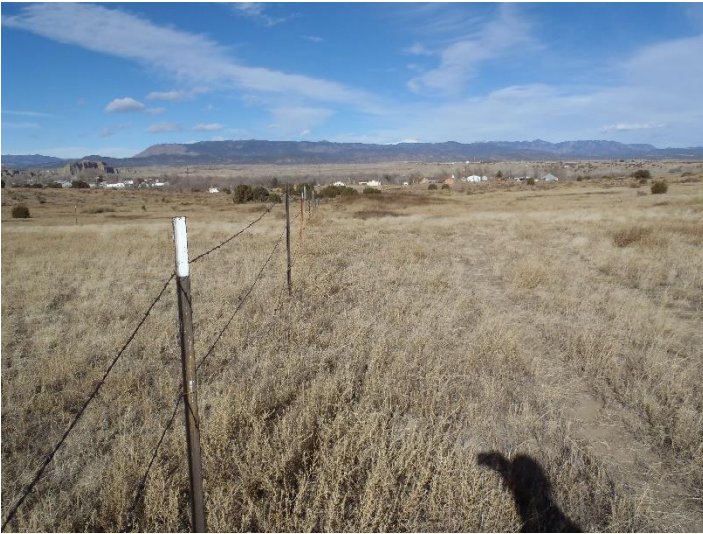
Photo #5 – Boundary fence (west side of north end)

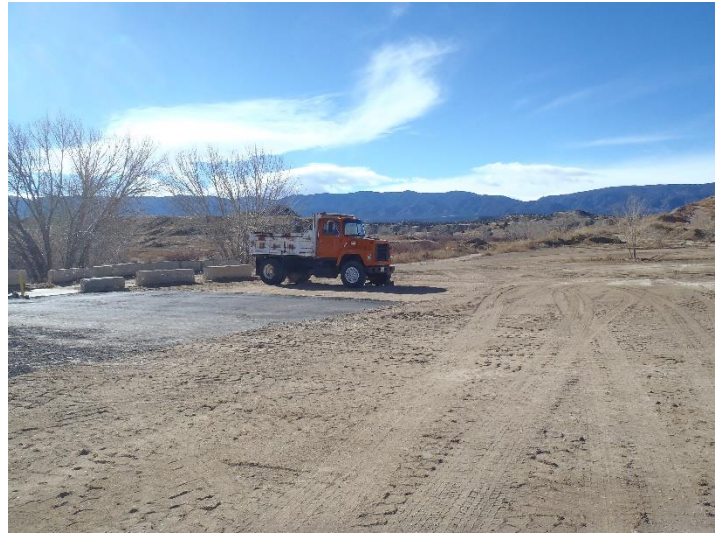
Photo #6 – Southern access road boundary (beyond truck)
