## MINERALS PROGRAM INSPECTION REPORT

<b>MINE NAME:</b> Fremont Gravel Pit	<b>MINE/PROSPECTING ID#:</b> M-1984-117	<b>MINERAL:</b> Sand & Gravel	<b>COUNTY:</b> Fremont
<b>INSPECTION TYPE:</b> Monitoring	<b>INSPECTOR(S):</b> Timothy A. Cazier	<b>INSP. DATE:</b> November 9, 2015	<b>INSP. TIME:</b> 11:55
<b>OPERATOR:</b> Fremont County	<b>OPERATOR REPRESENTATIVE:</b> Sterling Rife	<b>TYPE OF OPERATION:</b> 110c - Construction Limited Impact	
<b>REASON FOR INSPECTION:</b> Normal I&E Program	<b>BOND CALCULATION TYPE:</b> None	<b>BOND AMOUNT:</b> \$0.00	
<b>DATE OF COMPLAINT:</b> NA	<b>POST INSP. CONTACTS:</b> None	<b>JOINT INSP. AGENCY:</b> None	
<b>WEATHER:</b> Clear	<b>INSPECTOR'S SIGNATURE:</b>

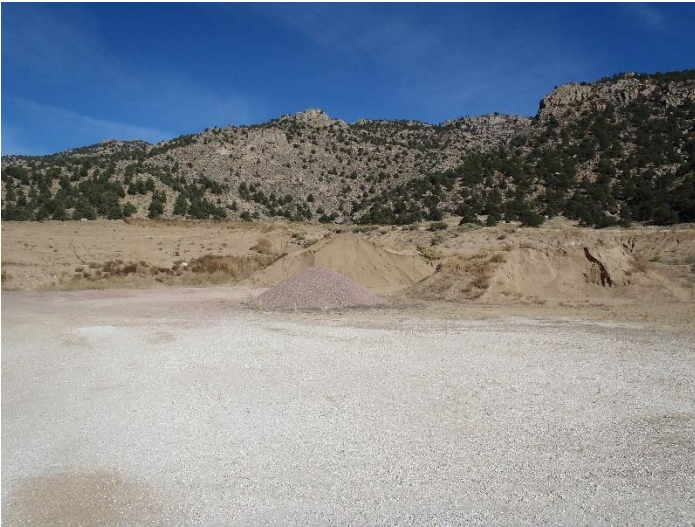
Backfilling and Grading: Final highwalls are to be 4H:1V. The north end of the pit appears to have slopes near 4H:1V (see **Photo 1**).

Photo #1 – Sloped highwall (left) & product stockpile

Sediment Control: Some minor erosion was observed. The county should monitor the 4H:1V slopes and implement BMPs where needed.

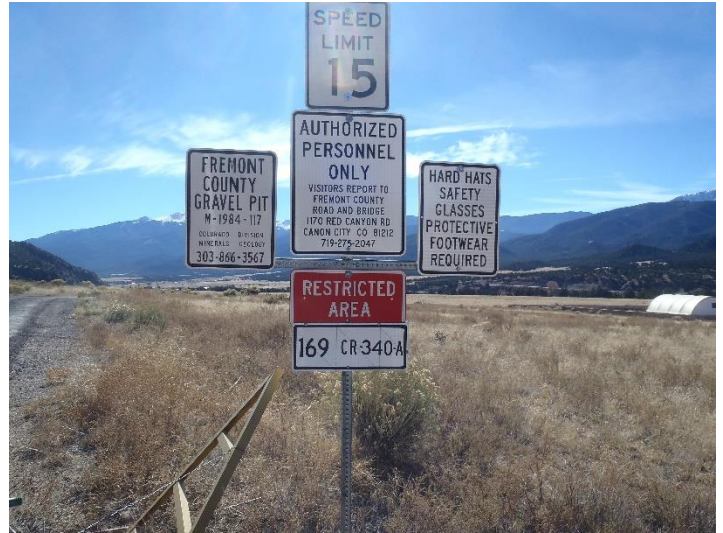
Signs and Markers: The permit sign was observed (see **Photo 2**) and boundary markers (T-posts) were observed near the entrance.

Photo #2 – Permit sign
