MINERALS PROGRAM INSPECTION REPORT
PHONE: (303) 866-3567

MINE NAME: Maverick Placer	MINE/PROSPECTING ID#: M-1979-206	MINERAL: Evaporites	COUNTY: Fremont
INSPECTION TYPE: Monitoring	INSPECTOR(S): Timothy A. Cazier	INSP. DATE: November 4, 2015	INSP. TIME: 13:10
OPERATOR: US Soil Conditioning Company	OPERATOR REPRESENTATIVE: Joe & Albert Lionelle, Jerry Seifert	TYPE OF OPERATION: 112c - Construction Regular Operation	
REASON FOR INSPECTION: Normal I&E Program	BOND CALCULATION TYPE: Partial Bond	BOND AMOUNT: \$32,500.00	
DATE OF COMPLAINT: NA	POST INSP. CONTACTS: None	JOINT INSP. AGENCY: None	
WEATHER: Cloudy	INSPECTOR'S SIGNATURE:

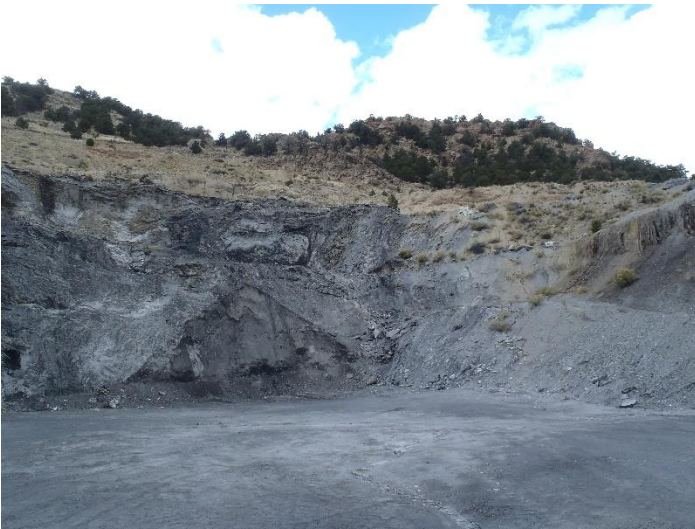
Backfilling and Grading: Upper highwalls have been benched between 1H:1V and 2.5H:1V (see **Photo 1**). Active highwalls are near vertical. No active face restrictions for the working face.

Photo #1 – Active highwall & reclamation area above

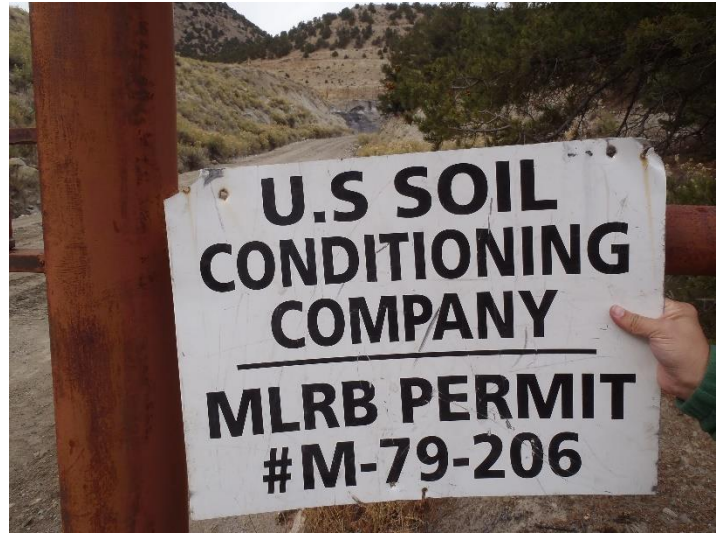
Signs and Markers: The permit sign was observed (see **Photo 2**) and the boundary is delineated by adjacent roads (inside the permit boundary) and reclaimed Zone I.

Photo #2 – Permit sign
