**MINERALS PROGRAM INSPECTION REPORT**  
**PHONE: (303) 866-3567**

<b>MINE NAME:</b> Ranch Land Rock Pit #2	<b>MINE/PROSPECTING ID#:</b> M-2003-021	<b>MINERAL:</b> Gravel	<b>COUNTY:</b> Fremont
<b>INSPECTION TYPE:</b> Monitoring	<b>INSPECTOR(S):</b> Timothy A. Cazier	<b>INSP. DATE:</b> March 8, 2016	<b>INSP. TIME:</b> 09:40
<b>OPERATOR:</b> Ranch Land LLC dba Pioneer Sand Co Inc	<b>OPERATOR REPRESENTATIVE:</b> Angela Bellantoni, Wayne Brantley	<b>TYPE OF OPERATION:</b> 112c - Construction Regular Operation	
<b>REASON FOR INSPECTION:</b> Normal I&E Program	<b>BOND CALCULATION TYPE:</b> Partial Bond	<b>BOND AMOUNT:</b> \$83,750.00	
<b>DATE OF COMPLAINT:</b> NA	<b>POST INSP. CONTACTS:</b> None	<b>JOINT INSP. AGENCY:</b> None	
<b>WEATHER:</b> Clear	<b>INSPECTOR'S SIGNATURE:</b>

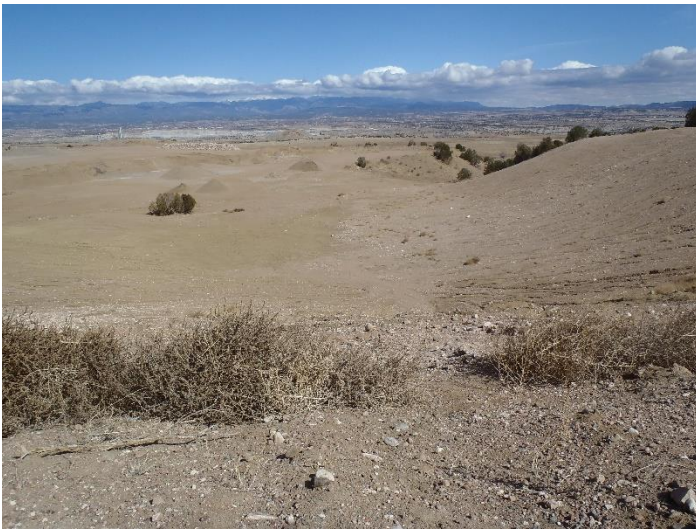
Gen. Compliance with Mine Plan: The operation appeared to be in compliance with the approved mine plan. Phase 3 was mostly mined out but still contained product stockpiles (see **Photo 1**).

Photo #1 – Phase 3 area with product stockpiles

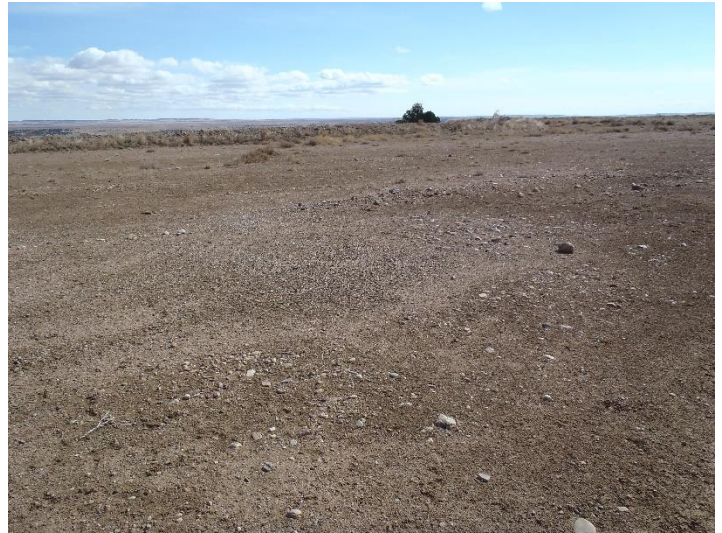
Reclamation Success: Grading of mined out areas (Phase 1) appeared to be completed (see **Photos 2 & 3**). Fines are used for growth media (and backfill where needed), but the Operator indicated no seeding had occurred at the time of the inspection.

Photo #2 – Phase 1 graded pit floor

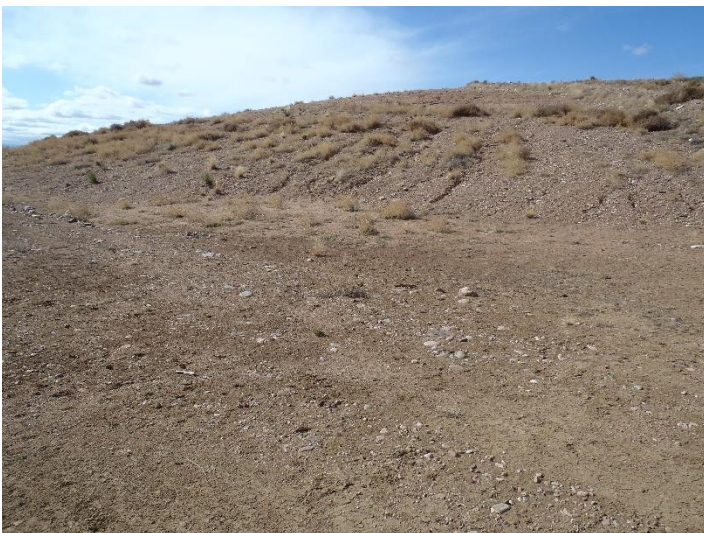
Backfilling and Grading: The Operator indicated they were mining at 3H:1V for the most part, so little backfill will be required for reclamation. Annual reports from 2015, and 2016 indicate 728.6 acres were backfilled. However, the Division has no record of a release or bond adjustment request. The Division reminded the Operator that test holes also need to be backfilled and reclaimed.

Photo #3 – Phase 1 Highwall graded to ~3H:1V

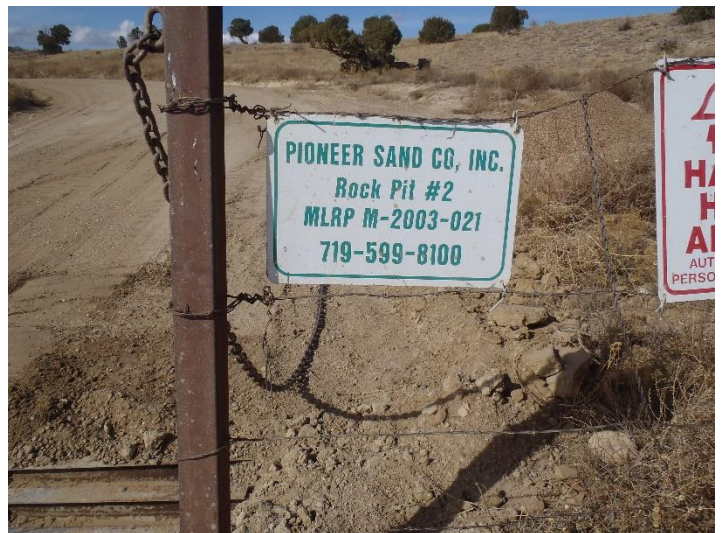
Signs and Markers: The permit sign was properly posted (see **Photo 4**). This is an upland mining operation and topography controls the extent of mining such that it stays within the permit boundary.

Photo #4 – Permit sign
