MINERALS PROGRAM INSPECTION REPORT**PHONE: (303) 866-3567**

MINE NAME: Penrose Pit	MINE/PROSPECTING ID#: M-1987-131	MINERAL: Sand and gravel	COUNTY: Fremont
INSPECTION TYPE: Monitoring	INSPECTOR(S): Timothy A. Cazier	INSP. DATE: March 8, 2016	INSP. TIME: 11:15
OPERATOR: Fremont Paving & Redi-Mix, Inc.	OPERATOR REPRESENTATIVE: Angela Bellantoni	TYPE OF OPERATION: 112c - Construction Regular Operation

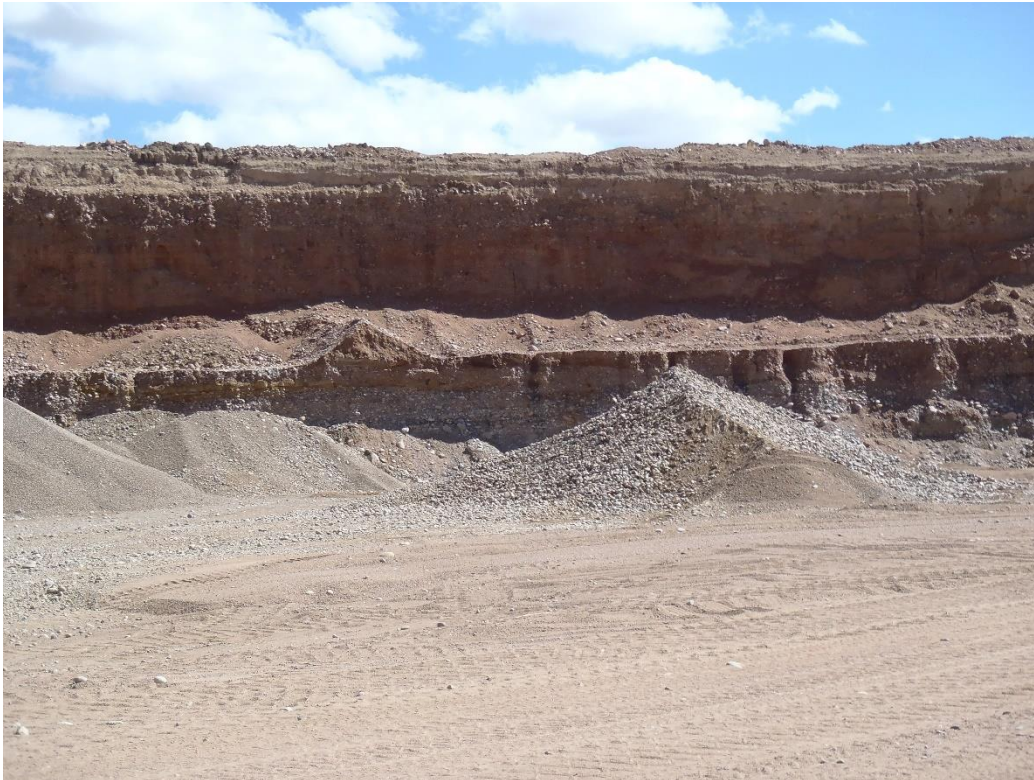
Gen. Compliance with Mine Plan: Mining is near vertical with one bench. The active highwall was estimated to be between 30 and 40 feet in height (see **Photo 1**). The maximum allowed disturbed area per the approved permit is 150 acres. The bond will need to be adjusted prior to reaching this limit.

Photo 1. Active highwall, note bench.

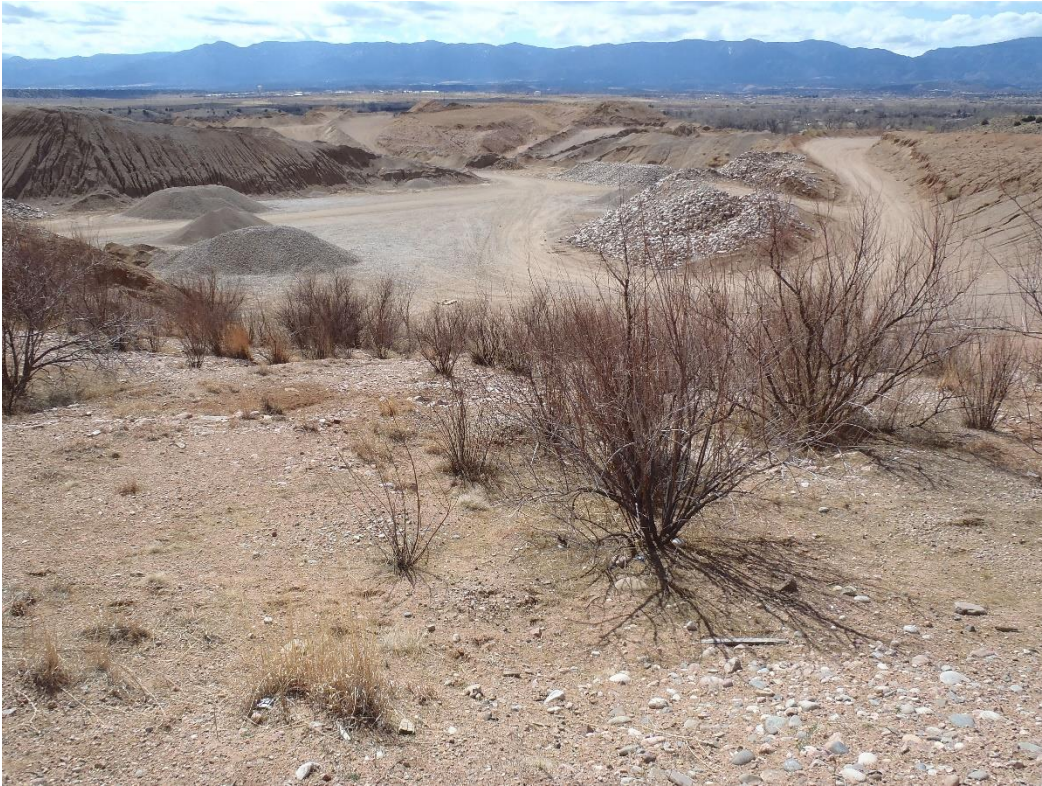
PROBLEM/POSSIBLE VIOLATION: Problem: Tamarisk (salt cedar) trees are present within or have volunteered into the permit area and are becoming established. This is a problem for failure to employ weed control methods for a state listed noxious weed species within the permitted area, and to reduce the spread of weeds to nearby areas as required by Section 3.1.10 (6) of the rule.

Revegetation: No revegetated areas were observed. The east slope of the main pit has several tamarisk (salt cedar, see **Photo 2**), which are on Colorado's noxious weed List B. The presence of tamarisk is cited as a problem on p. 1 of this report.

Photo 2. Tamarisk, east side of main pit (looking SW).

CORRECTIVE ACTIONS: The operator shall either implement the existing weed control plan, or develop a weed control and management plan in accordance with Section 3.1.10 (6) of the Rule. This plan should be developed in consultation with the county extension agency, or weed control district office and should include specific control measures to be applied, a schedule for when control measures will be applied and a post-treatment monitoring plan. This weed control plan shall be submitted to the Division as a Technical Revision to the approved plan with the appropriate Technical Revision fee of \$216.00 by the corrective action date.

CORRECTIVE ACTION DUE DATE: 3/15/17

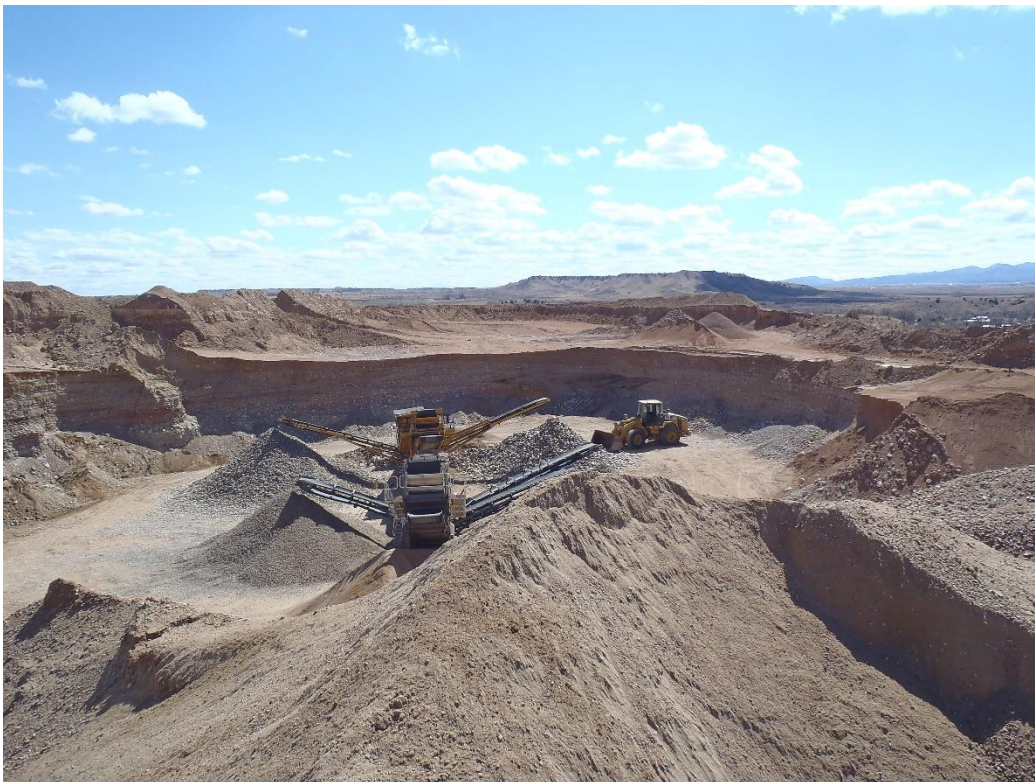
Support Facilities On-site: A screen plant was observed (see **Photo 3**) along with an operating loader.

Photo 3. Active pit screen plant and loader.

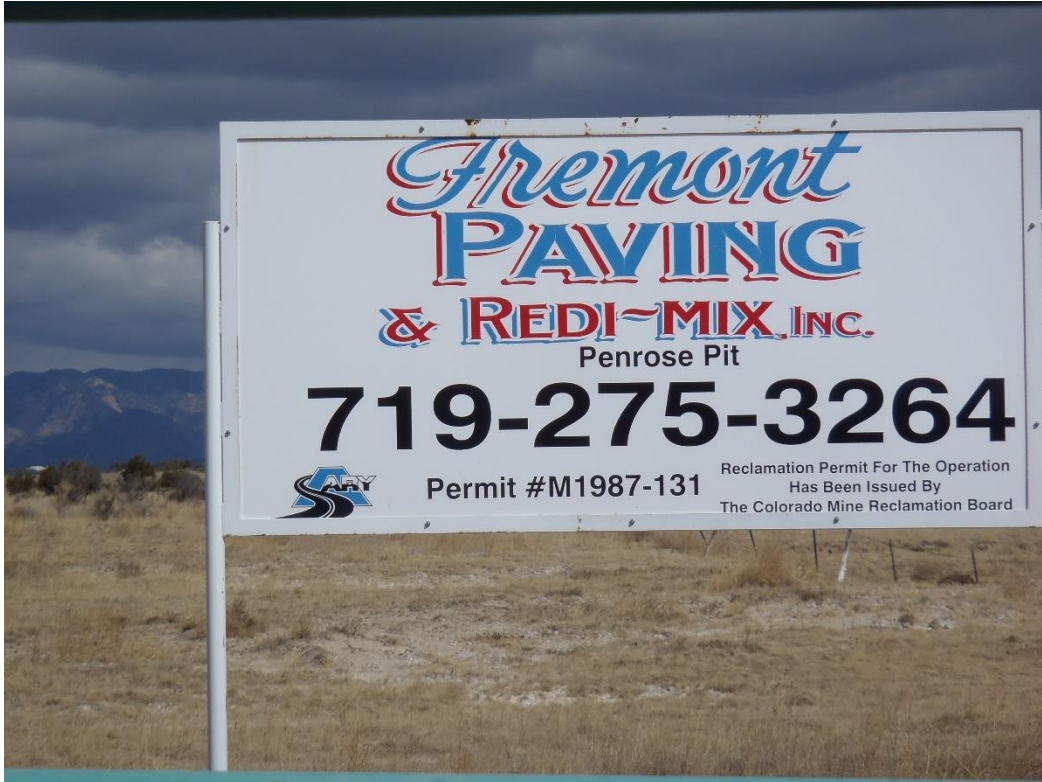
Signs and Markers: The permit sign was properly posted (see **Photo 4**) and boundary markers were observed to delineate the permit boundary (see **Photo 5**).

Photo 4. Permit sign.

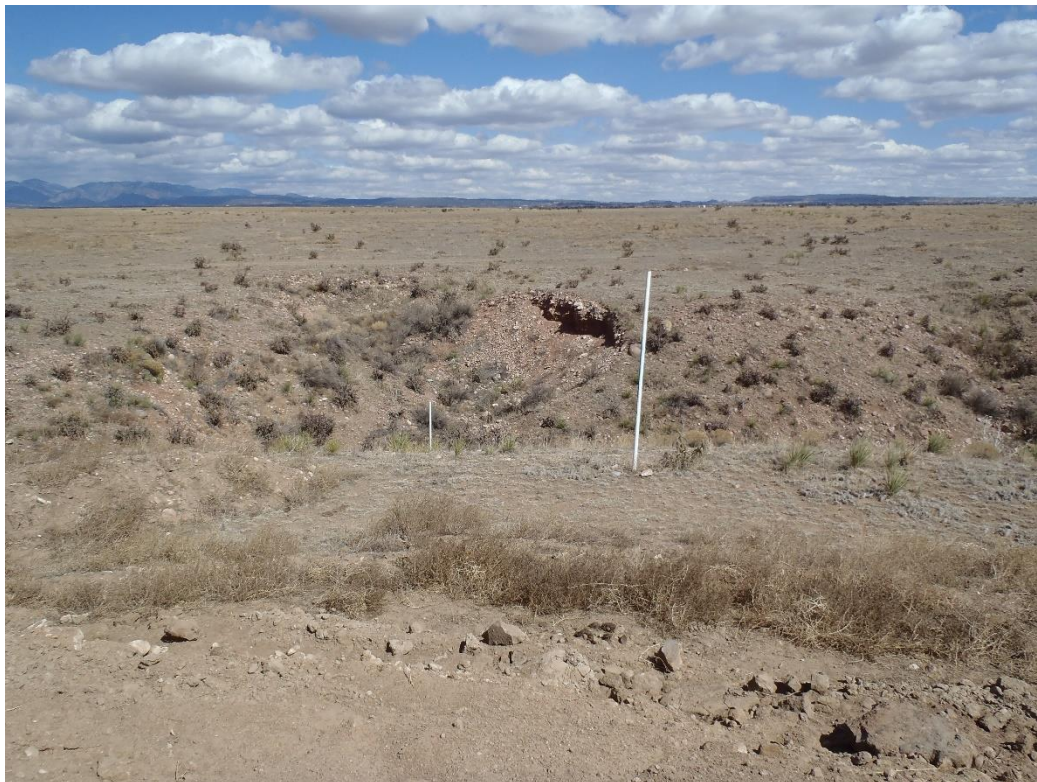
Photo 5. Typical boundary markers (south end, looking east).
