**COLORADO DIVISION OF RECLAMATION, MINING AND SAFETY**  
**MINERALS PROGRAM INSPECTION REPORT**  
**PHONE: (303) 866-3567**

<b>MINE NAME:</b> Stephens Pit	<b>MINE/PROSPECTING ID#:</b> M-1978-146	<b>MINERAL:</b> Sand and gravel	<b>COUNTY:</b> Logan
<b>INSPECTION TYPE:</b> Monitoring	<b>INSPECTOR(S):</b> Elliott R. Russell	<b>INSP. DATE:</b> March 9, 2016	<b>INSP. TIME:</b> 10:05
<b>OPERATOR:</b> Logan County	<b>OPERATOR REPRESENTATIVE:</b> Chad Wright & Rex Benson	<b>TYPE OF OPERATION:</b> 112c - Construction Regular Operation

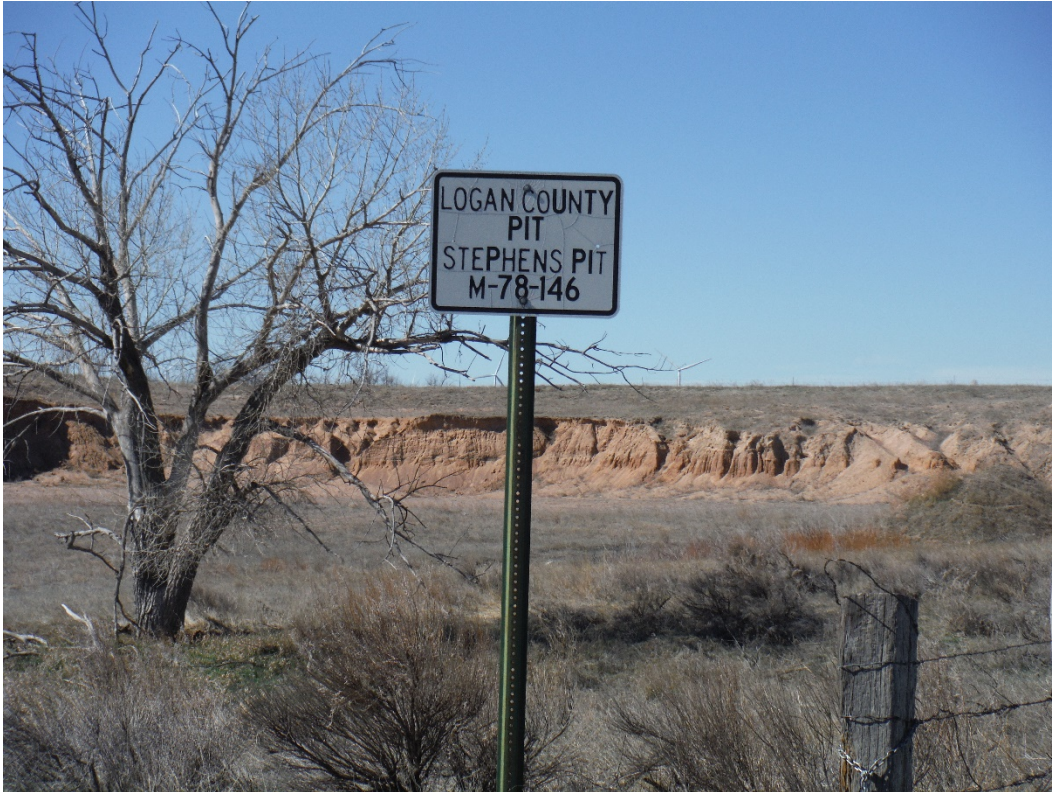
At 1005 hours, the Division, Mr. Wright, and Mr. Benson arrived at the mine site, located on the west side of County Road 93, approximately 1.5 miles north of County Road 46. At the time of the inspection the temperature was warm, the sky was clear, and the ground was dry. The mine site identification sign was posted where a private access road enters the permit boundary, approximately 2,000 feet from County Road 93. The Division recommends the Operator post an additional mine identification sign along County Road 93 where the private access road starts; this will help achieve the intent of the permit sign at the closest public access point.

Mine identification sign posted along the northern permit boundary; looking southwest.

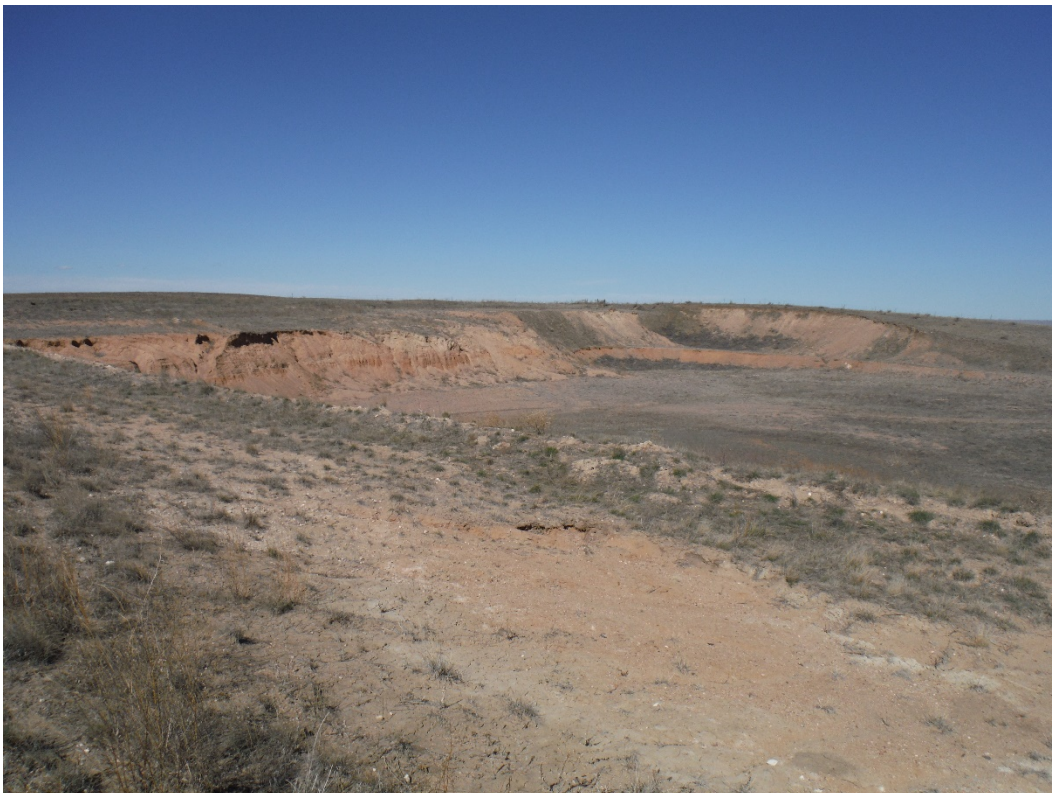
Overview of the western portion (older) of the mine site; looking northwest.

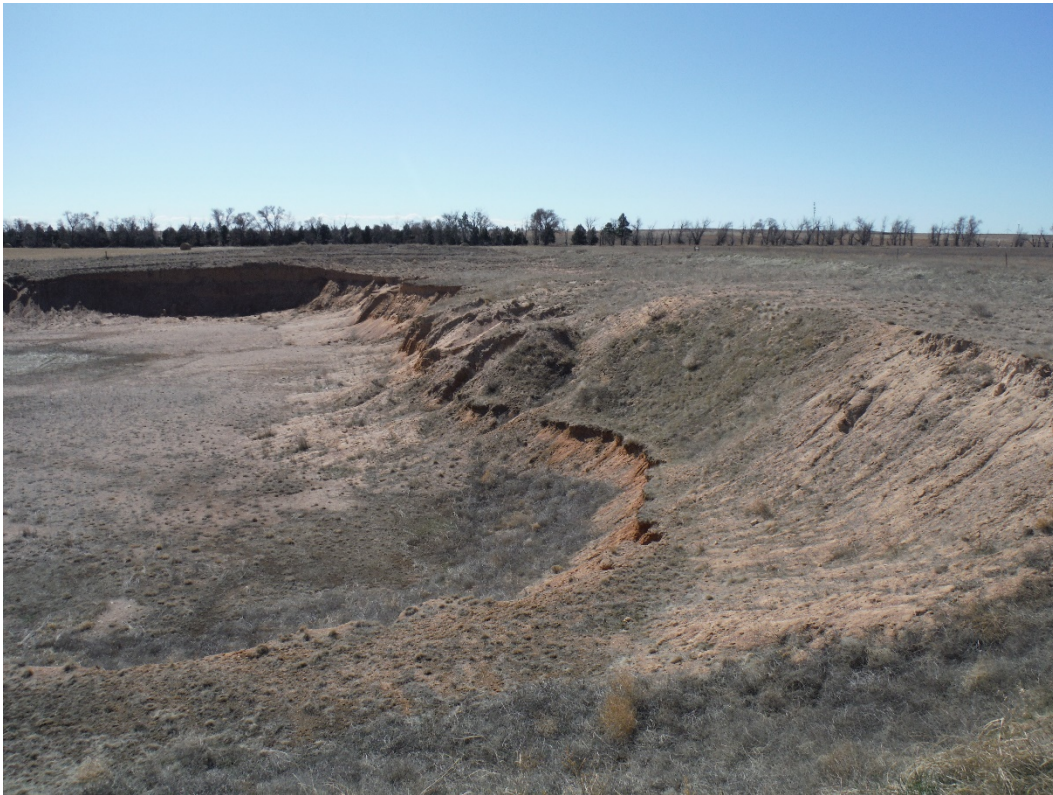
The site consists of a two distinct areas. The western portion has the most recent disturbance and consists of highwalls that range from 10 to 30 feet high. The Operator should take caution if they intend to advance the highwalls in the northwest corner of the site as the current mining area is approaching the permit boundary. The Operator will likely need to backfill this area to achieved the approved maximum reclamation slope of 3H:1V because the cut/fill approach is not possible due to the proximity to the permit boundary. The other option would be to amend the current permit boundary and expand this area to the north/west to accommodate the cut/fill approach. The eastern portion is an older mined area that contains a large topsoil stockpile on the pit floor. Although the pit floor is appropriately vegetated, the slopes (north, east, and south) are not properly graded to 3H:1V.

Western highwall; looking south.

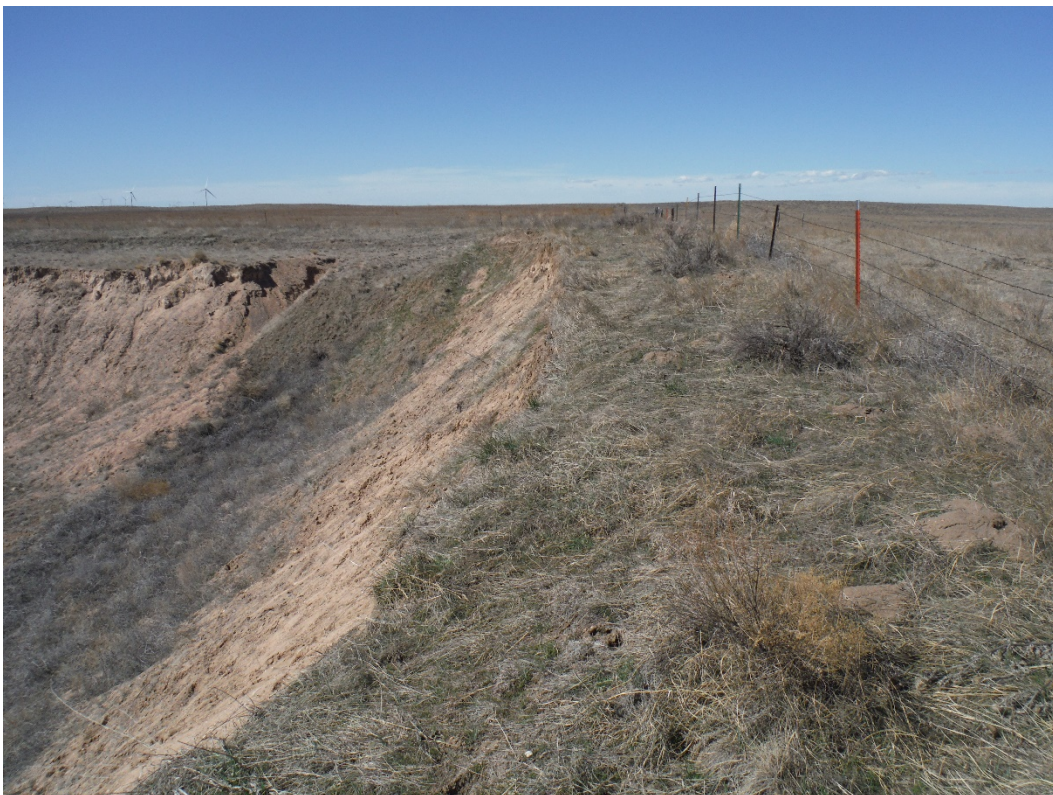
Northwest portion of the site, permit boundary is the fence line; looking west.

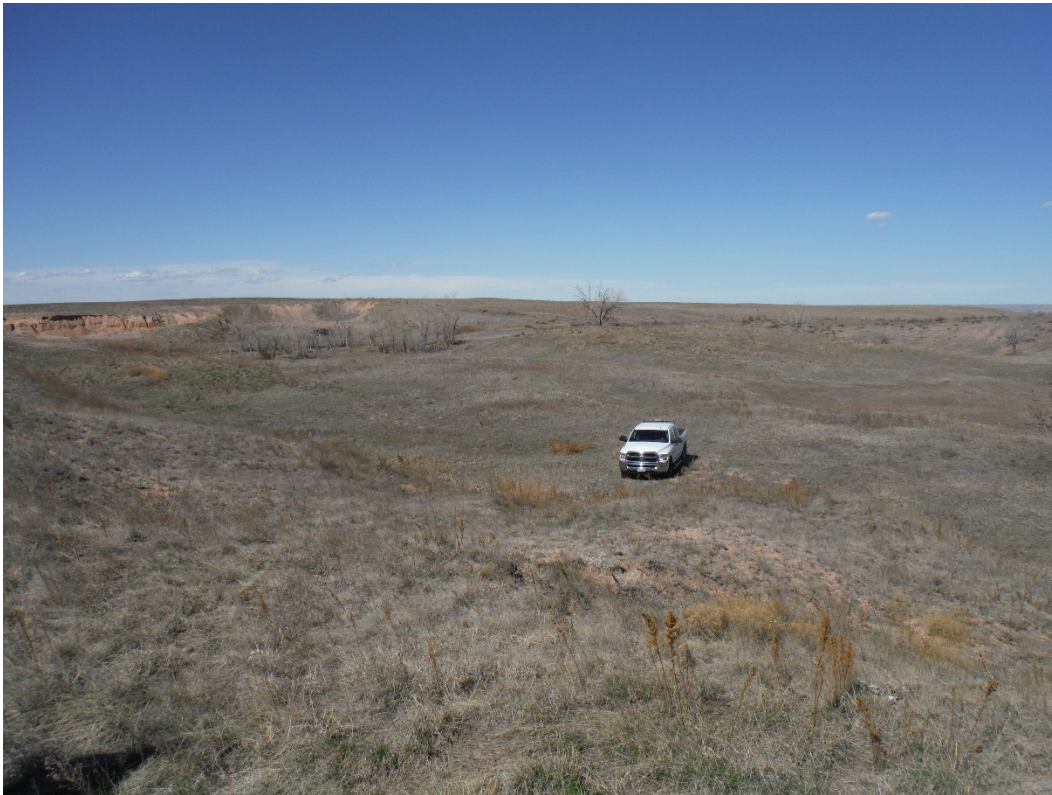
Overview of the eastern portion (older) of the mine site; looking northwest.

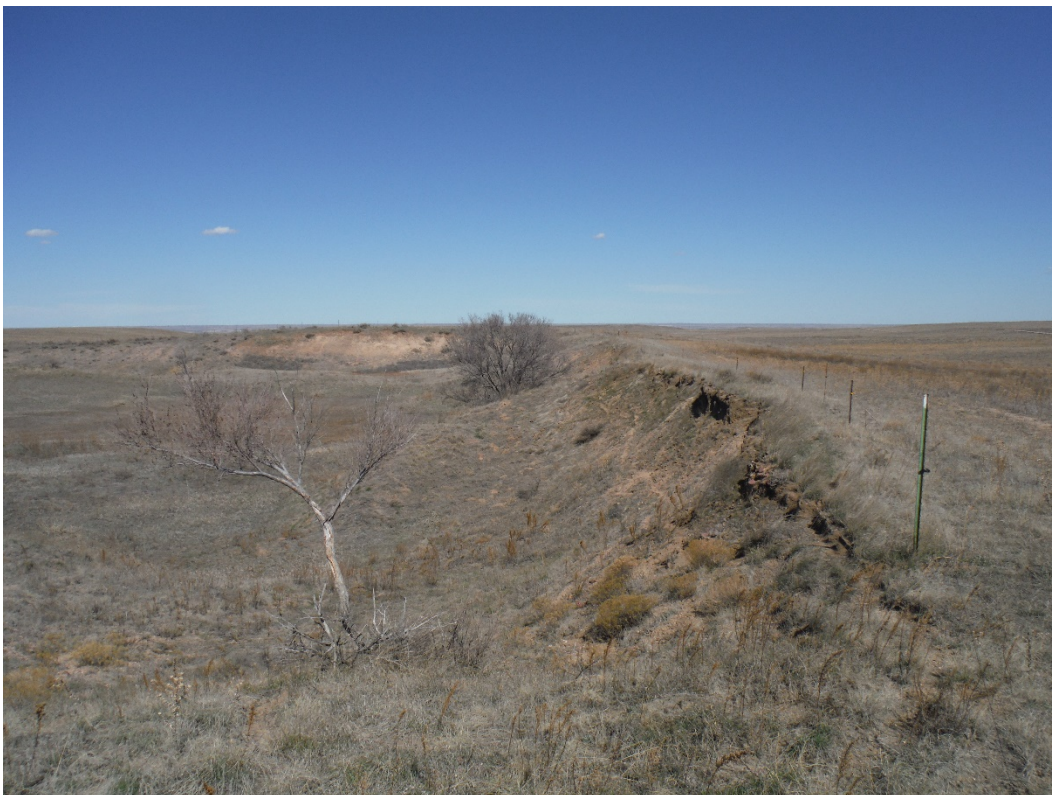
Eastern slope of the mine site, permit boundary is the fence line; looking north.
