COLORADO DIVISION OF RECLAMATION, MINING AND SAFETY
MINERALS PROGRAM INSPECTION REPORT
PHONE: (303) 866-3567

MINE NAME: Kues Gravel Pit	MINE/PROSPECTING ID#: M-1983-187	MINERAL: Sand and gravel	COUNTY: Logan
INSPECTION TYPE: Monitoring	INSPECTOR(S): Elliott R. Russell	INSP. DATE: March 9, 2016	INSP. TIME: 09:00
OPERATOR: Logan County	OPERATOR REPRESENTATIVE: Chad Wright & Rex Benson	TYPE OF OPERATION: 112c - Construction Regular Operation

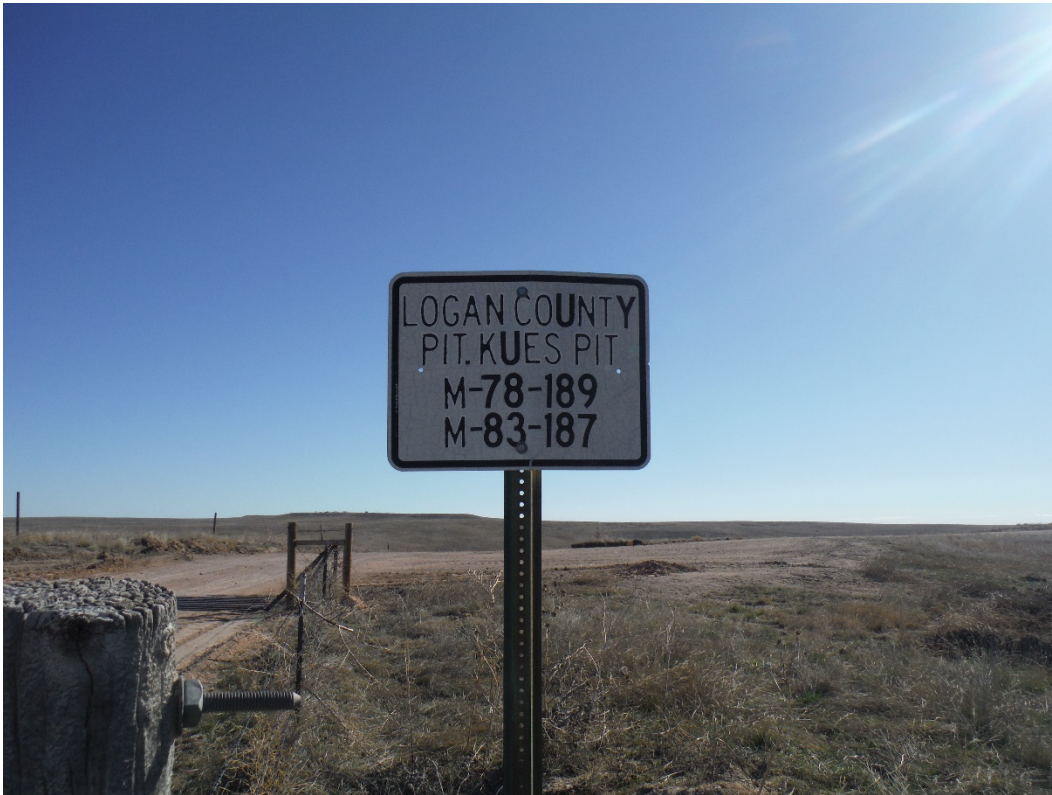
Mine identification sign posted along CR 67; looking east.

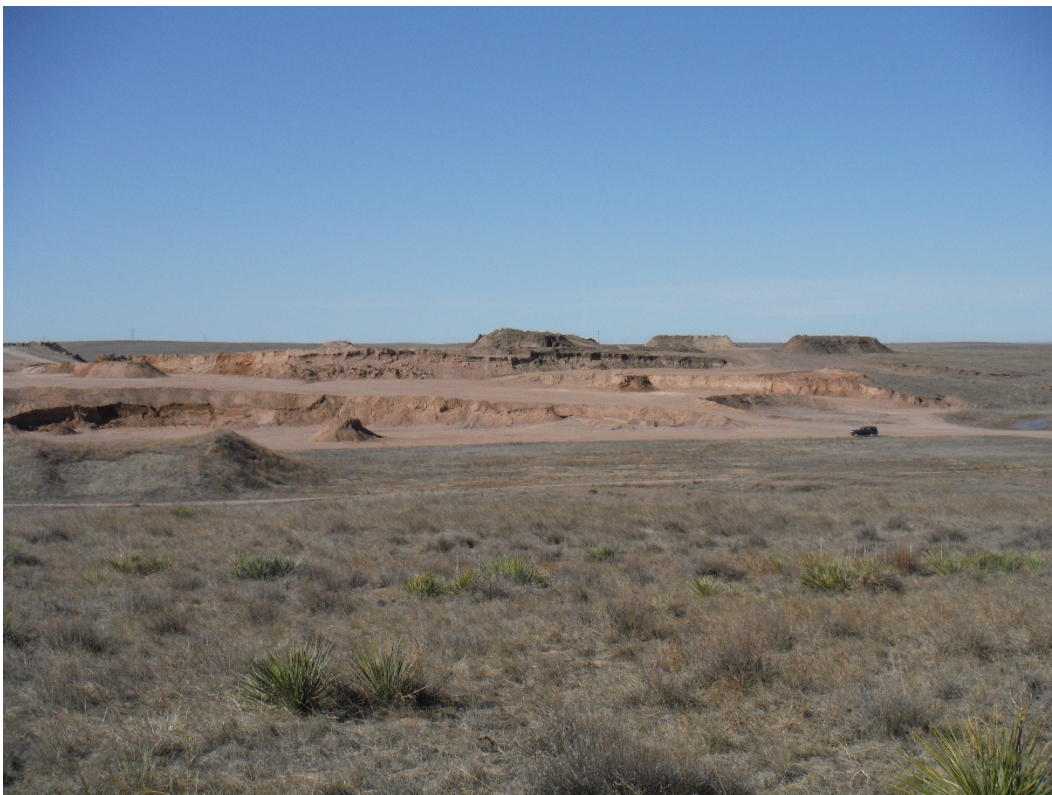
Overview of the western portion of the site; looking southwest.

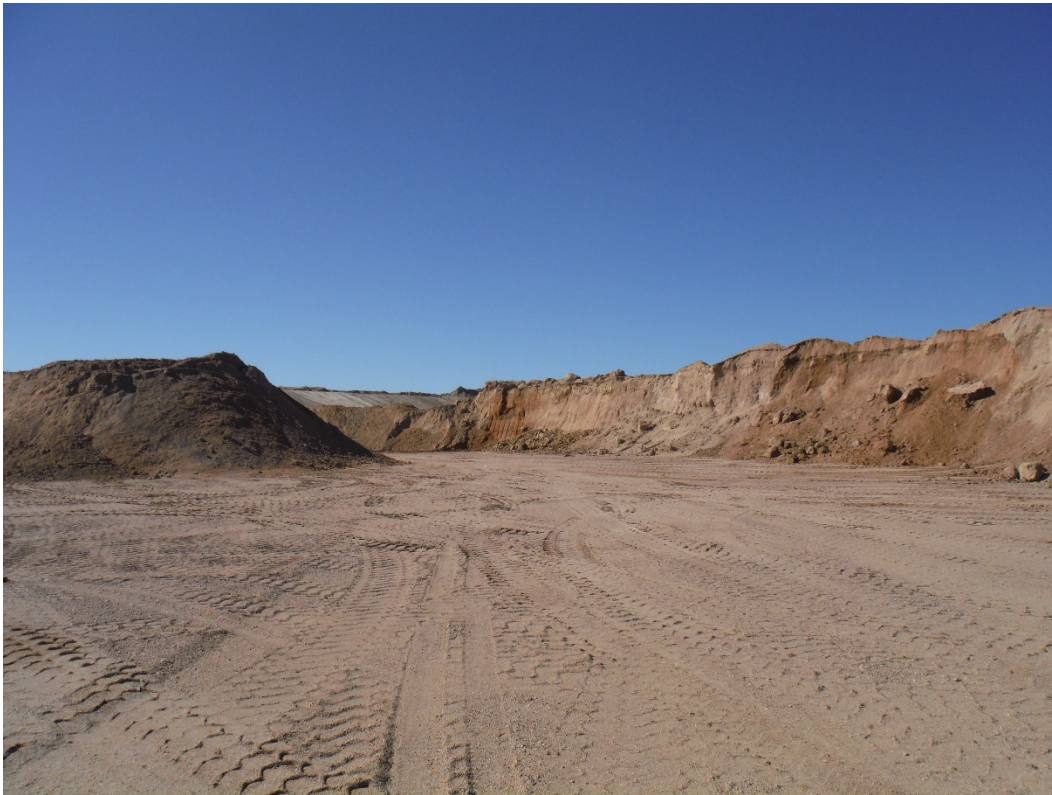
The Operator's representatives indicated that the operation is mined in two different lifts. Sand and gravel is extracted with the first lift (top) and clay is extracted on the second lift (bottom).

Active highwall of the first lift; looking south.

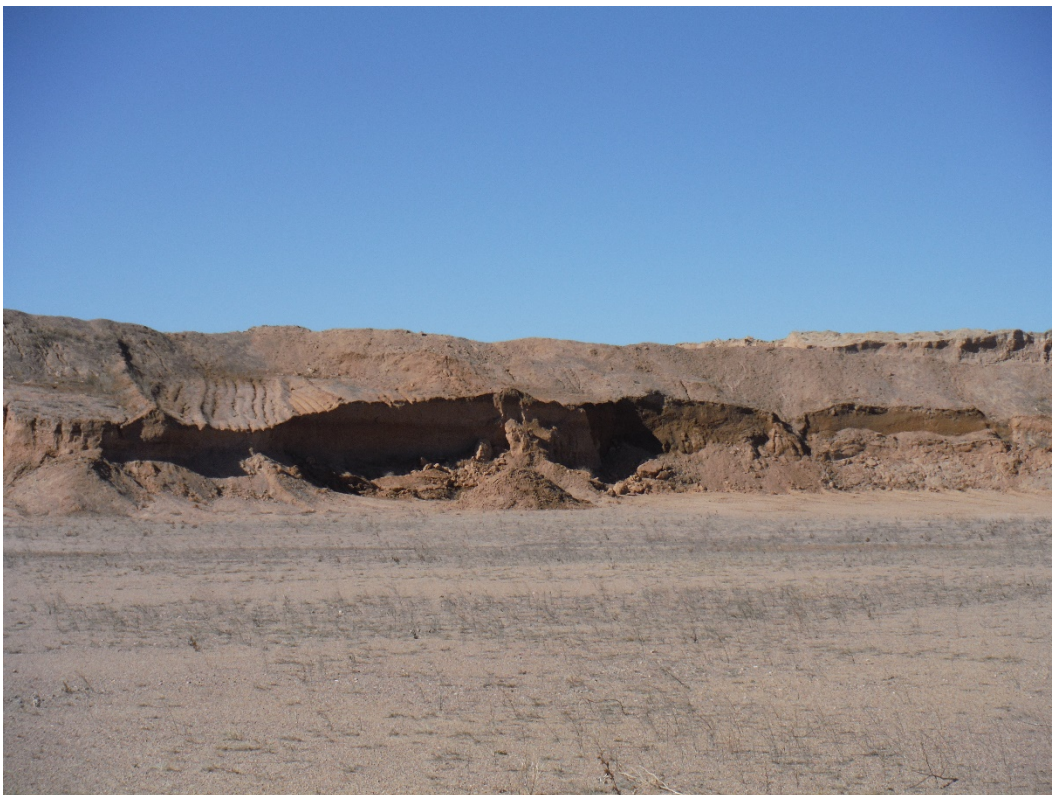
Active highwall of the second lift; looking south.

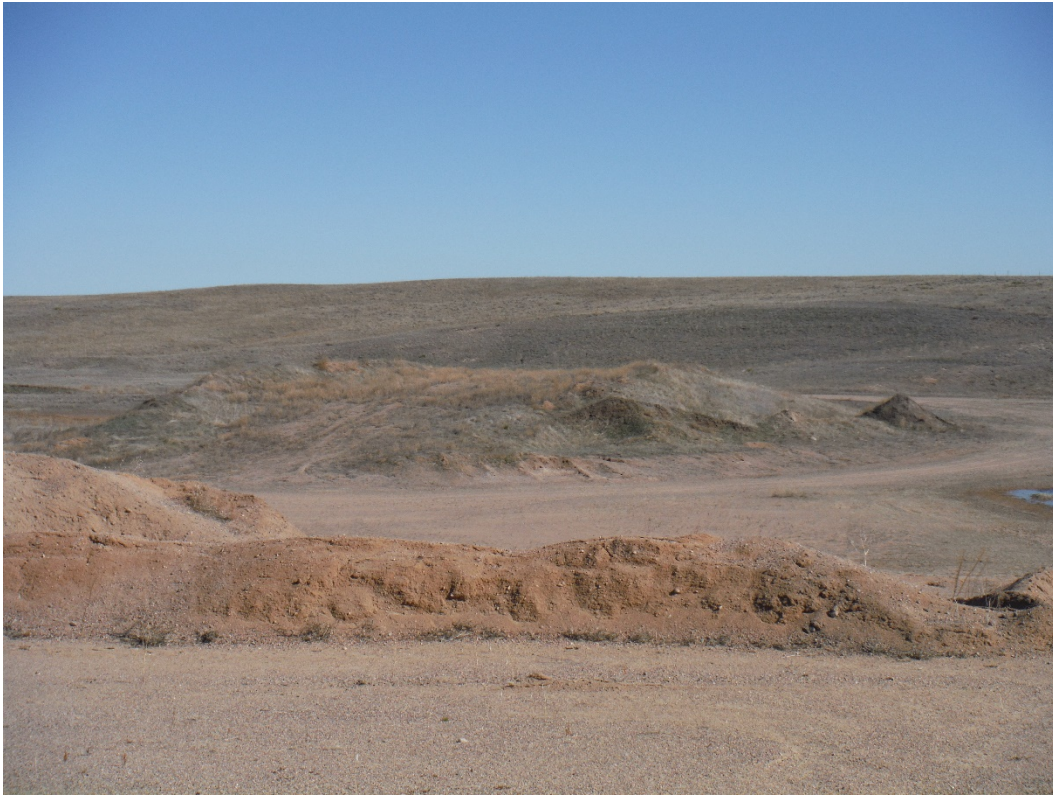
Topsoil stockpile located on the pit floor; looking northeast.

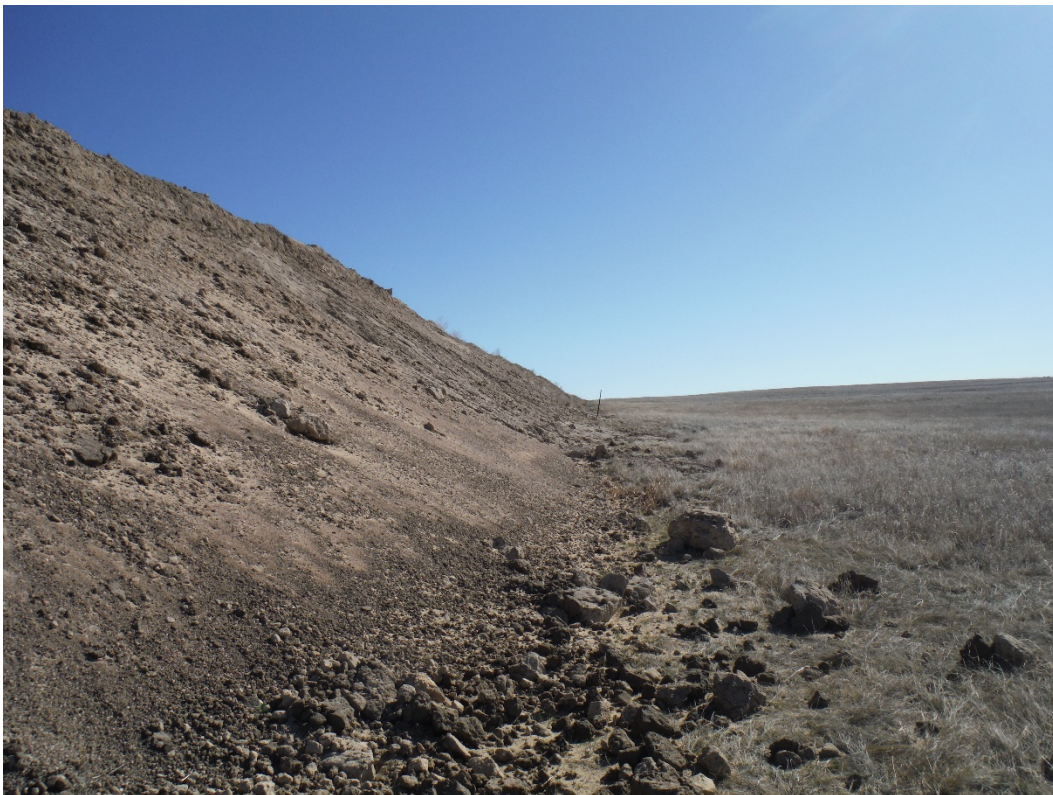
Outward slope of the long stockpile along the southern permit boundary; looking east.

A topsoil stockpile is located on the pit floor and is adequately vegetated. Another stockpile, consisting of overburden and topsoil, is located along the southern permit boundary. The Division recommends seeding the southern facing slope of this stockpile to reduce any erosion and sediment transport to off-site areas to the south

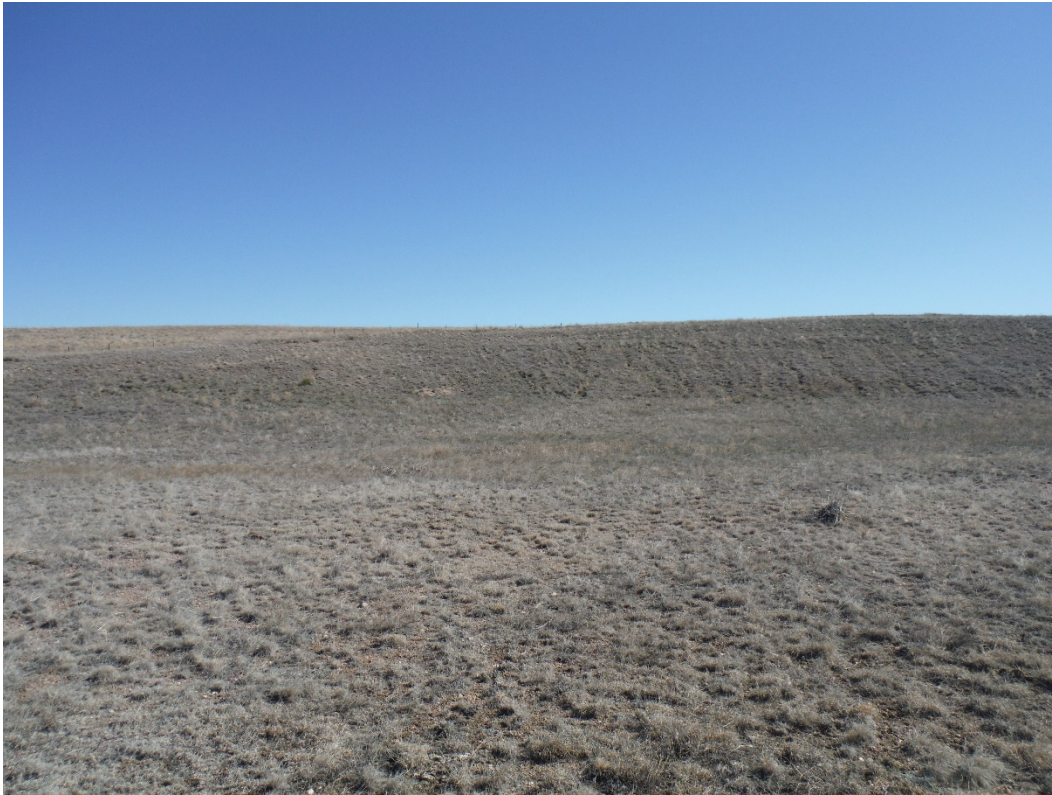
The northeast and eastern portions of the mine site have started to be reclaimed as these areas have been graded, seeded, and vegetation is being established.

Northeast portion of the mine site in reclamation; looking east.
