MINERALS PROGRAM INSPECTION REPORT
PHONE: (303) 866-3567

MINE NAME: Mica Lode	MINE/PROSPECTING ID#: M-1977-144	MINERAL: Sand and Gravel	COUNTY: Fremont
INSPECTION TYPE: Monitoring	INSPECTOR(S): Timothy A. Cazier	INSP. DATE: March 9, 2016	INSP. TIME: 11:25
OPERATOR: Colorado Quarries Inc	OPERATOR REPRESENTATIVE: Aaron Tezak	TYPE OF OPERATION: 112c - Construction Regular Operation	
REASON FOR INSPECTION: Normal I&E Program	BOND CALCULATION TYPE: Partial Bond	BOND AMOUNT: \$38,002.00	
DATE OF COMPLAINT: NA	POST INSP. CONTACTS: None	JOINT INSP. AGENCY: None	
WEATHER: Clear	INSPECTOR'S SIGNATURE:

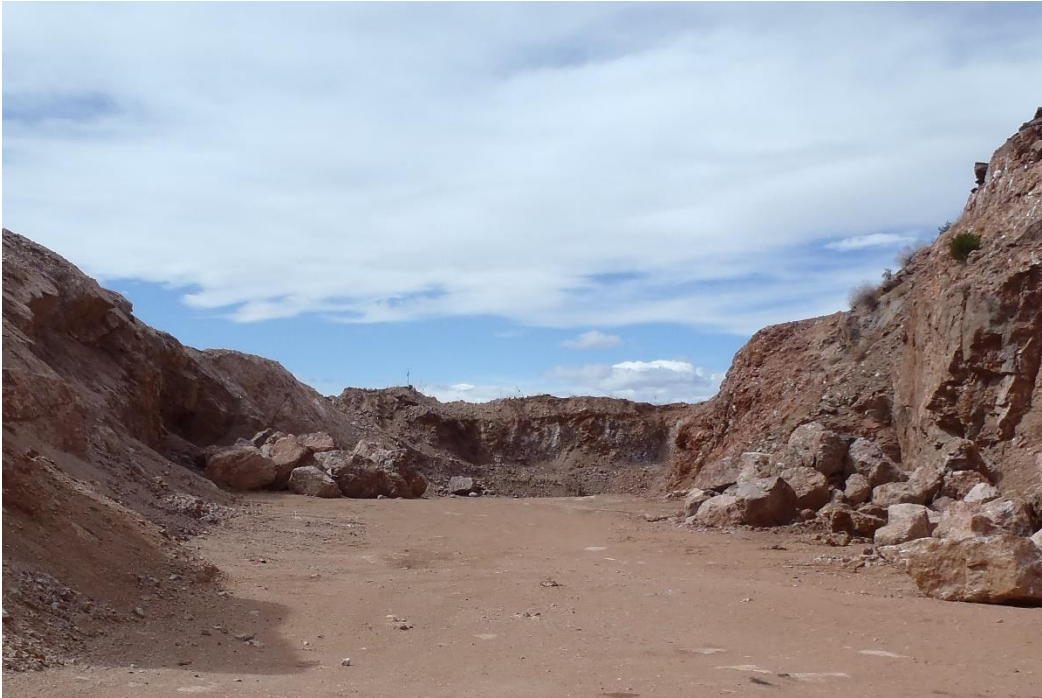
Hydrologic Balance: The Ruby pit was dry (see **Photo 1**). Water was observed in the main (Mica Lode) pit (see **Photo 2**), but is exempt from the requirement for augmentation as discussed above in "Availability of Records".

Photo 1. Ruby pit (looking west).

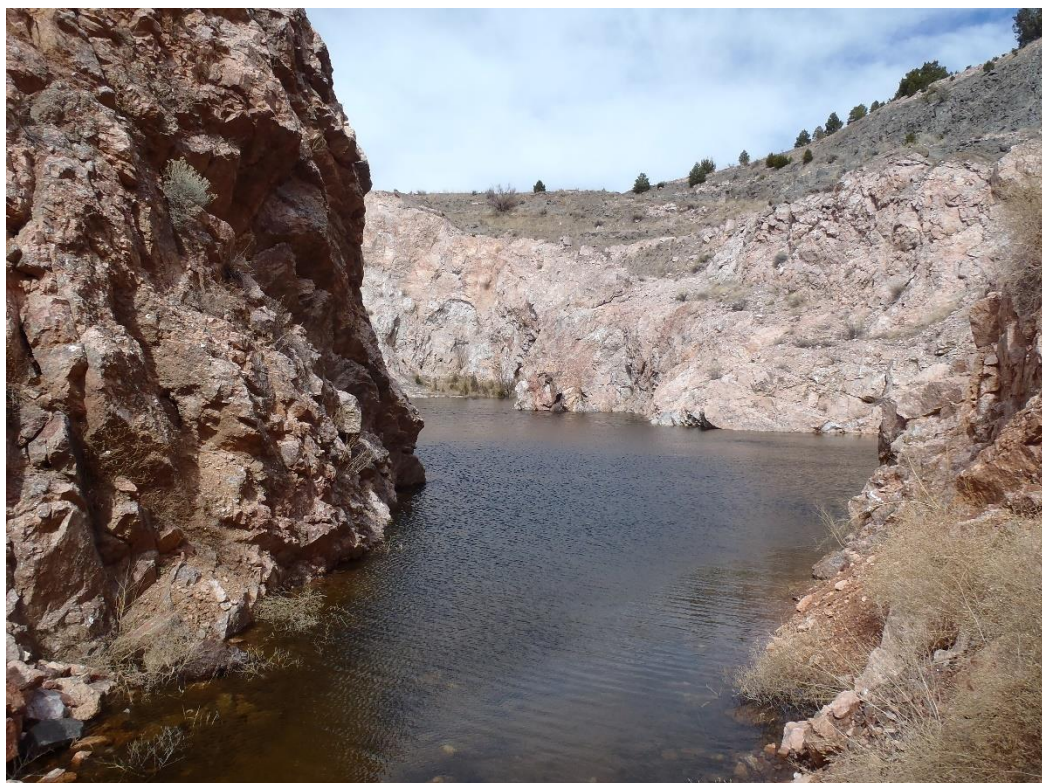
Availability of Records: Annual fees are paid through November 2016. There are no open infractions. The previous inspection was on June 27, 2010. One problem was cited for groundwater exposure. This was resolved on June 15, 2011, when the Division received a letter from the Division of Water Resources (DWR) confirming the exposed groundwater existed prior to 1981, had not measurably changed since then, therefore exempt from the need for an augmentation plan.

Photo 2. Mica Lode pit – exempt groundwater exposure (looking north).

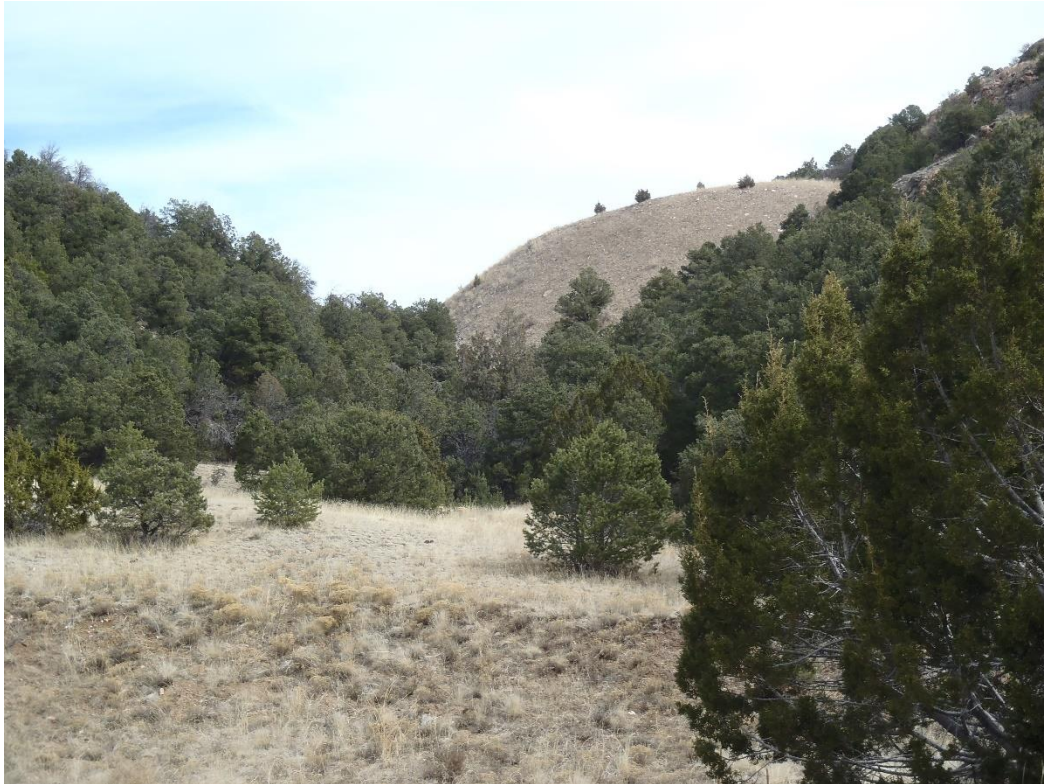
Revegetation: Mr. Tezak showed the old waste dump north of the Mica Lode pit that has been revegetated (see **Photo 3**). No noxious weeds were observed.

Photo 3. Reveg on old waste dump (looking east).

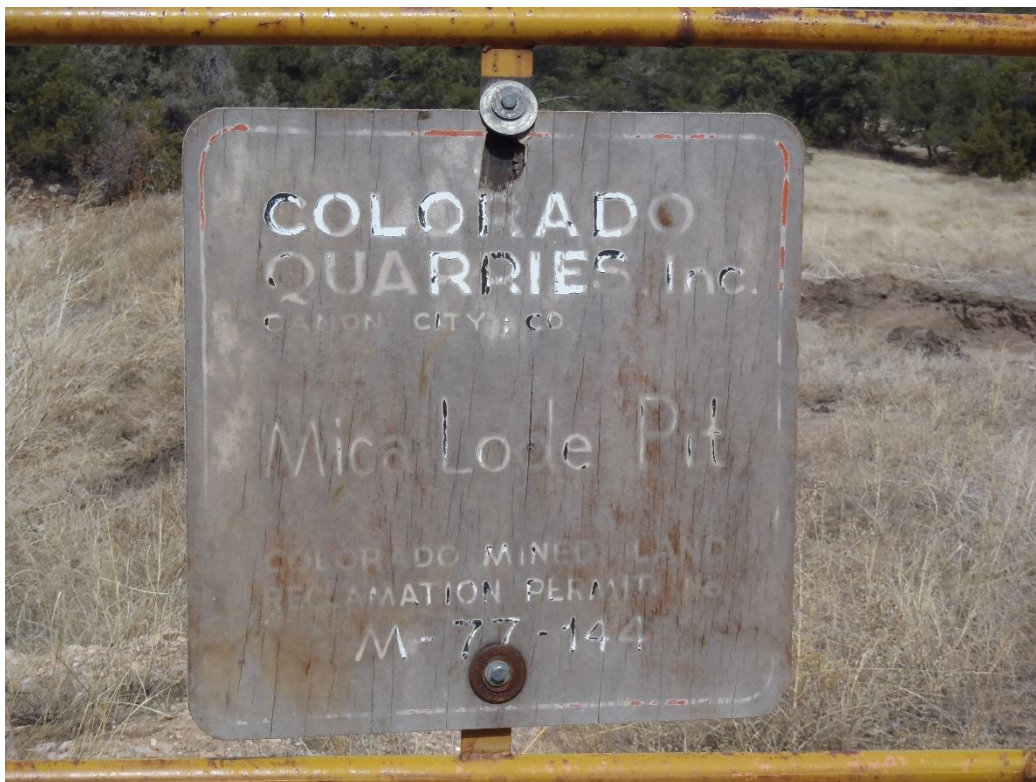
Signs and Markers: The permit sign was properly posted (see **Photo 4**) and boundary markers were observed to delineate the permit boundary (see **Photo 5**). The permit sign should be replaced or re-painted.

Photo 4. Permit sign (should be replaced or re-painted).

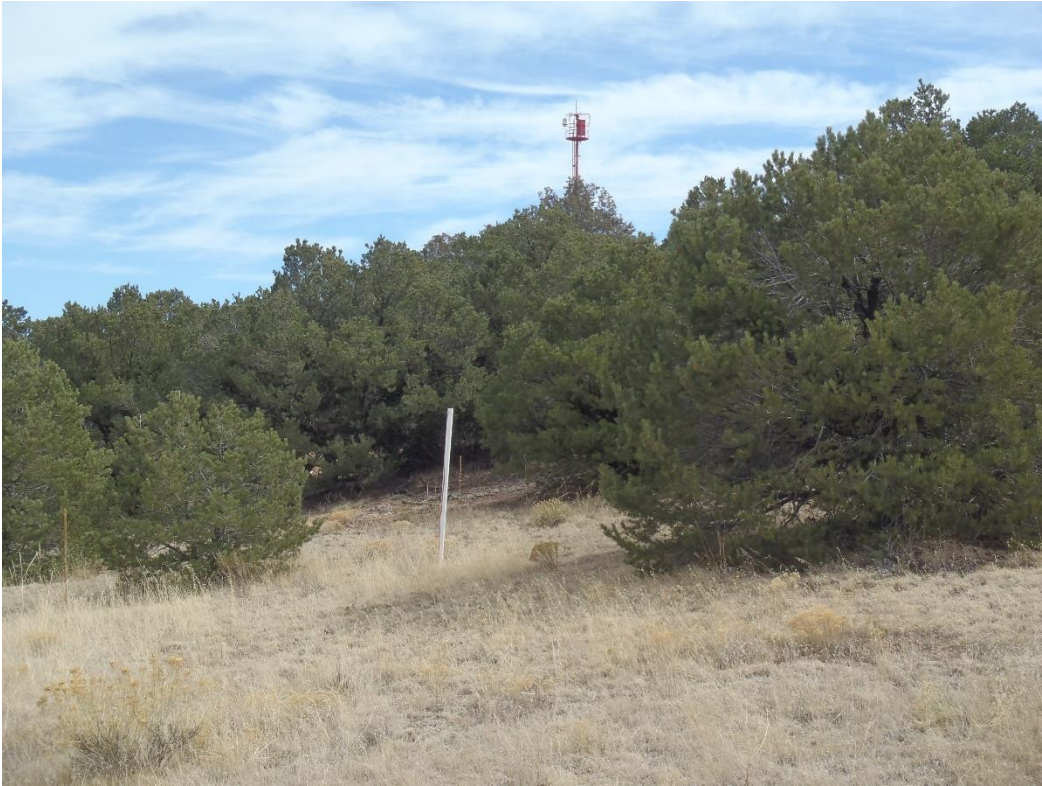
Photo 5. Typical permit boundary corner post (NE corner).

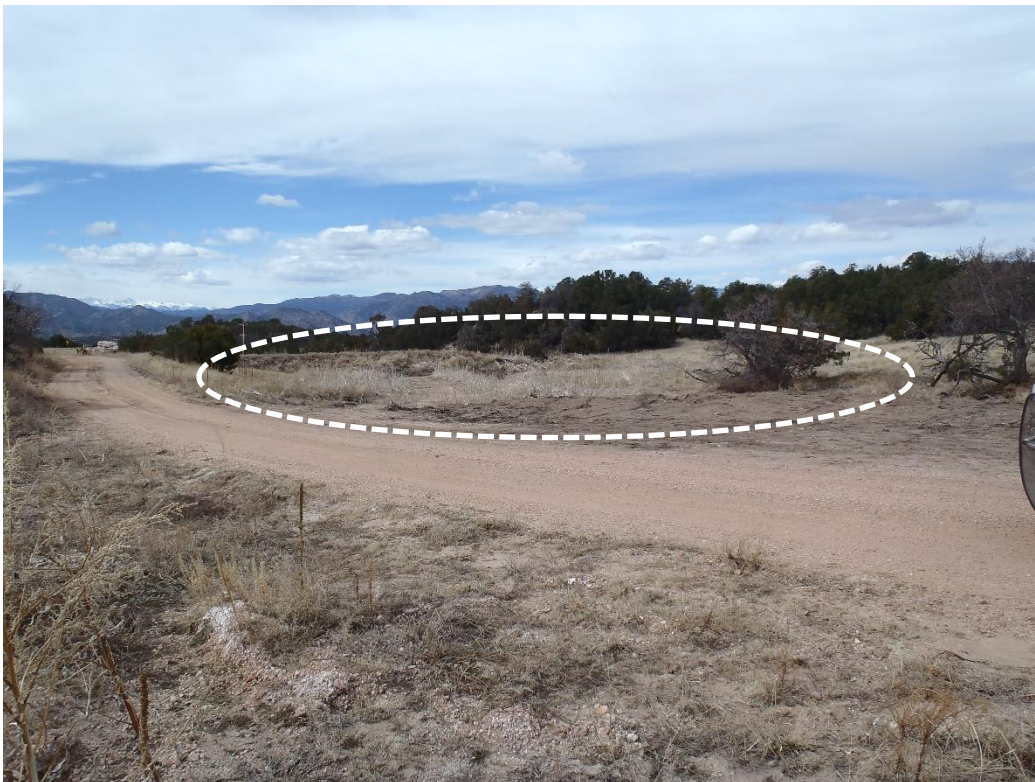
Storm Water MGT Plan: No oil or fuel spills observed. Mr. Tezak indicated the stormwater management plan is kept in Colorado Quarries' office. Site sediment pond appeared adequate (see **Photo 6**).

Photo 6. Stormwater pond (looking west).
