**MINERALS PROGRAM INSPECTION REPORT**  
**PHONE: (303) 866-3567**

<b>MINE NAME:</b> Yevoli Cobblestone Pit	<b>MINE/PROSPECTING ID#:</b> M-2007-003	<b>MINERAL:</b> Sand and Gravel	<b>COUNTY:</b> Fremont
<b>INSPECTION TYPE:</b> Monitoring	<b>INSPECTOR(S):</b> Timothy A. Cazier	<b>INSP. DATE:</b> March 9, 2016	<b>INSP. TIME:</b> 13:30
<b>OPERATOR:</b> Yevoli Cobblestone Inc	<b>OPERATOR REPRESENTATIVE:</b> Mark Yevoli	<b>TYPE OF OPERATION:</b> 110c - Construction Limited Impact	
<b>REASON FOR INSPECTION:</b> Normal I&E Program	<b>BOND CALCULATION TYPE:</b> Partial Bond	<b>BOND AMOUNT:</b> \$34,925.00	
<b>DATE OF COMPLAINT:</b> NA	<b>POST INSP. CONTACTS:</b> None	<b>JOINT INSP. AGENCY:</b> None	
<b>WEATHER:</b> Clear	<b>INSPECTOR'S SIGNATURE:</b>

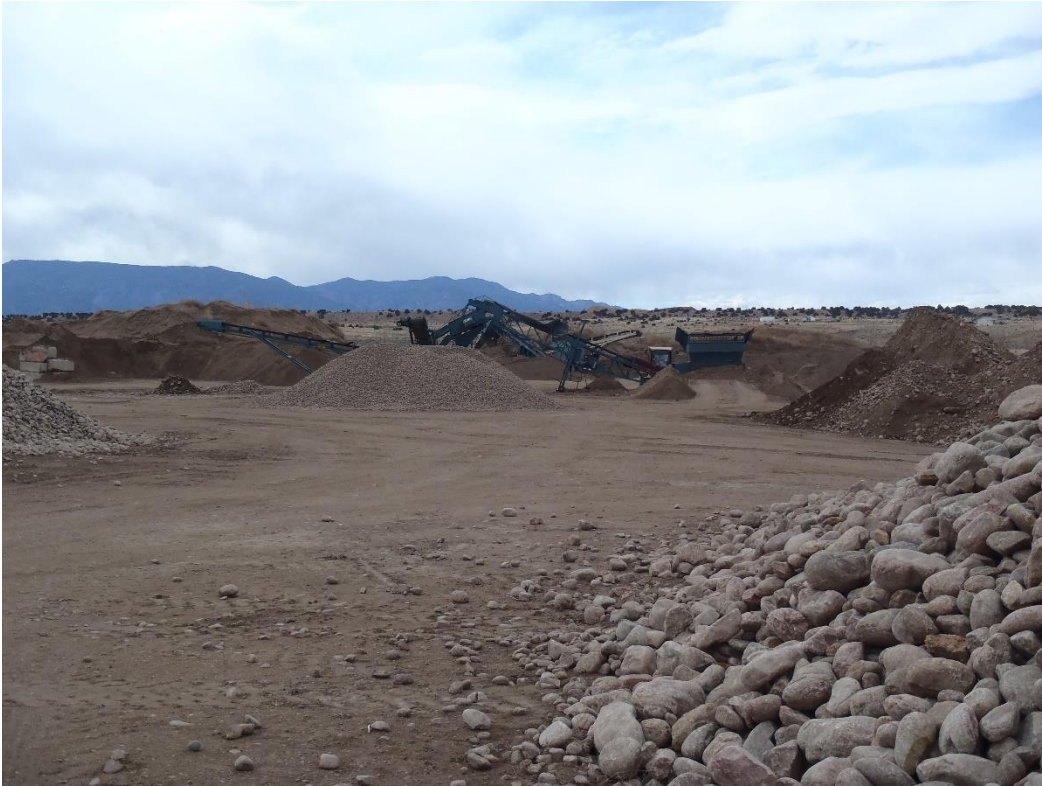
Support Facilities On-site: Several screens and conveyors were observed on site (see **Photo 1**). A semi-trailer, portable water tank and small shed were also observed (see **Photo 2**).

Photo 1. Conveyor & screen (looking south).

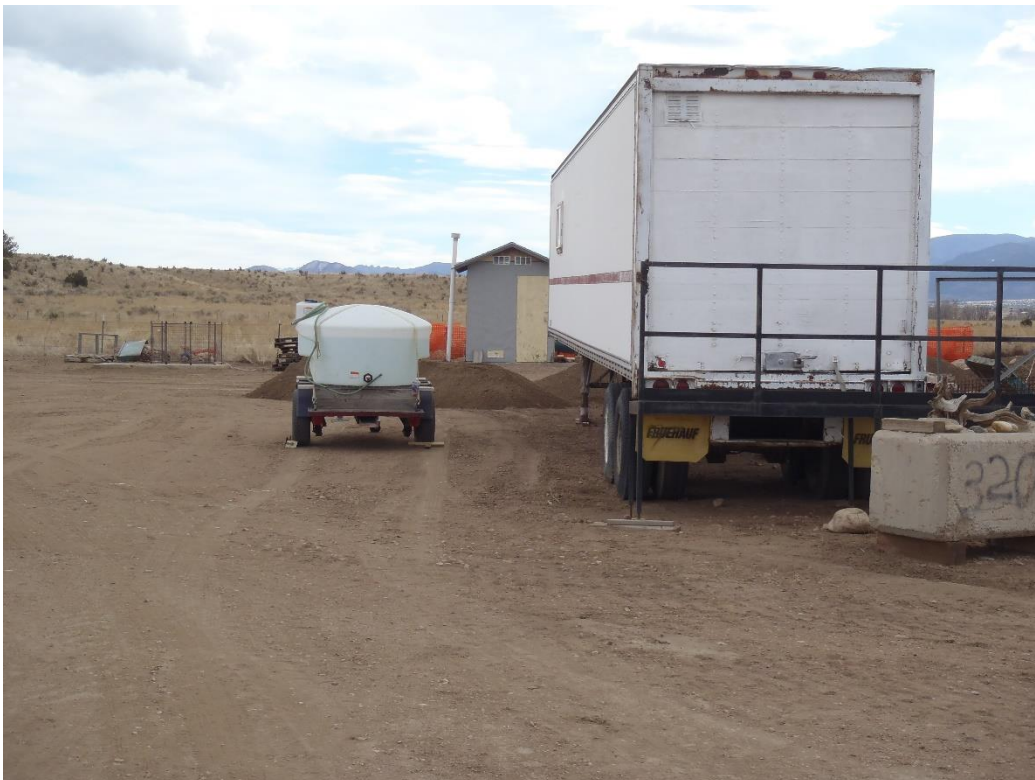
Photo 2. Semi-trailer, water tank & small shed (looking east).

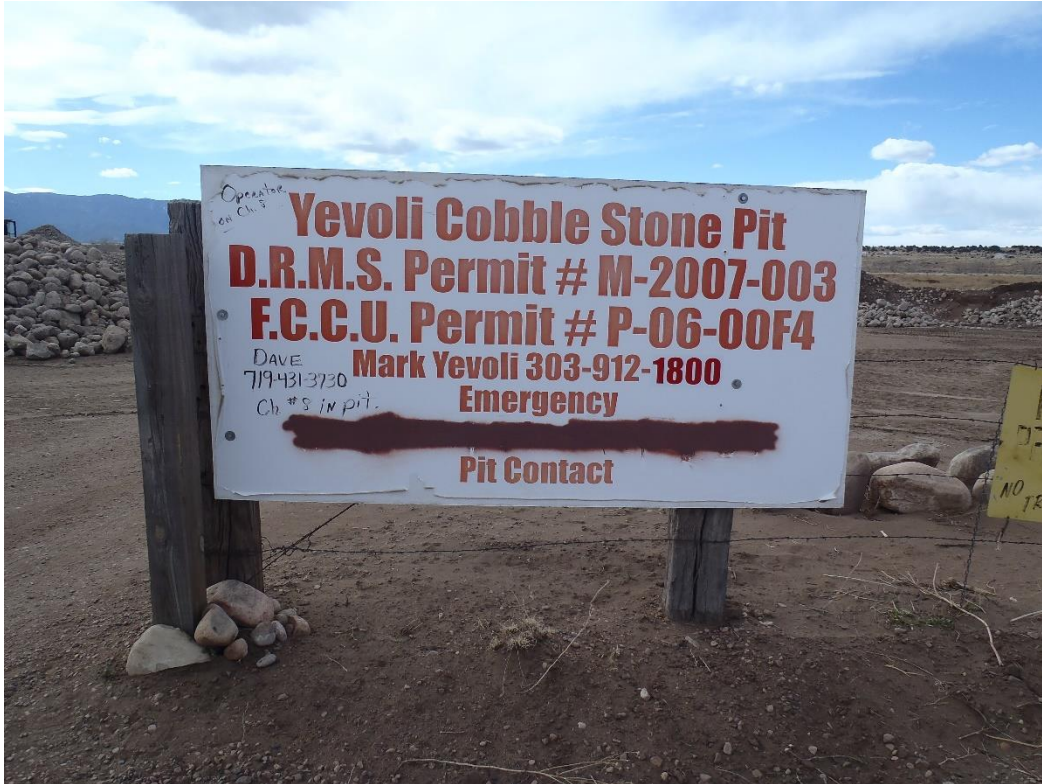
Signs and Markers: The permit sign was properly posted (see **Photo 3**) and boundary markers were observed to delineate the permit boundary with the exception of one post immediately west of the southeast corner. Mr. Yevoli stated he would get it replaced. The north and east sides were marked with fences.

Photo 3. Permit sign.
