MINERALS PROGRAM INSPECTION REPORT
PHONE: (303) 866-3567

MINE NAME: Midland Gravel Pit	MINE/PROSPECTING ID#: M-1993-039	MINERAL: Gravel	COUNTY: Teller
INSPECTION TYPE: Monitoring	INSPECTOR(S): Timothy A. Cazier	INSP. DATE: March 16, 2016	INSP. TIME: 8:05
OPERATOR: City of Cripple Creek	OPERATOR REPRESENTATIVE: Steve DeCamillo	TYPE OF OPERATION: 112c - Construction Regular Operation	
REASON FOR INSPECTION: Normal I&E Program	BOND CALCULATION TYPE: None	BOND AMOUNT: \$0.00	
DATE OF COMPLAINT: NA	POST INSP. CONTACTS: None	JOINT INSP. AGENCY: None	
WEATHER: Clear	INSPECTOR'S SIGNATURE:

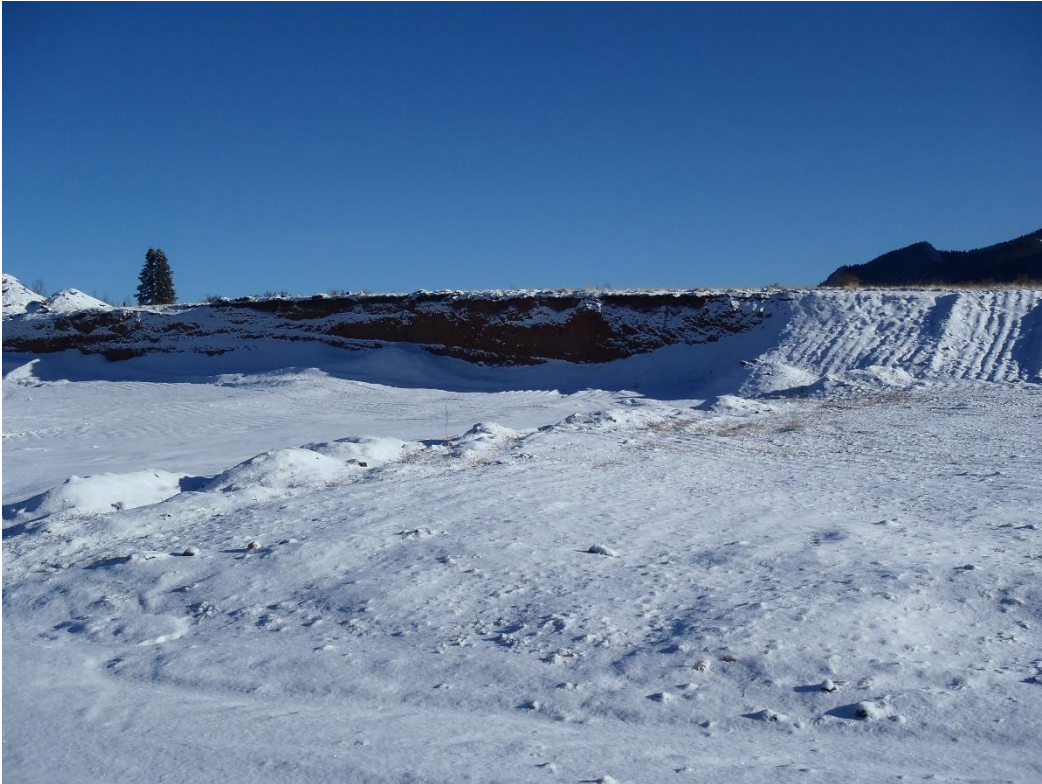
Gen. Compliance with Mine Plan: The operation appeared to be in compliance with the approved mine plan. The pit highwalls were estimated to be 8 to 10 feet in height (see **Photo 1**). Google Earth was used to measure the disturbed area, which was estimated to be approximately 1.5 acres. Mr. DeCamillo indicated the lease with the BLM had just been renewed.

Photo 1. Pit highwall (looking north).

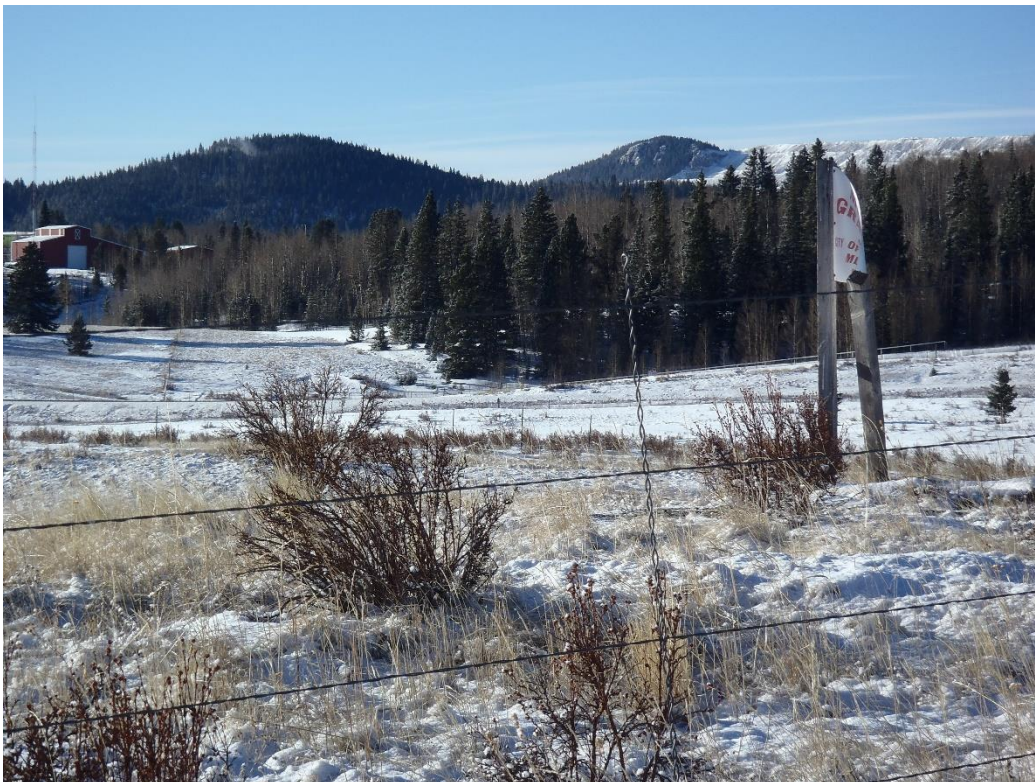
Signs and Markers: The permit sign was properly posted (see **Photo 2**), but folded due to a broken post. Mr. Decamillo stated he would get the sign post fixed. The permit boundary appeared to be adequately marked with fencing.

Photo 2. Permit sign (post needs repair).
