MINERALS PROGRAM INSPECTION REPORT
PHONE: (303) 866-3567

MINE NAME: Big R Pit	MINE/PROSPECTING ID#: M-1988-052	MINERAL: Sand and gravel	COUNTY: Elbert
INSPECTION TYPE: Monitoring	INSPECTOR(S): Amy Eschberger	INSP. DATE: February 18, 2016	INSP. TIME: 12:50
OPERATOR: Estate of Rick L Hunt	OPERATOR REPRESENTATIVE: Jake Mateer	TYPE OF OPERATION: 110c - Construction Limited Impact	
REASON FOR INSPECTION: Normal I&E Program	BOND CALCULATION TYPE: None	BOND AMOUNT: \$18,642.19	
DATE OF COMPLAINT: NA	POST INSP. CONTACTS: None	JOINT INSP. AGENCY: None	
WEATHER: Clear	INSPECTOR'S SIGNATURE:

M-1988-052 / Big R Pit / Estate of Rick L. Hunt

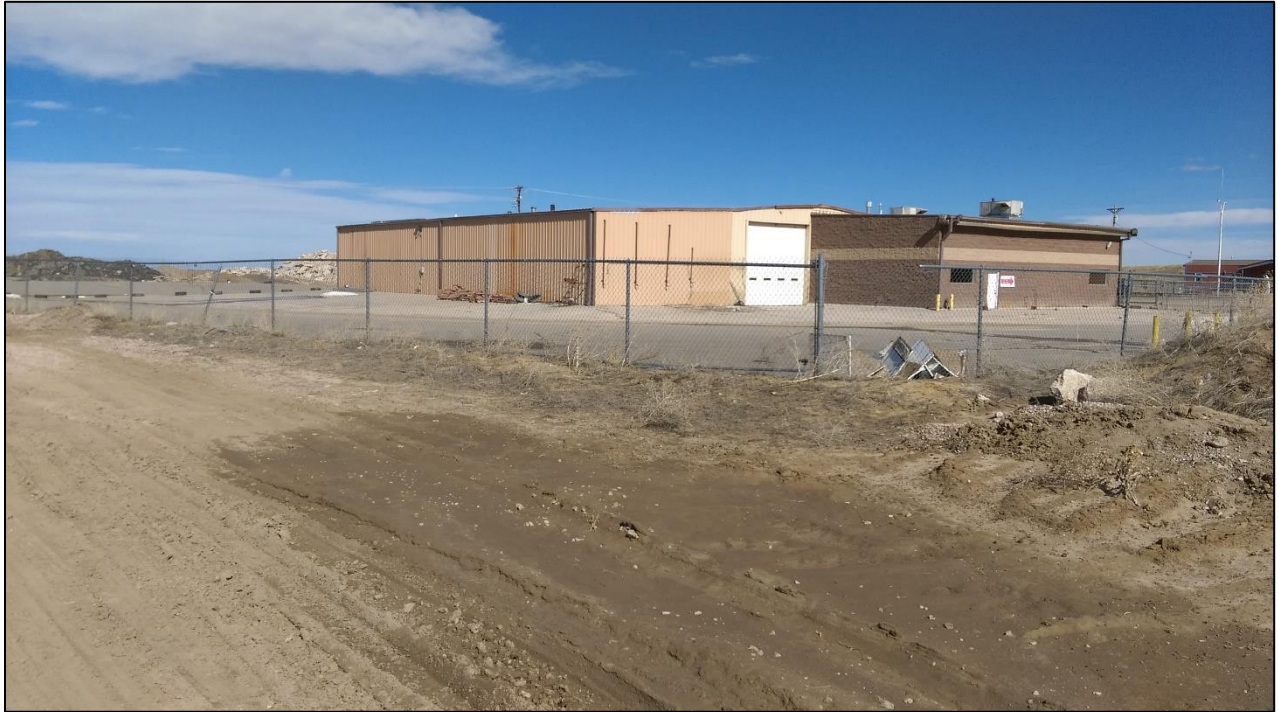
Photo 1. View looking northeast, showing Hunt Construction shop and office building located east of permit area.

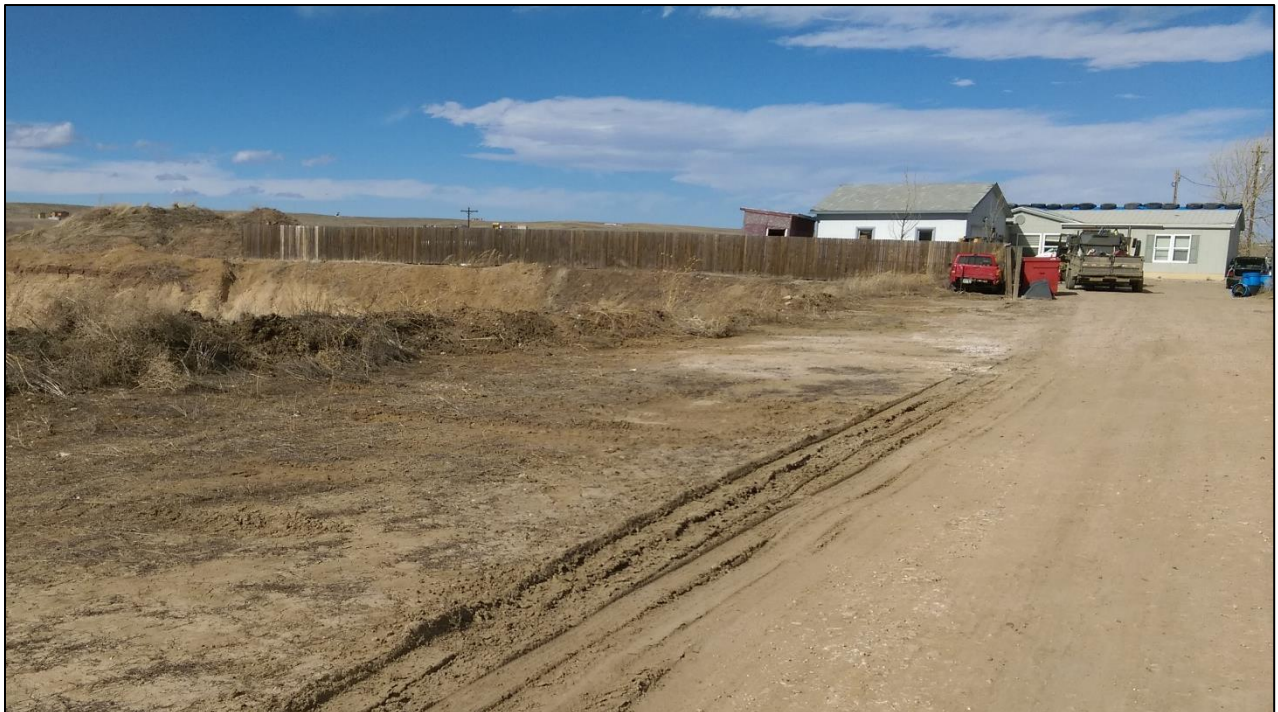
It should be noted the Division observed disturbance to the east of the permit area, south of the shop and office building. In reviewing historic images in Google Earth, this disturbance appears to have been present at least as early as 1998. On the site map submitted with AM-01 in 2011 (see enclosed site map), this area is labeled as "Weld County Well Location", and is not included in the permit area. Mr. Mateer indicated the disturbance was not related to the permitted mining operation, but the handlers of the Estate may wish to reclaim this area along with the facilities and stockpile area utilized by Hunt Construction before selling the land.

Photo 2. View looking north, showing single-wide trailer and garage located between eastern permit boundary and Hunt Construction shop and office building. Area to left (west) of dirt road is within permit area.

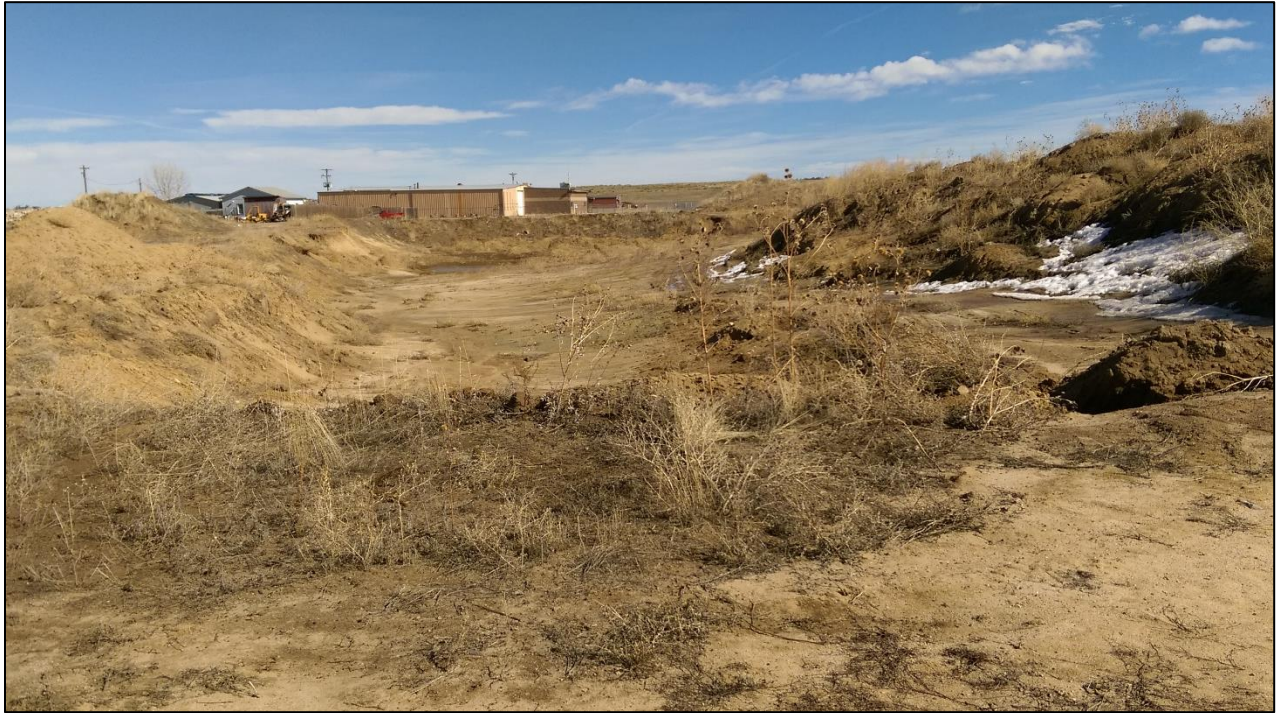
Photo 3. View looking east from western edge of excavation located in southern portion of permit area.

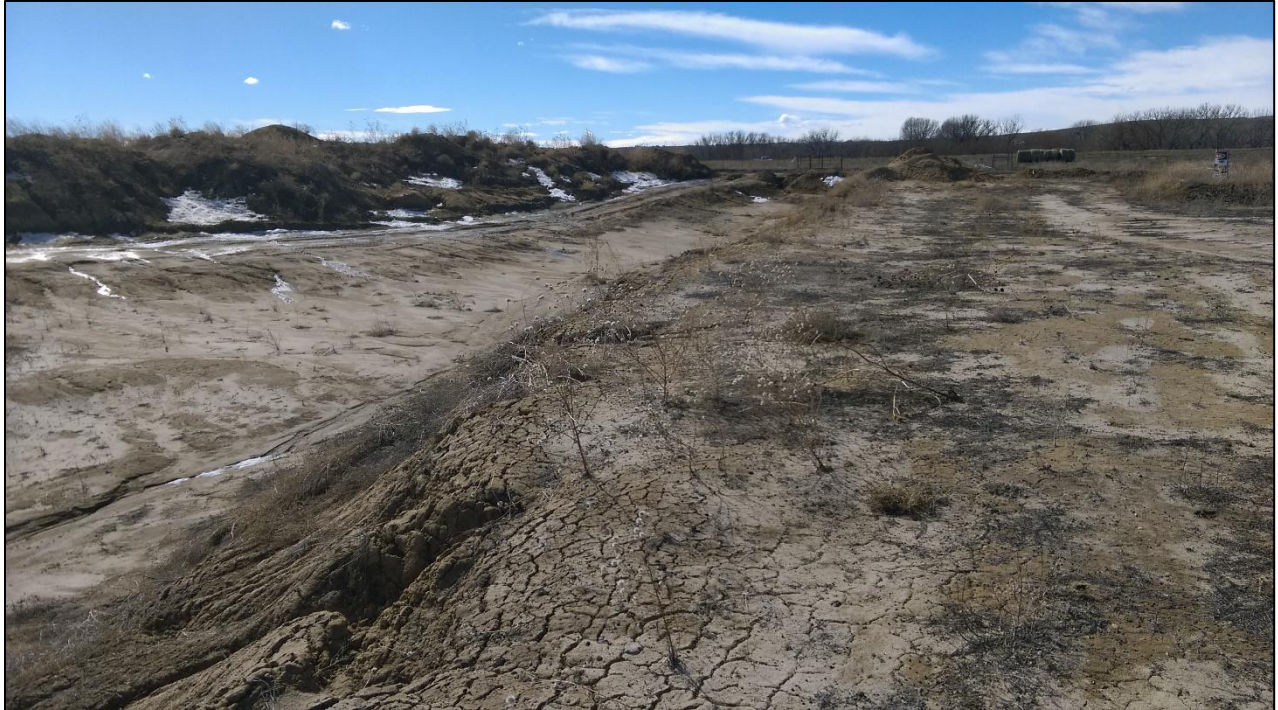
Photo 4. View looking west from northern edge of excavation located in southern portion of permit area.

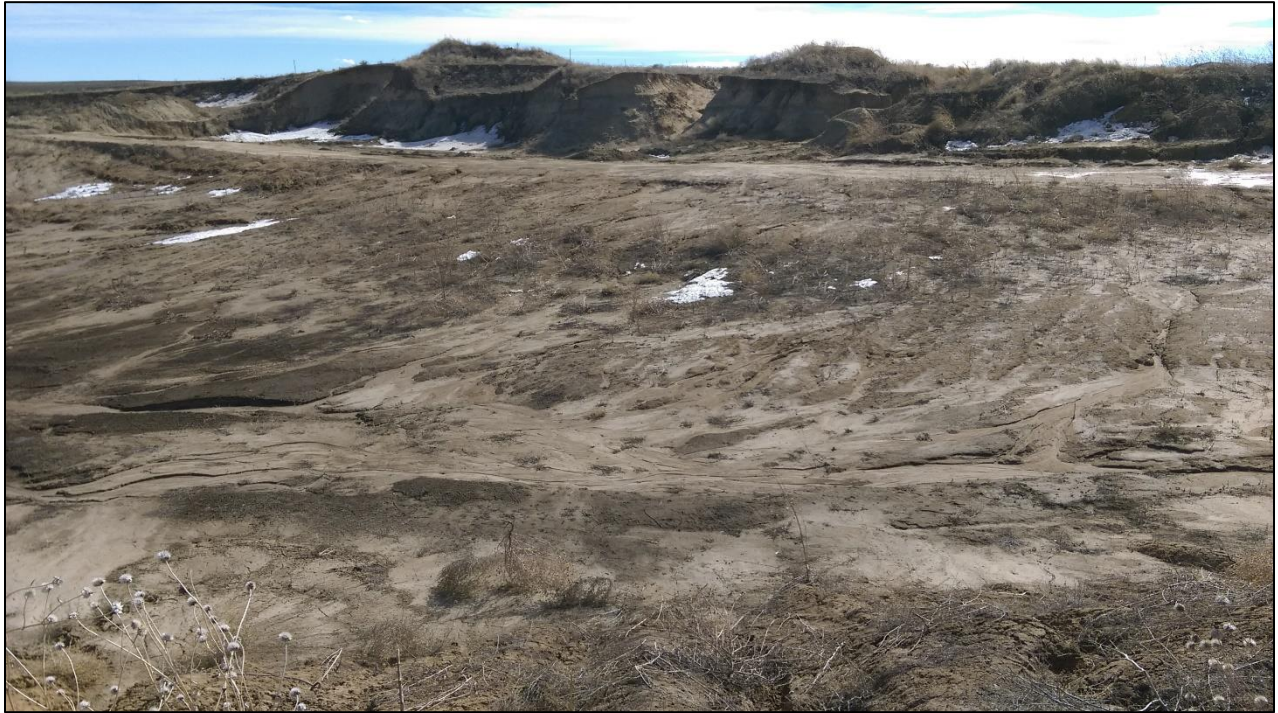
Photo 5. View looking south from northern edge of excavation located in southern portion of permit area.

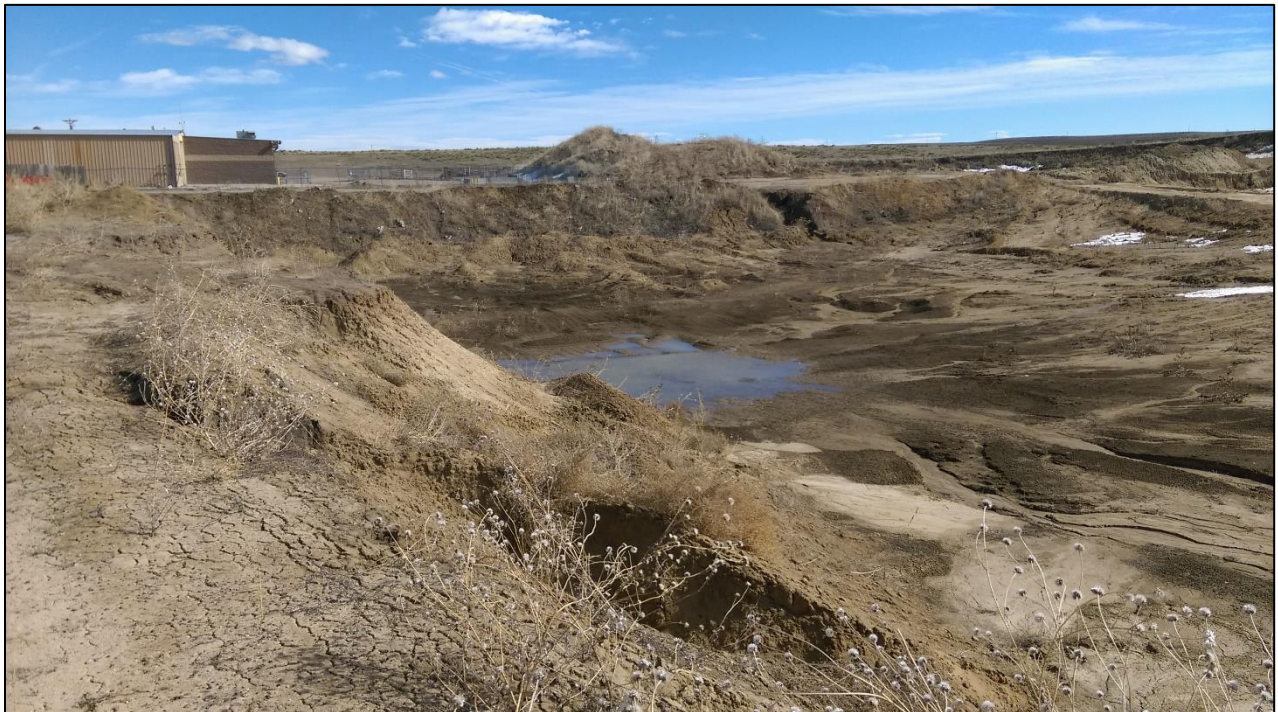
Photo 6. View looking east from northern edge of excavation located in southern portion of permit area.

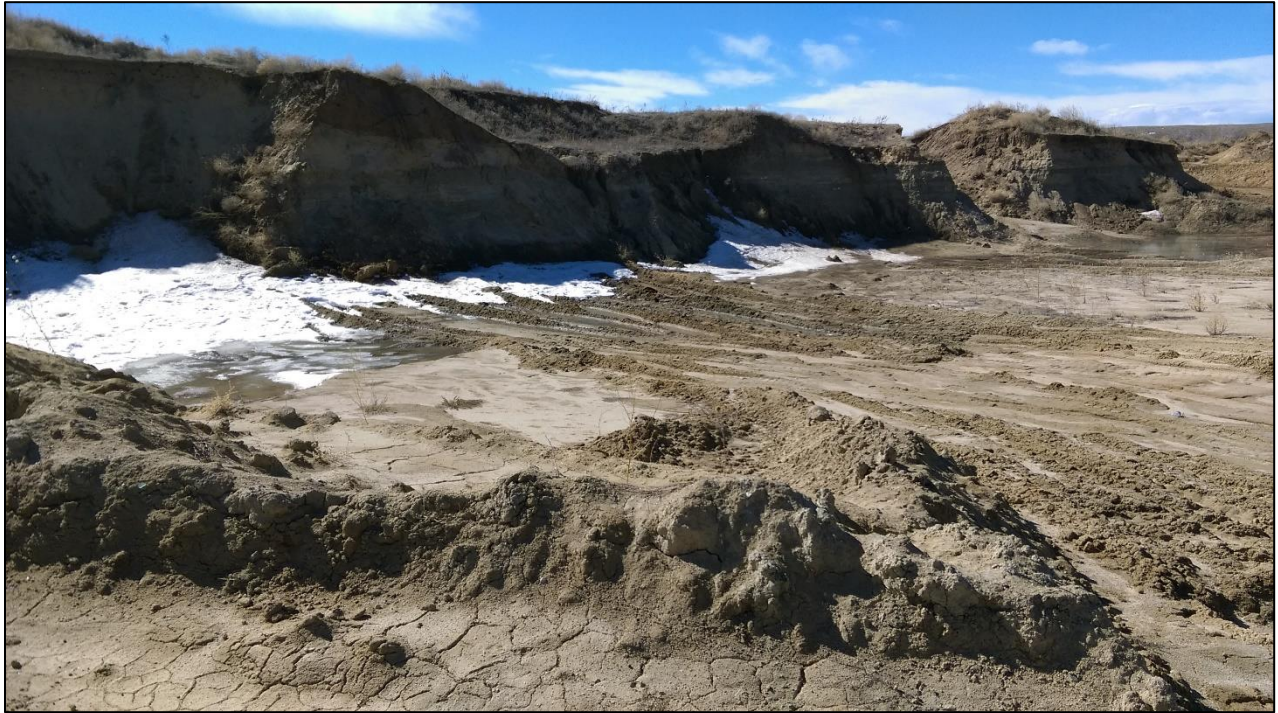
Photo 7. View of southern highwall of excavation located in southern portion of permit area, with slope gradients of approximately 1H:1V.

Because the site has been mined out and material stockpiles have been removed, the Division recommends the permittee complete final reclamation of the site as soon as possible. Pursuant to Rule 3.1.3, all reclamation shall be carried to completion with all reasonable diligence, and each phase of reclamation shall be completed within five years from the date the permittee informs the Division that such phase has commenced. According to the 2016 annual report, the date of last mining-related activity was May 16, 2015. This would give a deadline of May 16, 2020 for final reclamation of the site to be completed.

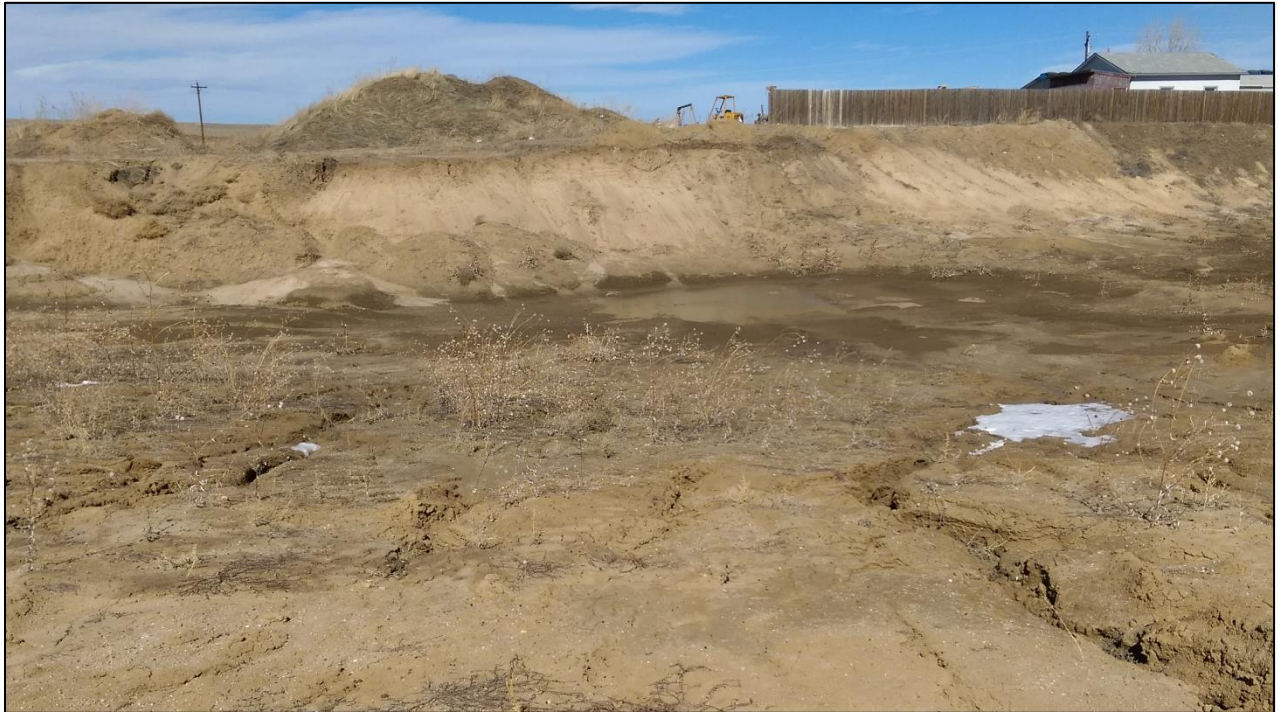
Photo 8. View of northern highwall of excavation located in southern portion of permit area, with slope gradients of approximately 1H:1V.

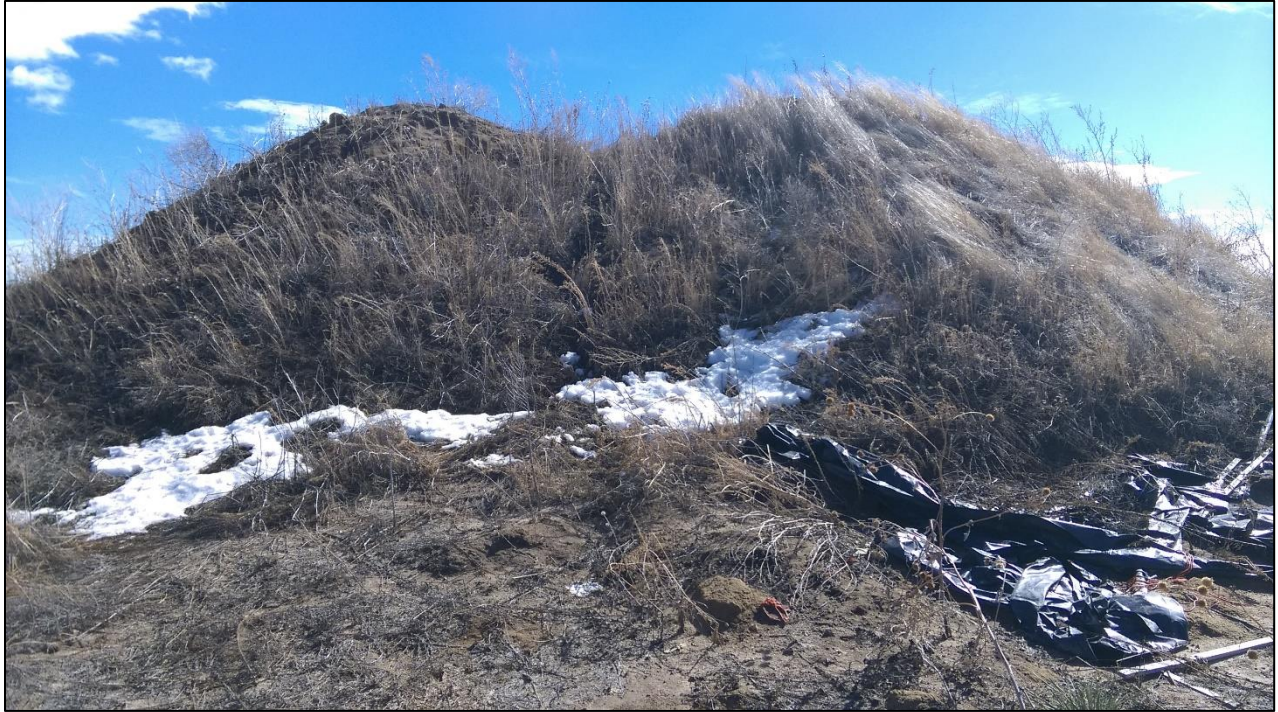
Photo 9. View of topsoil stockpile stored at northern edge of excavation located in southern portion of permit area. Note stockpile stable with vegetative cover.

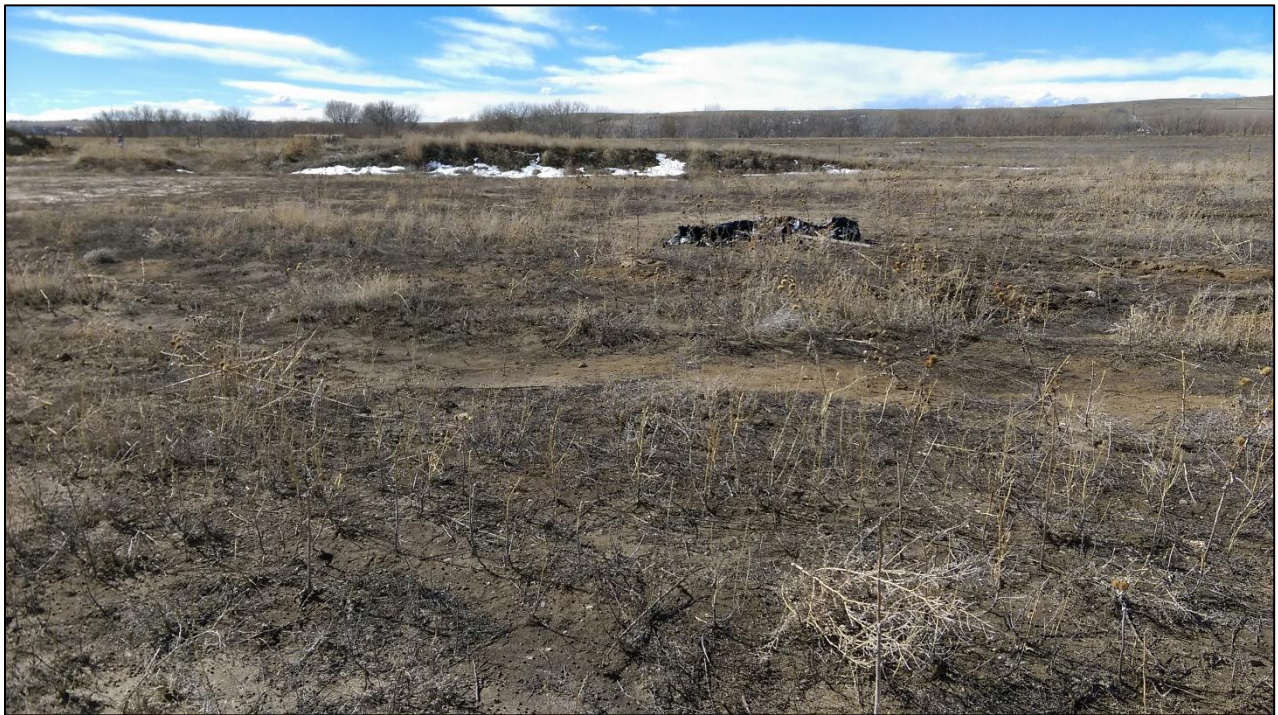
Photo 10. View looking northwest across disturbed area in northern portion of permit area that was backfilled, graded to near flat, and retopsoiled. Vegetative cover consists primarily of annual weeds, with some volunteer grasses and forbs.

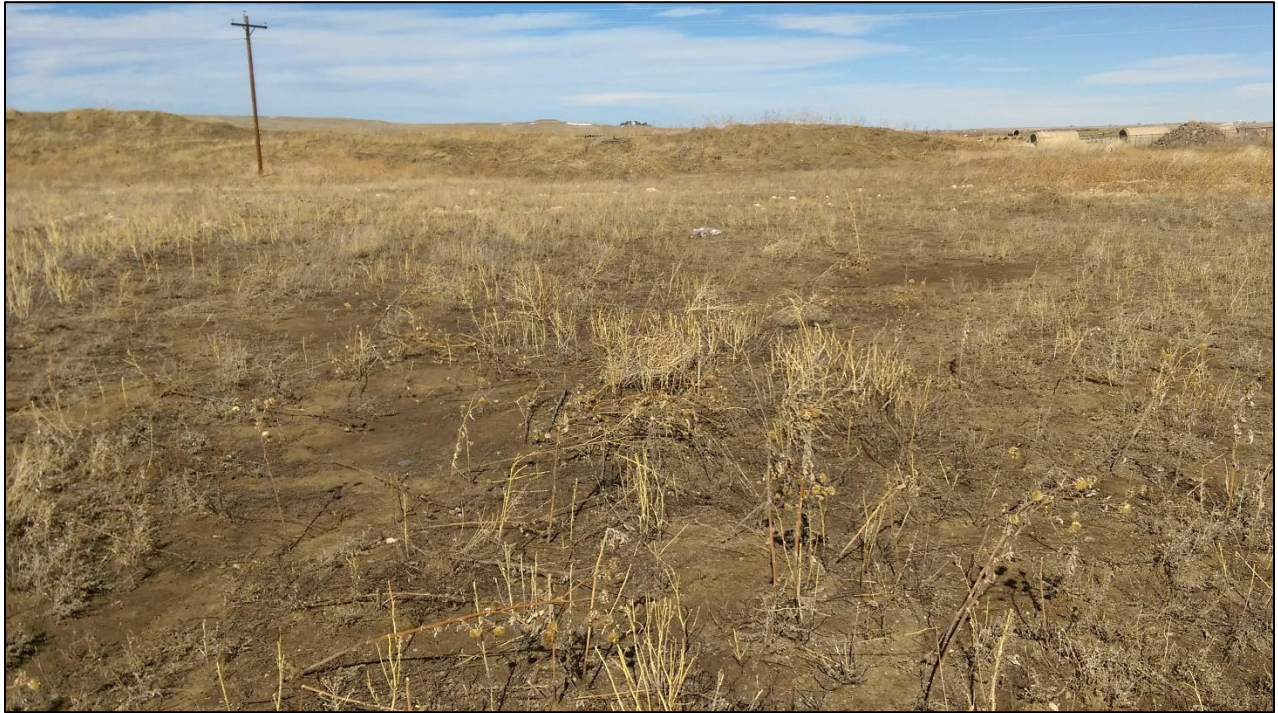
At the time of the inspection, it was sunny and cool with some snow cover remaining on the ground. The site was not active during the inspection. According to Mr. Mateer, the operation has completed mining activities at the site, and will proceed with final reclamation. An excavation is present in the southern portion of the site, with highwalls along its northern and southern edges (**Photos 3-6**). The highwalls of the southern pit are up to 15 feet in height, with slope gradients of approximately 1H:1V (**Photos 7 and 8**). Topsoil stripped from this area is stored along the pit perimeter, primarily along the northern edge (**Photo 9**). The smaller excavation that was present in the northern portion of the permit area has been backfilled, graded to nearly flat, and retopsoiled (**Photos 10-12**). Some native grasses and forbs have volunteered across this area, but the vegetative cover consists primarily of annual weeds. According to annual reports submitted by the permittee, this reclamation work was completed in 2014. It appears that a portion of the topsoil stockpile that was stored along the northern permit boundary remains, and is stable with vegetative cover (shown in **Photo 11**).

Photo 11. View looking north across disturbed area in northern portion of permit area that was backfilled, graded to near flat, and retopsoiled. Vegetative cover consists primarily of annual weeds, with some volunteer grasses and forbs. Note portion of topsoil stockpile that remains along northern permit boundary (in background).

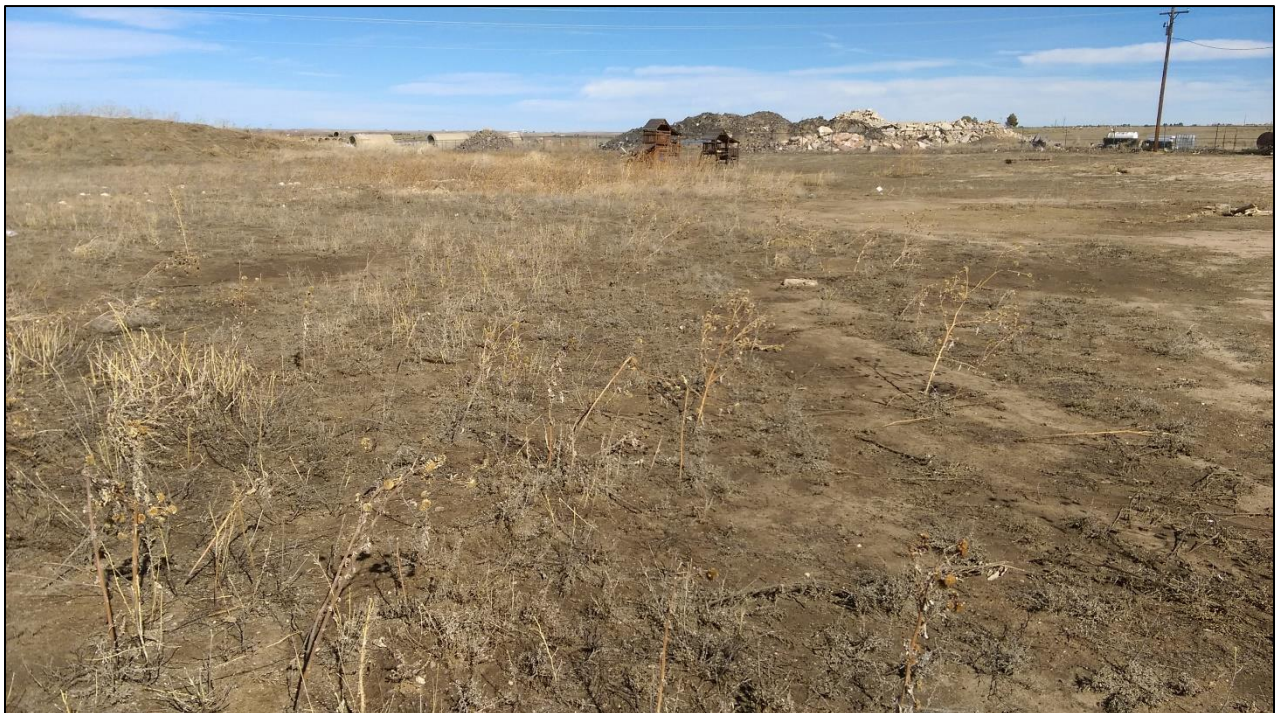
Photo 12. View looking northeast across disturbed area in northern portion of permit area that was backfilled, graded to near flat, and retopsoiled. Vegetative cover consists primarily of annual weeds, with some volunteer grasses and forbs.
