MINERALS PROGRAM INSPECTION REPORT
PHONE: (303) 866-3567

MINE NAME: Road Runner Rest	MINE/PROSPECTING ID#: M-1979-195	MINERAL: Sand and gravel	COUNTY: Adams
INSPECTION TYPE: Monitoring	INSPECTOR(S): Jared L. Ebert	INSP. DATE: February 2, 2017	INSP. TIME: 09:00
OPERATOR: Denver Water Department	OPERATOR REPRESENTATIVE: Ryan Stitt, Denver Water	TYPE OF OPERATION: 112c - Construction Regular Operation	
REASON FOR INSPECTION: Normal I&E Program	BOND CALCULATION TYPE: None	BOND AMOUNT: \$0.00	
DATE OF COMPLAINT: NA	POST INSP. CONTACTS: None	JOINT INSP. AGENCY: None	
WEATHER: Cloudy	INSPECTOR'S SIGNATURE:

This was a monitoring inspection of the Reclamation Pit No. 1 (M-1977-153) and the Road Runner's Rest II Pit (M-1979-195). These are two separate permits that are operated by the City and County of Denver, Board of Water Commissioners (Denver Water). Denver Water treats these two sites as one operation since the permit area for these two sites encompass one large reservoir. Given this, the inspection of these sites occurred simultaneously. I, Jared Ebert of the Colorado Division of Reclamation, Mining and Safety (Division) conducted the inspection. Mr. Ryan Stitt, Wes Eversole, Kris S

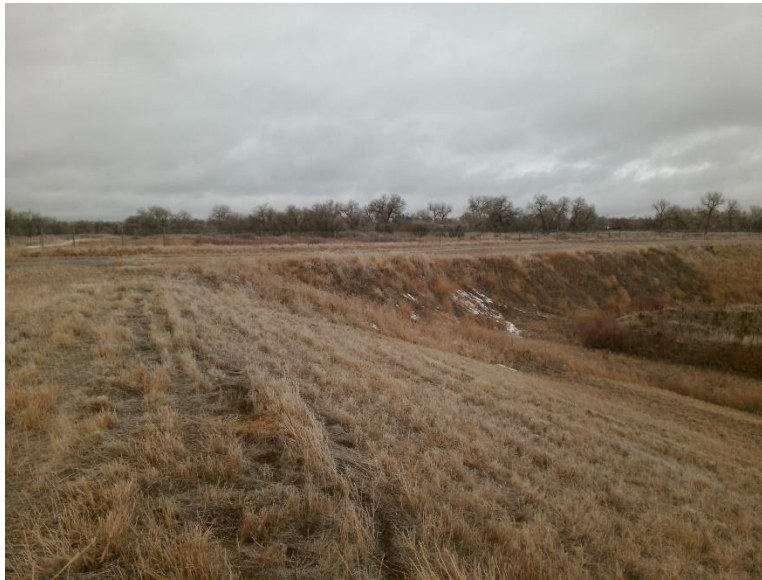
The majority of the reservoir's interior pit slopes varied in steepness from a 4:1 to 3:1 horizontal to vertical ratio. The reclamation plan requires the interior pit slopes to be graded to a 3:1 horizontal to vertical ratio. The pit slopes were stable and vegetated with grasses. One small portion of the southwest corner of the reservoir has interior slopes that were steeper than a 3:1 horizontal to vertical ratio. This area was shown to the representatives of Denver Water. This area will need to be graded to the required 3:1 horizontal to vertical ratio.

Figure 1. Southwest corner of the Reservoir, steep pit slope that will need to be graded to a 3:1.

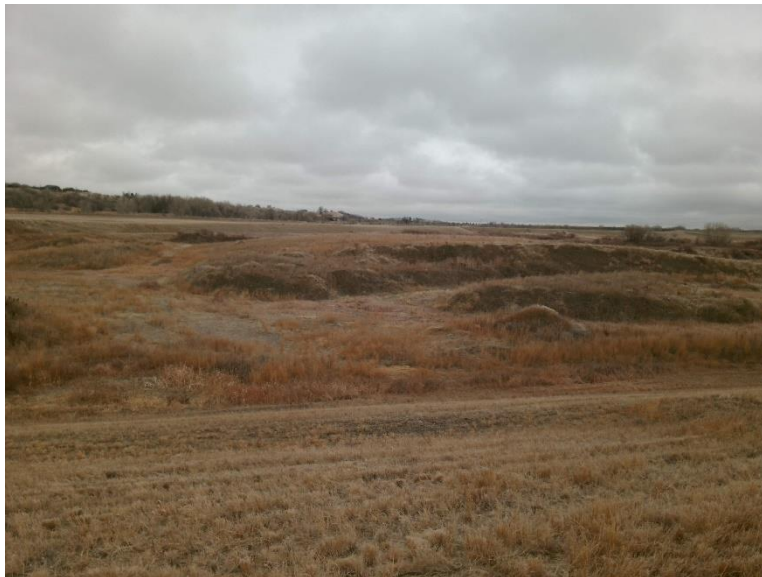
Mining appears to be mostly complete at the site. There are some stockpiles of material still in place on the southwest side of the reservoir in the bottom of the pit. According to Mr. Stitt, Denver Water would like to

get rid of some or most of this material to increase the reservoirs capacity.

Figure 2. Stockpiles at southwest corner of reservoir.

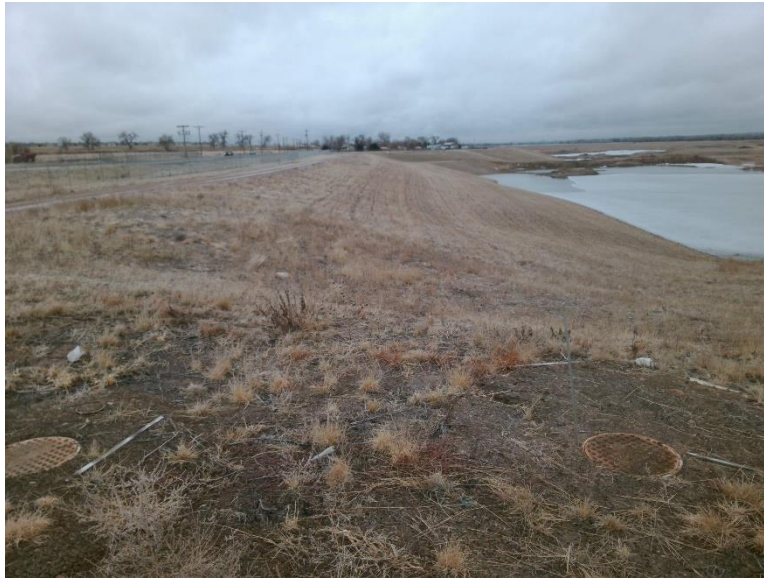
Figure 3. From northwest corner of the reservoir looking east.

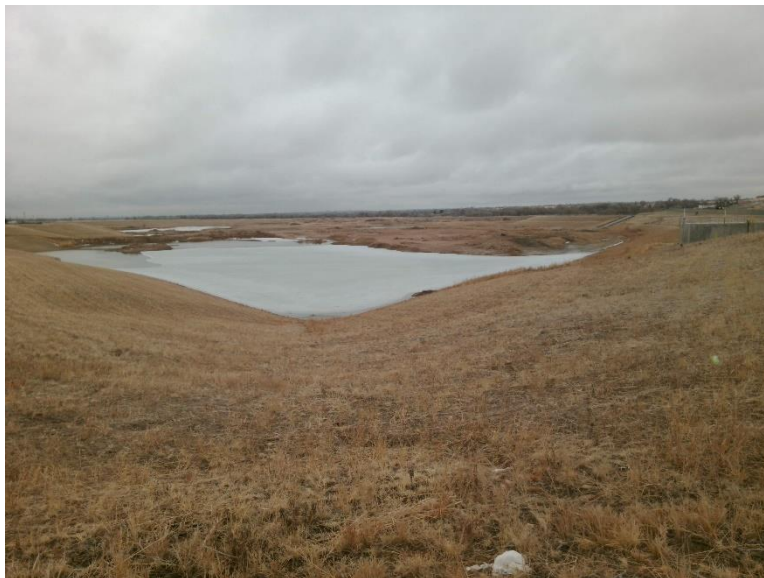
Figure 4. From northwest corner looking southeast.

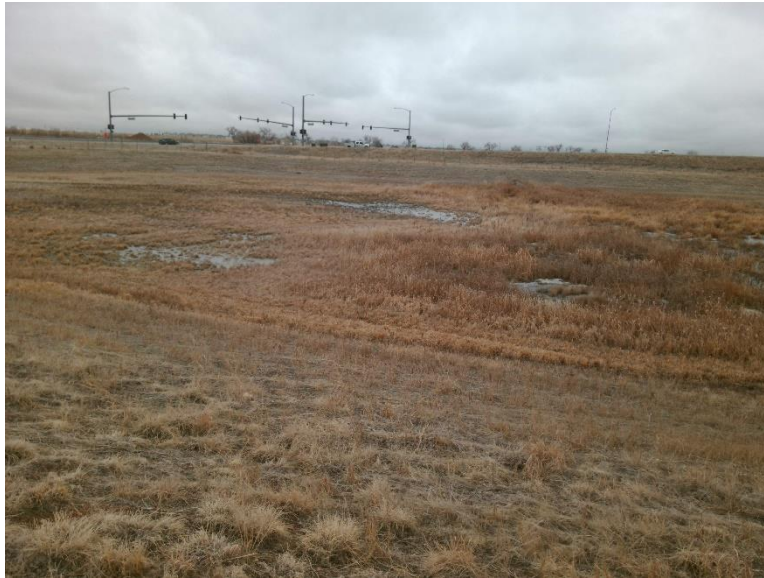
Separate from the reservoir is a small parcel that was mined in the northeast parcel of the Reclamation Pit No. 1 site. A small pit basin remains at this site that appears to catch run-off from the surrounding area. The side slopes of this basin were gentle and did not appear to be greater than a 3:1 angle.

Figure 5. Northeast parcel of the Reclamation Pit No. 1 area. Small drainage basin.
