MINERALS PROGRAM INSPECTION REPORT
PHONE: (303) 866-3567

MINE NAME: Reclamation Pit No 1	MINE/PROSPECTING ID#: M-1977-153	MINERAL: Sand and gravel	COUNTY: Adams
INSPECTION TYPE: Monitoring	INSPECTOR(S): Jared L. Ebert	INSP. DATE: February 2, 2017	INSP. TIME: 09:00
OPERATOR: Denver Water Department	OPERATOR REPRESENTATIVE: Ryan Stitt, Denver Water	TYPE OF OPERATION: 112c - Construction Regular Operation	
REASON FOR INSPECTION: Normal I&E Program	BOND CALCULATION TYPE: None	BOND AMOUNT: \$0.00	
DATE OF COMPLAINT: NA	POST INSP. CONTACTS: None	JOINT INSP. AGENCY: None	
WEATHER: Cloudy	INSPECTOR'S SIGNATURE:

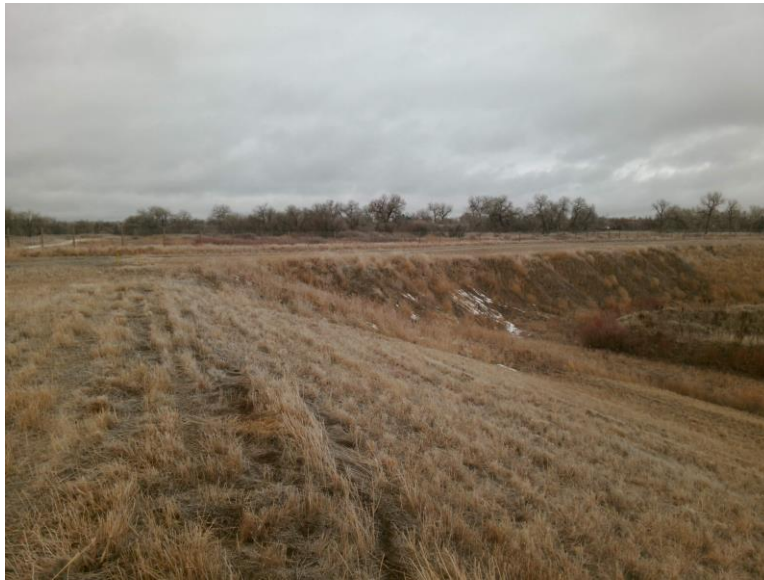
The majority of the reservoir's interior pit slopes varied in steepness from a 4:1 to 3:1 horizontal to vertical ratio. The reclamation plan requires the interior pit slopes to be graded to a 3:1 horizontal to vertical ratio. The pit slopes were stable and vegetated with grasses. One small portion of the southwest corner of the reservoir has interior slopes that were steeper than a 3:1 horizontal to vertical ratio. This area was shown to the representatives of Denver Water. This area will need to be graded to the required 3:1 horizontal to vertical ratio.

Figure 1. Southwest corner of the Reservoir, steep pit slope that will need to be graded to a 3:1.

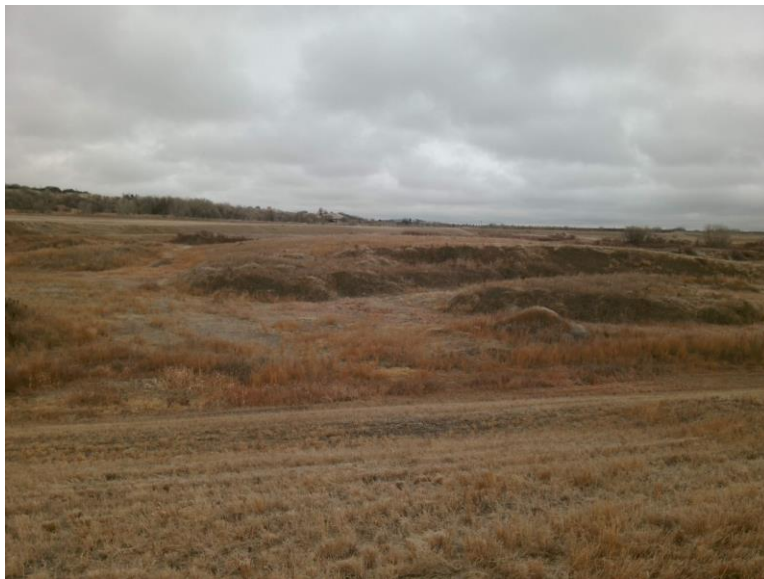
Mining appears to be mostly complete at the site. There are some stockpiles of material still in place on the southwest side of the reservoir in the bottom of the pit. According to Mr. Stitt, Denver Water would like to get rid of some or most of this material to increase the reservoirs capacity.

Figure 2. Stockpiles at southwest corner of reservoir.

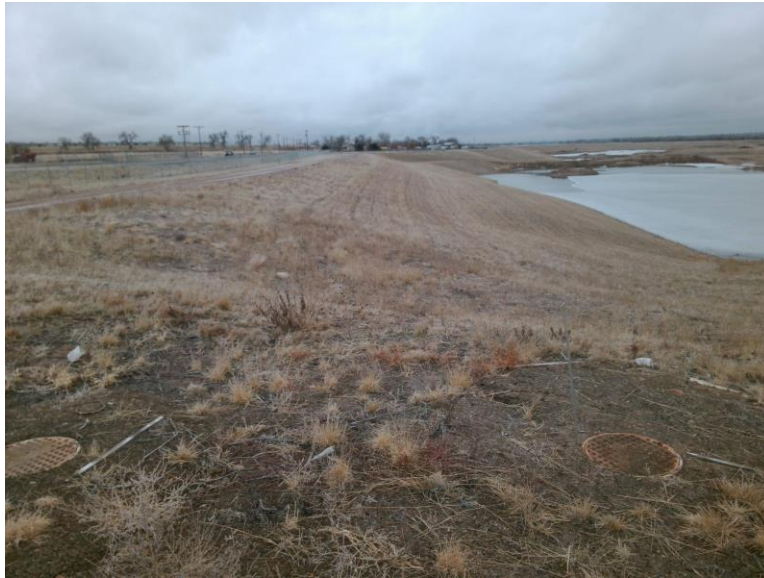
Figure 3. From northwest corner of the reservoir looking east.

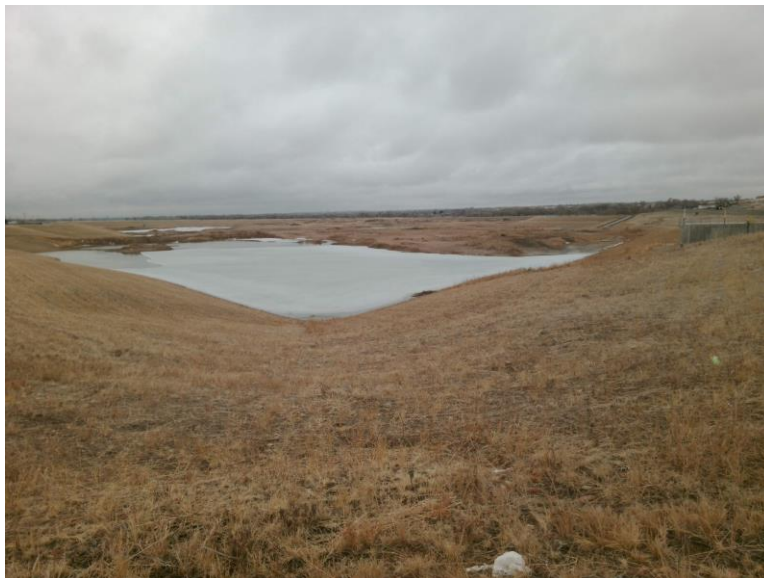
Figure 4. From northwest corner looking southeast.

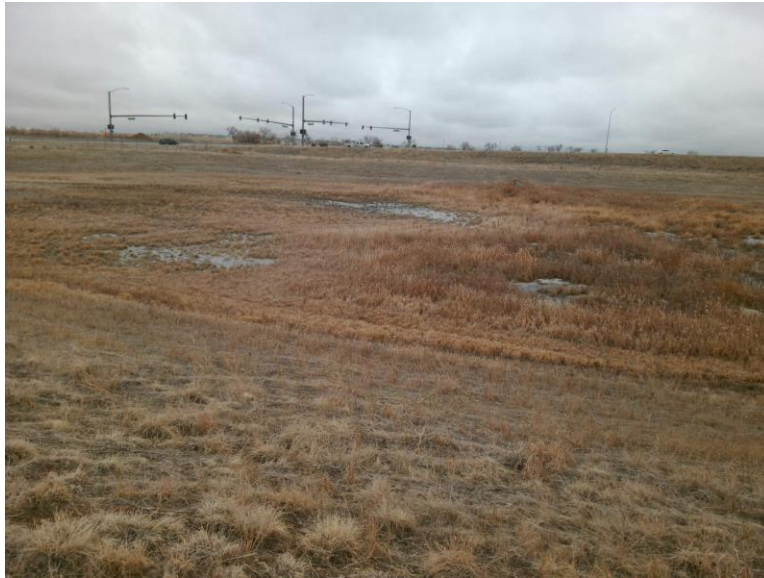
Separate from the reservoir is a small parcel that was mined in the northeast parcel of the Reclamation Pit No. 1 site. A small pit basin remains at this site that appears to catch run-off from the surrounding area. The side slopes of this basin were gentle and did not appear to be greater than a 3:1 angle.

Figure 5. Northeast parcel of the Reclamation Pit No. 1 area. Small drainage basin.
