## MINERALS PROGRAM INSPECTION REPORT

<b>MINE NAME:</b> Howe Pit	<b>MINE/PROSPECTING ID#:</b> M-1978-052	<b>MINERAL:</b> Sand and gravel	<b>COUNTY:</b> Adams
<b>INSPECTION TYPE:</b> Monitoring	<b>INSPECTOR(S):</b> Jared L. Ebert	<b>INSP. DATE:</b> February 2, 2017	<b>INSP. TIME:</b> 09:00
<b>OPERATOR:</b> City & County of Denver, Board of Water Commissioners	<b>OPERATOR REPRESENTATIVE:</b> Ryan Stitt, Denver Water	<b>TYPE OF OPERATION:</b> 112c - Construction Regular Operation	
<b>REASON FOR INSPECTION:</b> Normal I&E Program	<b>BOND CALCULATION TYPE:</b> None	<b>BOND AMOUNT:</b> \$0.00	
<b>DATE OF COMPLAINT:</b> NA	<b>POST INSP. CONTACTS:</b> None	<b>JOINT INSP. AGENCY:</b> None	
<b>WEATHER:</b> Cloudy	<b>INSPECTOR'S SIGNATURE:</b>

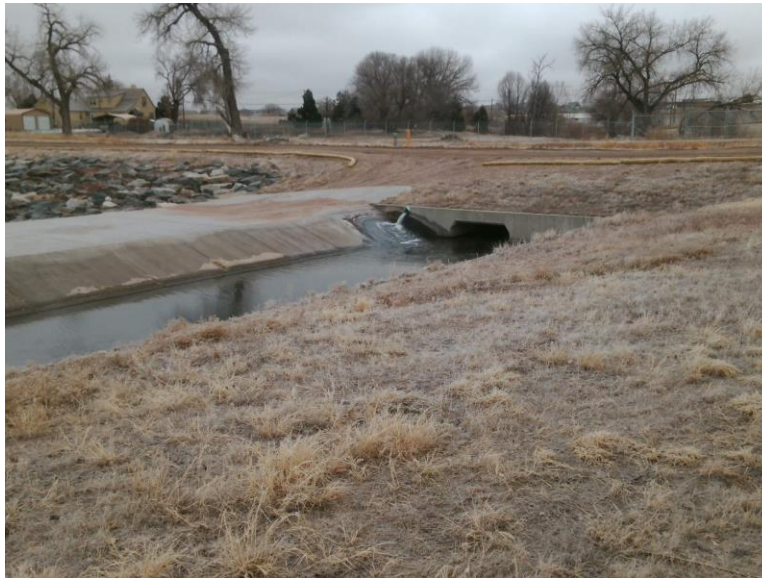
First Creek runs from a head gate at the Fulton Ditch into a channel that bisects Reservoirs A and B. This channel is stable with dense grassy vegetation established on the slopes of the channel. A mounding drainage has been installed west of Reservoir B. The representatives from Denver Water showed me various plumbing and valve features that controls the mounding drain. The primary outlet for the mounding drain is located adjacent to the site's main office. The mounding drain discharges from a pipe into the First Creek channel.

**Figure 1. Water discharging from mounding drain into the First Creek Channel north of the site office.**

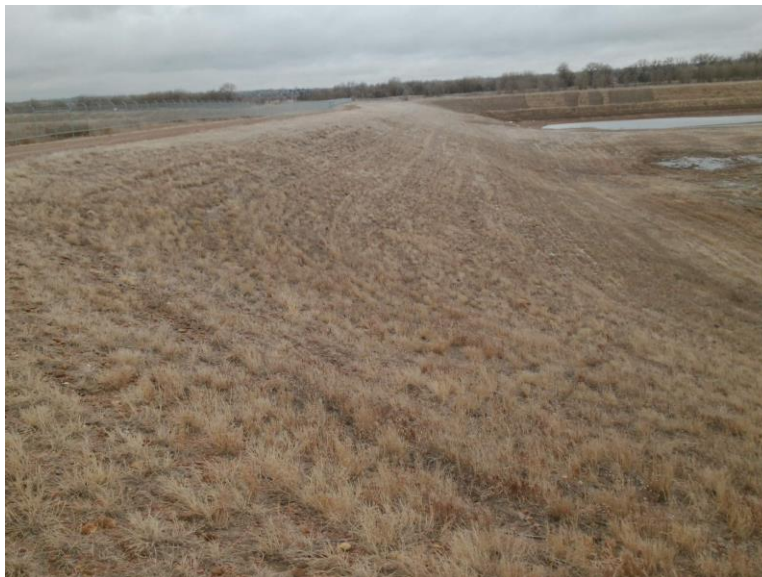
**Figure 2. Southern pit slope of Reservoir A.**

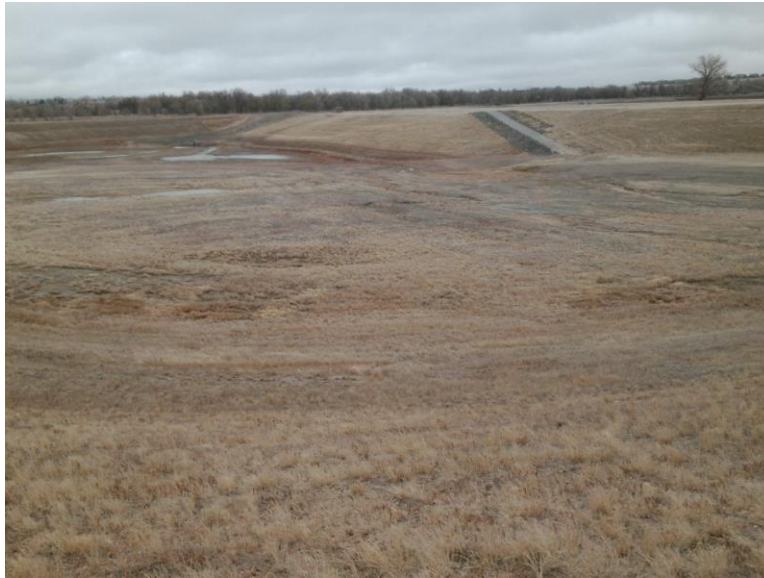
Figure 3. From southeast corner of Reservoir A looking northwest.

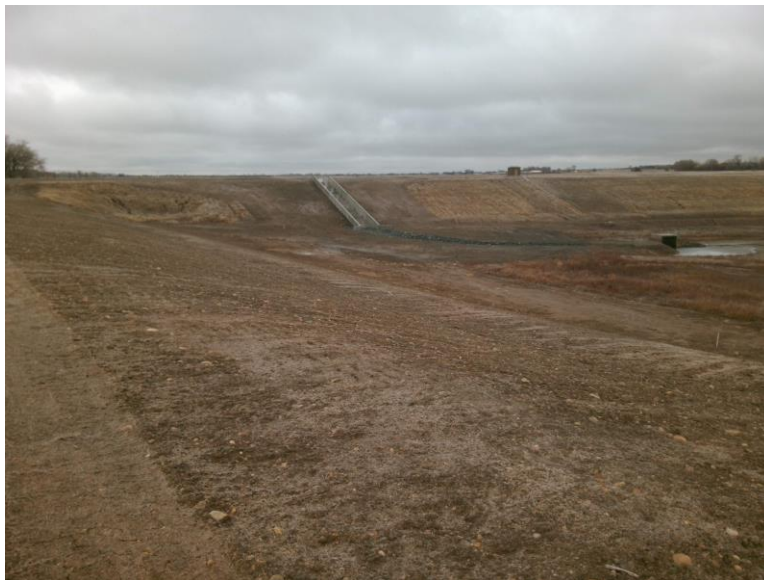
The South Platte River flooded in 2013 and damaged the western side slopes of Reservoir A and B in several locations. Denver Water has repaired these areas and they appear stable. These areas are largely devoid of vegetation. Vegetation will need to be established in these areas before they are eligible for bond release.

Figure 4. Northwest corner of Reservoir A. Area where slope repair occurred from flood damage.

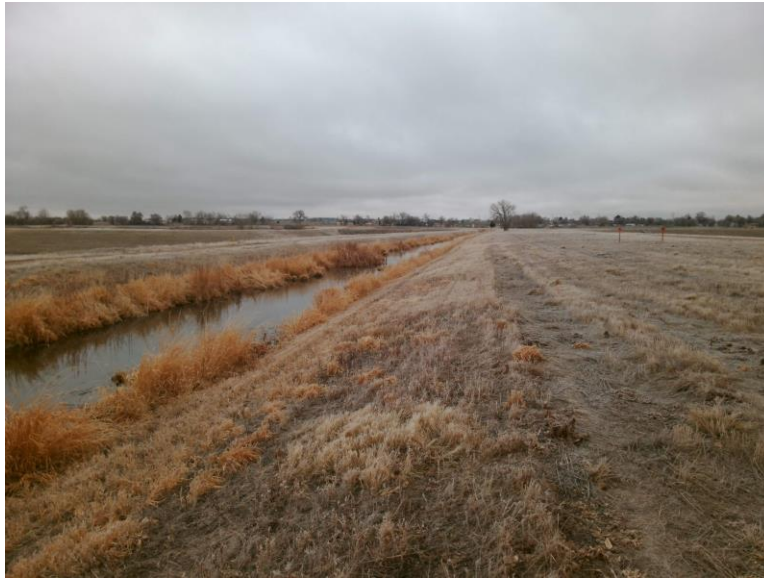
Figure 5. From the west end of the First Creek Channel looking southeast.

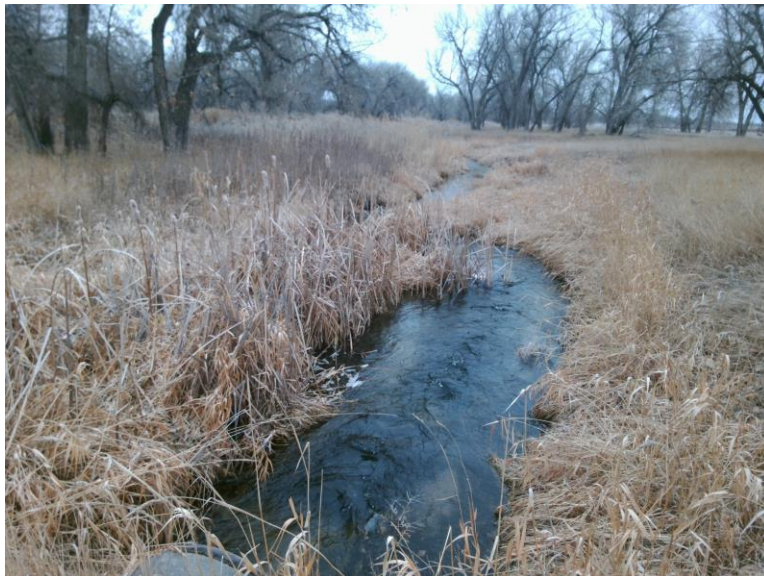
Portions of the re-located Bull Seep were observed south of Reservoir A and west of both reservoirs. The channel appears stable and functional and dense riparian vegetation has established adjacent to the channel.

Figure 6. View of the Bull Seep near the confluence of First Creek, looking north.

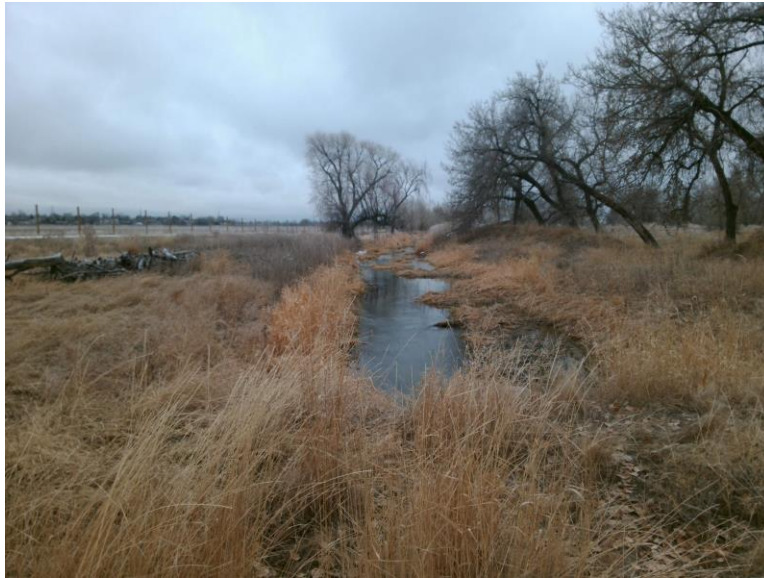
Figure 7. View of the Bull Seep near the confluence of First Creek, looking south.

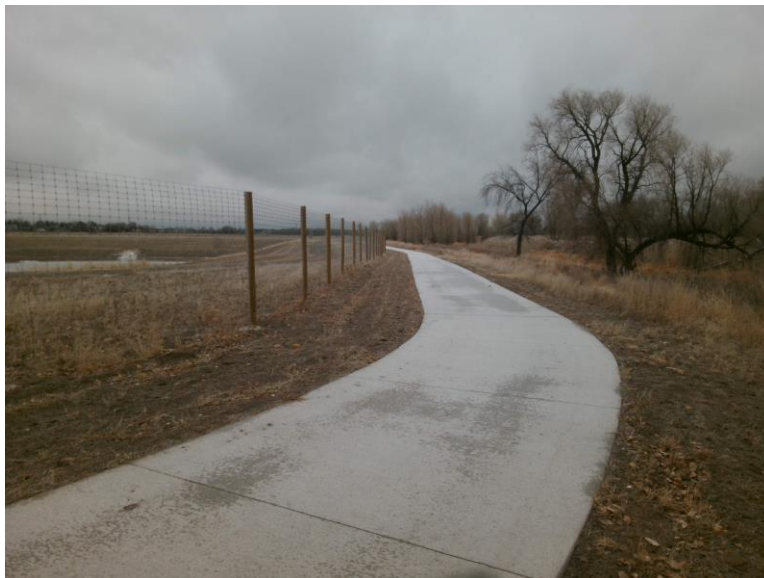
Figure 8. Public path adjacent to Reservoirs A and B.

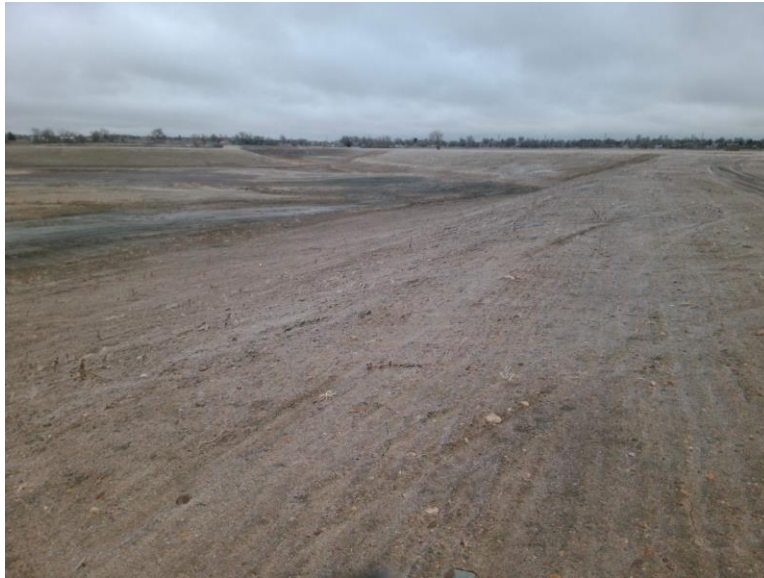
**Figure 9. Western Slope of Reservoir B.**

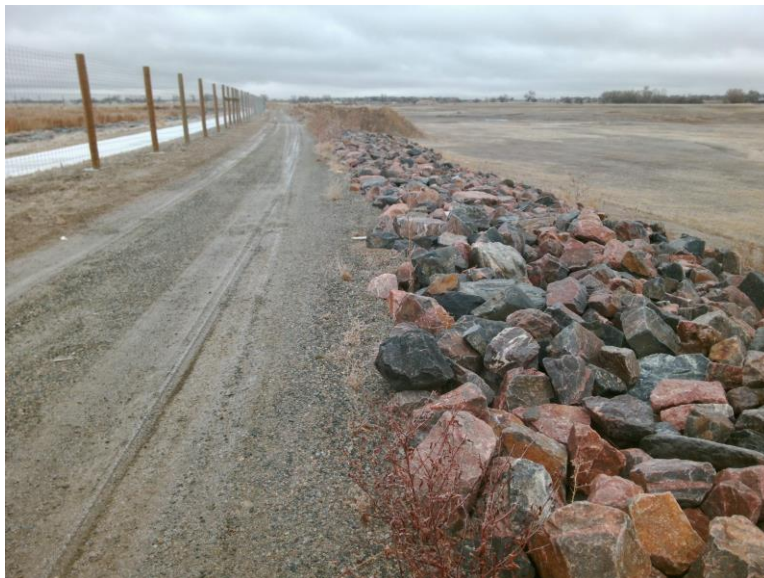
A small workspace/pad area has been extended out from the access road on the east side of the emergency spillway of Reservoir B (northern reservoir). The side slopes of this pad extend into the reservoir and are steeper than the required 3:1 angle. This area will need to be graded to the approved slope angle.

**Figure 10. Emergency Spillway of Reservoir B.**

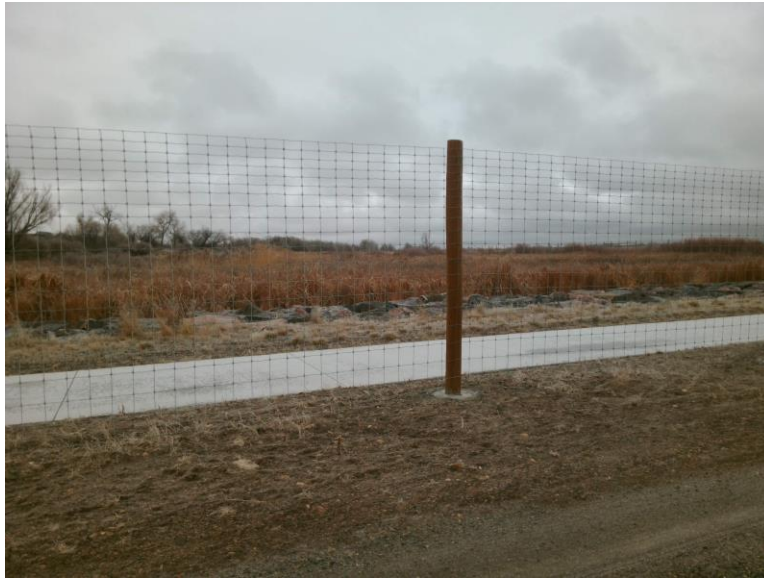
Figure 11. From the emergency spillway of Reservoir B looking north at the outlet of the Bull Seep.

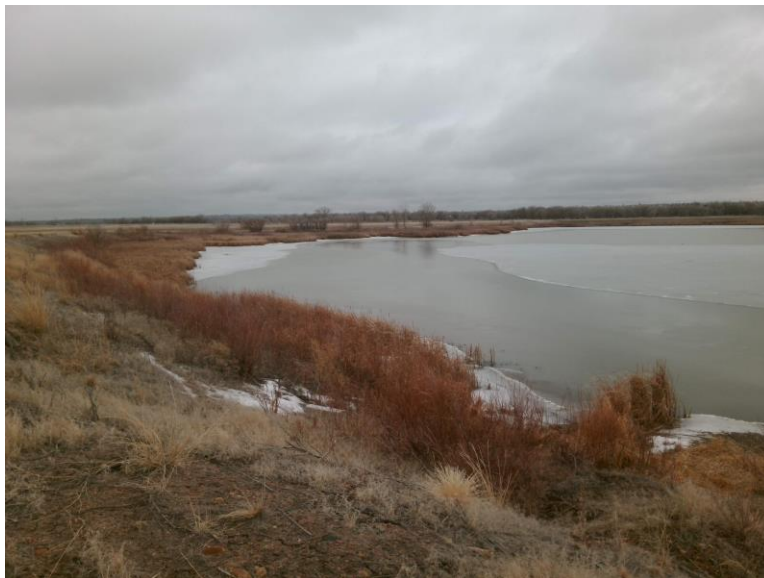
The exposed ground water pond that is located to the east of Reservoir B was an area that that was mined prior to 1981 according to Mr. Stitt. Based on the original permit application submitted for the Howe Pit in 1978, it appears this was an existing feature.

Figure 12. View of the open groundwater pond from the east end looking west.
