**MINERALS PROGRAM INSPECTION REPORT**  
**PHONE: (303) 866-3567**

<b>MINE NAME:</b> Winter Ranch Pit	<b>MINE/PROSPECTING ID#:</b> M-1985-165	<b>MINERAL:</b> Sand and gravel	<b>COUNTY:</b> Las Animas
<b>INSPECTION TYPE:</b> Monitoring	<b>INSPECTOR(S):</b> Michael A. Cunningham	<b>INSP. DATE:</b> January 26, 2017	<b>INSP. TIME:</b> 15:00
<b>OPERATOR:</b> Arthur A. Winter	<b>OPERATOR REPRESENTATIVE:</b> Arthur Winter	<b>TYPE OF OPERATION:</b> 110c - Construction Limited Impact	
<b>REASON FOR INSPECTION:</b> Normal I&E Program	<b>BOND CALCULATION TYPE:</b> Complete Bond	<b>BOND AMOUNT:</b> \$13,500.00	
<b>DATE OF COMPLAINT:</b> NA	<b>POST INSP. CONTACTS:</b> None	<b>JOINT INSP. AGENCY:</b> None	
<b>WEATHER:</b> Clear	<b>INSPECTOR'S SIGNATURE:</b>

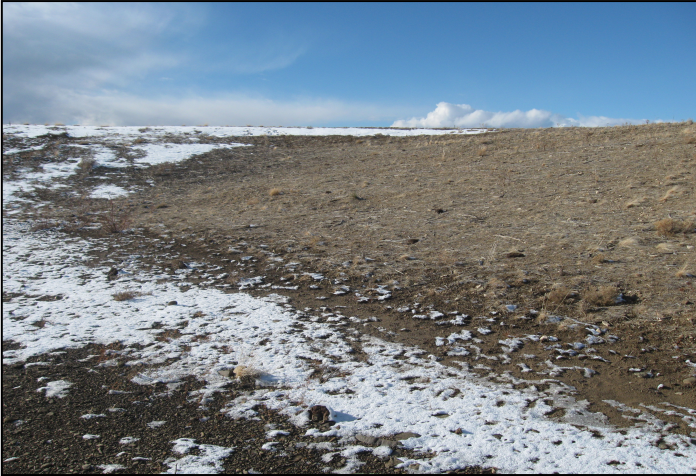
The Winter Ranch Pit is currently in the second term of Temporary Cessation, which will expire on November 26, 2017. According to the Operator, no additional mining will occur. The Division did not observe any equipment or stockpiles at the site. The pit walls have been graded to 3H:1V or flatter; the slopes are stable and did not show any signs of erosion. The Operator has seeded the site several times; however, there is very little vegetation within the reclaimed area. The Operator is encouraged to reseed the site this spring to take advantage of early season moisture. The Operator indicated that seed has been broadcast across the site in the past. The approved Reclamation Plan calls for drill seeding the approved seed mixture, followed by mulching. Any change to the Reclamation Plan, including changes to the seeding method or seed mixture, must be approved through a Technical Revision. A copy of the approved Reclamation Plan has been enclosed with this report for reference. The site is situated within a larger pasture area and is currently being used to graze cattle. The establishment of grass will be aided by keeping cattle from the seeded areas for a minimum of two growing seasons.

1. Northern pit slope.

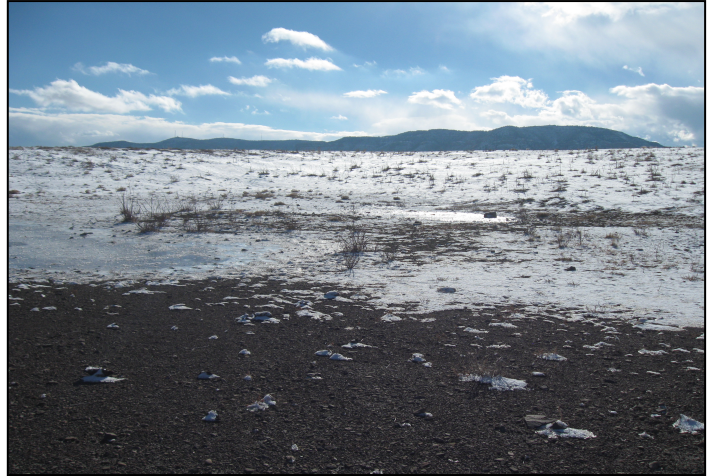
2. Pit floor, photo taken facing west.

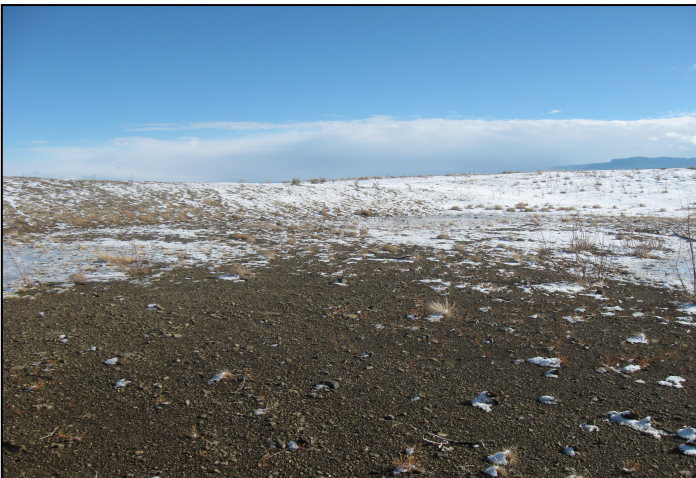
3. Pit floor, photo taken facing south.

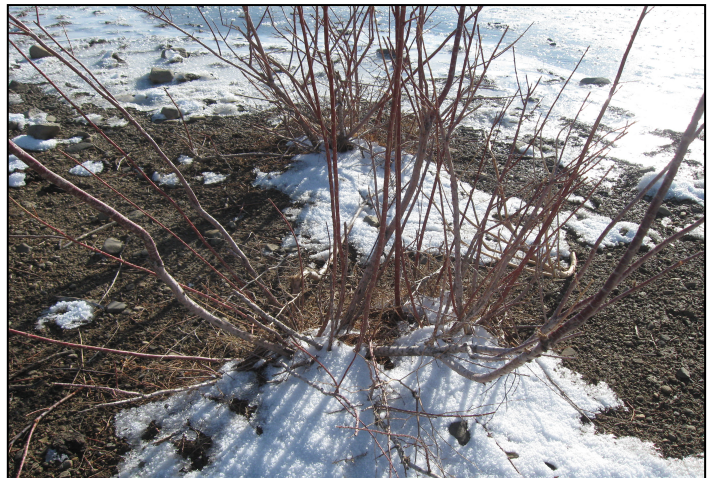
The Division observed several tamarisk plants on the pit floor. The Operator has an approved Weed Control Plan to address the treatment of the tamarisk. The Operator should continue to cut the tamarisk plants and treat the stumps with Arsenal or Habitat. Tamarisk is not present outside of the pit and does not appear to be spreading to surrounding areas. Treatment of tamarisk should occur until the plant has been eliminated from the site.

4. Tamarisk on pit floor.
