MINERALS PROGRAM INSPECTION REPORT

MINE NAME: Canyon Rim Stone Quarry	MINE/PROSPECTING ID#: M-2006-053	MINERAL: Stone	COUNTY: Las Animas
INSPECTION TYPE: Monitoring	INSPECTOR(S): Michael A. Cunningham	INSP. DATE: January 27, 2017	INSP. TIME: 09:00
OPERATOR: Canyon Rim Stone, LLC	OPERATOR REPRESENTATIVE: None	TYPE OF OPERATION: 110c - Construction Limited Impact

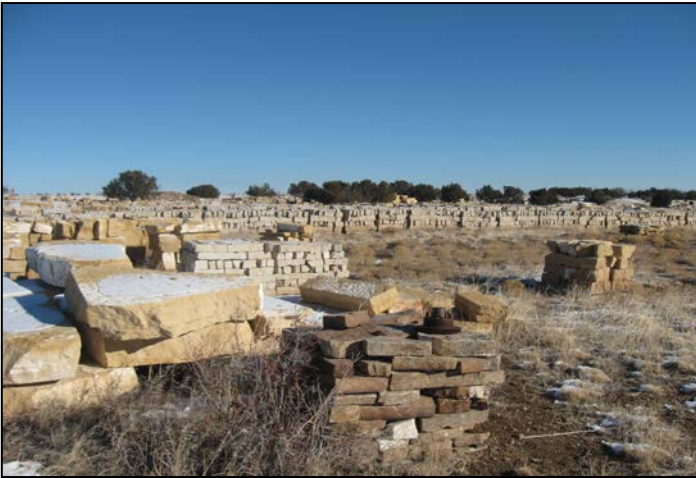
1. Material storage.

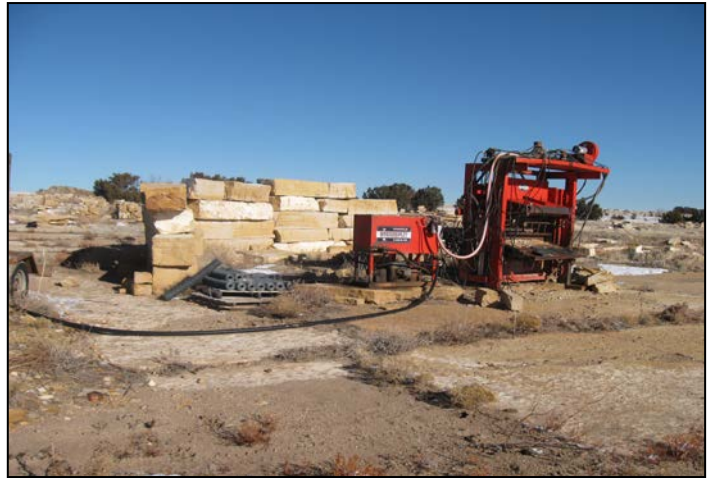
2. Processing area.

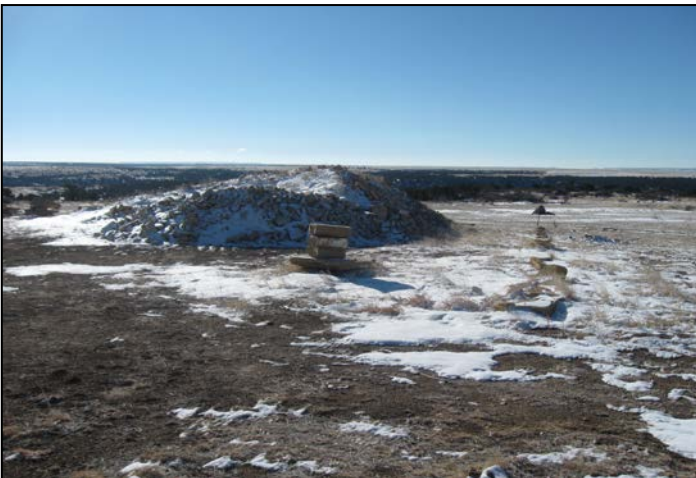
3. Product stockpile.

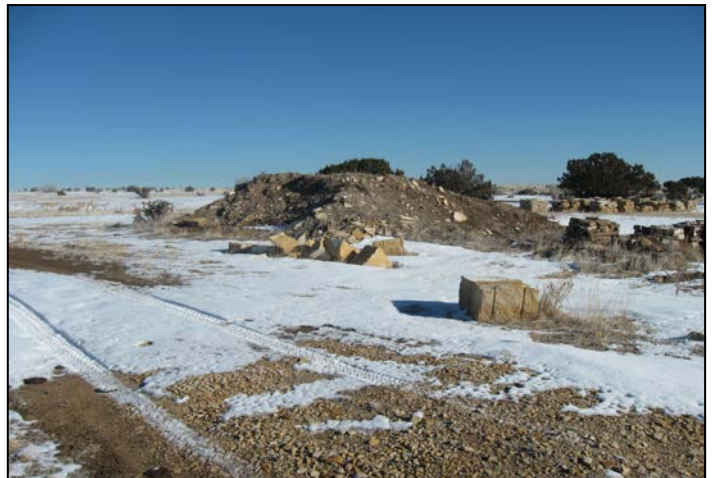
4. Topsoil stockpile.

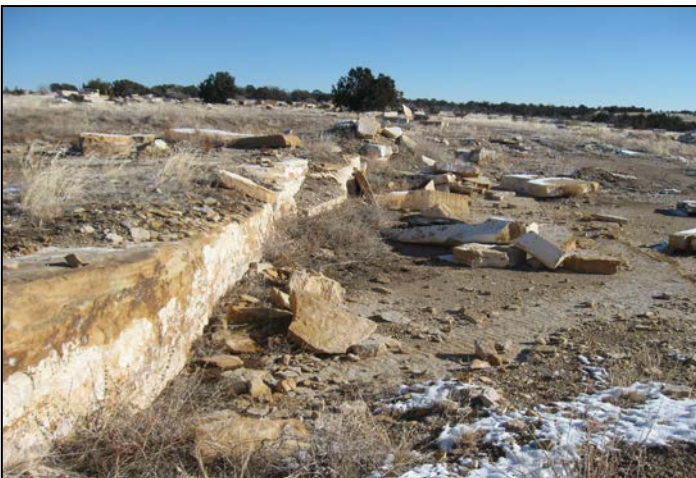
5. Typical bench in quarry.

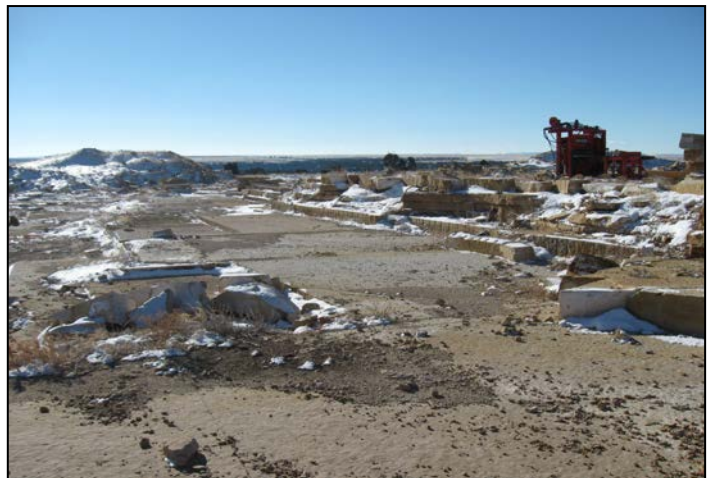
6. Quarry floor.
