MINERALS PROGRAM INSPECTION REPORT
PHONE: (303) 866-3567

MINE NAME: Cresson Project	MINE/PROSPECTING ID#: M-1980-244	MINERAL: Gold	COUNTY: Teller
INSPECTION TYPE: Monitoring	INSPECTOR(S): Elliott R. Russell	INSP. DATE: October 27, 2016	INSP. TIME: 8:00
OPERATOR: Cripple Creek & Victor Gold Mining Company	OPERATOR REPRESENTATIVE: Gary Horton & Erik Munroe	TYPE OF OPERATION: 112d-3 - Designated Mining Operation

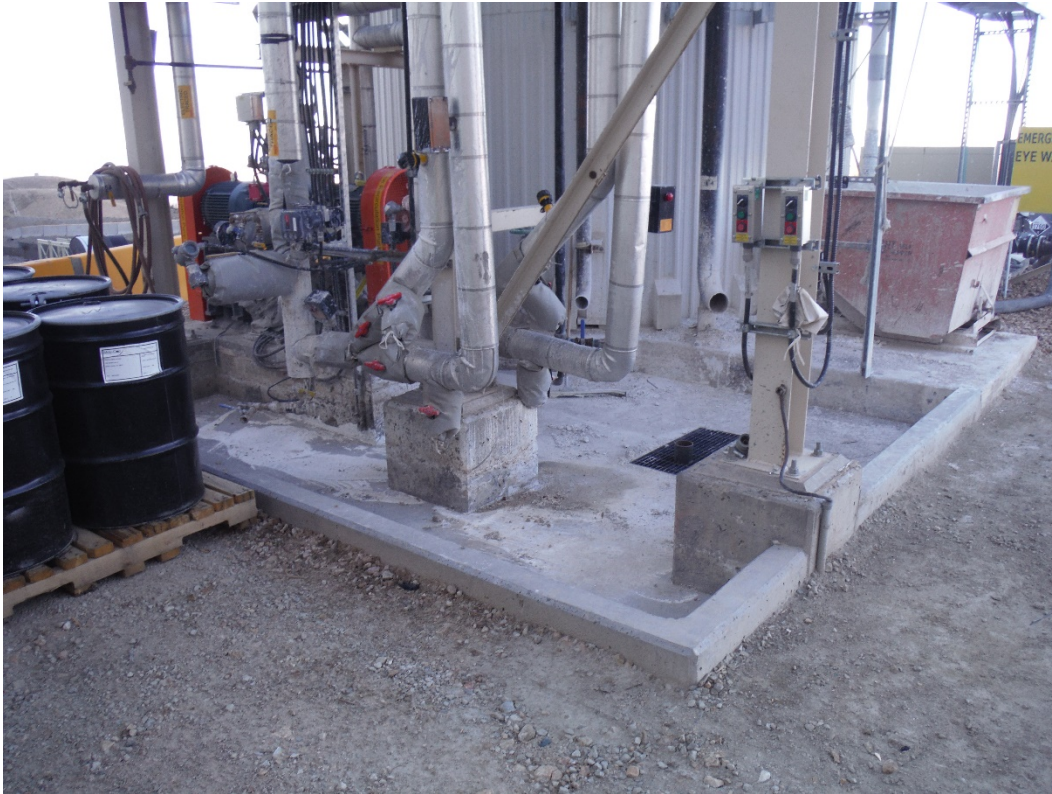
The Division and Mr. Horton were accompanied by Mr. Don Rodabough around the HGM. Mr. Rodabough showed and informed the Division about the recently constructed containment curbing for the lime silo and neutral pH tank (**Photos 1 & 2**). A new pump had been installed for the HGM pad liner and the mill return pipe had been buried while heat tape had been placed on the portions of the pipes exposed to the winter elements. The HGM infiltration trench was backfilled and graded (**Photo 3**).

Photo 1. Containment curbing on lime silo; looking southwest.

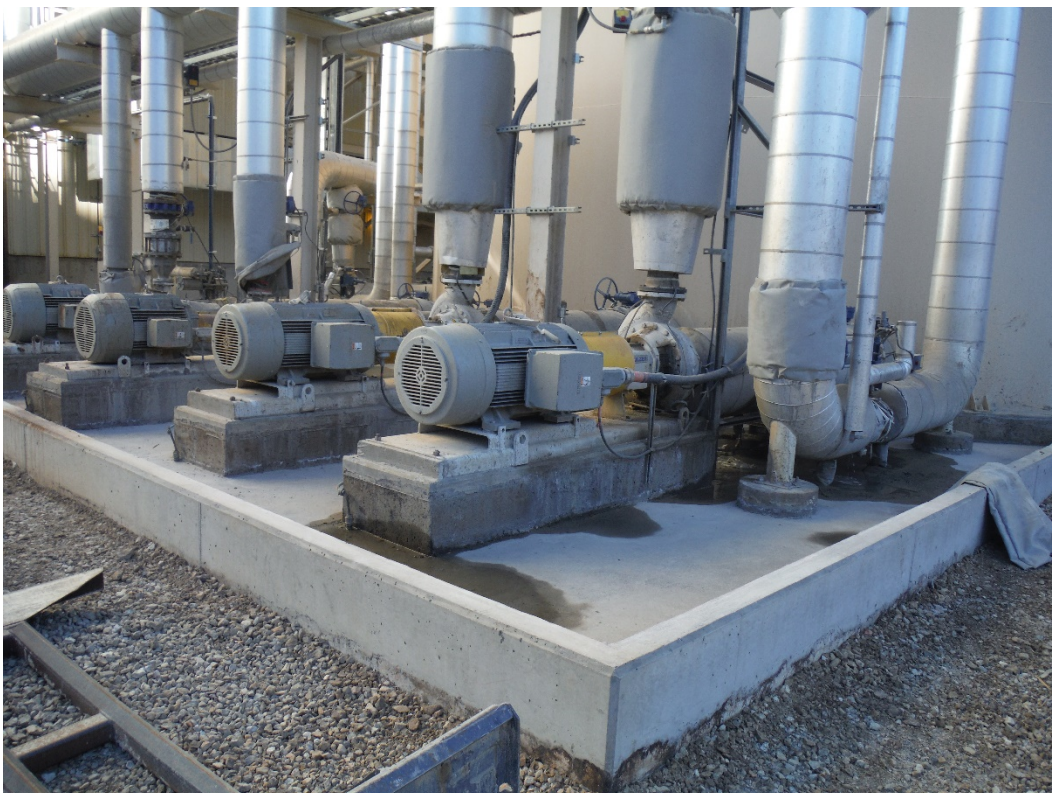
Photo 2. Containment curbing on the neutral pH tank; looking northwest.

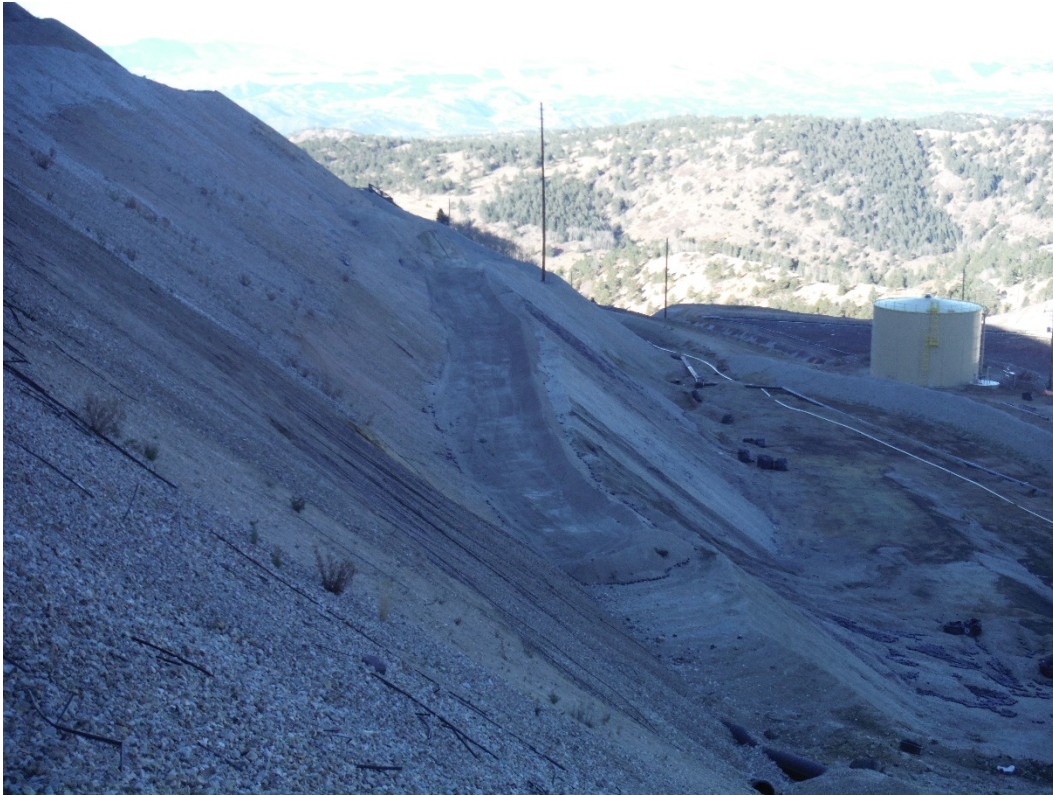
Photo 3. Backfilled and graded HGM infiltration trench; looking west.

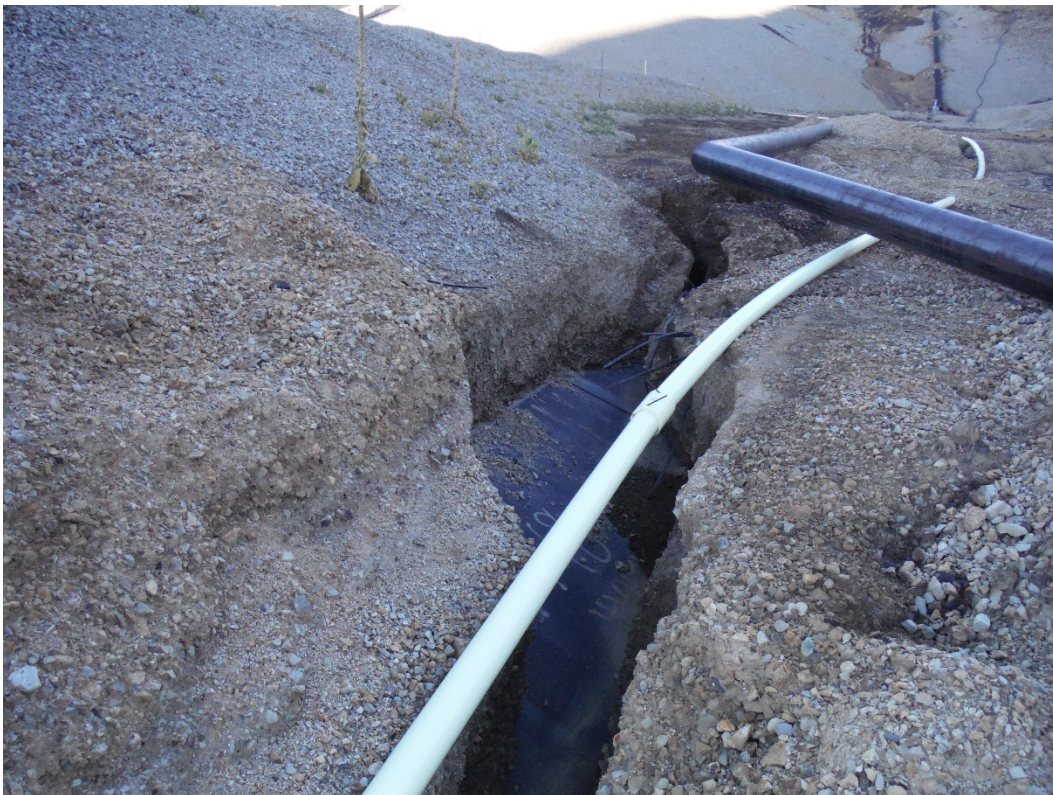
PROBLEM 1: Drain Cover Fill (DCF) has eroded on a northwest portion of the Arequa Gulch Valley Leach Facility and the liner is exposed. The DCF was transported into the trough between the perimeter berm and the toe of the pad, reducing the capacity of this area.

The Division and Mr. Horton inspected the AGVLF. The Division observed an area where Drain Cover Fill (DCF) had been eroded and exposed a small section of the liner (**Photo 4**) near the water tank located southwest of the HGM, in the northwest portion of AGVLF. The DCF was transported to the trough-like area between the VLF perimeter berm/liner and the toe of the heap leach pad. Due to the amount of DCF transported, the capacity of this trough has been reduced from several feet in height to approximately 6" (**Photo 5**). This has been cited as Compliance Problem #1 requiring CC&V to re-establish the trough between the perimeter berm and the toe of the pad, and backfill the exposed liner.

Photos 4. Eroded DCF and exposed liner; looking northeast.

CORRECTIVE ACTIONS: Provide the Division with photographic evidence that erosion feature has been backfilled and the trough appropriately re-established

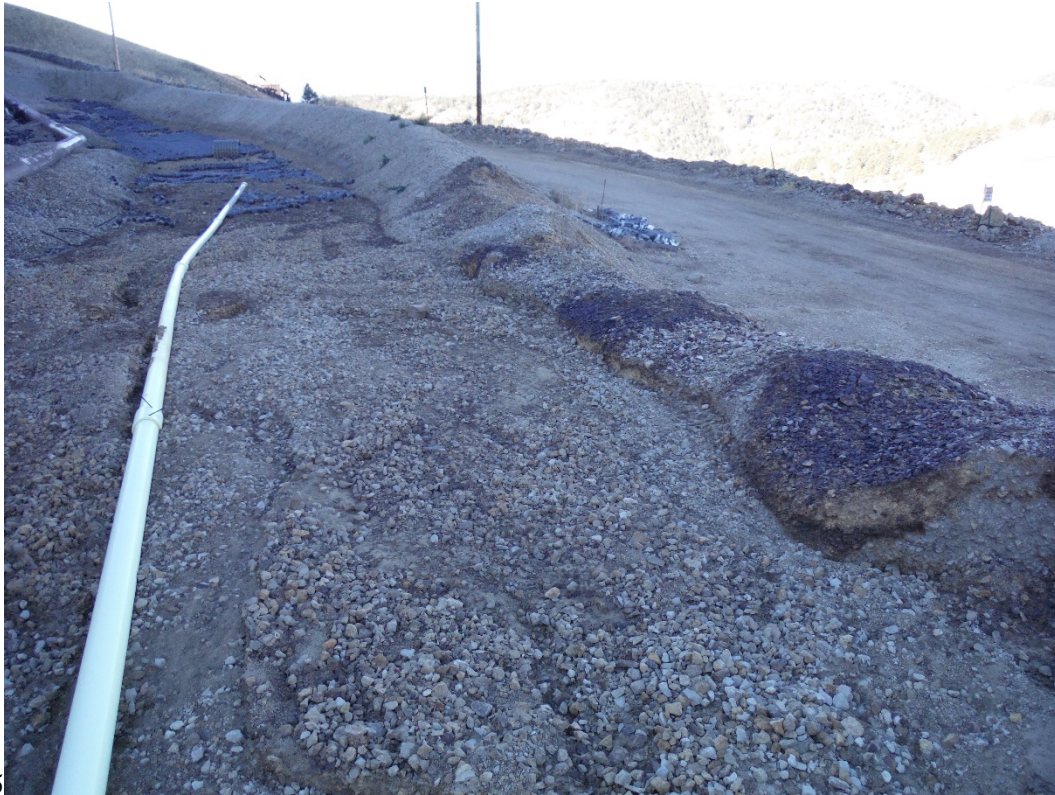
Photo 5. Transported DCF causing limited capacity between perimeter berm (edge of liner) and the VLF's toe; looking southwest.

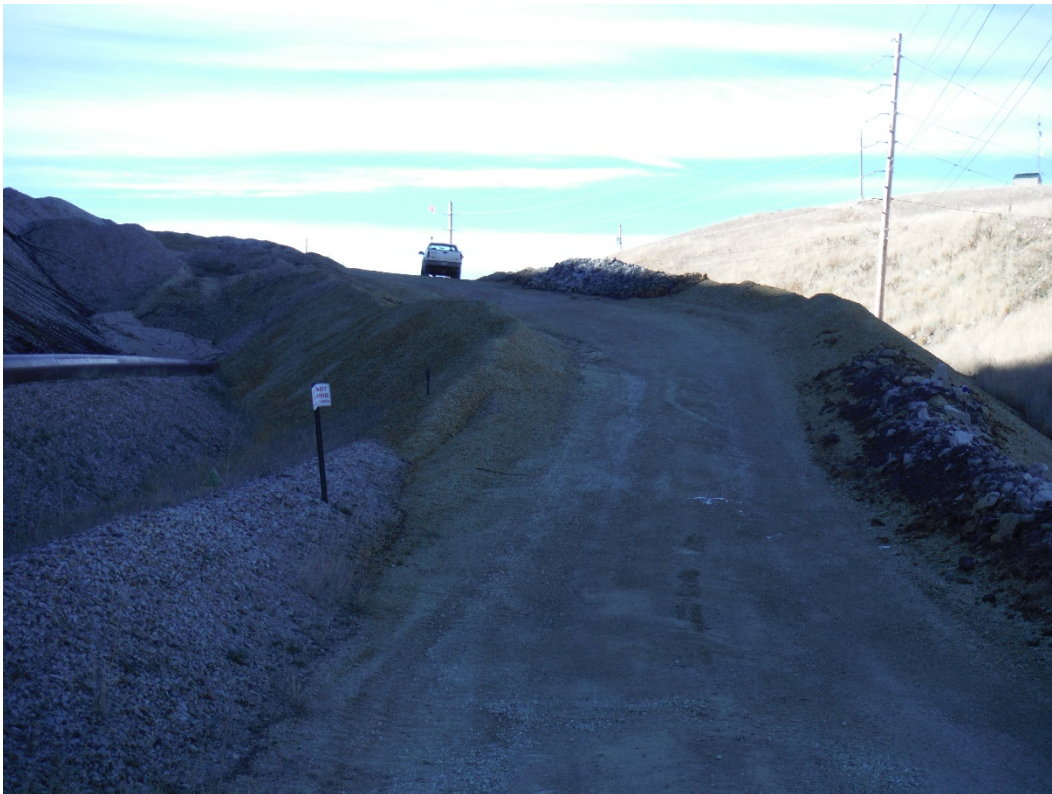
Farther southwest of the area discussed above is another area of concern. The access road which comes from the pad to off-liner crosses the edge of liner in an area that is sloped outward toward the edge of liner (**Photo 6**). The Division will re-inspect this area at a later time to ensure that stormwater from AGVLF stays on the liner system and does not have a change to leave the liner via the access road.

Photos 6. Northwestern AGVLF access road which crosses from pad to off-liner; looking southwest.

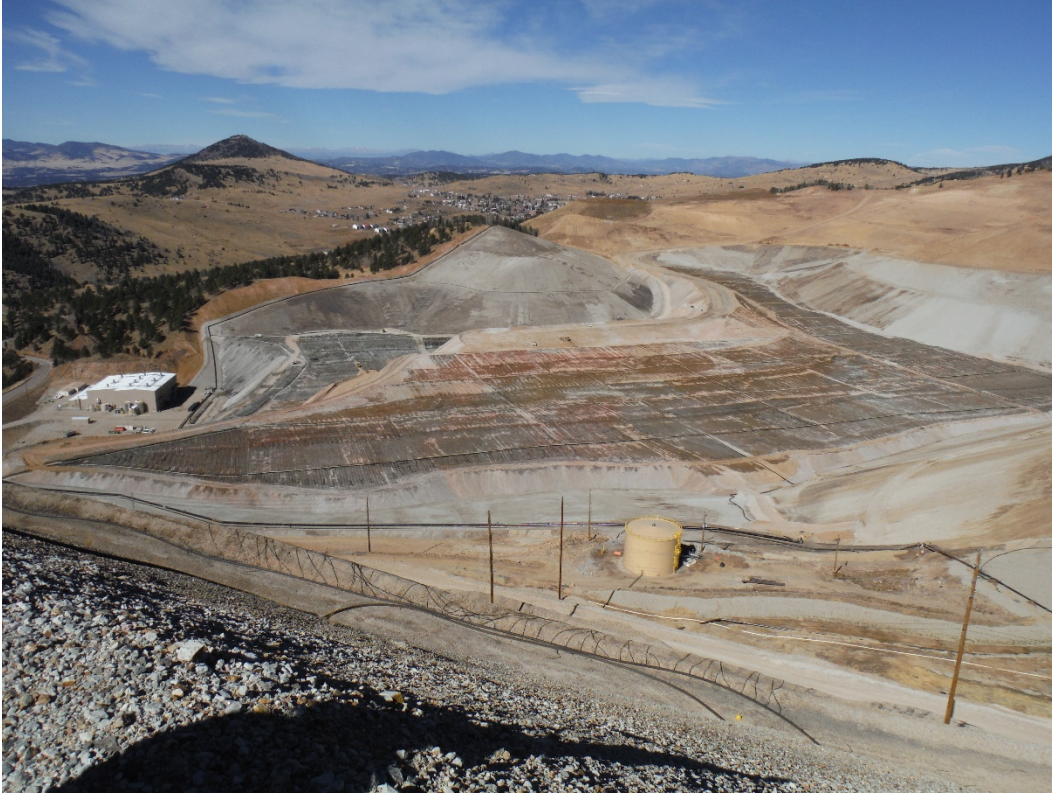
The Division and Mr. Horton inspected the SGVLF (**Photo 7**). There was no longer any standing solution in the area where a Compliance Problem was cited following the August 18, 2016 inspection. The Division observed the new Edge

Photo 7. Overview of the SGVLF; looking northwest.

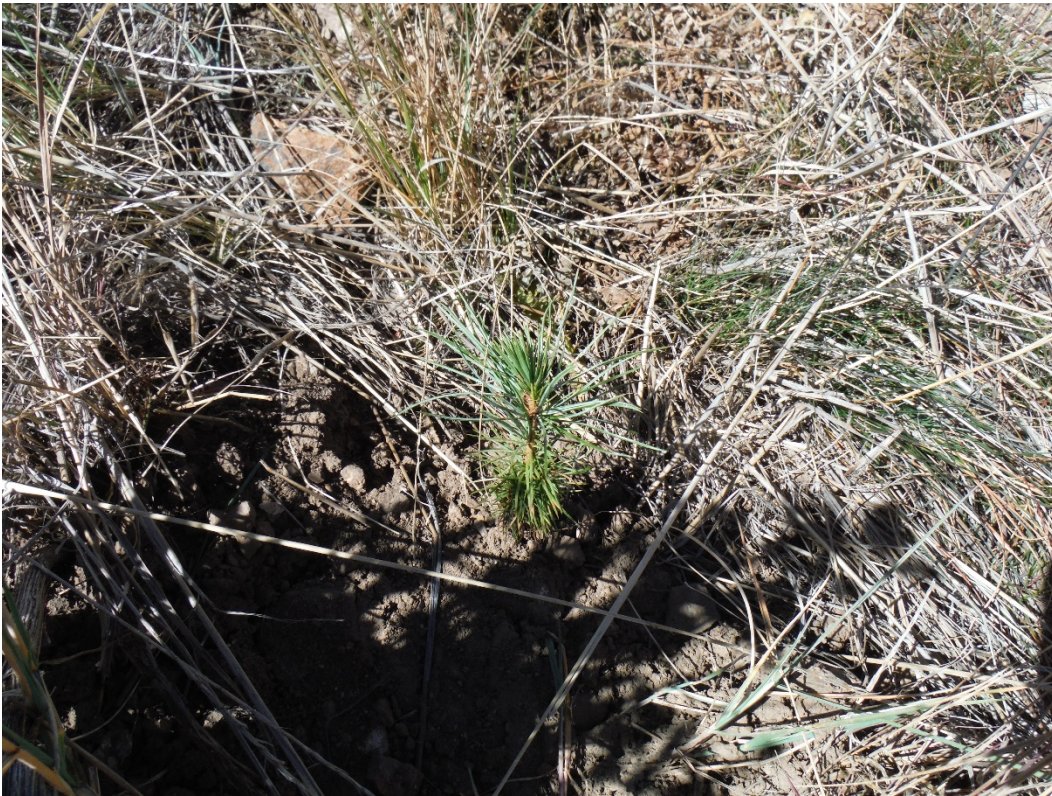
The Division and Mr. Munroe inspected portions of the Altman Backfill which were in various stages of reclamation. Bristlecone pine tree seedlings had recently been planted on the easterly aspect on areas just above the old access road to the American Eagles Overlook (**Photos 8 & 9**). The trees are marked with small flags to help locate them while watering. Mr. Munroe explained that these seedlings were grown from seeds that were locally harvested. The upper portion of the Altman Backfill had recently been seeded and vegetation is beginning to establish. The Division observed minor erosion in this area, but expects the vegetation will stabilize this area within the next growing season or two. The Division observed large area that had yet to be backfilled and graded near the interface of the backfill and native ground (**Photo 10**).

Photo 8. Bristlecone pine tree seedling on the Altman-Backfill; looking north.

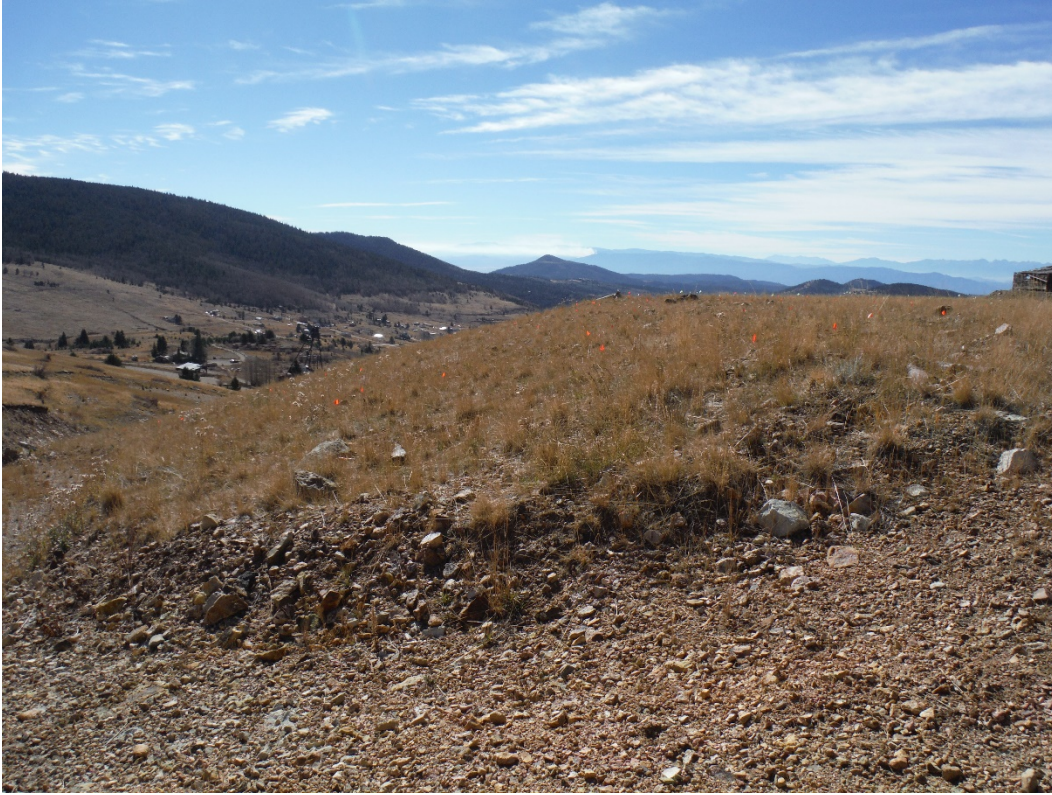
Photo 9. Bristlecone pine tree seedling on the Altman-Backfill; looking south.

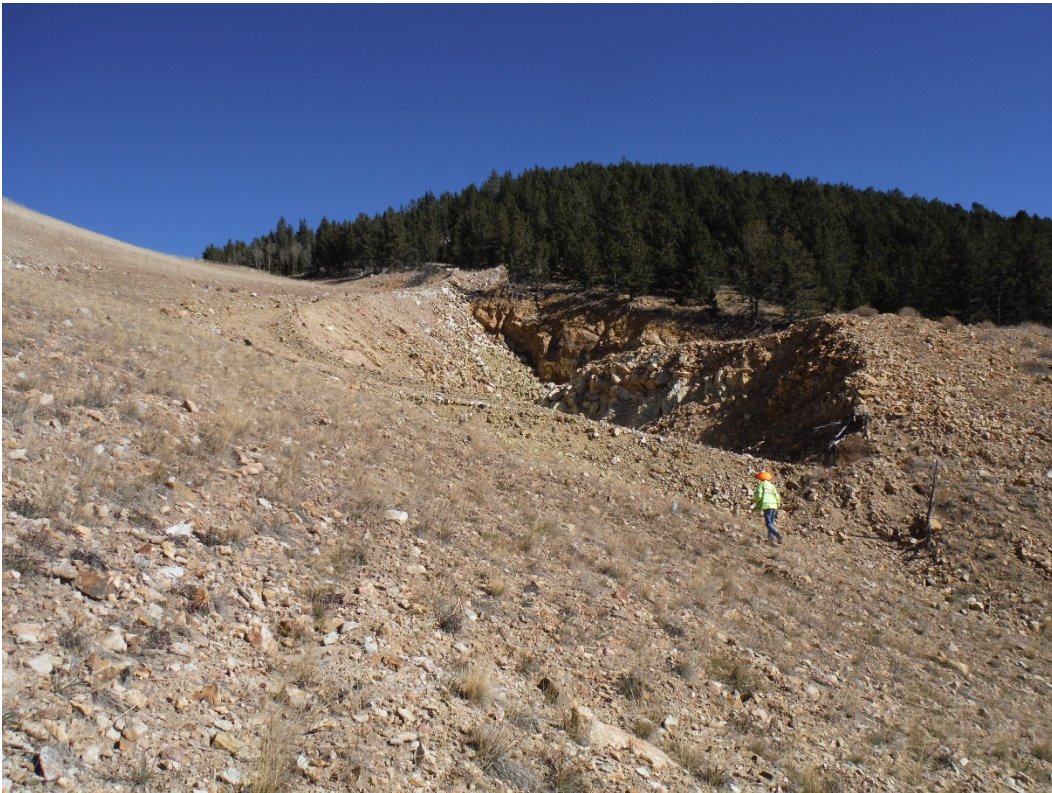
Photo 10. Area needing to be backfilled and graded; looking northeast.

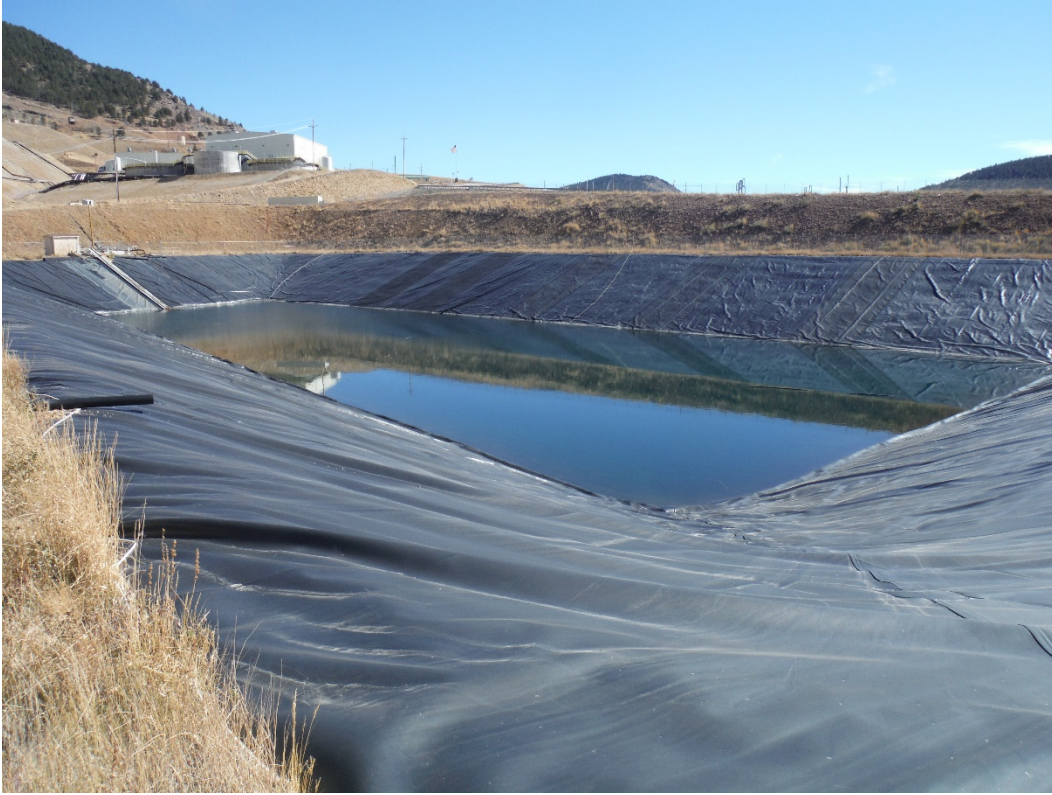
Farther west of the ADADR and PSES is the External Storage Pond (ESP). The ESP was constructed in the early 2000s to provide approximately 20 million gallons of additional storage capacity beyond what is provided in the Pregnant Solution Storage Ponds (PSSA). The ESP is similarly constructed as a PSSA with a triple-lined containment system with leak detection. The ESP was inspected and the liner showed no signs of wear or damage (**Photo 11**). At 12:41pm the Division recoded the following readings: water level at 6.8 feet, Pump XDCR #1-EXT (AUTO) at 11.8 inches, and Pump XDCR #2-EXT (AUTO) at 17.5 inches. Mr. Ballard stated he thought the pond was last used in 2013. Hydrogen peroxide is used to destruct the cyanide in the solution prior being routed to the ESP.

Photo 11. External Storage Pond; looking southeast.
