COLORADO DIVISION OF RECLAMATION, MINING AND SAFETY MINERALS PROGRAM INSPECTION REPORT

MINE NAME:	MINE/PROSPECTING ID#:	MINERAL:	COUNTY:
Rocky Ford East Pit	M-1977-560	Sand and gravel	Otero
INSPECTION TYPE:	INSPECTOR(S):	INSP. DATE:	INSP. TIME:
Partial Release Inspection	Amy Eschberger, Wally Erickson	May 13, 2016	10:00
OPERATOR:	OPERATOR REPRESENTATIVE:	TYPE OF OPERATION:	
VALCO, INC.	Tom Brubaker and Steve O'Brian	112c - Construction Regular Operation

This inspection of the Rocky Ford East Pit (Permit No. M-1977-560) was conducted by Amy Eschberger and Wally Erickson of the Division of Reclamation, Mining and Safety (Division) in response to an Acreage Reduction request (Revision No. AR-01) submitted by the operator on April 29, 2016. Mr. Tom Brubaker represented the operator, Valco, Inc. during the inspection. Mr. Steven O'Brian of Environment, Inc. was also present for the inspection. The site is located approximately 1.5 miles east of Rocky Ford, Colorado, just north of and adjacent to Hwy 50. The permit area is divided into two parcels by Co Rd 22, giving a western parcel comprised of 71.83 acres where mining activities first occurred on site, and a larger eastern parcel co

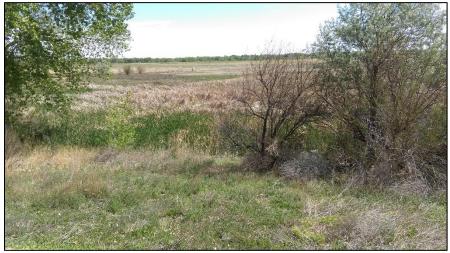
The Division observed the northern release area of 4.48 acres. This area appeared to have never been disturbed by the operation, with vegetative cover consisting of mature trees and well-established native grasses and forbs (**Photos 1 and 2**). A two-string wire fence separates the northern release area from the rest of the permit area until it reaches the corner posts at the western edge of the Crystal Drainage Ditch. At this point, the southern boundary of the northern release area follows the southern edge of the Crystal Drainage Ditch (**Photo 3**). The Division observed a few small cuts and old waste rock stockpiles present in the northern portion of the site (**Photo 4**) which will remain in the permit area to be reclaimed.

Photo 1. View looking north, showing northern release area for AR-01.

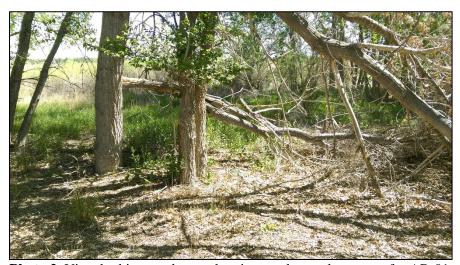
Photo 2. View looking northeast, showing northern release area for AR-01.

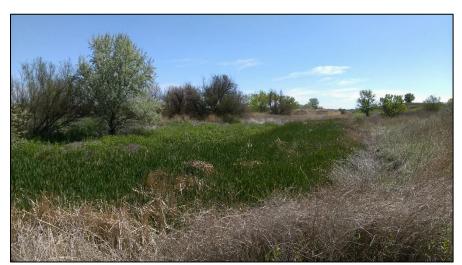
Photo 3. View looking northeast, showing Crystal Drainage Ditch (green area at center). Northern permit boundary follows southern edge of ditch (at right).

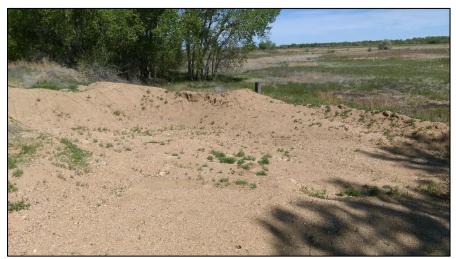
Photo 4. View looking northwest, showing disturbed area at northern edge of site to remain in permit area.

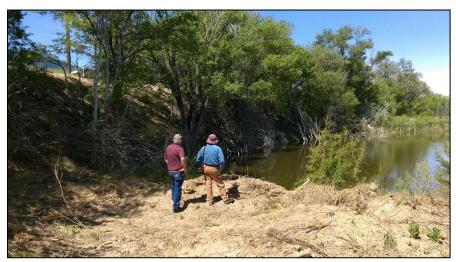
The Division observed the southern release area of 27.38 acres, including the pre-law disturbed southern shoreline of the small pond and eastern shoreline of the larger pond, the pre-law disturbed southwestern edge of the permit area, and the reclaimed southern shoreline of the larger pond. The southern shoreline of the small pond has slope gradients of approximately 1H:1V to 2H:1V, with mature trees growing along the pond edge (**Photo 5**). According to the approved permit materials, this shoreline of the smaller pond was disturbed before the site was permitted, and would not be redisturbed by the operation. The approved reclamation plan calls for leaving this portion of the pond as-is as long as it was not redisturbed.

Photo 5. View looking southwest, showing pre-law disturbed southern shoreline of small pond released in AR-01.

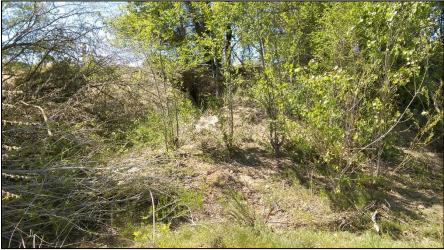
Photo 6. View looking south, showing pre-law disturbed portion of land connecting two ponds released in AR-01.

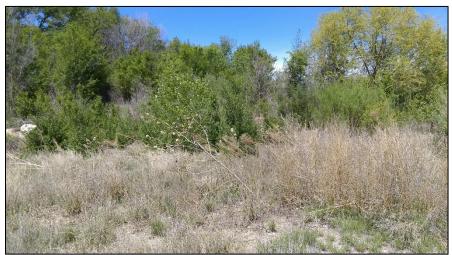
The Division observed the sliver of land connecting the small pond to the larger pond, the southern edge of which was proposed for release. This area was also disturbed prior to the site being permitted and was not redisturbed by the operation. This area appeared to be stable with vegetative cover consisting of native grasses, forbs, and cottonwood trees (**Photo 6**). The portion of pre-law disturbed land located west of the small pond was also covered with native grasses and forbs, with mature trees growing along the southern fenceline (**Photos 7 and 8**).

Photo 7. View looking south, showing pre-law disturbed portion of land west of small pond released in AR-01.

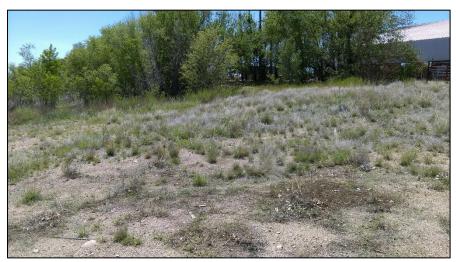
Photo 8. View looking southeast, showing pre-law disturbed portion of land west of small pond released in AR-01.

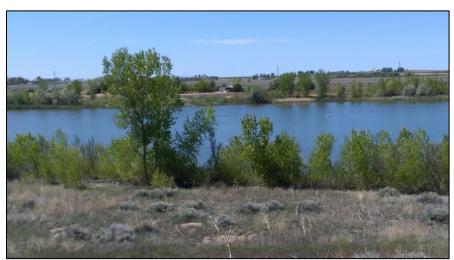
The Division observed the reclaimed southern shoreline of the larger pond. The slopes along this shoreline appeared to be graded to flatter than 3H:1V, with various grasses, shrubs, and trees established across the slopes (**Photos 9 and 10**). This area appears to have been reclaimed many years ago. The pre-law disturbed eastern shoreline had slope gradients of approximately 2H:1V to 3H:1V, and also exhibited a well-established stand of grasses, shrubs, and several trees (**Photos 11 and 12**). The southern release area includes 17.4 acres of exposed groundwater, so the revised permit boundary will cut across the ponds. The Division discussed with the operator the possibilities for adequately delineating the revised southern permit boundary, including placing a buoy at the boundary corner located near the center of the larger pond. The other boundary corners are on land, and could be easily marked with stakes.

Photo 9. View looking south from northern edge of larger pond, showing reclaimed southern shoreline released in AR-01.

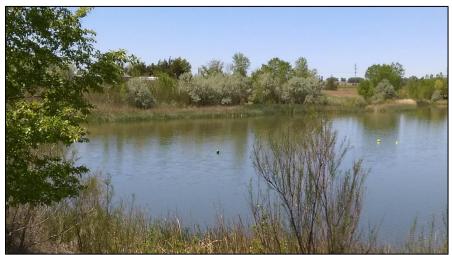
Photo 10. View looking southwest from eastern edge of larger pond, showing reclaimed southern shoreline released in AR-01.

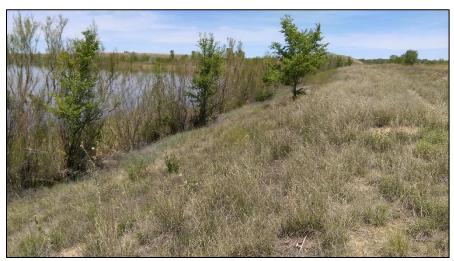
Photo 11. View looking north across pre-law disturbed eastern shoreline of larger pond released in AR-01.

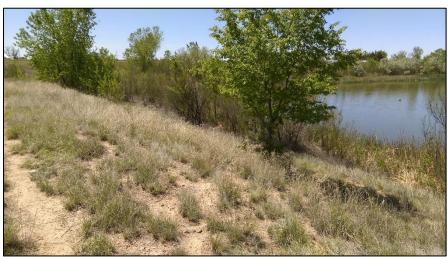
Photo 12. View looking south across pre-law disturbed eastern shoreline of larger pond released in AR-01.
