MINERALS PROGRAM INSPECTION REPORT
PHONE: (303) 866-3567

MINE NAME: Camenish Borrow	MINE/PROSPECTING ID#: M-2006-078	MINERAL: Sand and gravel	COUNTY: Weld
INSPECTION TYPE: Monitoring	INSPECTOR(S): Peter S. Hays	INSP. DATE: February 17, 2017	INSP. TIME: 11:30
OPERATOR: Flatiron Constructors, Inc.	OPERATOR REPRESENTATIVE: John Lamb	TYPE OF OPERATION: 111 - Construction by Government Agency	
REASON FOR INSPECTION: Normal I&E Program	BOND CALCULATION TYPE: Partial Bond	BOND AMOUNT: \$127,000.00	
DATE OF COMPLAINT: NA	POST INSP. CONTACTS: None	JOINT INSP. AGENCY: None	
WEATHER: Clear	INSPECTOR'S SIGNATURE:

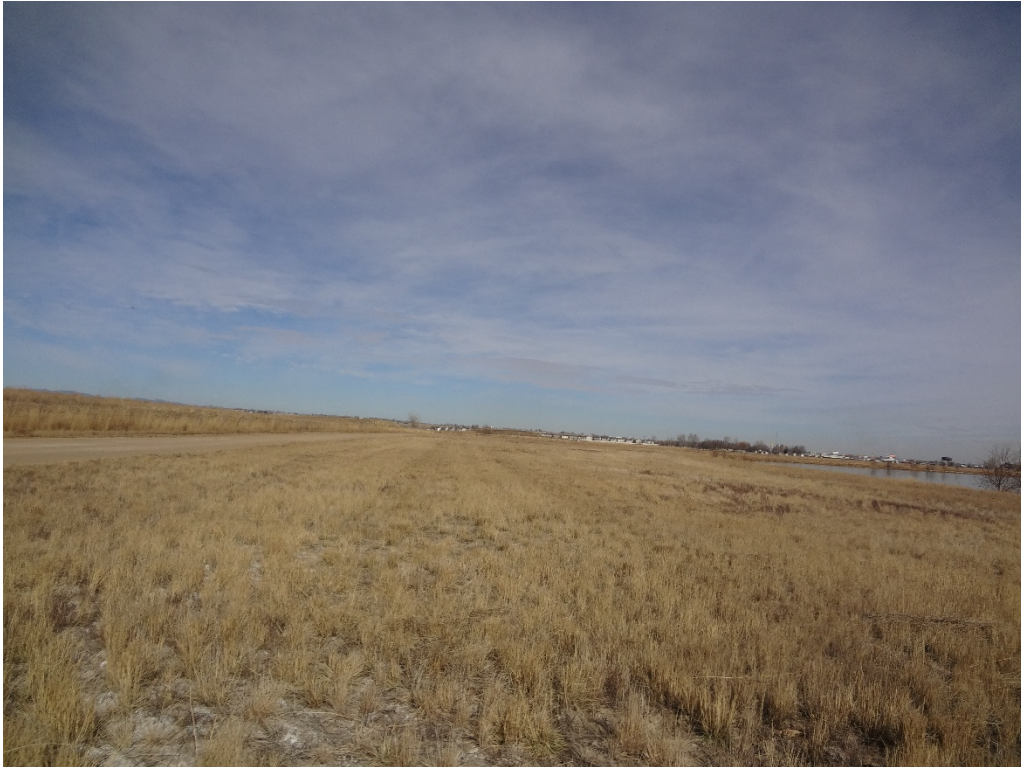
View of west shoreline from the SW corner looking north

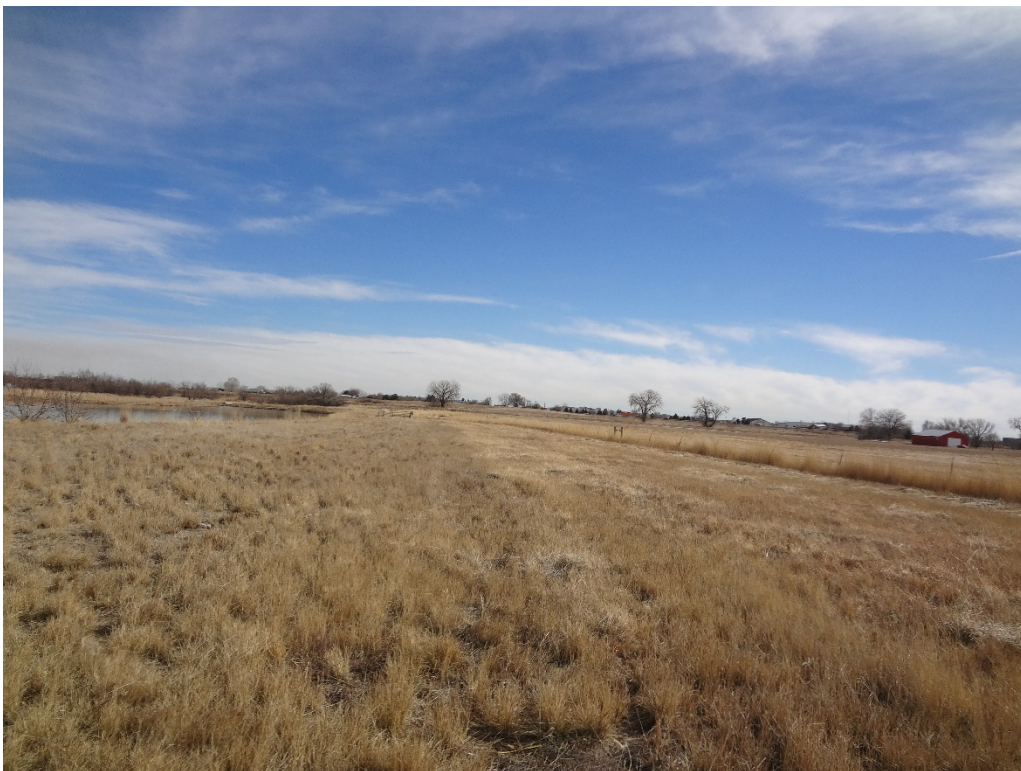
View of south shoreline from the SW corner looking north

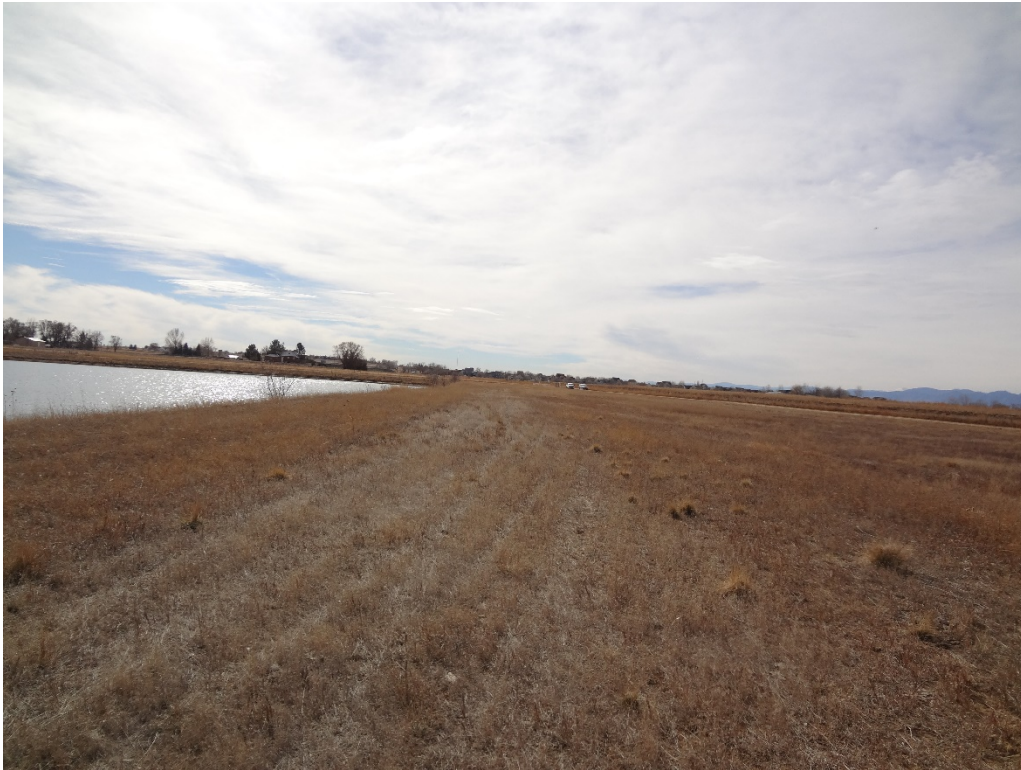
View of west shoreline from the NW corner looking south

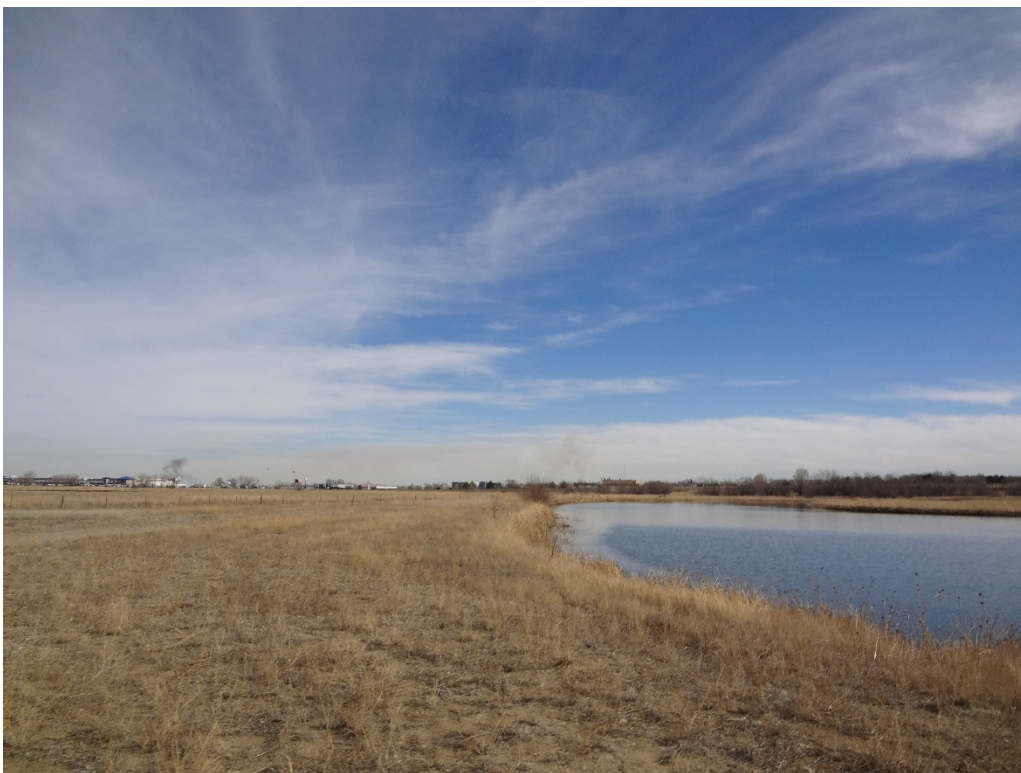
View of north shoreline from the NW corner looking east

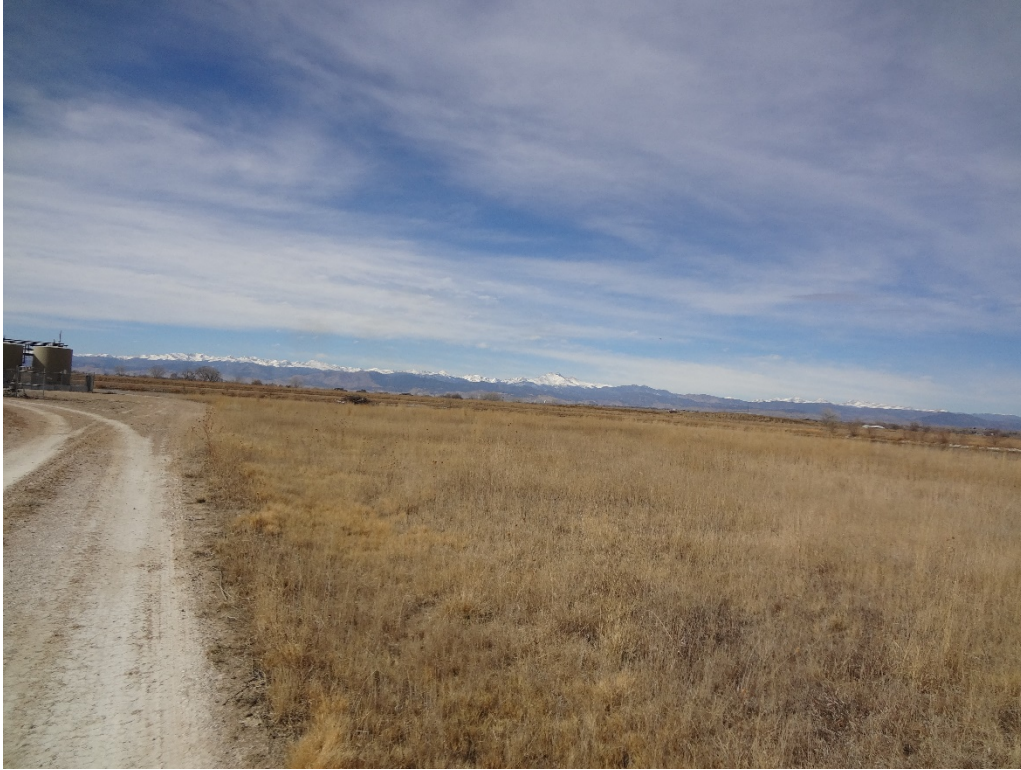
The site vegetation was well established and consisted of several varieties of wheatgrasses and brome grass. The grasses were recently mowed. The site was stable and no erosion features were observed during the inspection. The Division recommends the Operator submit a final release request for the site in the spring when the vegetation is green, if the groundwater augmentation issue has been resolved satisfactorily. A copy of the request for full release of permit area form is attached.

View of vegetation north of oil and gas road looking west

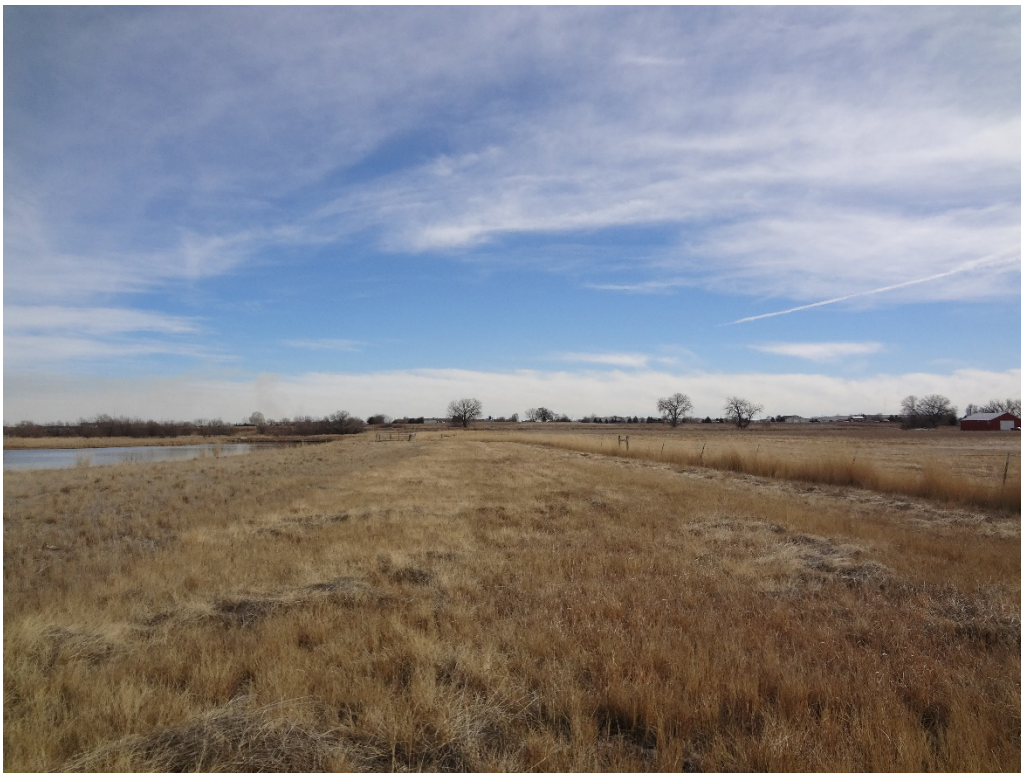
View of south shoreline vegetation looking east
