**MINERALS PROGRAM INSPECTION REPORT**  
**PHONE: (303) 866-3567**

<b>MINE NAME:</b> Schumacher II	<b>MINE/PROSPECTING ID#:</b> M-2001-018	<b>MINERAL:</b> Gravel	<b>COUNTY:</b> Logan
<b>INSPECTION TYPE:</b> Monitoring	<b>INSPECTOR(S):</b> Jared L. Ebert	<b>INSP. DATE:</b> February 15, 2017	<b>INSP. TIME:</b> 12:00
<b>OPERATOR:</b> Nienhueser Construction & Excavating Co	<b>OPERATOR REPRESENTATIVE:</b> None	<b>TYPE OF OPERATION:</b> 110c - Construction Limited Impact	
<b>REASON FOR INSPECTION:</b> Normal I&E Program	<b>BOND CALCULATION TYPE:</b> IT.Bondcalculationtype.CD.Desc	<b>BOND AMOUNT:</b> \$16,470.90	
<b>DATE OF COMPLAINT:</b> NA	<b>POST INSP. CONTACTS:</b> None	<b>JOINT INSP. AGENCY:</b> None	
<b>WEATHER:</b> Clear	<b>INSPECTOR'S SIGNATURE:</b>

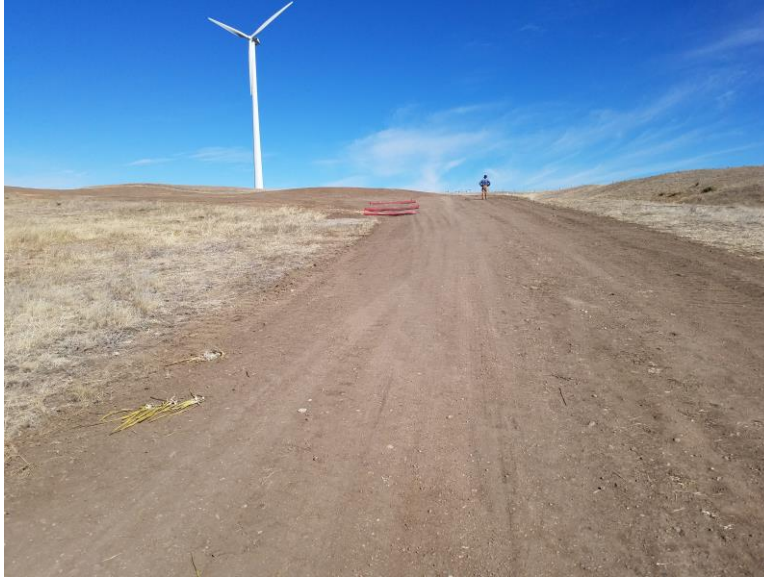
**Figure 1. From the access road looking northeast.**

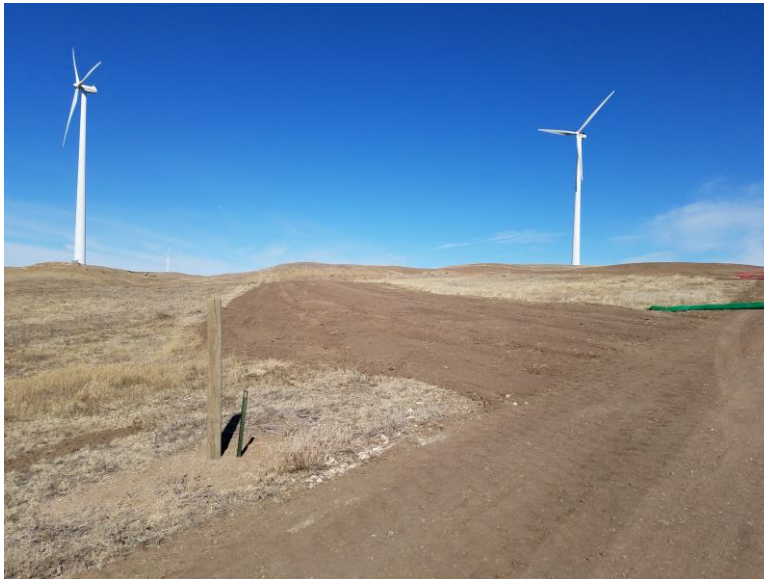
**Figure 2. Former topsoil stockpile area.**

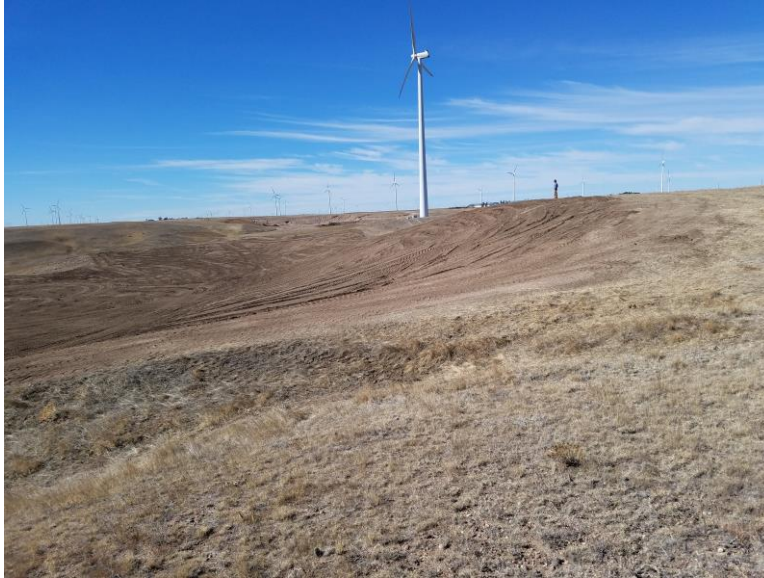
**Figure 3. From the northeast corner of the affected area looking west.**
