MINERALS PROGRAM INSPECTION REPORT

MINE NAME: Thorson Mine	MINE/PROSPECTING ID#: M-1981-020	MINERAL: Anhydrite, gypsum	COUNTY: Fremont
INSPECTION TYPE: Monitoring	INSPECTOR(S): Timothy A. Cazier	INSP. DATE: February 16, 2017	INSP. TIME: 13:50
OPERATOR: Indian Springs Ranch, LLP	OPERATOR REPRESENTATIVE: Ina Finch	TYPE OF OPERATION: 110c - Construction Limited Impact	
REASON FOR INSPECTION: Normal I&E Program	BOND CALCULATION TYPE: Partial Bond	BOND AMOUNT: \$2,500.00	
DATE OF COMPLAINT: NA	POST INSP. CONTACTS: None	JOINT INSP. AGENCY: None	
WEATHER: Clear	INSPECTOR'S SIGNATURE:

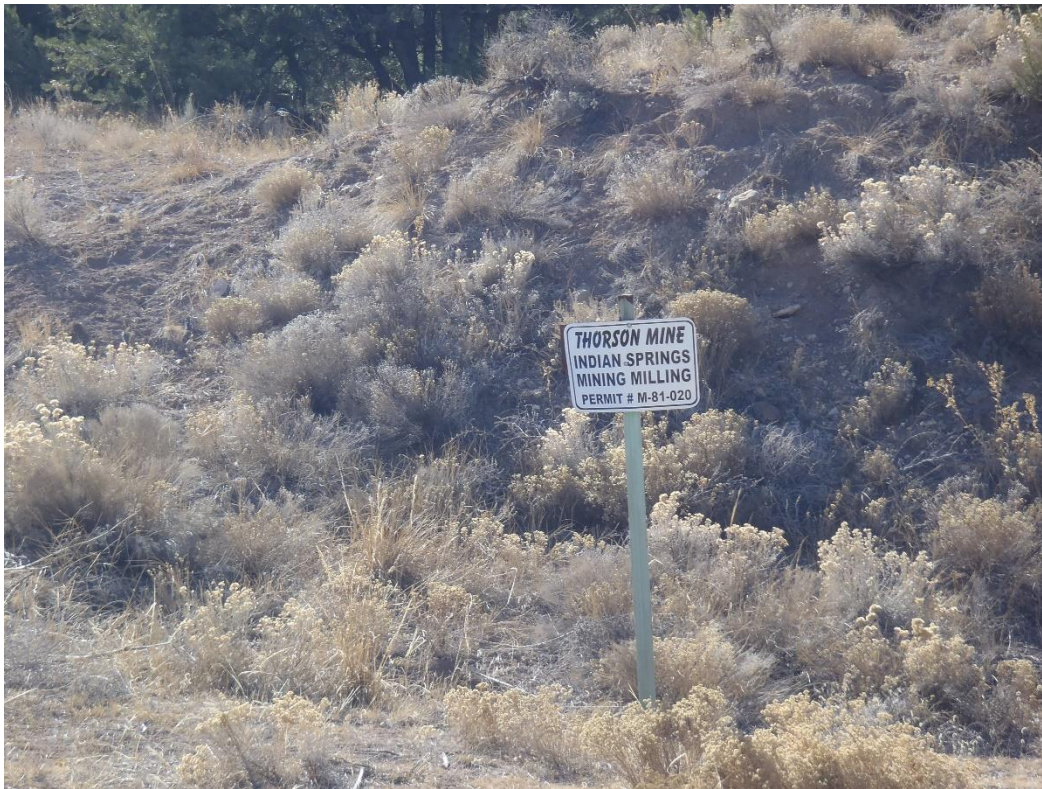
Markers & Boundary – A permit sign was displayed at the site entrance (see **Photo 1**).

Photo 1. Permit sign.

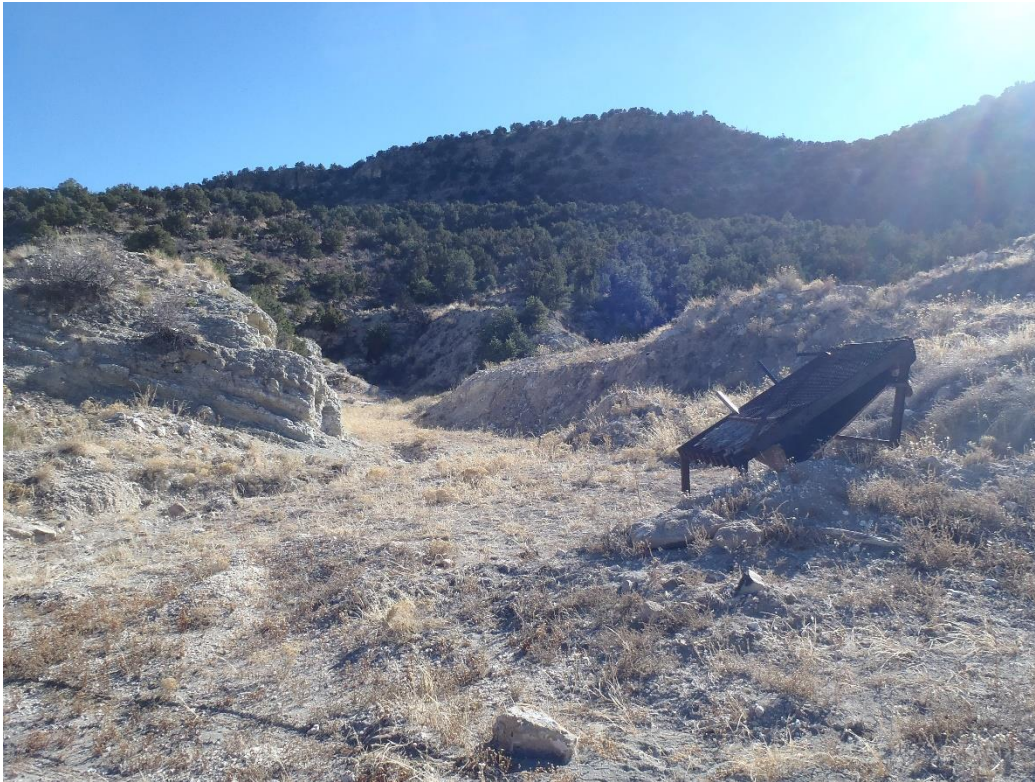
Mining Plan – No deviations from the approved mining plan were observed. Ms. Finch indicated no mining activity had occurred since the previous inspection (on September 26, 2012). Some backfilling or grading to knock down the short highwalls (see **Photo 2**) may be required for final reclamation. A small screen and conveyor were also observed (see **Photo 3**).

Photo 2. Most recent active area & screen (looking SE).

Reclamation – Ms. Finch indicated they have not seeded any areas, but much of the site exhibits some level of self/natural revegetation. The Operator should be aware that in accordance with the approved reclamation plan, the excavated areas of the mine are to be graded to match the natural slopes that vary between 2H:1V and 4H:1V.

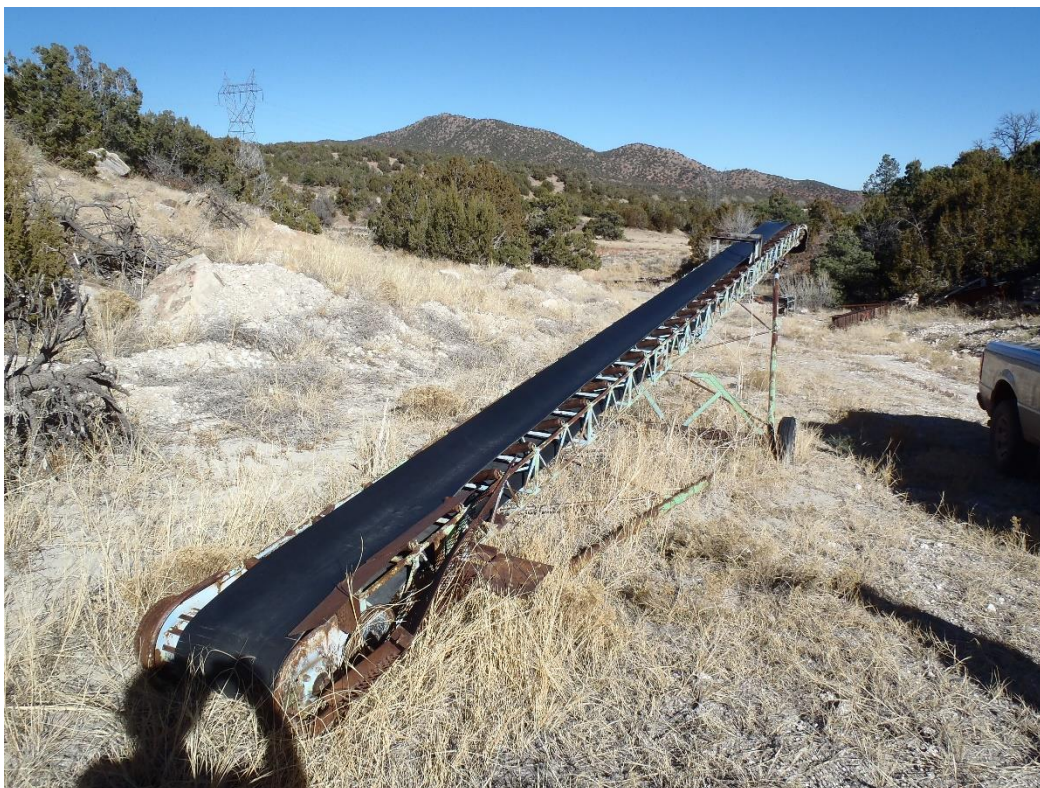
Photo 3. Conveyor.
