**MINERALS PROGRAM INSPECTION REPORT****PHONE: (303) 866-3567**

<b>MINE NAME:</b> Ard Property Borrow	<b>MINE/PROSPECTING ID#:</b> M-2017-002	<b>MINERAL:</b> Borrow material	<b>COUNTY:</b> Weld
<b>INSPECTION TYPE:</b> Monitoring	<b>INSPECTOR(S):</b> Peter S. Hays	<b>INSP. DATE:</b> March 2, 2017	<b>INSP. TIME:</b> 09:00
<b>OPERATOR:</b> Ames Construction, Inc.	<b>OPERATOR REPRESENTATIVE:</b> None	<b>TYPE OF OPERATION:</b> 111 - Construction by Government Agency

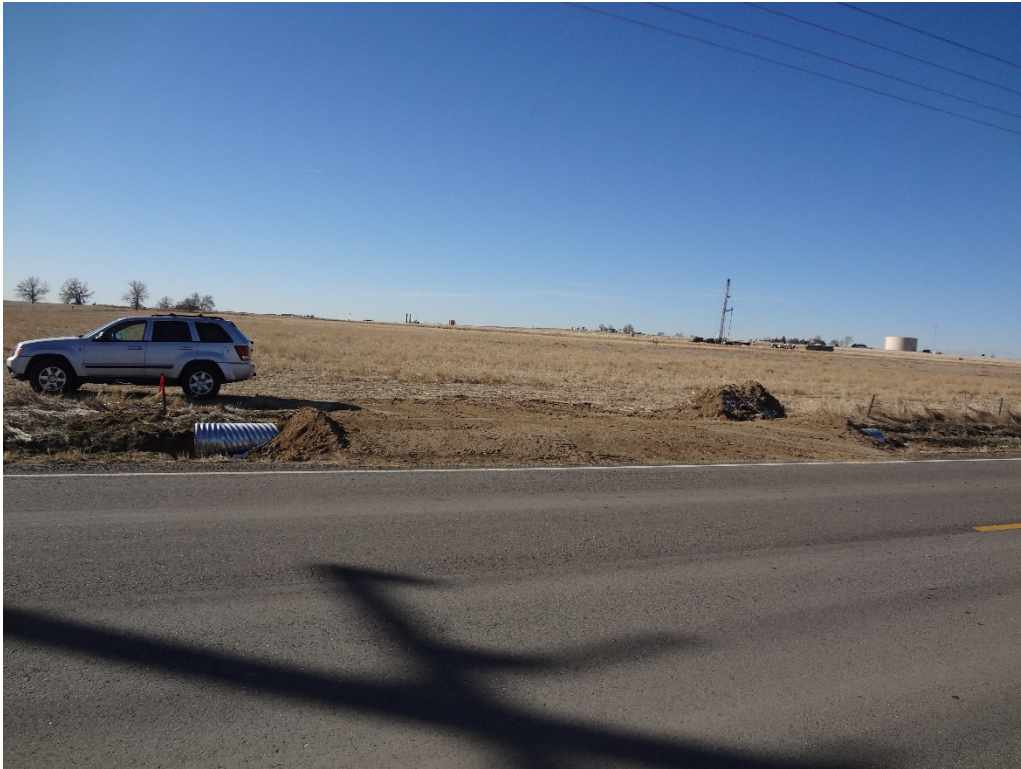
Ard Property Borrow 111 site entrance from WCR 50

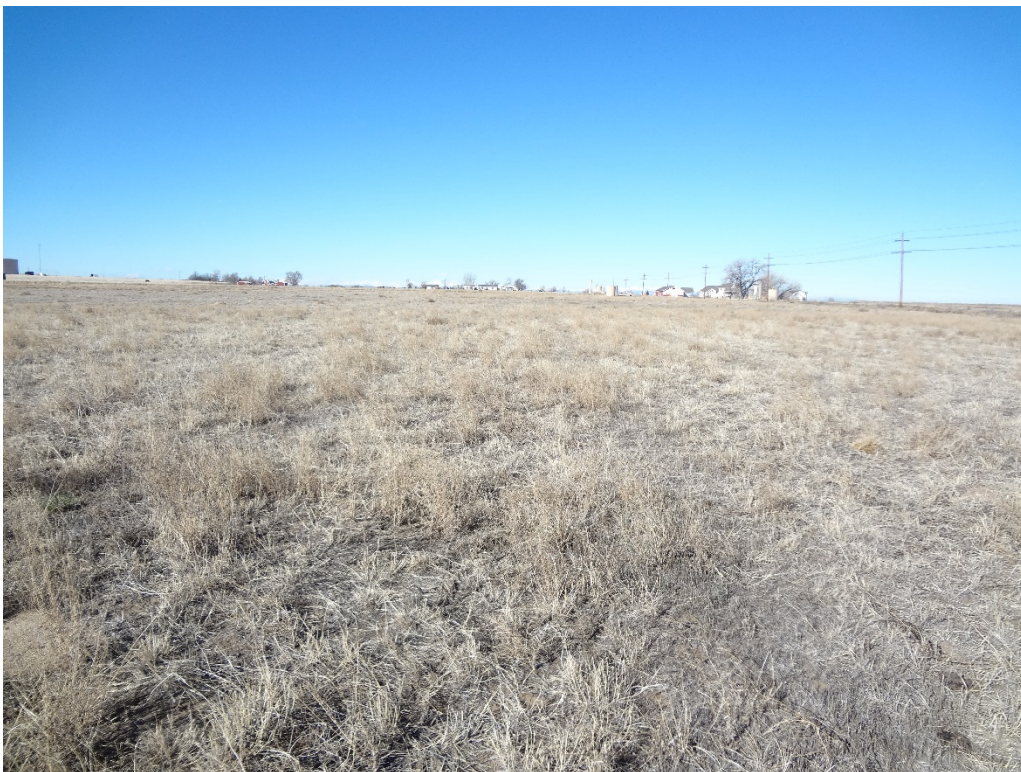
View of site from NE corner looking west

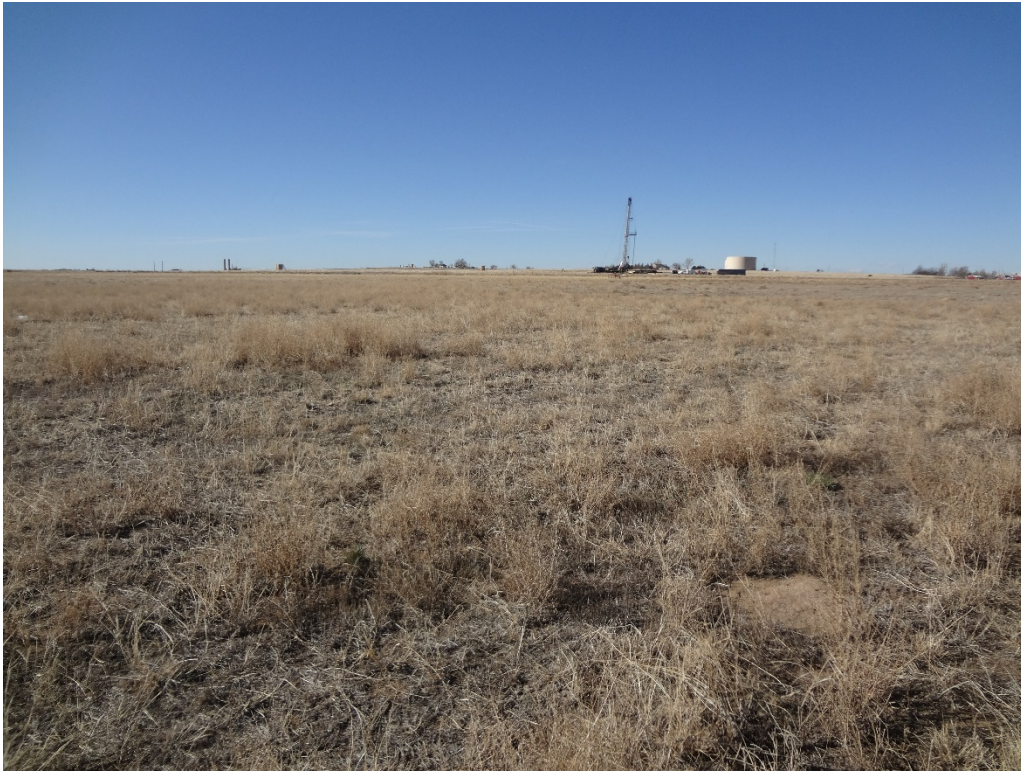
View of site from NE corner looking southwest

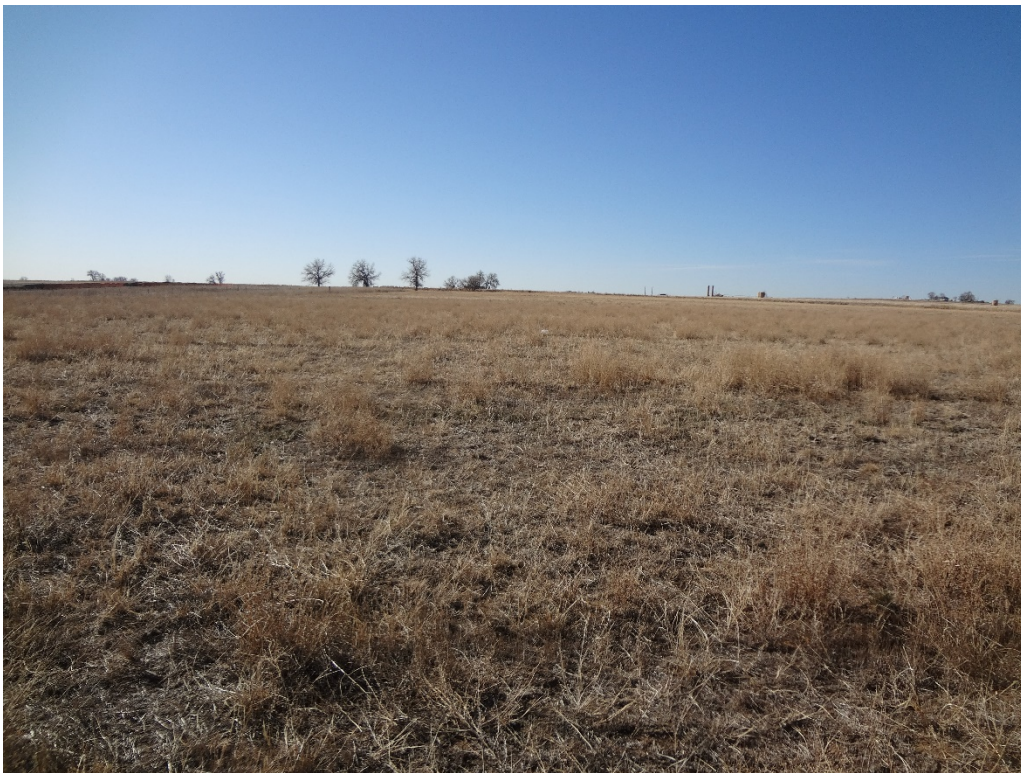
View of site from NE corner looking south

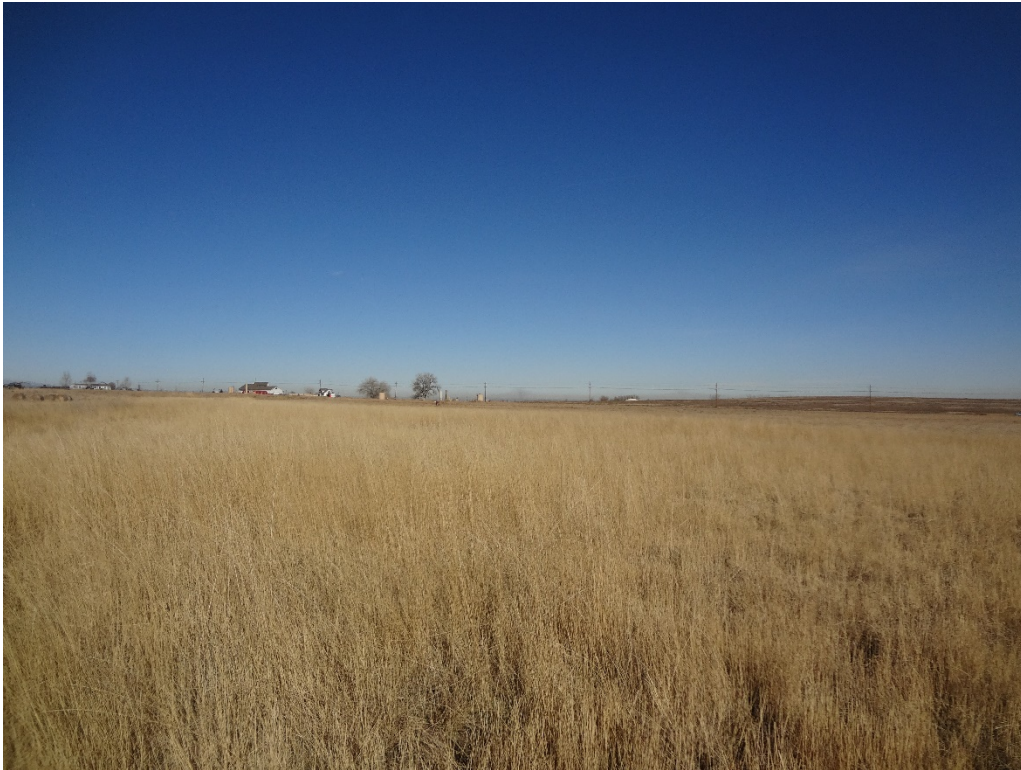
View of site from SE corner looking northwest

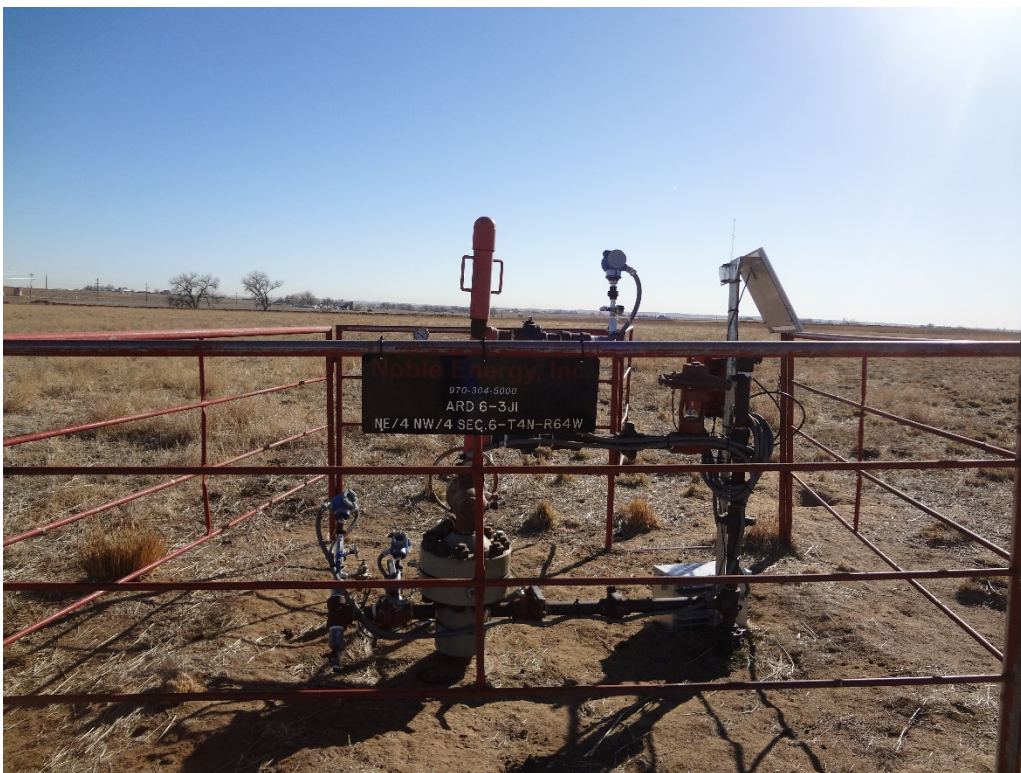
**PROBLEM/POSSIBLE VIOLATION:** Problem: The Exhibit L – Permanent Man-Made Structures and the current mine and reclamation plans need to be updated and clarified pursuant to C.R.S. 34-32.5-112(1)(c)(VI) and C.R.S. 34-32.5-116(1). The Operator must provide sufficient information to describe how the Operator intends to conduct the operation related to the Noble Energy wellhead located within 200 feet of the permit boundary.

As cited as a problem on Page 1, an oil and gas wellhead owned by Noble Energy was observed along the west boundary of the site during the inspection. The structure was not identified by the Operator during the permit application process. The Division will require the Operator to update Exhibit L – Permanent Man-Made Structures and the approved mine and reclamation plans and maps to identify and incorporate the wellhead into the permit. Since the wellhead is within 200 feet of the permit boundary, the Operator must provide a notarized agreement, pursuant to Rule 6.3.12, between the Operator and Noble Energy that the Operator will provide compensation for any damage to the structure. The Operator must comply with the requirements of Rule 6.3.12 prior to disturbing land within 200 feet of the wellhead. The mine and reclamation plans and maps must be updated to indicate a 200 foot offset from the wellhead or the Noble Energy agreed offset from the wellhead to the mining disturbance.

Noble wellhead adjacent to west boundary

**CORRECTIVE ACTIONS:** The Operator shall submit a Technical Revision, with the required \$216 revision fee, to update and clarify the approved mine and reclamation plans to reflect existing and proposed activities with respect to the Noble Energy wellhead by the corrective action date.

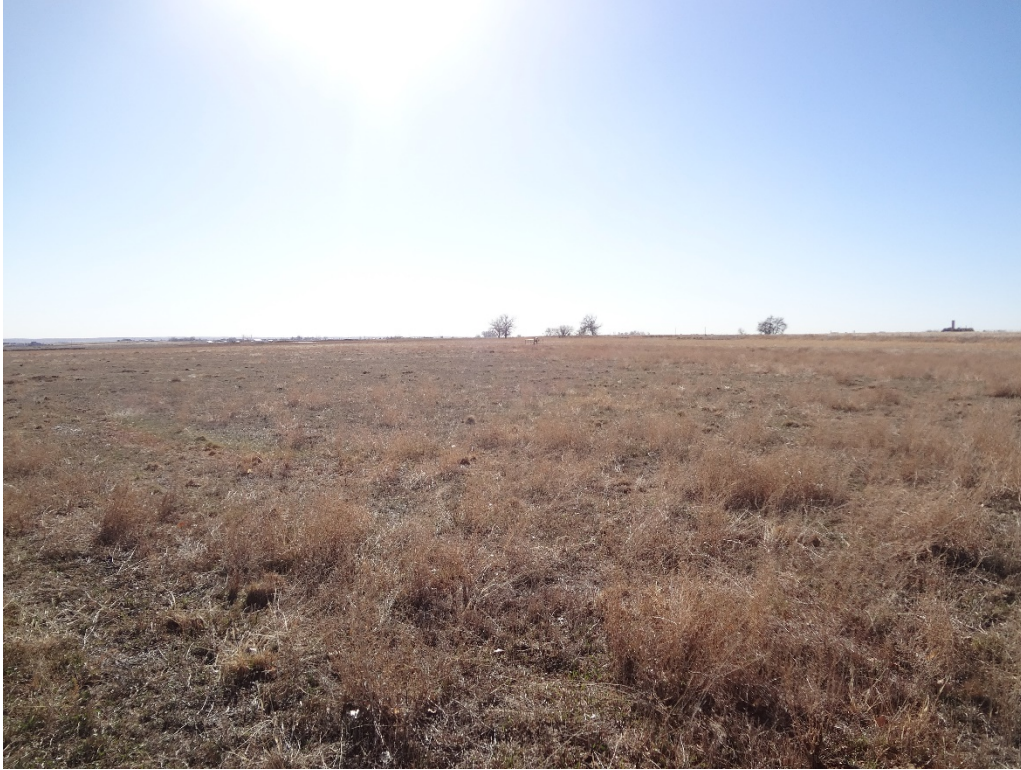
View of site from NW corner looking southeast

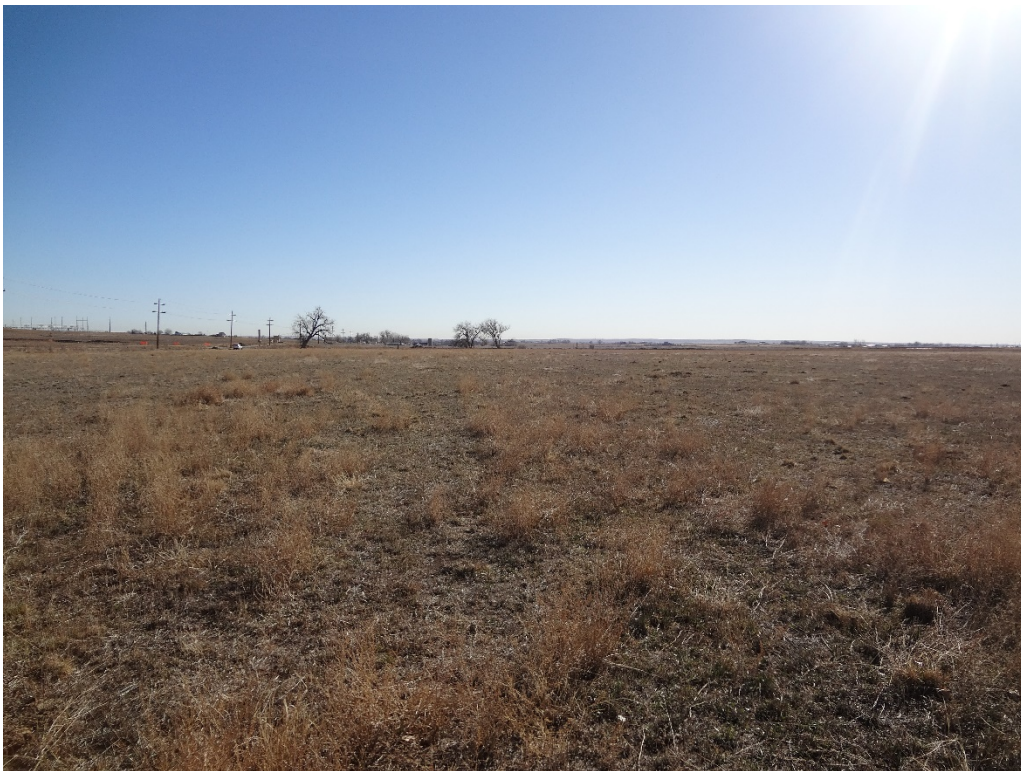
View of site from NW corner looking east
