**COLORADO**Division of Reclamation,
Mining and Safety

MINERALS PROGRAM INSPECTION REPORT**PHONE: (303) 866-3567**

MINE NAME: Varra-Coulson Resource Project	MINE/PROSPECTING ID#: M-2013-064	MINERAL: Gravel and sand	COUNTY: Weld
INSPECTION TYPE: Monitoring	INSPECTOR(S): Peter S. Hays	INSP. DATE: March 2, 2017	INSP. TIME: 10:00
OPERATOR: Varra Companies, Inc.	OPERATOR REPRESENTATIVE: Brad Janes, Brad Jones	TYPE OF OPERATION: 112c - Construction Regular Operation

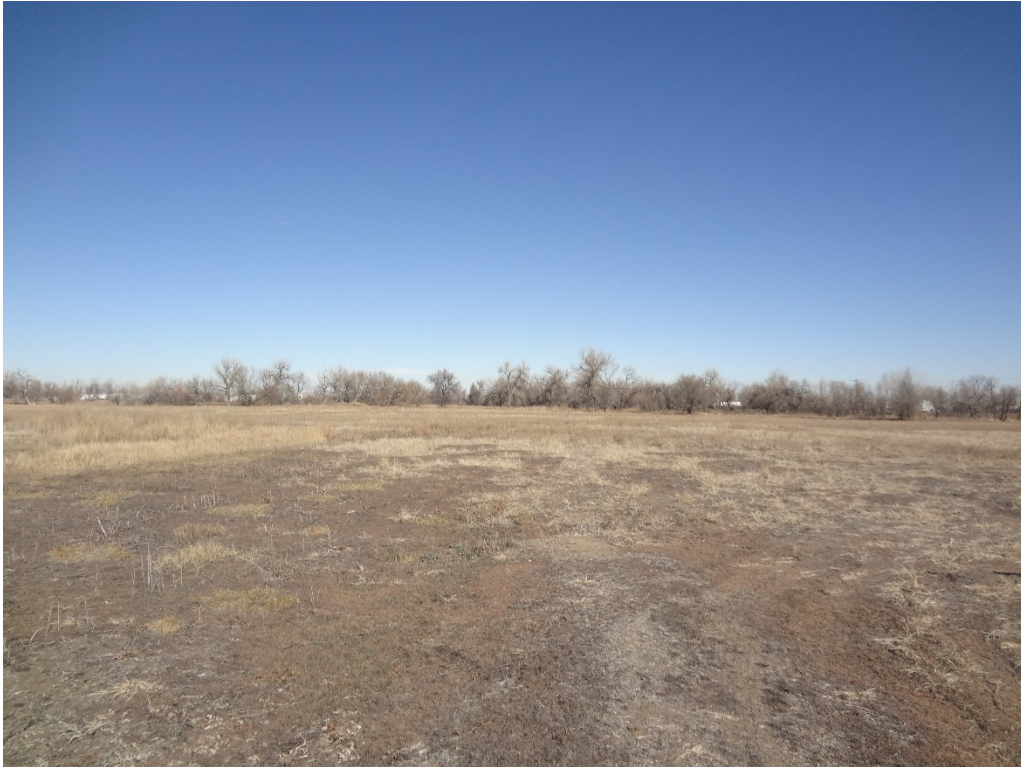
View of site from entrance gate looking north

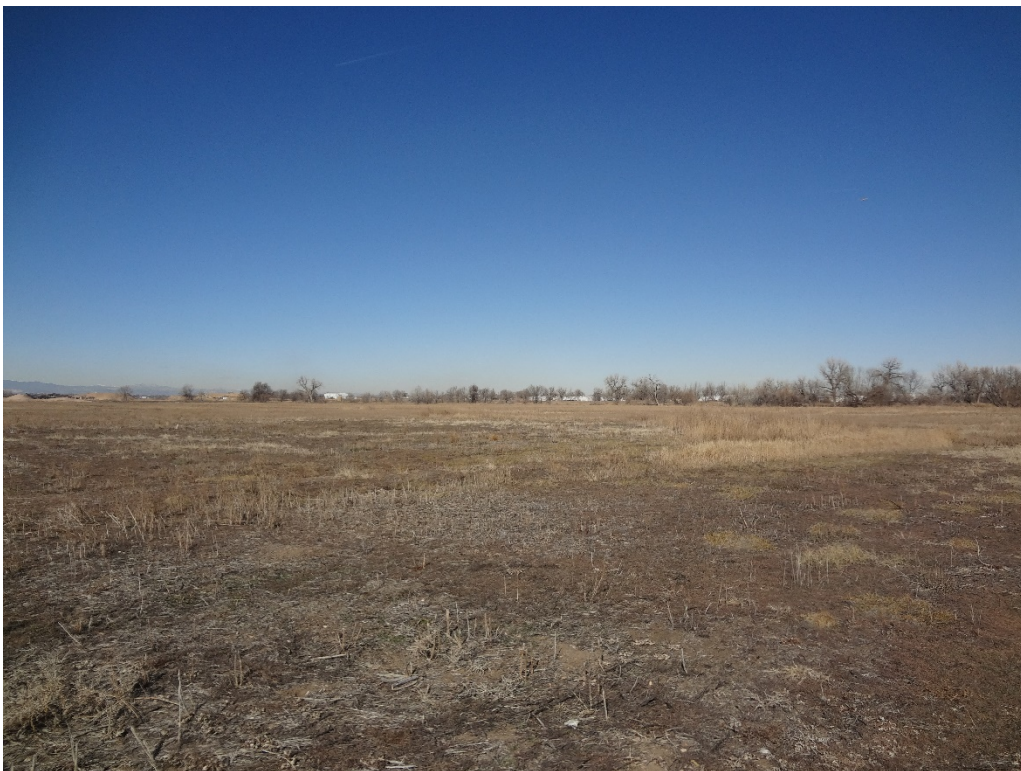
View of site from entrance gate looking NW

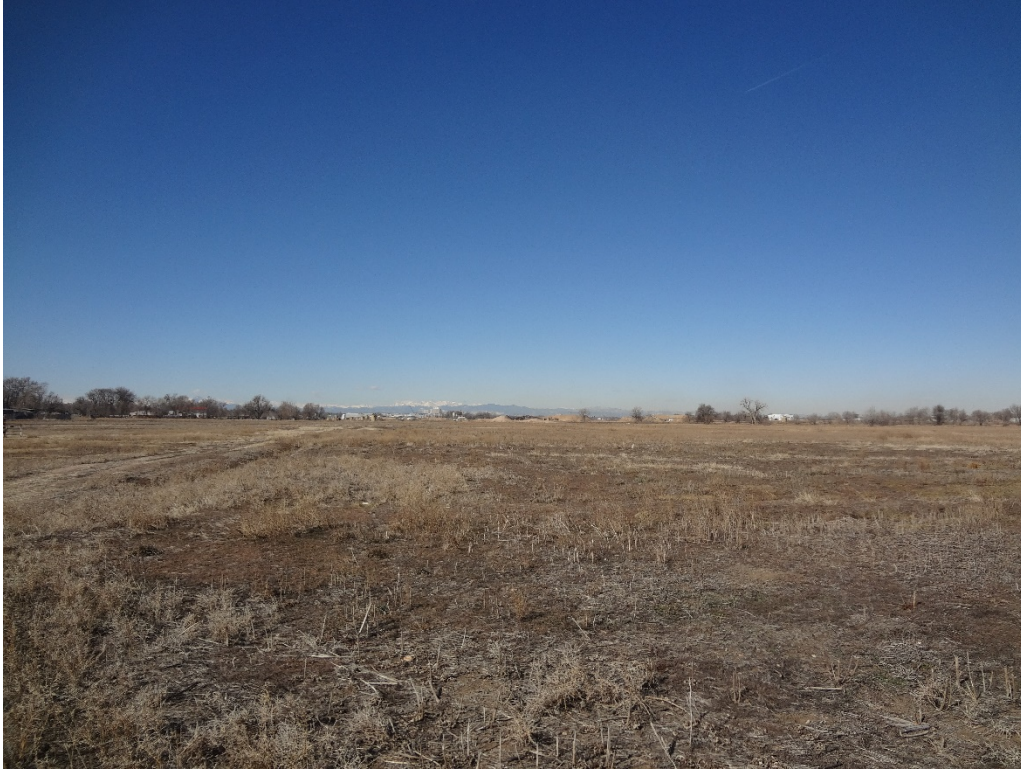
View of site from entrance gate looking west

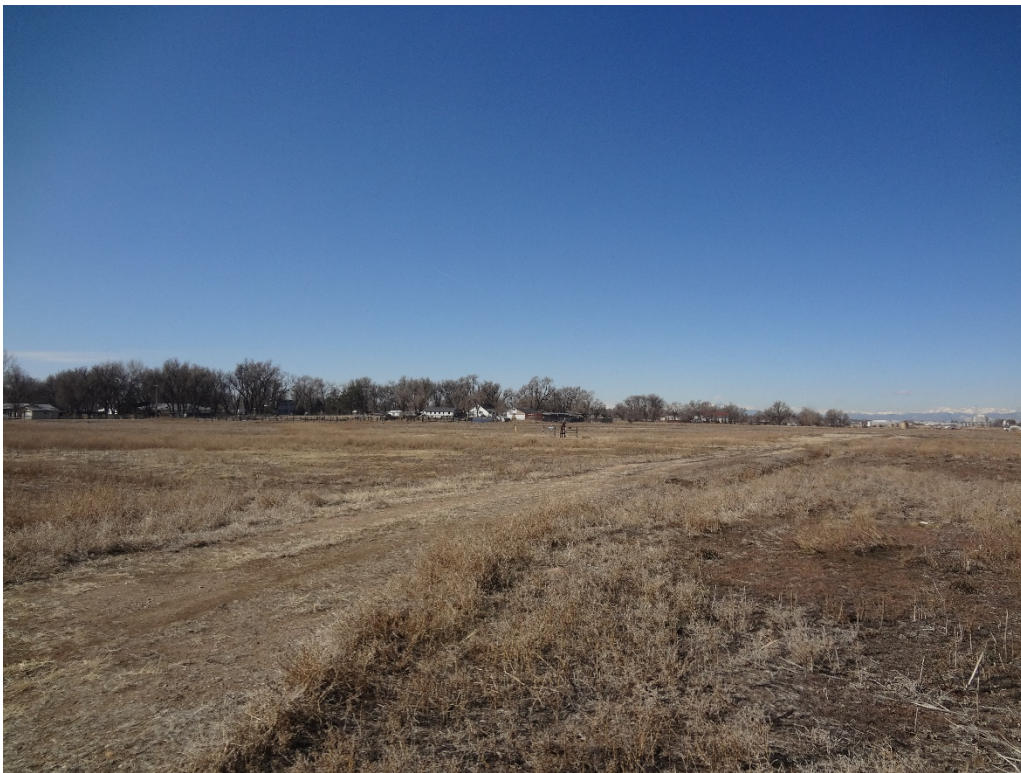
View of site from entrance gate looking southwest

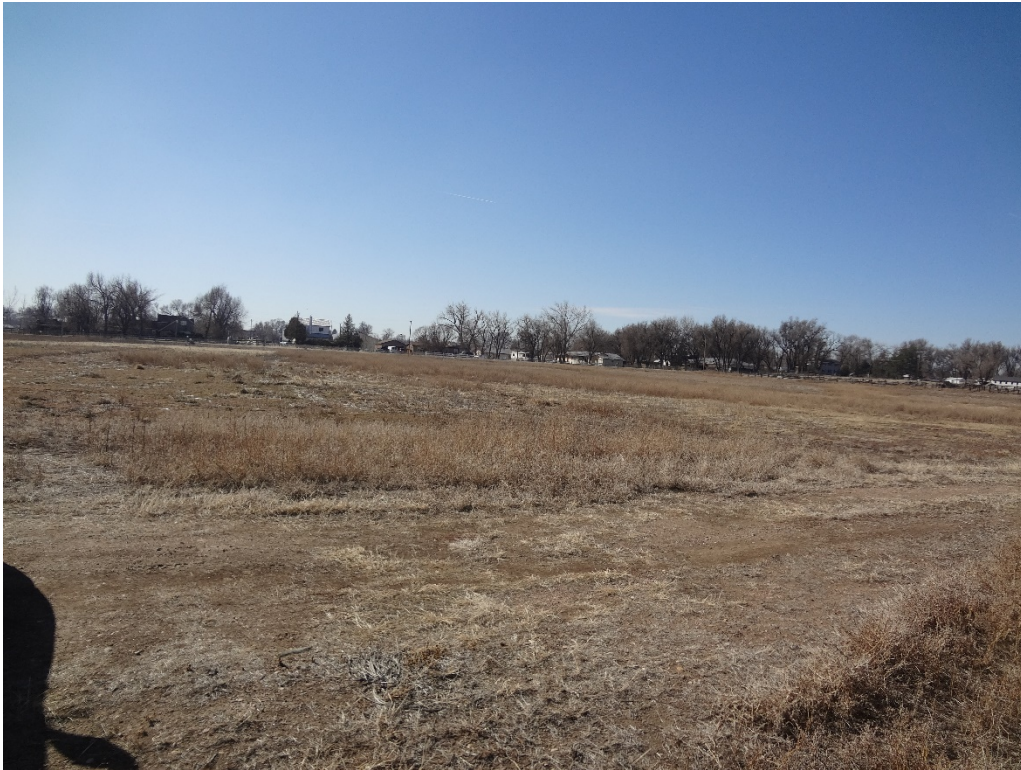
View of site from entrance gate looking south

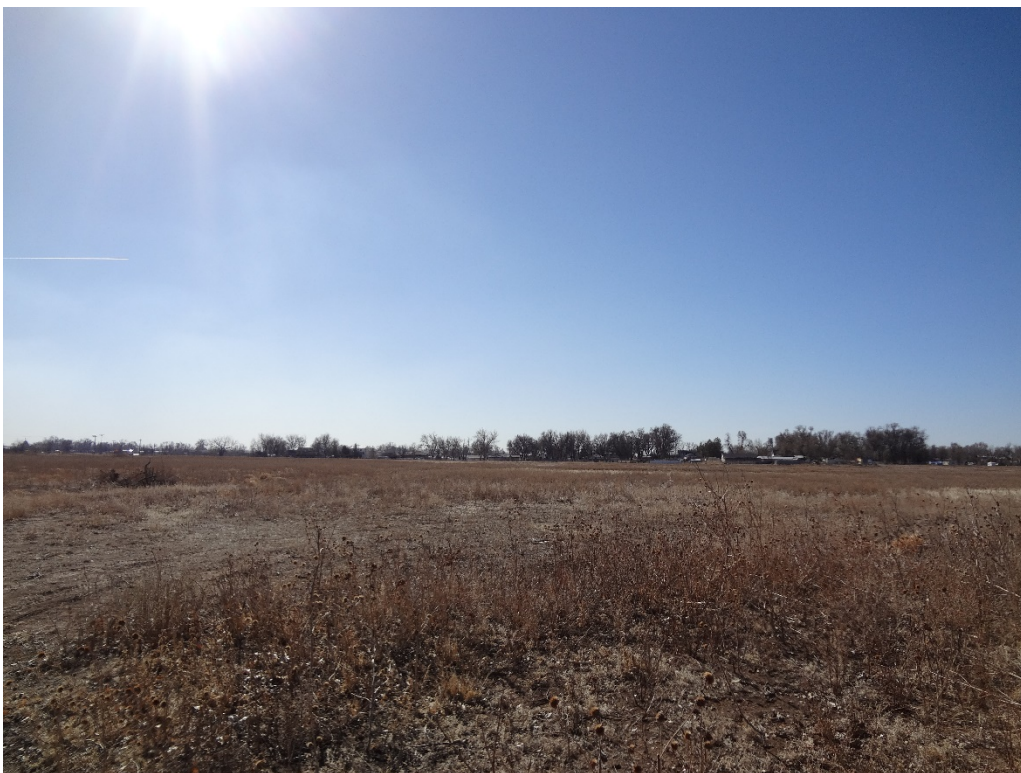
View of site from north side of Southfield looking south
