COLORADO

MINERALS PROGRAM INSPECTION REPORT

MINE NAME: Durham Sand & Gravel Pit	MINE/PROSPECTING ID#: M-1978-056	MINERAL: Sand and gravel	COUNTY: Weld
INSPECTION TYPE: Monitoring	INSPECTOR(S): Peter S. Hays	INSP. DATE: March 2, 2017	INSP. TIME: 10:00
OPERATOR: Varra Companies, Inc.	OPERATOR REPRESENTATIVE: Brad Janes, Brad Jones	TYPE OF OPERATION: 112c - Construction Regular Operation	
REASON FOR INSPECTION: Normal I&E Program	BOND CALCULATION TYPE: Partial Bond	BOND AMOUNT: \$300,000.00	
DATE OF COMPLAINT: NA	POST INSP. CONTACTS: None	JOINT INSP. AGENCY: None	
WEATHER: Clear	INSPECTOR'S SIGNATURE:

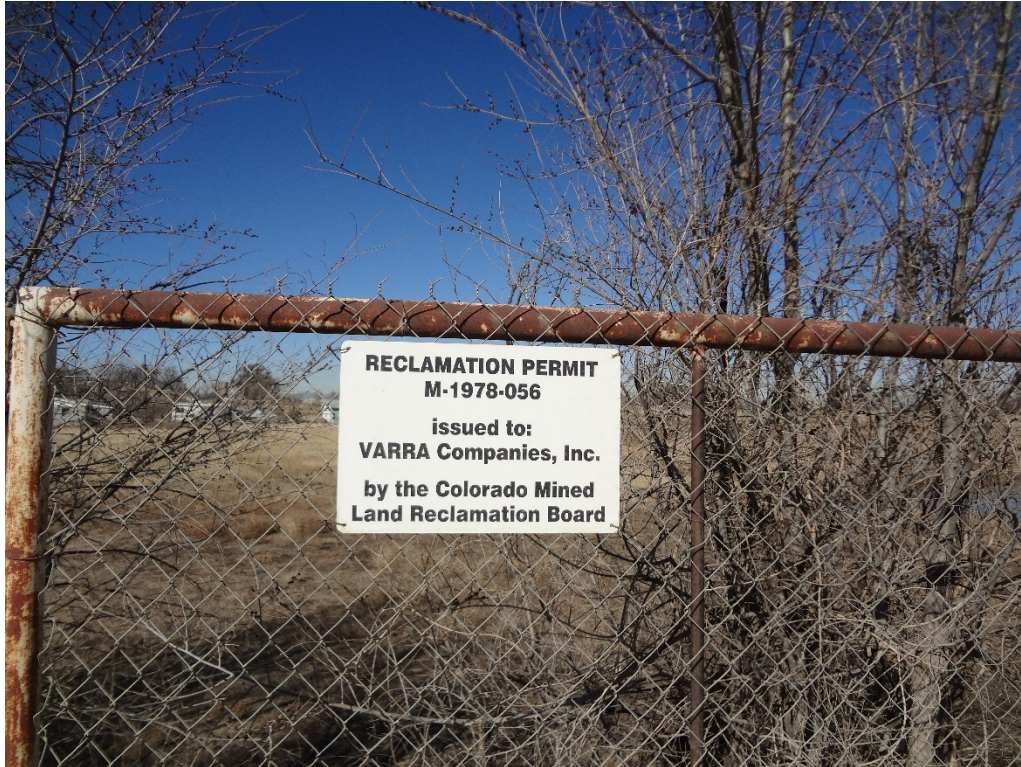
The mine identification sign was posted at the entrance of the site and the mine boundaries were well defined as required by Rule 3.1.12.

Durham Sand and Gravel Pit mine sign

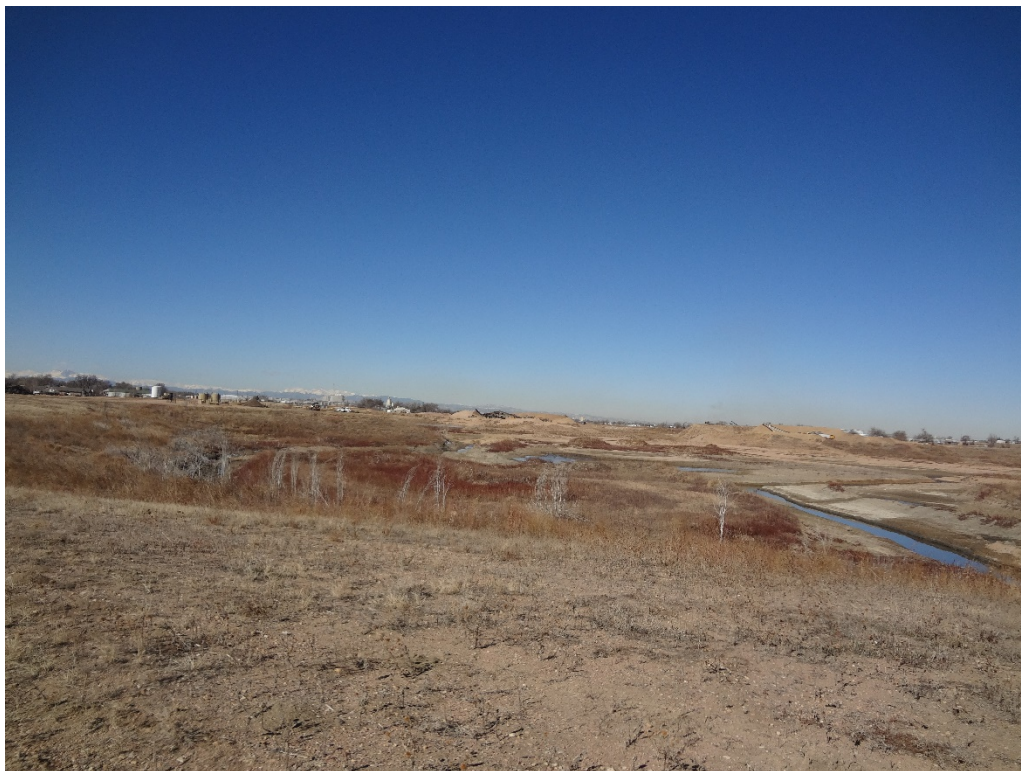
View of site from SE corner of Tract A looking west

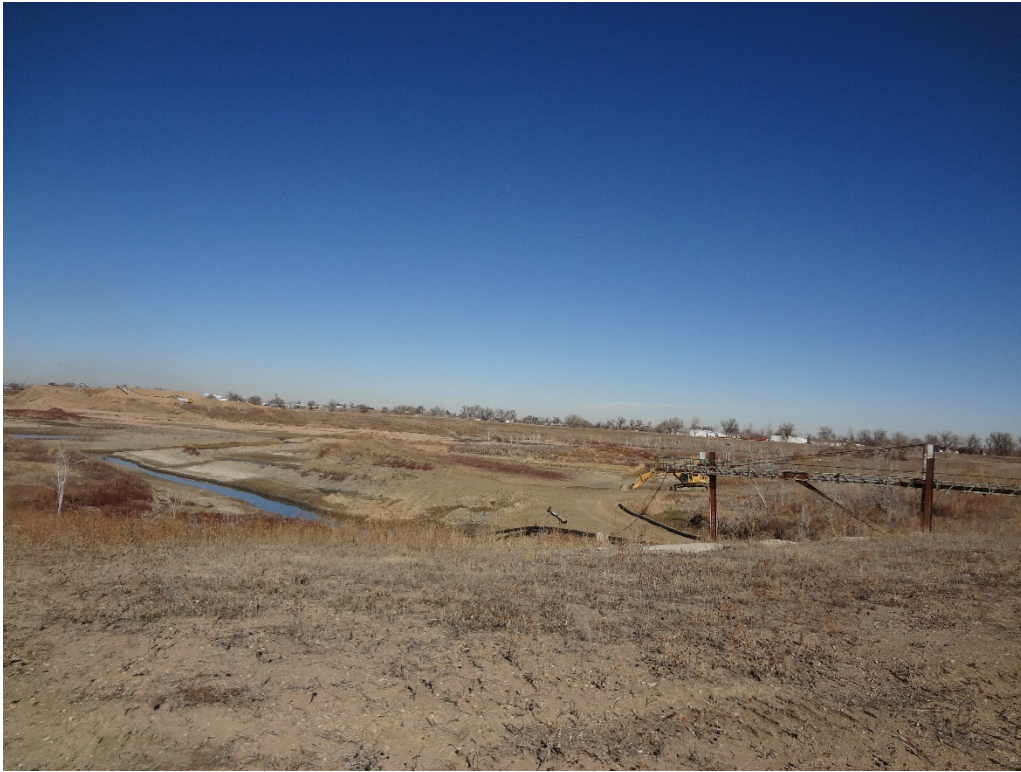
The site is permitted for 229.89 acres and is divided into four Tracts; A, B, C and D. The site was active during the inspection. Tract A is located in the southeast corner of the site. The tract was dewatered to allow mining excavation in the pit floor. The majority of the tract has been mined and reclamation has begun on the pit slopes. The dewatering pumps for the site are located in the southeast corner of the tract.

View of site from SE corner of Tract A and dewatering infrastructure looking northwest

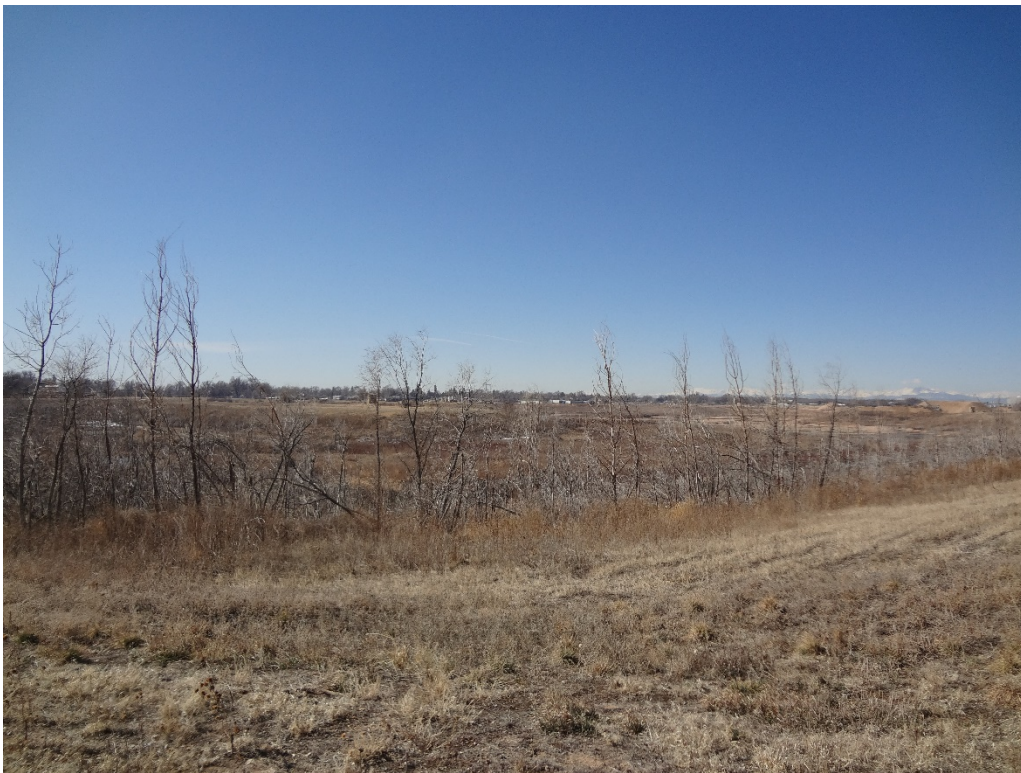
View of site from NE corner of Tract A looking southwest

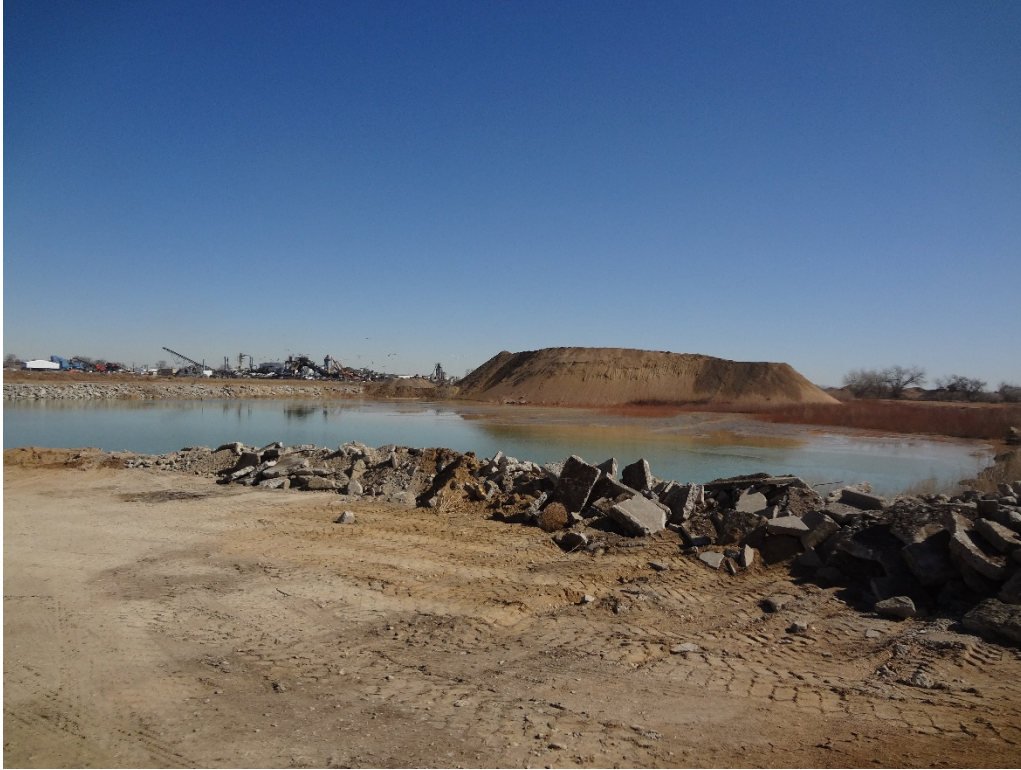
Tract D is located in the northwest corner of the site. The tract was being backfilled with wash fines and a large stockpile of material was located along the east boundary of the tract. The north boundary of the tract consists of the required flood control berm, which was repaired following the 2013 flood event.

View of site from SW corner of Tract D looking northeast

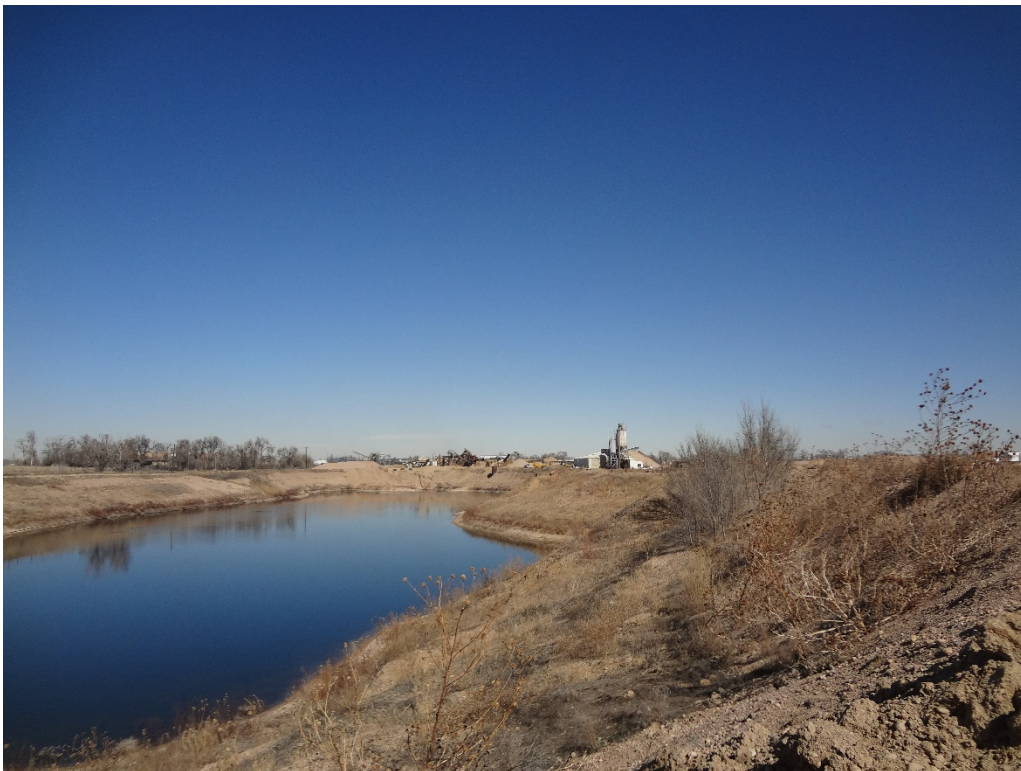
Tract B is located in the southwest corner of the site. The southern portion of the tract was partially fill with groundwater. The northern portion of the tract contains the concrete batch plant, processing plant and material stockpiles.

View of site from SE corner of Tract B looking north at batch plant
