**COLORADO**Division of Reclamation,
Mining and Safety

MINERALS PROGRAM INSPECTION REPORT**PHONE: (303) 866-3567**

MINE NAME: Gleason Pit	MINE/PROSPECTING ID#: M-1983-159	MINERAL: Sand and gravel	COUNTY: Montrose
INSPECTION TYPE: Monitoring	INSPECTOR(S): Dustin M. Czapla	INSP. DATE: February 24, 2017	INSP. TIME: 10:00
OPERATOR: S & S Aggregate, Inc	OPERATOR REPRESENTATIVE: None	TYPE OF OPERATION: 112c - Construction Regular Operation

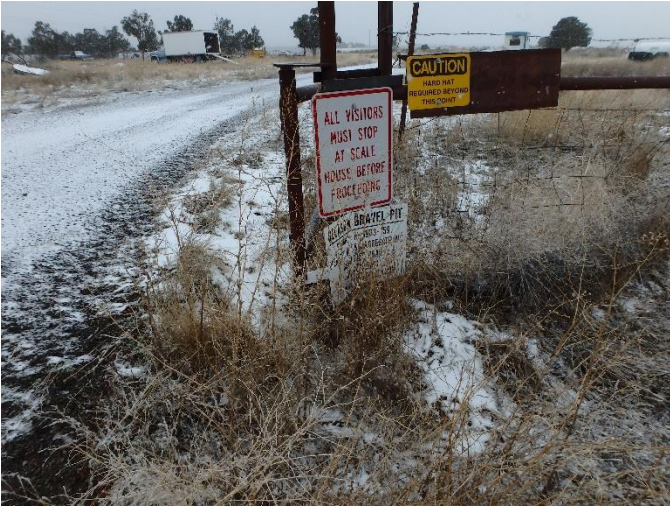
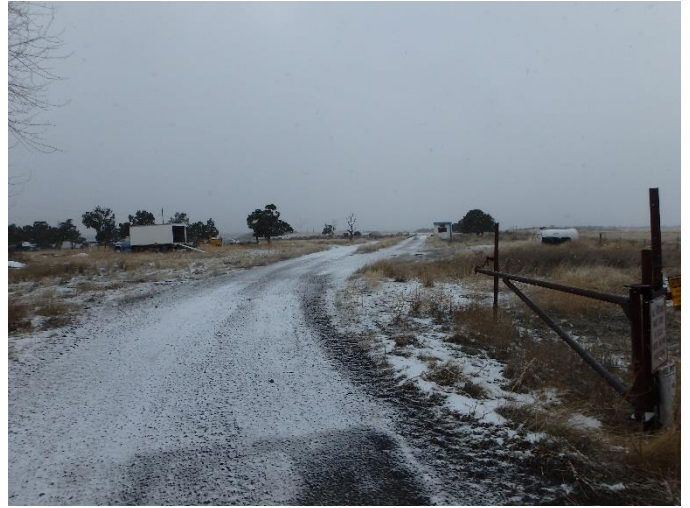
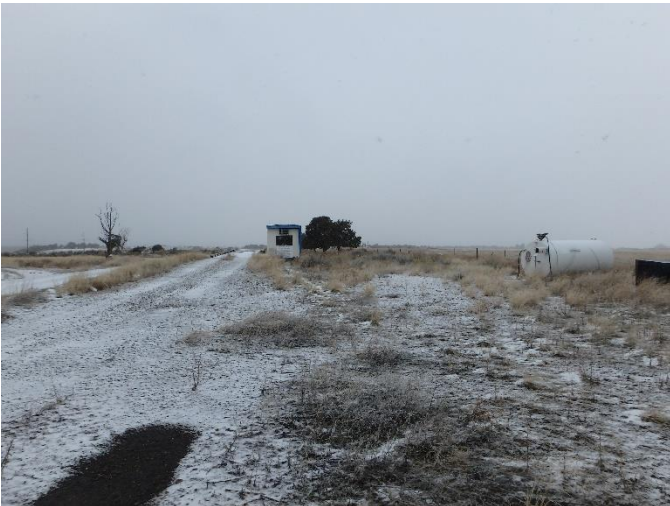
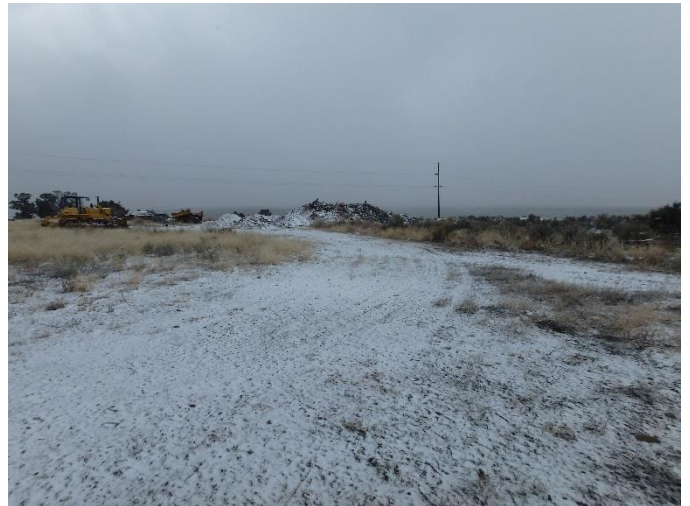
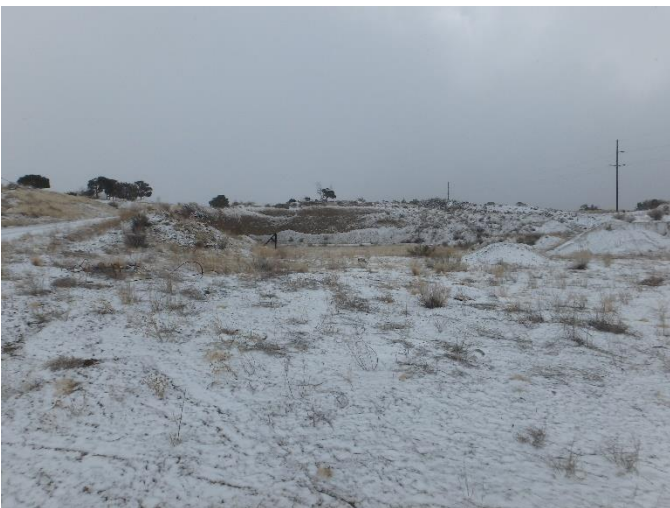
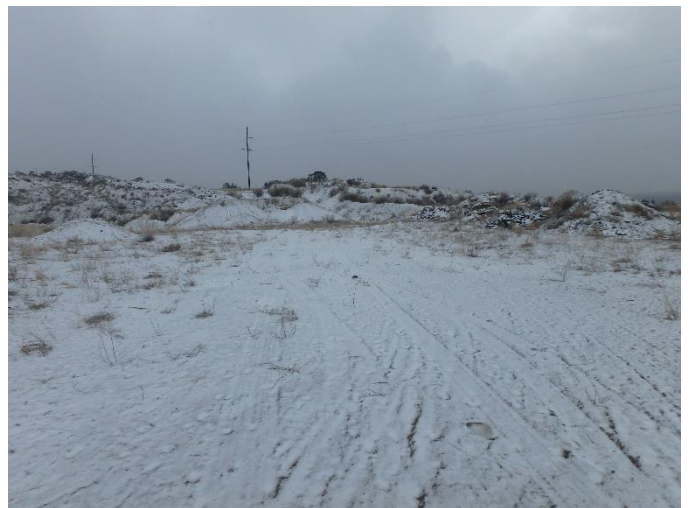
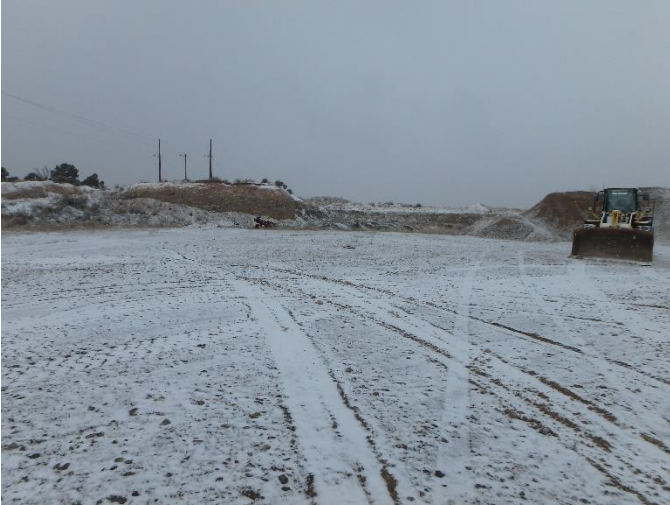
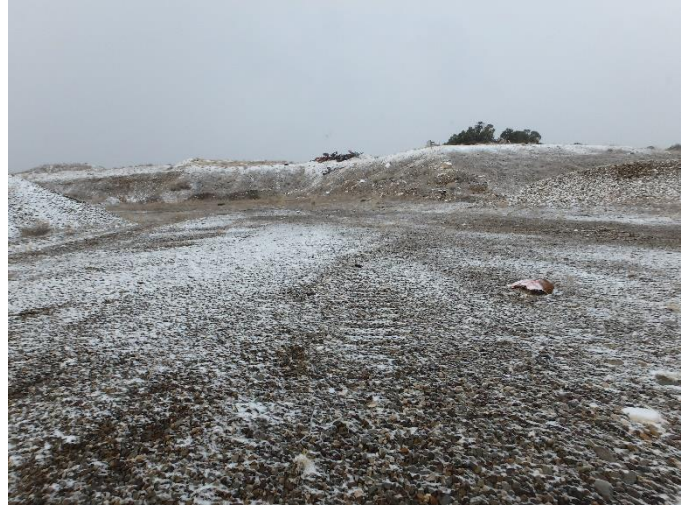
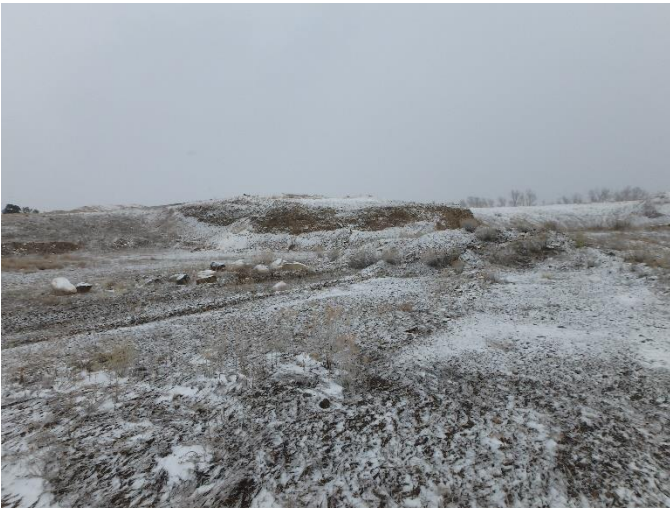
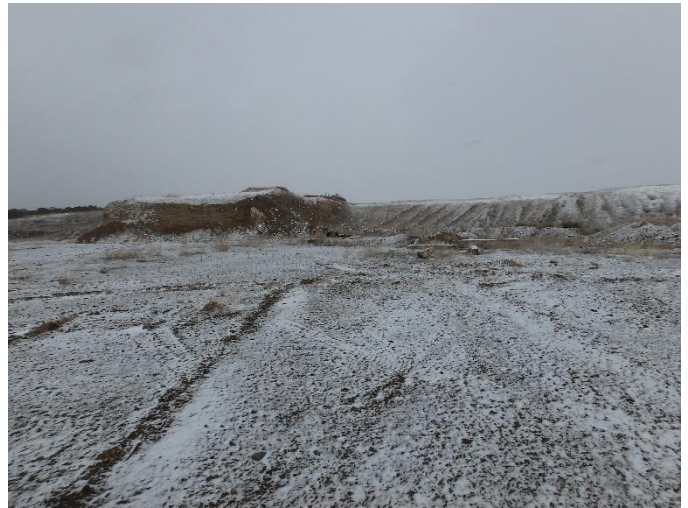
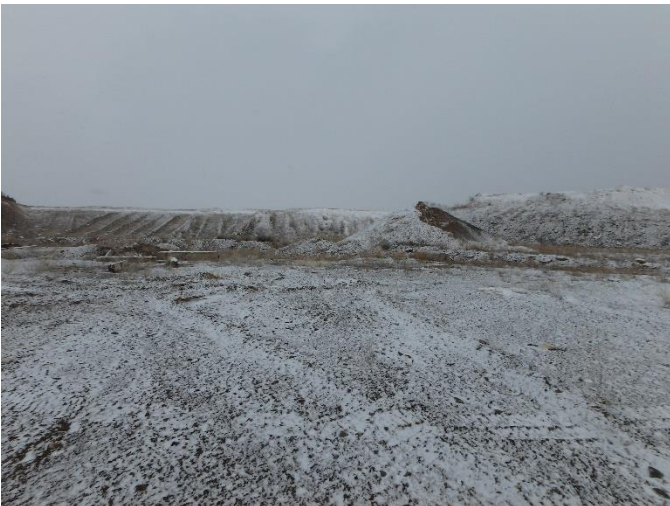
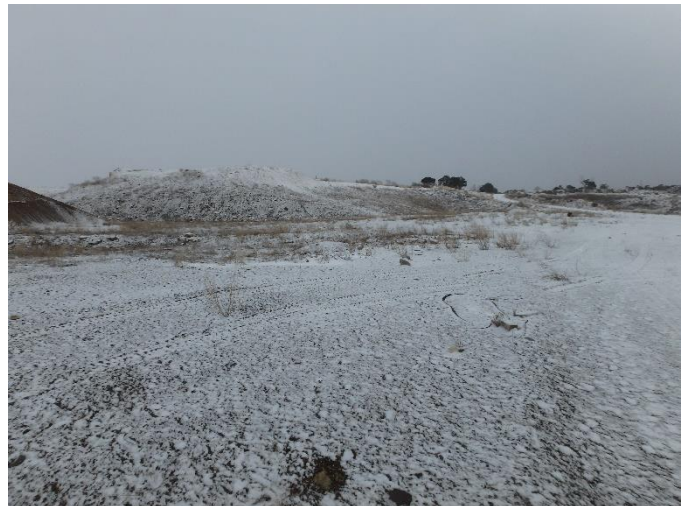
PHOTOGRAPHS

Adequate mine identification signage was noted near the entrance to the site.

The affected area was marked by posts and fencing that was clearly visible and adequate to delineate the affected area boundary.

A scale and scalehouse are located near the site entrance. Various equipment and refuse are stored in the area south of the scale.

The pit area appeared unchanged from the Division's 2014 inspection. The existing highwalls were left at random grades, from near vertical to 3H:1V. A near vertical highwall exists on the south side of the access road in the east side of the pit. Highwalls around the power poles are approximately 0.5H:1V. Except for a section of 0.5H:1V slope in the central part of the north pit wall, the west and north slopes are graded from 2H:1V to 3H:1V.
