**MINERALS PROGRAM INSPECTION REPORT****PHONE: (303) 866-3567**

<b>MINE NAME:</b> Jemadojin Sand Mine	<b>MINE/PROSPECTING ID#:</b> M-2006-017	<b>MINERAL:</b> Sand	<b>COUNTY:</b> El Paso
<b>INSPECTION TYPE:</b> Surety-Related Inspection	<b>INSPECTOR(S):</b> Timothy A. Cazier	<b>INSP. DATE:</b> October 11, 2016	<b>INSP. TIME:</b> 09:50
<b>OPERATOR:</b> Premier Silica LLC	<b>OPERATOR REPRESENTATIVE:</b> Jackie Campo	<b>TYPE OF OPERATION:</b> 112c - Construction Regular Operation

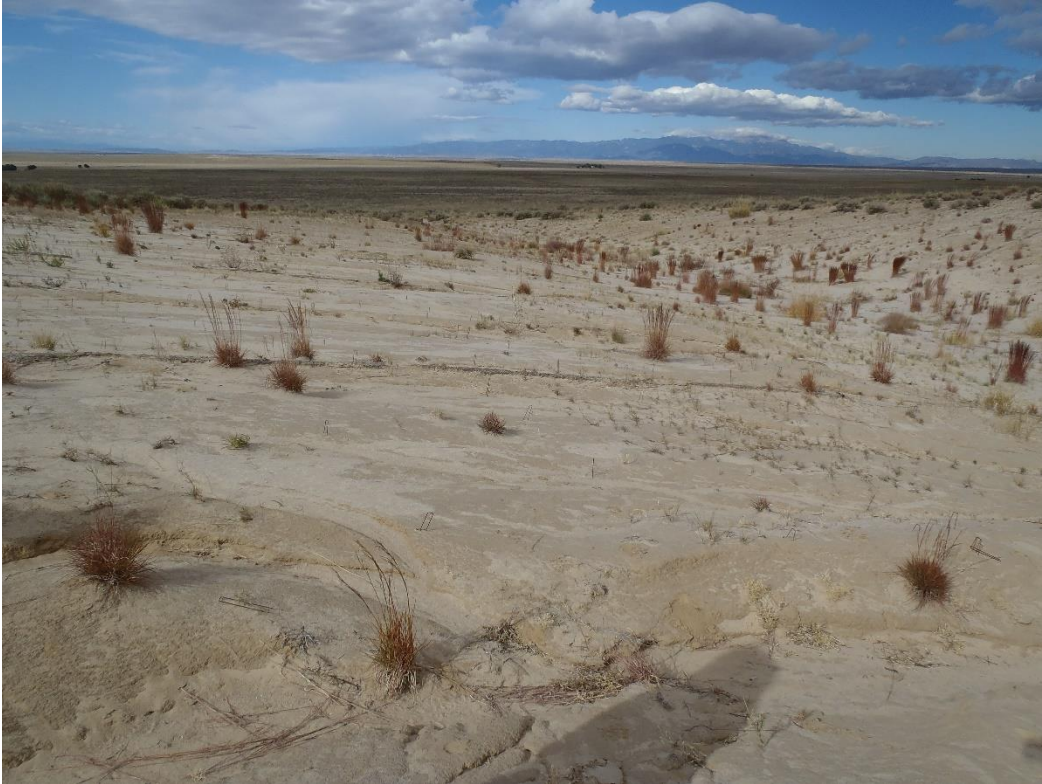
**Reclamation Success:** Reclamation appears successful for the most part with notable exceptions in: A) the stormwater diversion cut on the north end (see **Photos 1 - 3**); B) the majority of the sloped highwalls in the pit area (see **Photos 4 and 5**); and C) a small area in the bottom of the pit sloping gradually to the north. The Division strongly recommends adding topsoil to these areas prior to reseeding. Previous attempts using wattles, erosion control blankets and other methods have failed to stabilize the soil in the stormwater diversion with virtually no vegetation being established. The Division recommended contacting the County and/or the NRCS regarding modifying the seed mix, which would require a Technical Revision to the permit if desired.

**Sediment Control:** The stormwater diversion cut appeared to be the only area requiring erosion control. However, the eroded material did not appear to have migrated off site.

Photo 1. Stormwater cut requiring revegetation (looking NW).

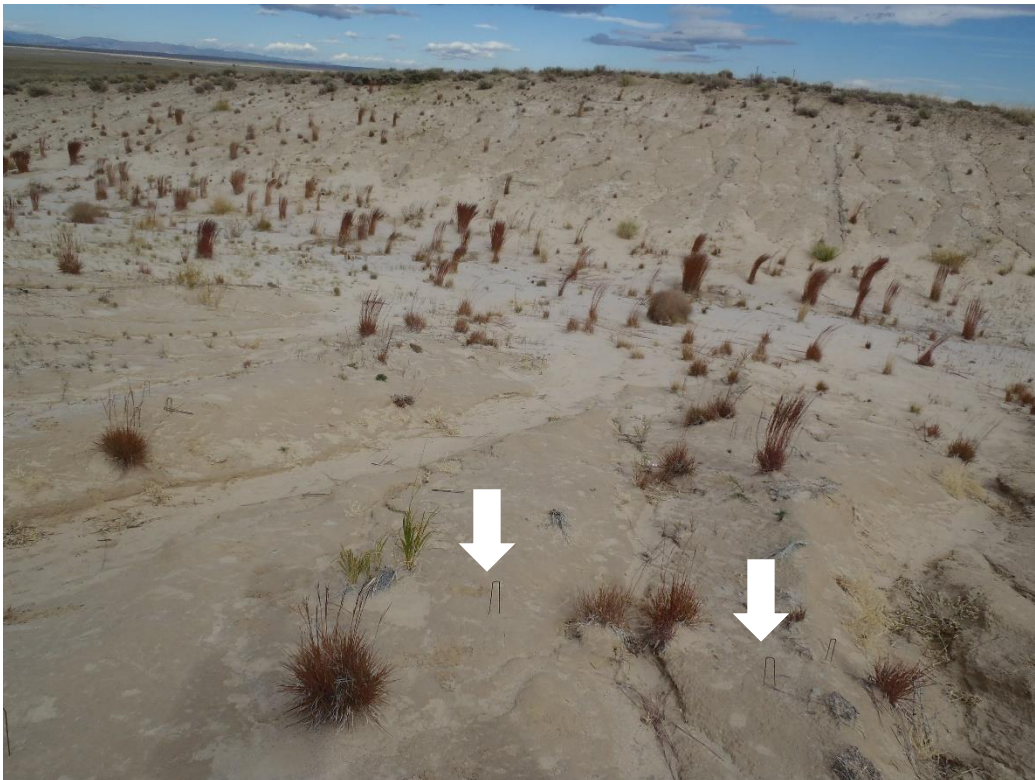
Photo 2. Stormwater cut requiring revegetation (looking north). *Note erosion control blanket staples*

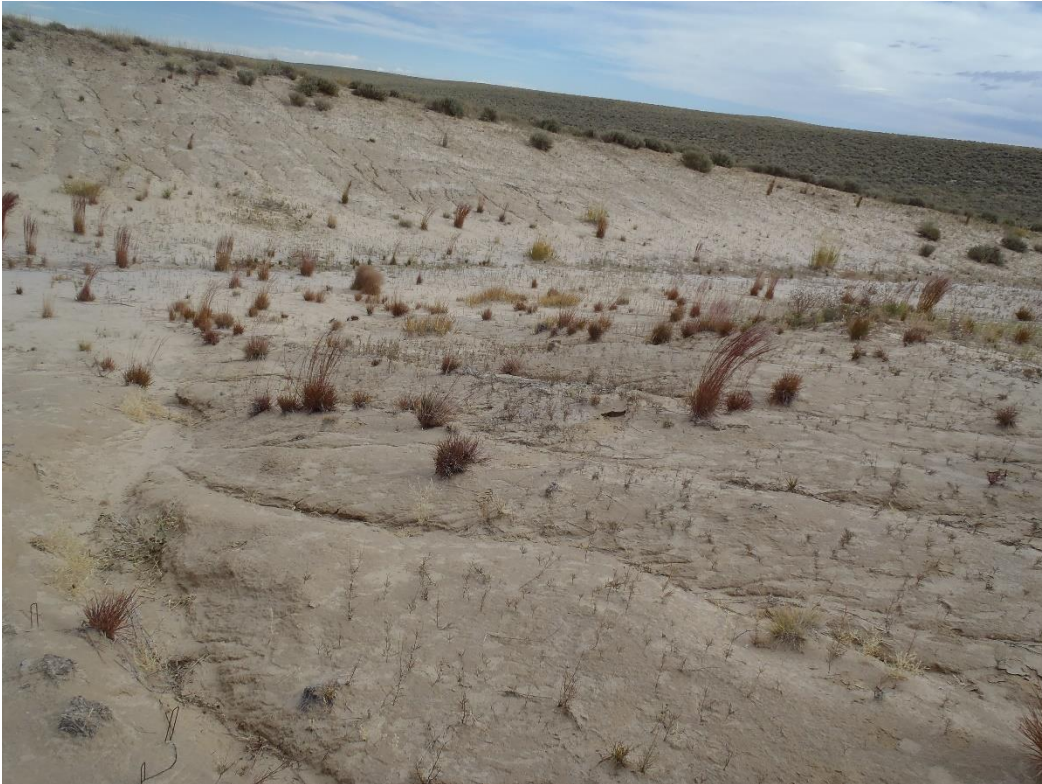
Photo 3. Stormwater cut requiring revegetation (looking NE).

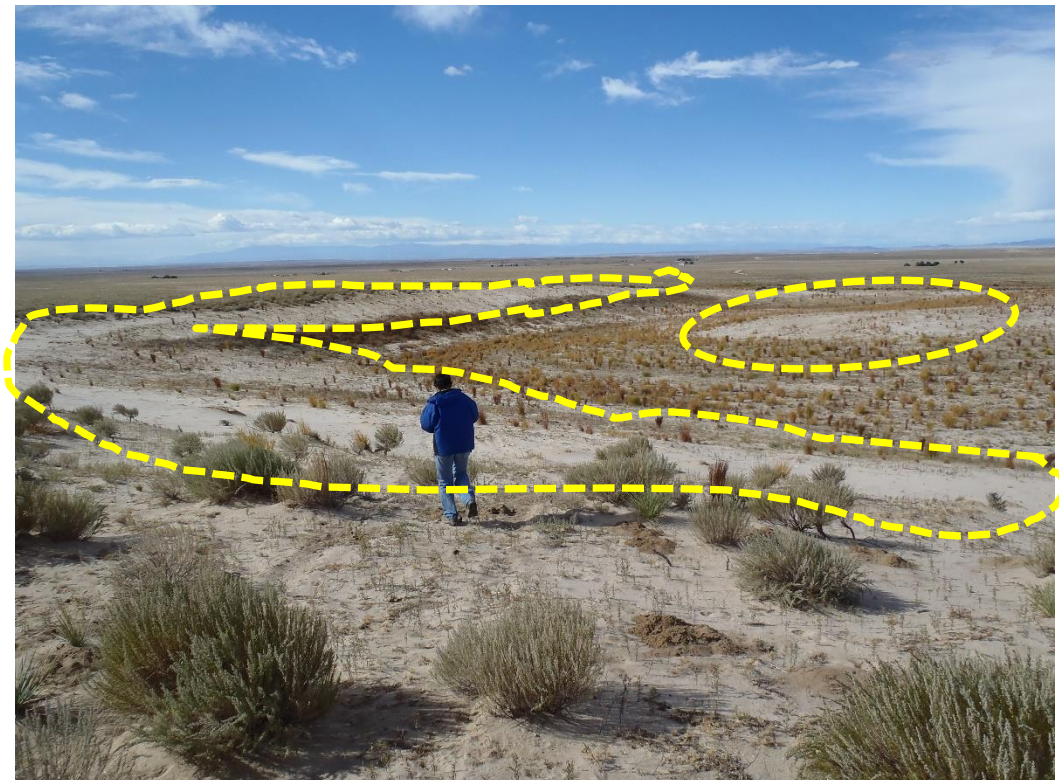
Photo 4. Main pit areas requiring revegetation (looking SW).

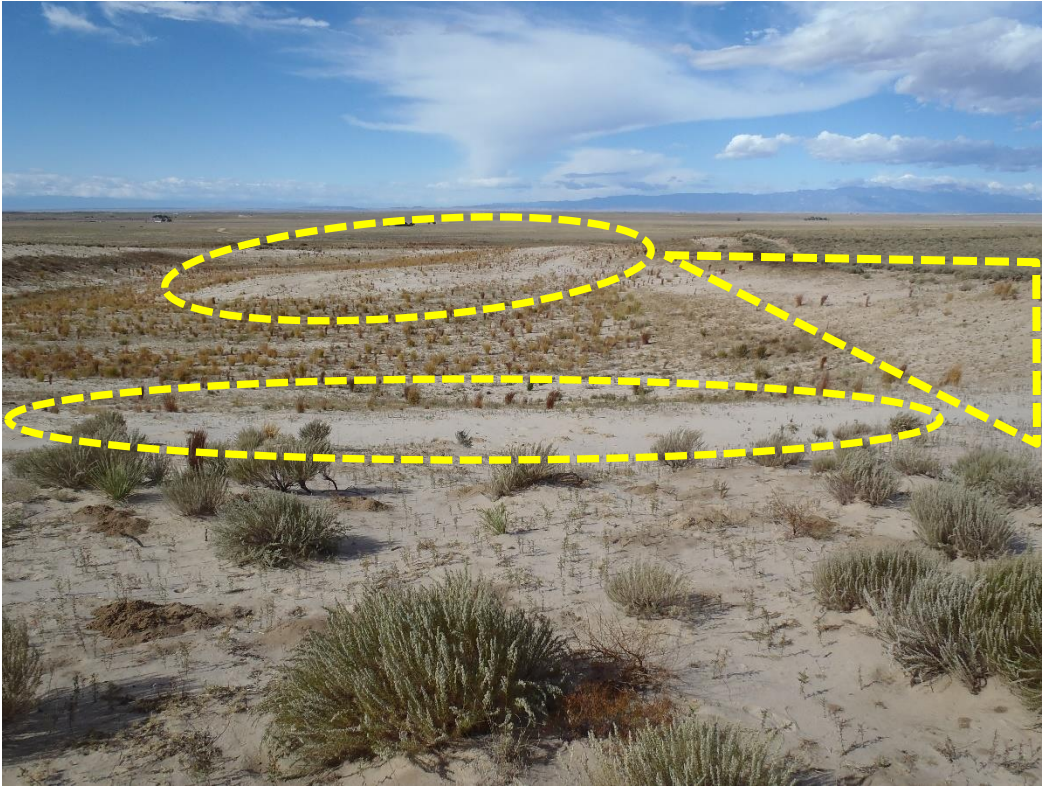
Photo 5. Main pit areas requiring revegetation (looking west).

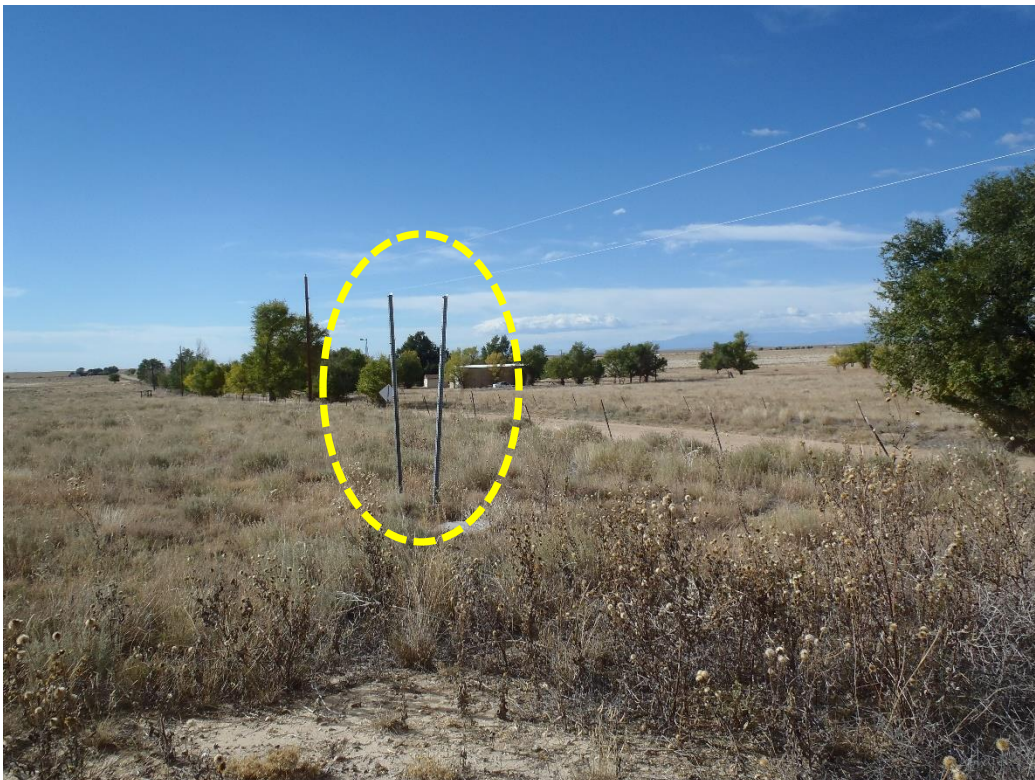
**PROBLEM/POSSIBLE VIOLATION:** Problem: The mine identification sign was not posted at the entrance of the mine site. This is a problem for failure to post a mine identification sign as required by Section 3.1.12(1) of the rule.

**Signs and Markers:** The permit sign that was posted during the previous inspection (10/8/2013) appeared to have blown down (see **Photo 6**). **The missing sign is cited as a problem on page 1 of this report.**

Photo 6. Previous location of permit sign (east side of Dearing Rd.).

**CORRECTIVE ACTIONS:** The permittee shall, at the entrance of the mine site, post a sign which shall be clearly visible from the access road with the following: the name of the permittee, a statement that a reclamation permit for the operation has been issued by the Colorado Mined Land Reclamation Board; and the permit number. The operator shall submit photo documentation that a proper sign has been posted by the corrective action date.

**CORRECTIVE ACTION DUE DATE:** 4/14/17
