MINERALS PROGRAM INSPECTION REPORT
PHONE: (303) 866-3567

MINE NAME: Cresson Project	MINE/PROSPECTING ID#: M-1980-244	MINERAL: Gold	COUNTY: Teller
INSPECTION TYPE: Monitoring	INSPECTOR(S): Amy Eschberger	INSP. DATE: December 20, 2016	INSP. TIME: 10:00
OPERATOR: Cripple Creek & Victor Gold Mining Company	OPERATOR REPRESENTATIVES: Clara Steward, Jeff Campbell, Don Rodaba, Gary Hornton, Roy Leed, Cheyne Mann, Erik Munroe, and Ron Parratt	TYPE OF OPERATION: 112d-3 - Designated Mining Operation	
REASON FOR INSPECTION: Normal I&E Program	BOND CALCULATION TYPE: None	BOND AMOUNT: \$173,934,420.00	
DATE OF COMPLAINT: NA	POST INSP. CONTACTS: None	JOINT INSP. AGENCY: None	
WEATHER: Clear	INSPECTOR'S SIGNATURE:

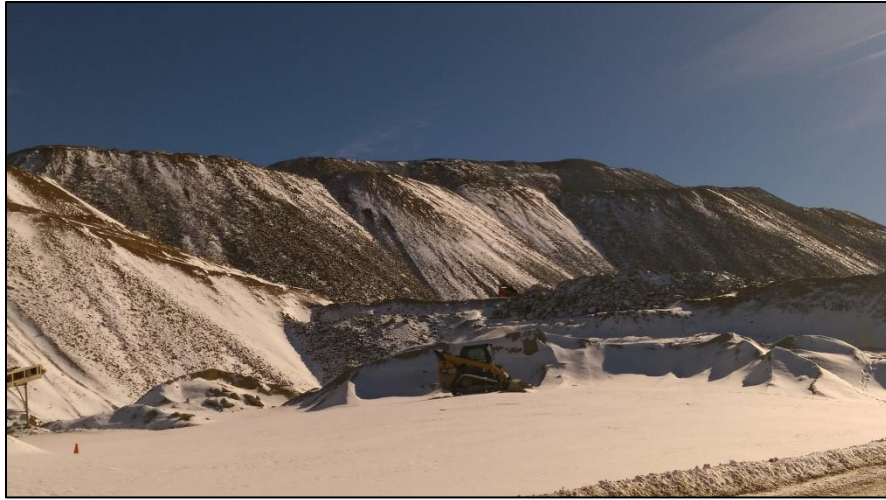
Photo 1. View of northwestern side of SGOSA.

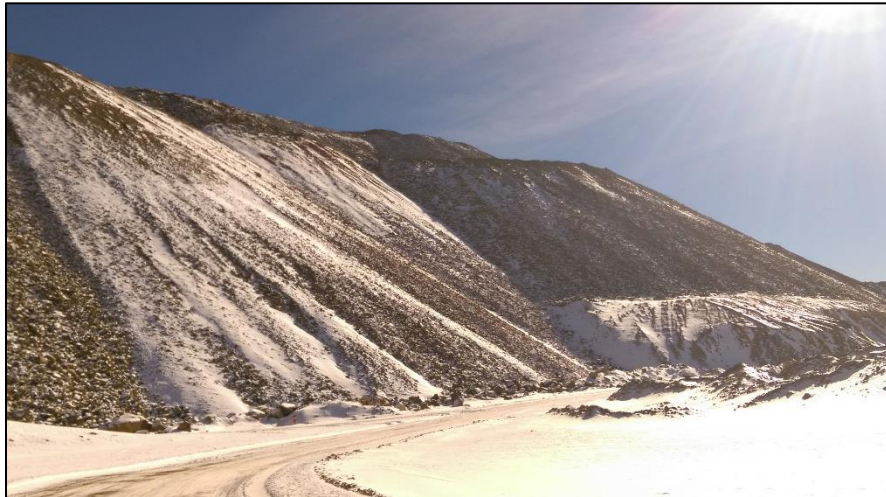
Photo 2. View of western side of SGOSA, showing slope gradients of approximately 1.5H:1V to 2H:1V.

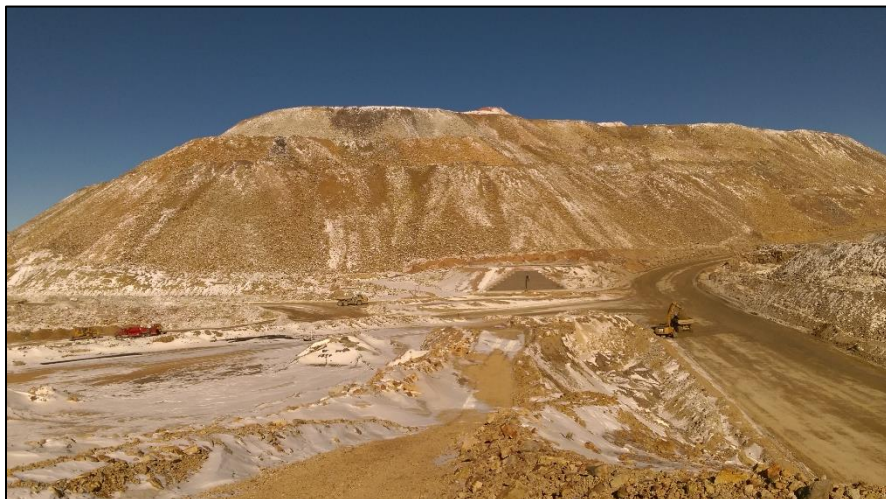
Photo 3. View of southern side of SGOSA.

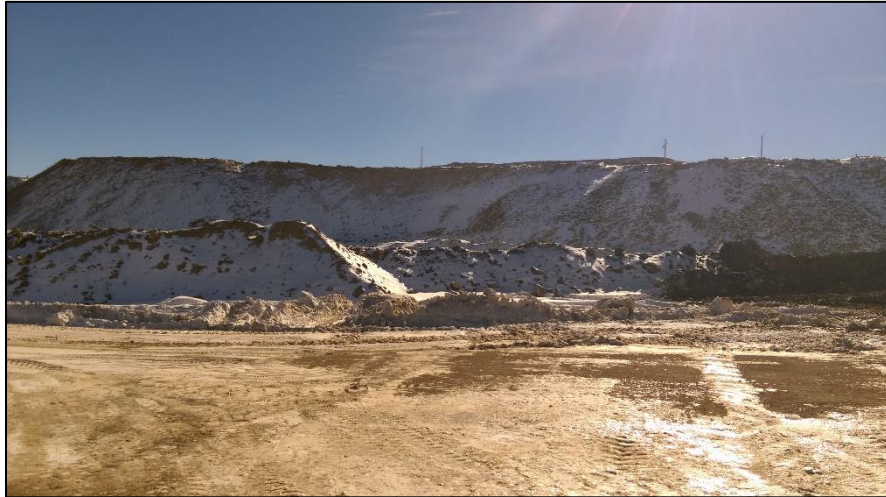
Photo 4. View of northern side of SGOSA.

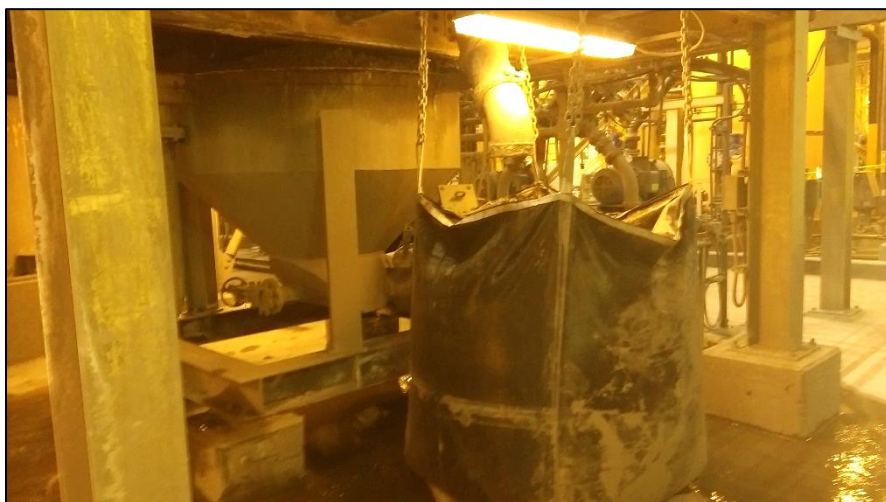
Don Rodaba, Gary Hornton, and Roy Leed represented the operator during the Division's inspection of the mill facility. During the inspection, the Division observed the CIP #5 area where the spill had occurred (**Photo 6**). The equipment appeared to be functioning properly, and no evidence of the spill remained. The Division observed the concrete containment wall around the CIP area which was constructed approximately 1-1/2 years ago (**Photo 7**). The capacity of the containment structure did not appear to be compromised at the time of the inspection. A concrete ramp had been constructed across the containment wall to allow access for a loader, without compromising the function of the containment structure. The operator estimates this ramp was constructed approximately 4 months prior to the inspection. The Division observed the access door which had been compromised by the slurry spill had been removed and the bottom half filled in with concrete (**Photos 8 and 9**). The Division observed the mill secondary containment floor (outside of the building) where the slurry had seeped from beneath the access door. It appeared that all of the slurry had been extracted from the floor of this area.

Photo 6. View of Carbon in Pulp #5 area located inside high grade mill facility where December 5, 2016 spill occurred.

On December 12, 2016, the operator submitted to the Division a written report of the event in accordance with Rule 8.2.3, which requires the report be submitted within five working days after an emergency situation or condition is reported and addressed. The operator determined the main cause of the event to be the failure of the CIP transfer pump. Since then, the operator has repaired the pump and continues to operate with a duty/standby pump. The access door which was compromised by the slurry spill will be removed and replaced with a concrete berm that adjoins the existing structure walls. This will increase the existing facility containment by an estimated 8 inches.

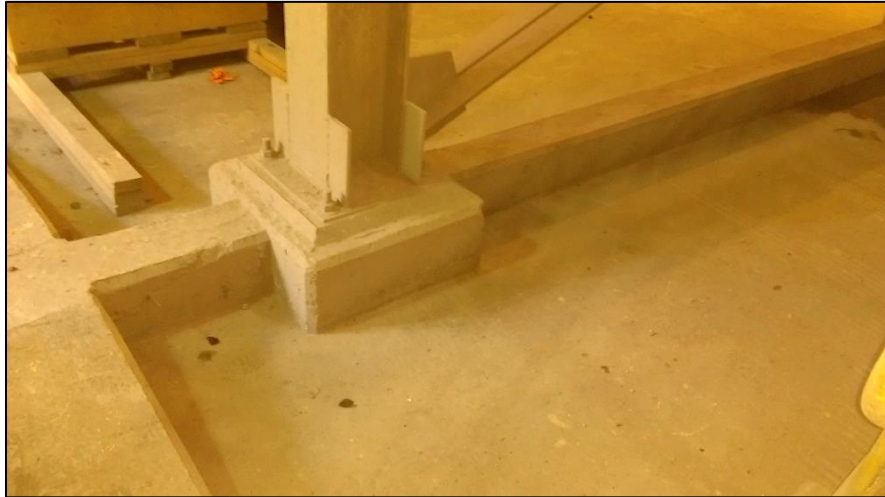
Photo 7. View of concrete containment wall lining perimeter of CIP area inside high grade mill facility.

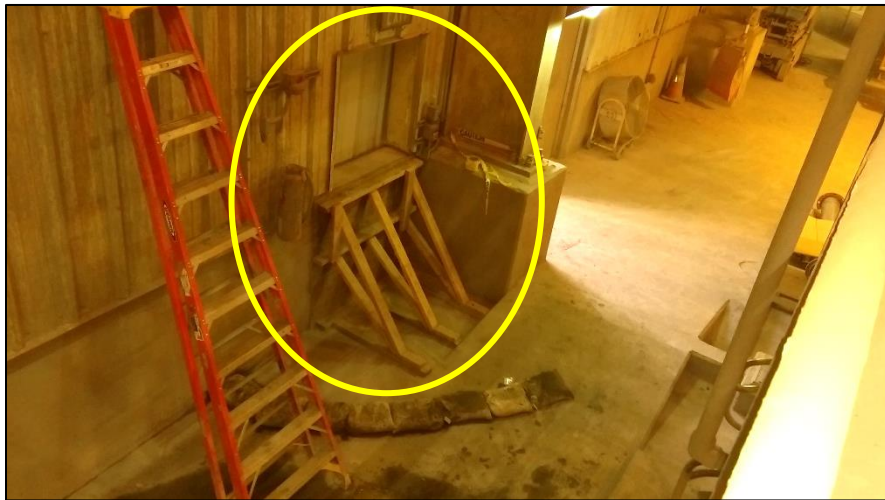
Photo 8. View of access door (now removed and bottom half filled in with concrete; circled) where December 5, 2016 spill left mill building. Note concrete ramp constructed across containment wall for loader access.

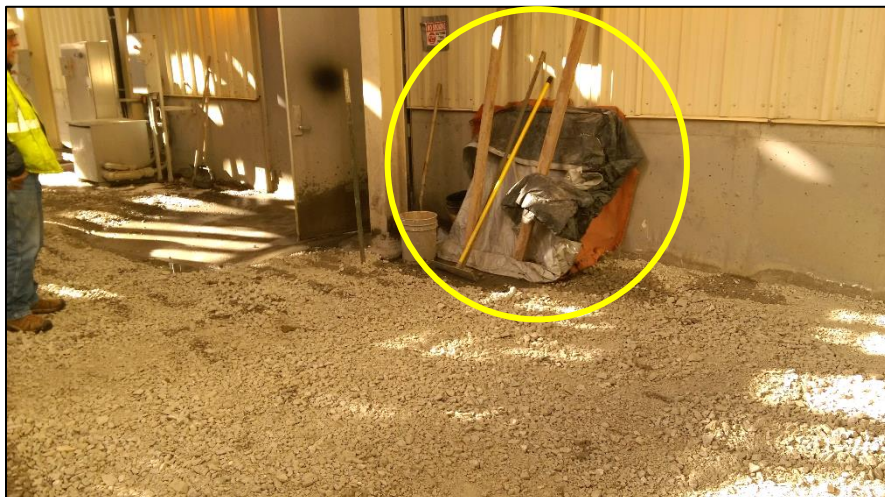
Photo 9. Outside view of access door (circled) shown in Photo 8. Slurry has been extracted from floor of mill secondary containment.

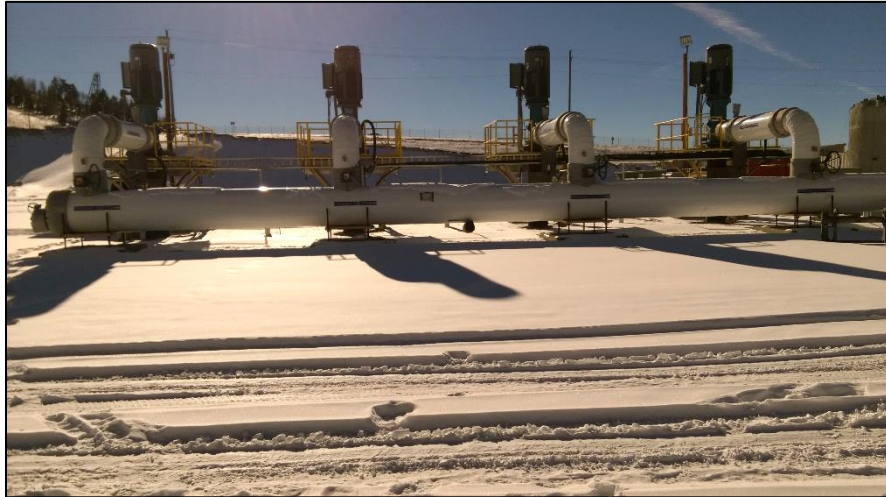
Photo 10. View of SGVLF High Volume Solution Collection System pumps from which water level readings were recorded.

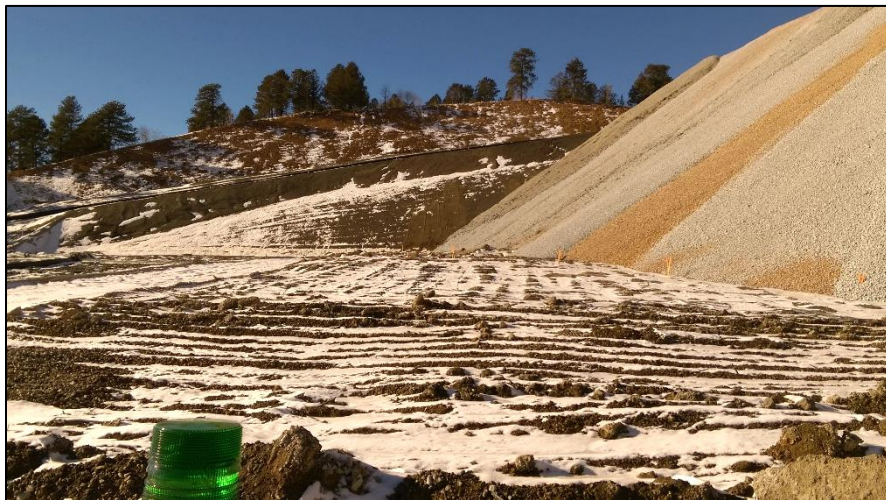
Jeff Campbell represented the operator during this portion of the inspection. The Division inspected the top surface of the Squaw Gulch Valley Leach Facility (SGVLF) where cyanide solution is leached through the ore via driplines (**Photos 11-15**). The top of the leach pad was ripped leaving approximately 8 inch deep furrows across the surface. The Division did not observe any ponded solution exceeding the 3 feet x 3 feet maximum surface area allowed under the operator's approved Wildlife Protection Plan. However, it should be noted that some snow cover was present at the top of the leach pad, which prevented the Division from completing a full visual inspection of the surface.

Photo 11. View looking west across top surface of first lift in SGVLF. No ponded solution exceeding 3' x 3' observed.

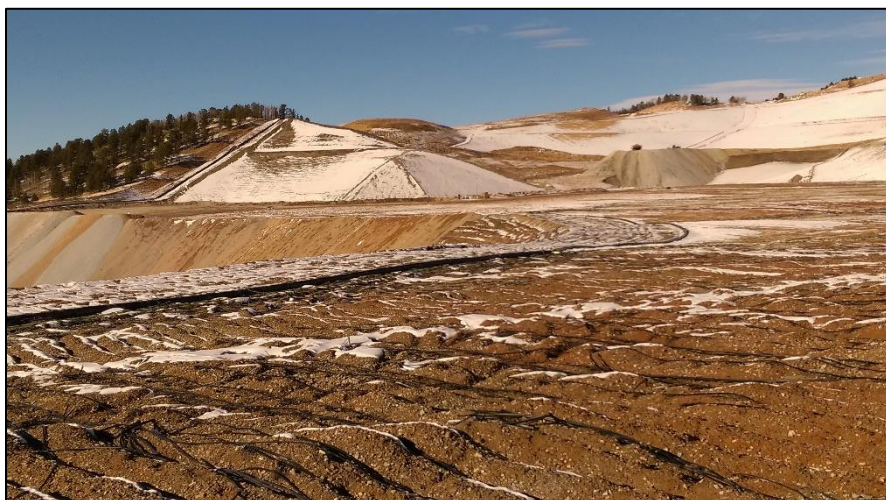
Photo 12. View looking northwest across top surface of SGVLF. No ponded solution exceeding 3' x 3' observed.

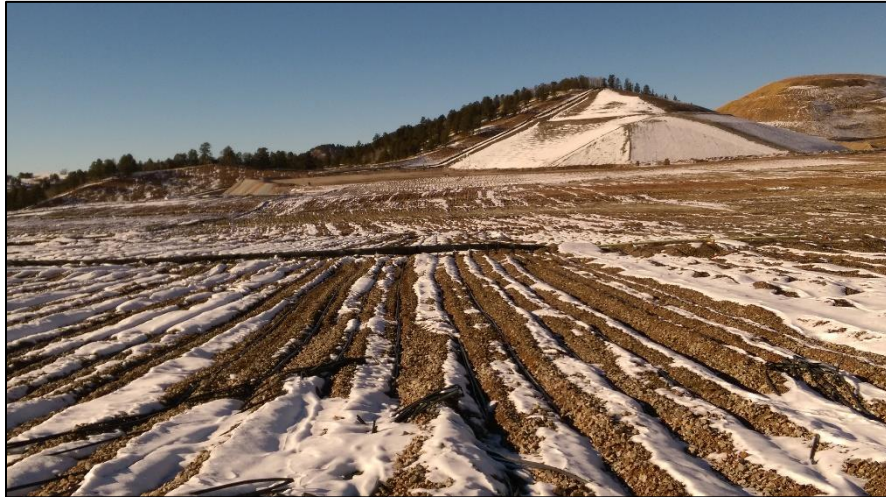
Photo 13. View looking northwest across top surface of SGVLF. No ponded solution exceeding 3' x 3' observed. Note surface ripped to create furrows.

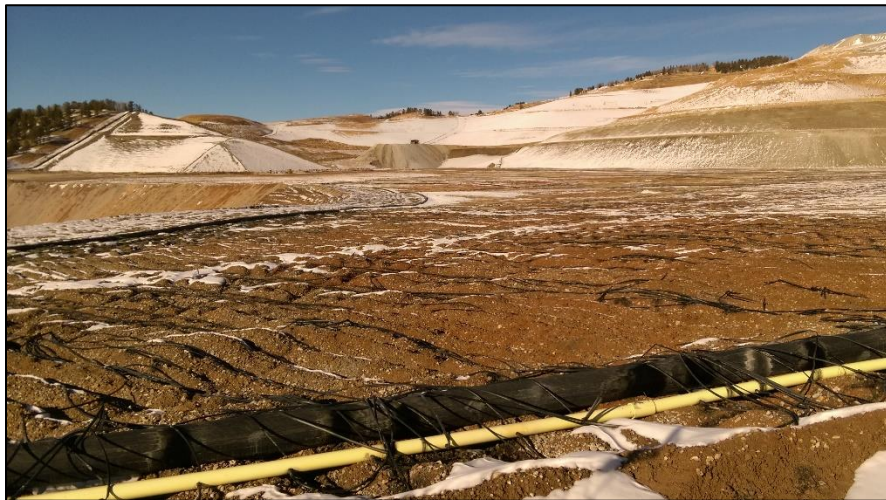
Photo 14. View looking north across top surface of SGVLF. No ponded solution exceeding 3' x 3' observed.

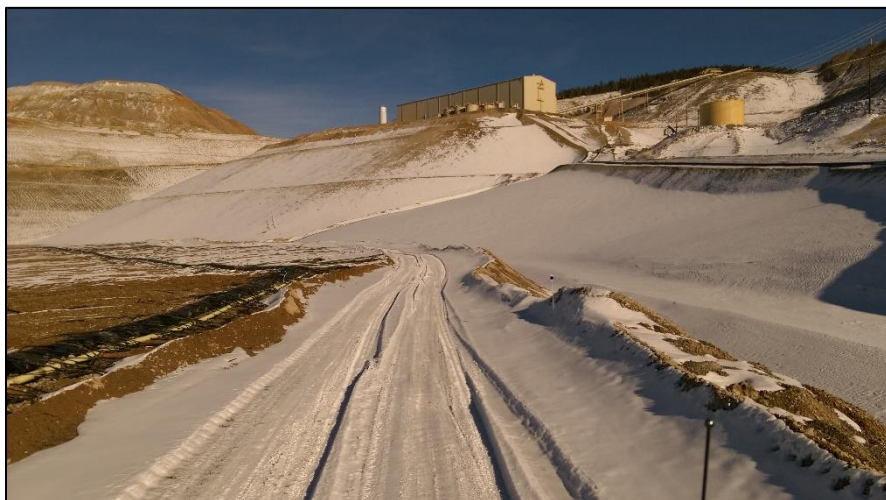
Photo 15. View looking northeast from top surface of SGVLF. No ponded solution exceeding 3' x 3' observed. Note high grade mill facility located in background (top center).
