**MINERALS PROGRAM INSPECTION REPORT****PHONE: (303) 866-3567**

<b>MINE NAME:</b> 120th Estates Partners	<b>MINE/PROSPECTING ID#:</b> M-2001-085	<b>MINERAL:</b> Sand and gravel	<b>COUNTY:</b> Adams
<b>INSPECTION TYPE:</b> Monitoring	<b>INSPECTOR(S):</b> Jared L. Ebert	<b>INSP. DATE:</b> March 15, 2017	<b>INSP. TIME:</b> 10:30
<b>OPERATOR:</b> 120 85 LLC	<b>OPERATOR REPRESENTATIVE:</b> Juan Padilla, Safety Coordinator	<b>TYPE OF OPERATION:</b> 112c - Construction Regular Operation

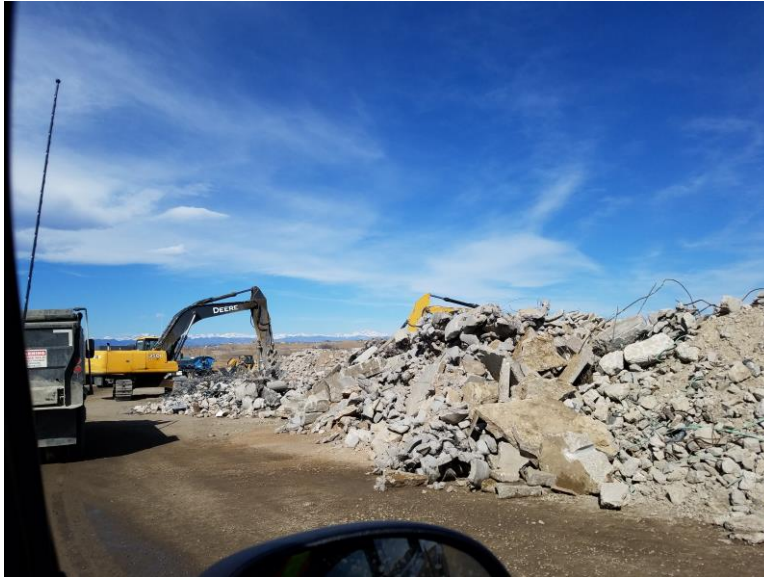
Figure 1. Removing rebar from the concrete.

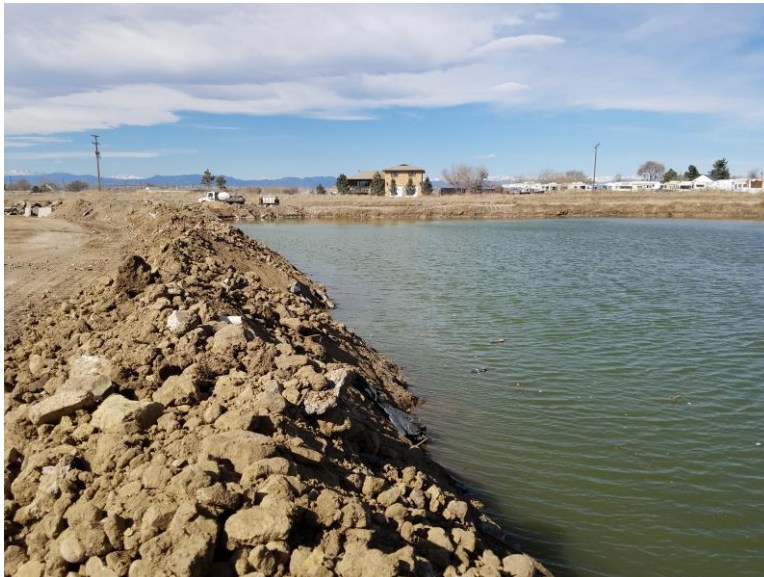
Mining is complete at the site which resulted in a 28 acre pit that is being backfilled with inert material in

accordance with the approval of Amendment No. 6 (AM06). The Division estimates about seven acres of open groundwater remain to be backfilled.

Figure 2. From the southern end of the pit looking west.

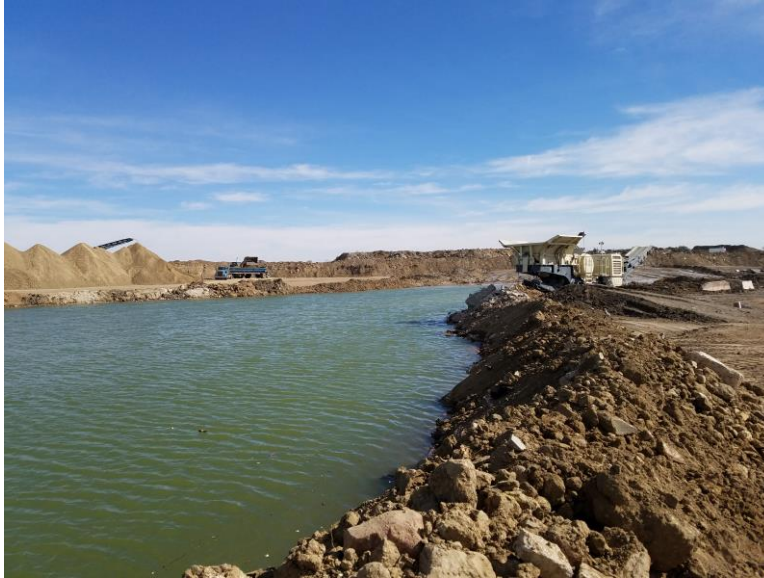
Figure 3. From the southern end of the pit looking east.

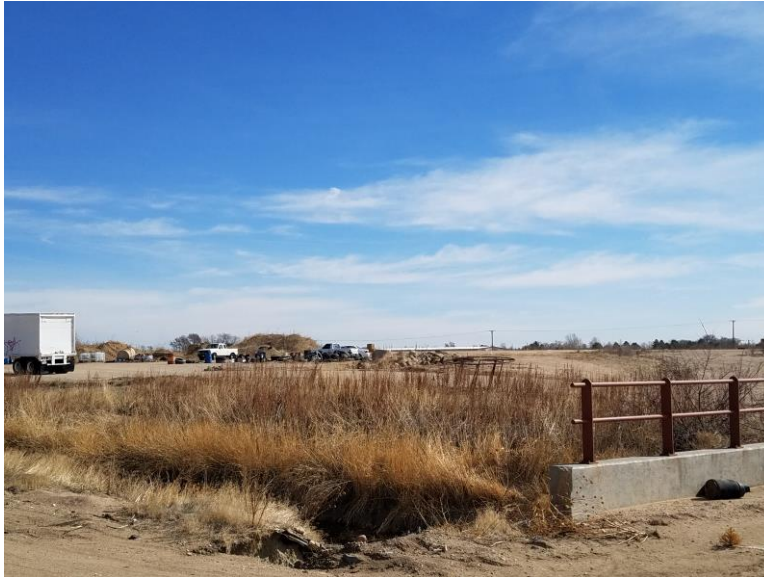
There is a portion of permitted area east of the main facility. These areas were incorporated into the permit area with the approval of AM03 and AM05 (See the enclosed map). These areas include a .4 acre access road to the bridge that crosses the ditch into the site, a 2.2 acre road that was to be used to access the original permit area from 120th Avenue and a 2.7 acre overburden stockpile area that was incorporated into the permit with AM05. According to Mr. Padilla and Mr. Dave Schultejann, they do not own this property and the current landowner uses the site for a number of purposes. A number of vehicles/equipment and hay is stored on this property. It appears overburden is still stockpiled at this location. I explained to Mr. Schultejann, that these areas have not been bond released and that they are still liable for the reclamation of these areas.

Figure 4. View of the property east of the main facilities area. Overburden pile still visible.

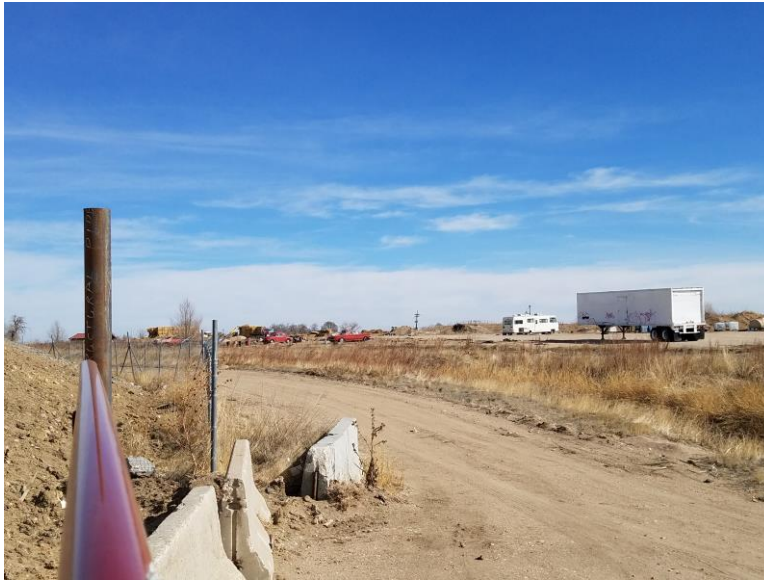
**Figure 5.** From the bridge that crosses the ditch looking northeast.

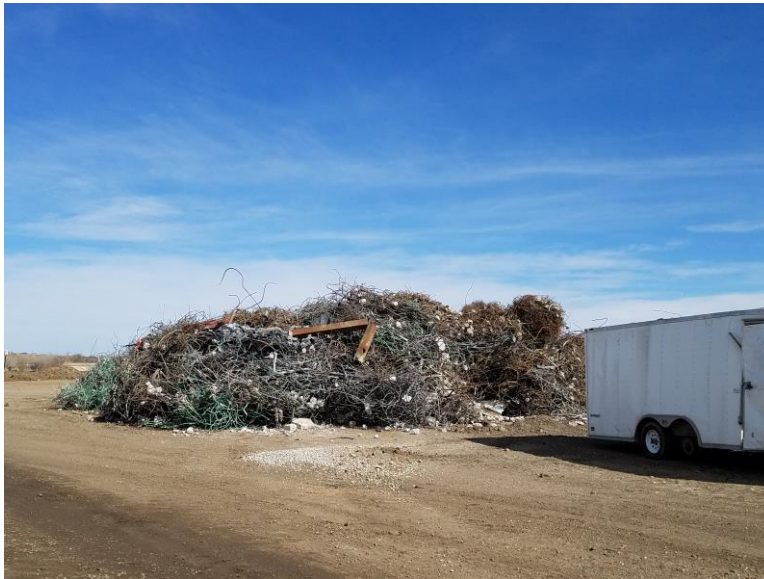
**Figure 6.** Stockpiled rebar.

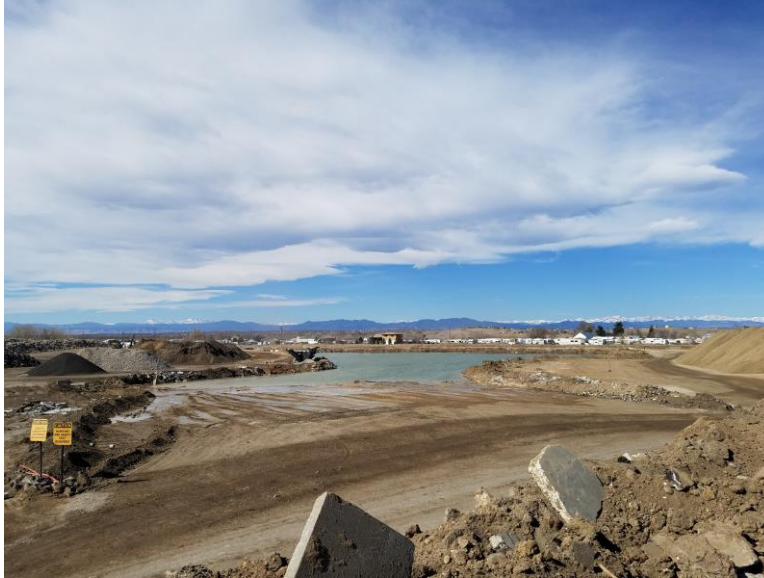
Figure 7. From the northeast end of the site looking west.

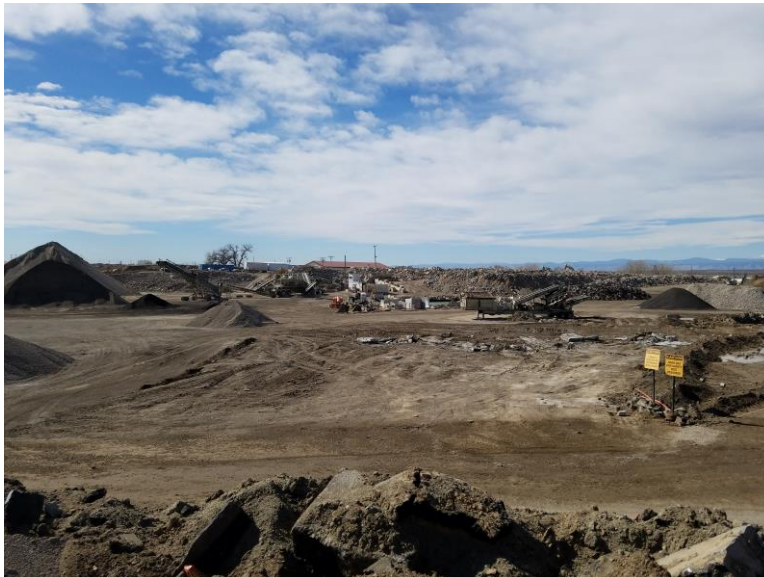
Figure 8. From the northeast end of the site looking southwest.

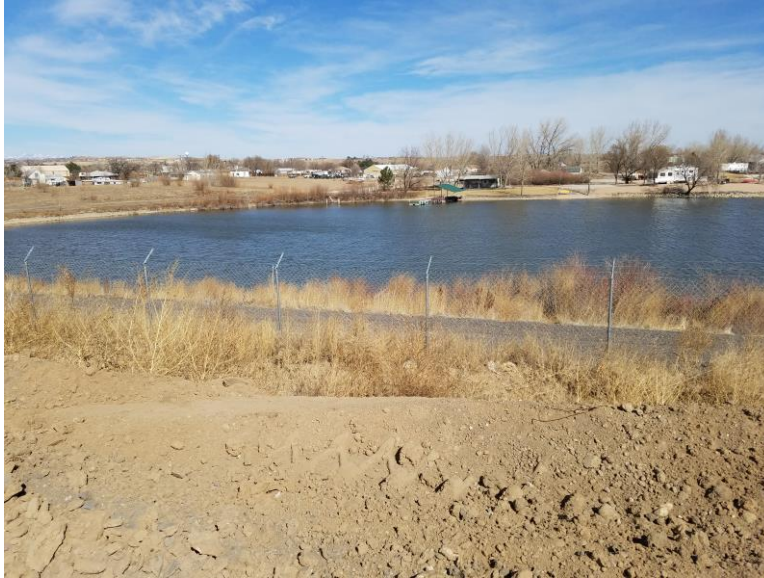
As approved with AM03, according to Mr. Dave Schultejann, a small portion of the Henderson Ski Lake that is located to the north of the site was dredged some years ago. This activity was completed. The permitted portion of the lake was observed. No surface disturbance was noted. The slope to the lake appears vegetated and stable.

**Figure 9. View of the Henderson Ski Lake from the north end of the property. View of the approximate area where dredging occurred.**

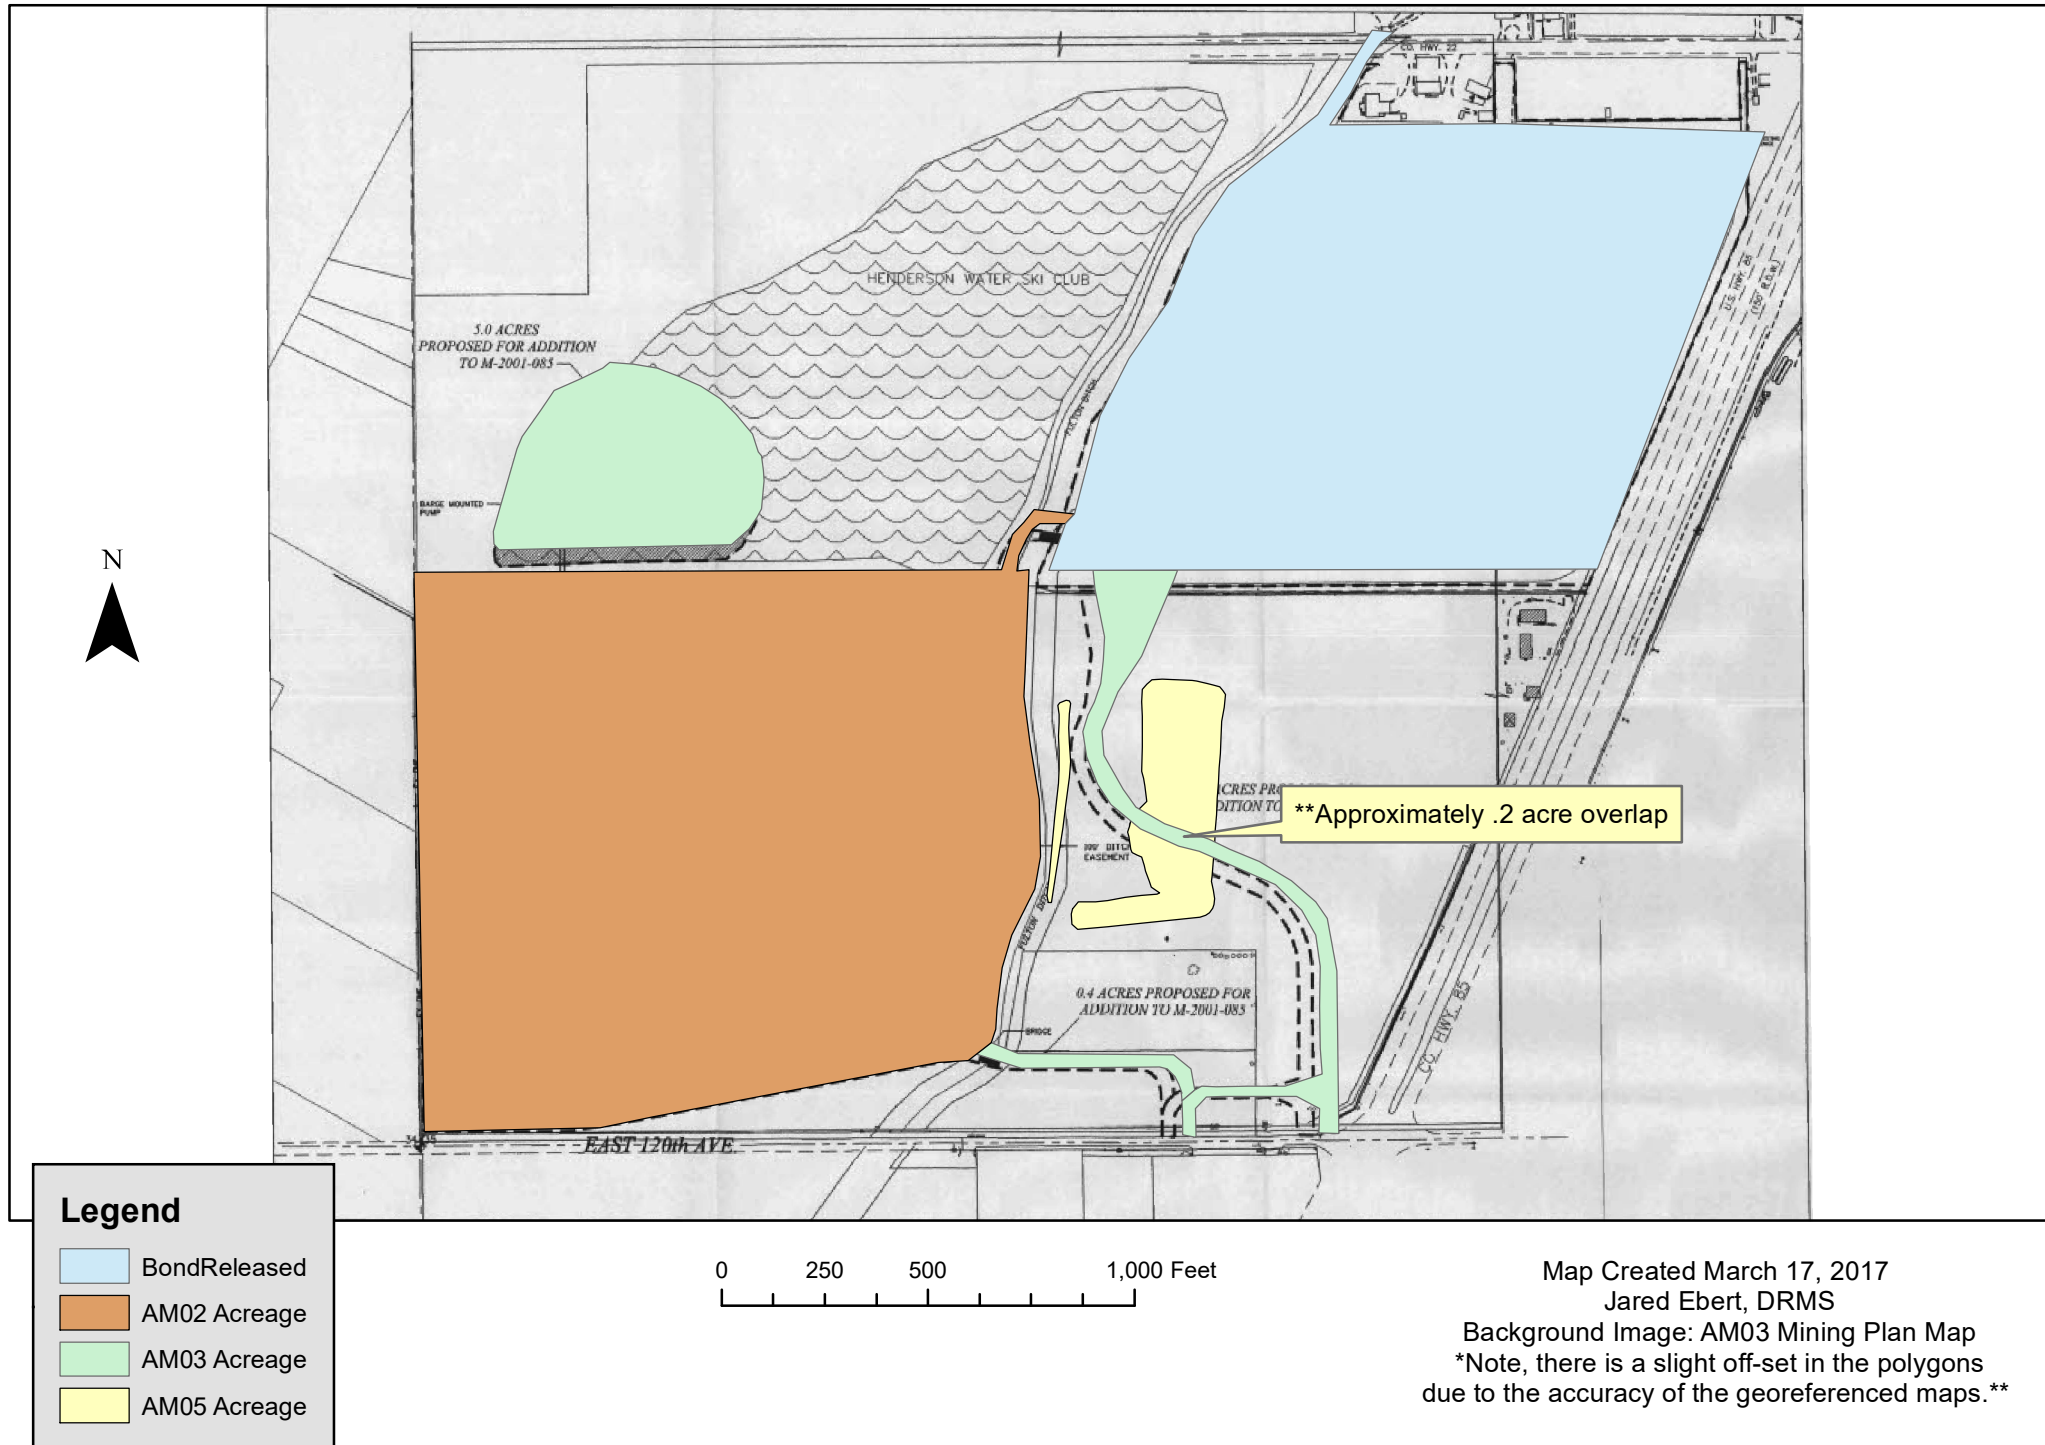
March 15, 2017 Inspection, Permit Area review

This is a 112c operation. There appears to be a discrepancy in the number of permitted acres associated with this site. The original permitted acres for the site was 34.3 acres. In March of 2003 Amendment No. 2 (AM02) was approved which added 41.2 acres to the site bringing the total permit acres to 75.5 acres. In February of 2004, Amendment No. 3 (AM03) was approved which added 7.6 acres to the permit area bringing the total permit area to 83.1 acres. On September 13, 2004 the Division approved an acreage reduction (AR01) of 34 acres bringing the permit area to 49.1 acres. Amendment No. 5 (AM05) was submitted to encompass some offsite disturbance which resulted in an enforcement action, this resulted in an increase in the permit area by 2.7 acre, however the AM05 application form only listed the approved permit area to be 41.3 acres. It does not appear the acreage associated with AM03 was accounted for with the AM05 application; also, there is approximately a .2 acre area of overlap between the acres permitted with AM03 and AM05. Given this, the Division believe the correct permit acreage for the site is 51.6 acres, which includes the 49.1 acres remaining within the permit area after the approval of AR01, the addition of 2.7 acres with AM05 and the subtraction of about .2 acre of overlap between the AM03 area and the AM05 area. Please see the enclosed map which depicts each of the areas discussed. The applicant should be aware they are responsible for all the areas shown on the map that have not been bond released.
