MINERALS PROGRAM INSPECTION REPORT

MINE NAME: Dallas Gravel Pit	MINE/PROSPECTING ID#: M-1978-268	MINERAL: Gravel	COUNTY: Ouray
INSPECTION TYPE: Monitoring	INSPECTOR(S): Travis H. Marshall	INSP. DATE: March 8, 2017	INSP. TIME: 10:00
OPERATOR: Ouray County	OPERATOR REPRESENTATIVE: Steven Calkins	TYPE OF OPERATION: 112c - Construction Regular Operation

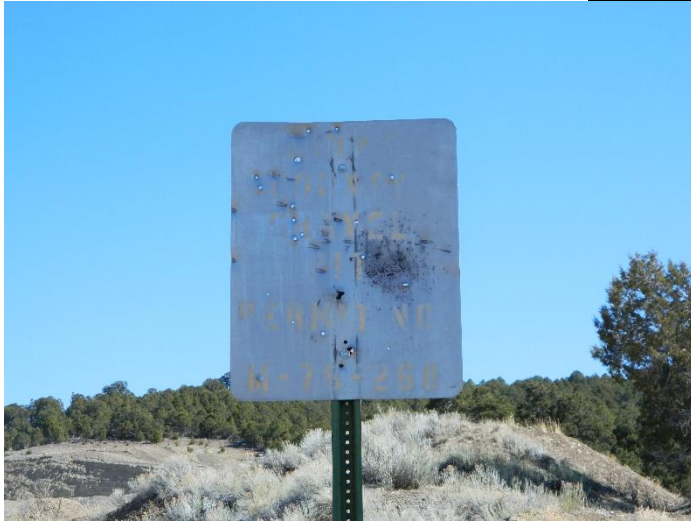
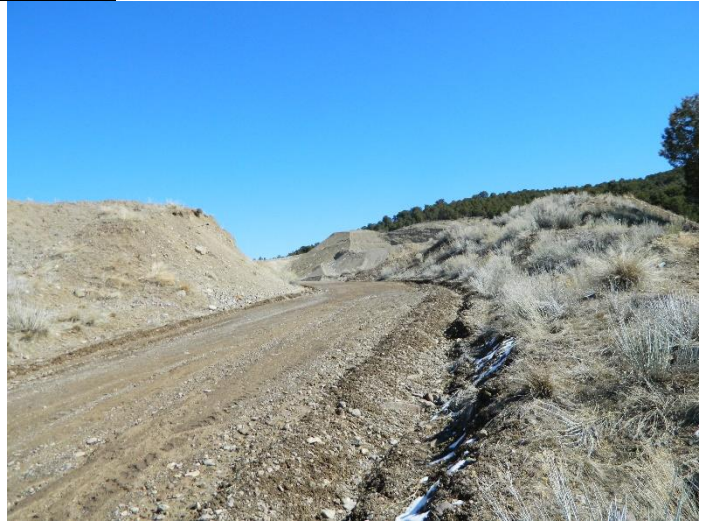
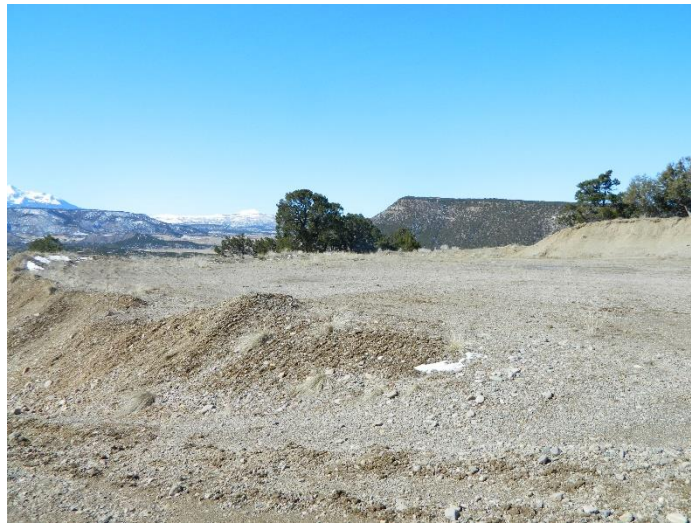
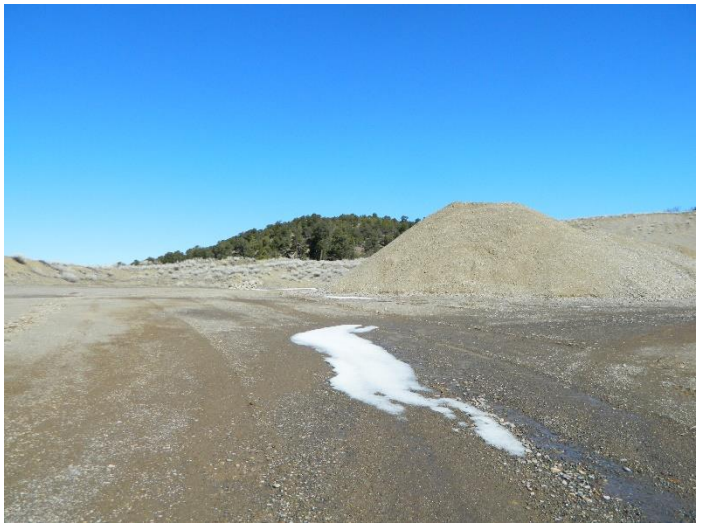
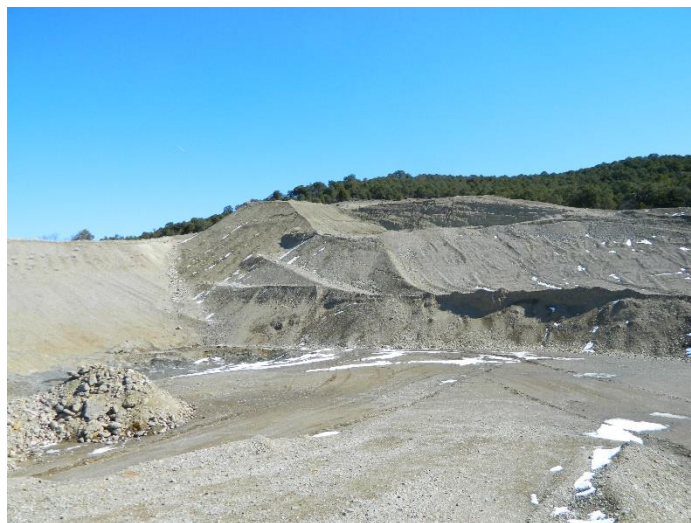
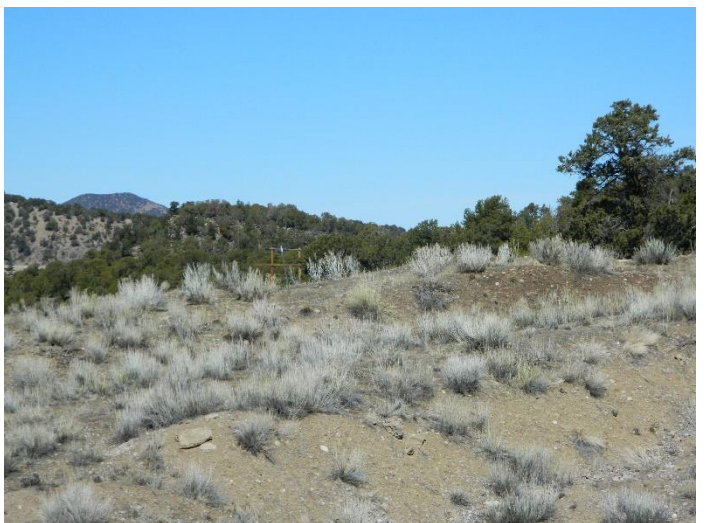
The mine identification sign was located and observed at the main entrance to the site and permit boundary markers were located around the entire boundary of the permit area. The Mine identification sign was very faded and nearly illegible. The sign needs to be replaced and in compliance with the requirements of Rule 3.1.12. Please provide this office with photo-documentation of a new sign installed at the entrance of the mine site no later than May 12, 2017. This is noted as a problem and failure to provide proof that a new sign has been installed by May 12, 2017 will initiate enforcement action.

The site appeared to not have adequate topsoil on site to complete the required reclamation. This is seen as a problem and will require the operator to submit a technical revision to the permit (with the required \$216 fee) identifying the source of the additional topsoil required to reclaim the site in accordance with the approved reclamation plan by the corrective action date of July 3, 2017.

CORRECTIVE ACTIONS: The operator shall, at the entrance of the mine site, post a sign which shall be clearly visible from the access road with the following: the name of the operator, a statement that a reclamation permit for the operation has been issued by the Colorado Mined Land Reclamation Board; and the permit number. The operator shall submit photo documentation that a proper sign has been posted by the corrective action date.

CORRECTIVE ACTIONS: The operator shall submit a technical revision to the permit (with the required \$216 fee) identifying the source of the additional topsoil required to reclaim the site in accordance with the approved reclamation plan by the corrective action date.
