RE: 83rd Joint Venture; ID # M-1992-069

Re: Response to Comments Provided by the Division of Reclamation, Mining and Safety and Aggregate Industries Regarding the 83rd Joint Venture Pit

This letter, prepared by Wright Water Engineers, Inc. (WWE) on behalf of the Boyd Irrigation Company (BIC), addresses the BIC's flood damaged pipeline for the Boyd-Freeman Ditch. The damaged pipeline section is located north of F Street and west of the 83rd Joint Venture gravel pit owned by Aggregate Industries.

**BOYD-FREEMAN DITCH AND F ST. PROPERTY
OVERVIEW MAP**

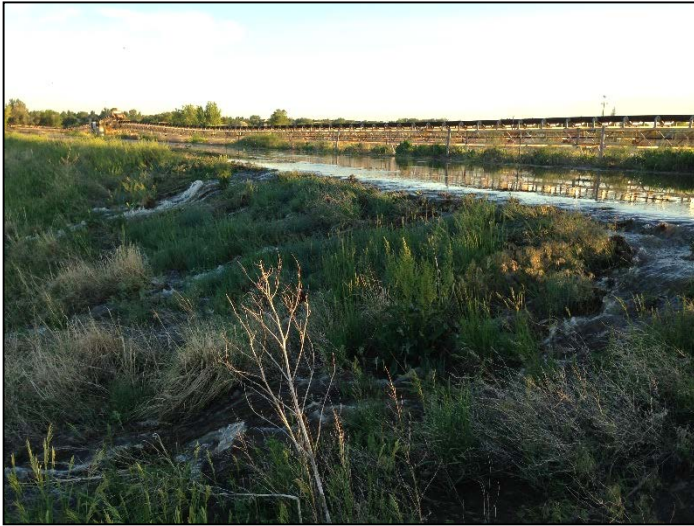
- Photos taken by Roger Schmidt, BIC President, on May 27, 2014 during the early stages of the 2014 flood event, show a broad sheet of flow reaching the top of the pit's embankment and starting to flow down into the pit (see photos in Appendix B to this letter). The photos do not show a distinct location with settlement in the pipeline that caused flows to concentrate down the embankment.

Sheet flow down the reclamation slope is the only mode of failure that is supported with evidence based on the information we have reviewed. Photos of water flowing over the crest of the embankment, taken during the early stages of the 2014 flood event, show evenly distributed sheet flow as it reaches the crest of the pit’s embankment.

Photo B.1 - View south along embankment of AI pit with water beginning to flow over the embankment.

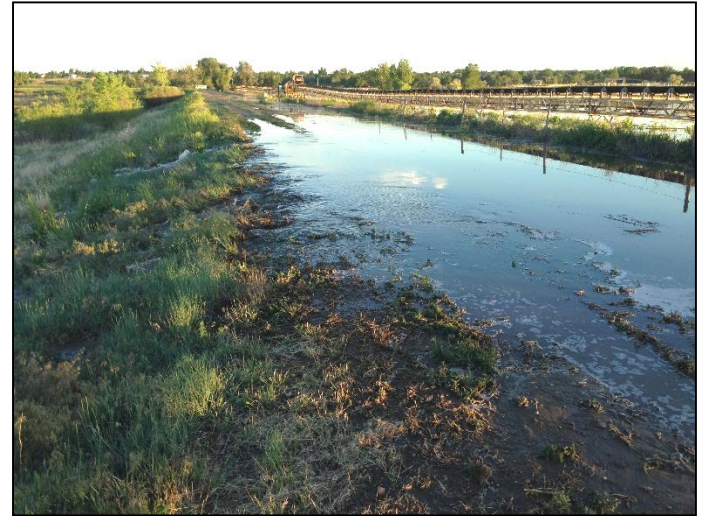
Photo B.2. View south along embankment of AI pit with water beginning to flow over the embankment.

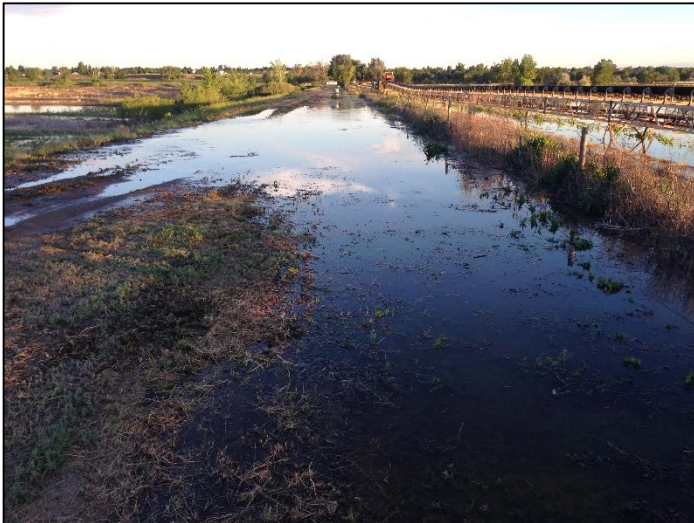
Photo B.3 - View south along pipeline alignment with AI pit on left and F Street agricultural field on right, with water beginning to flow over the embankment.

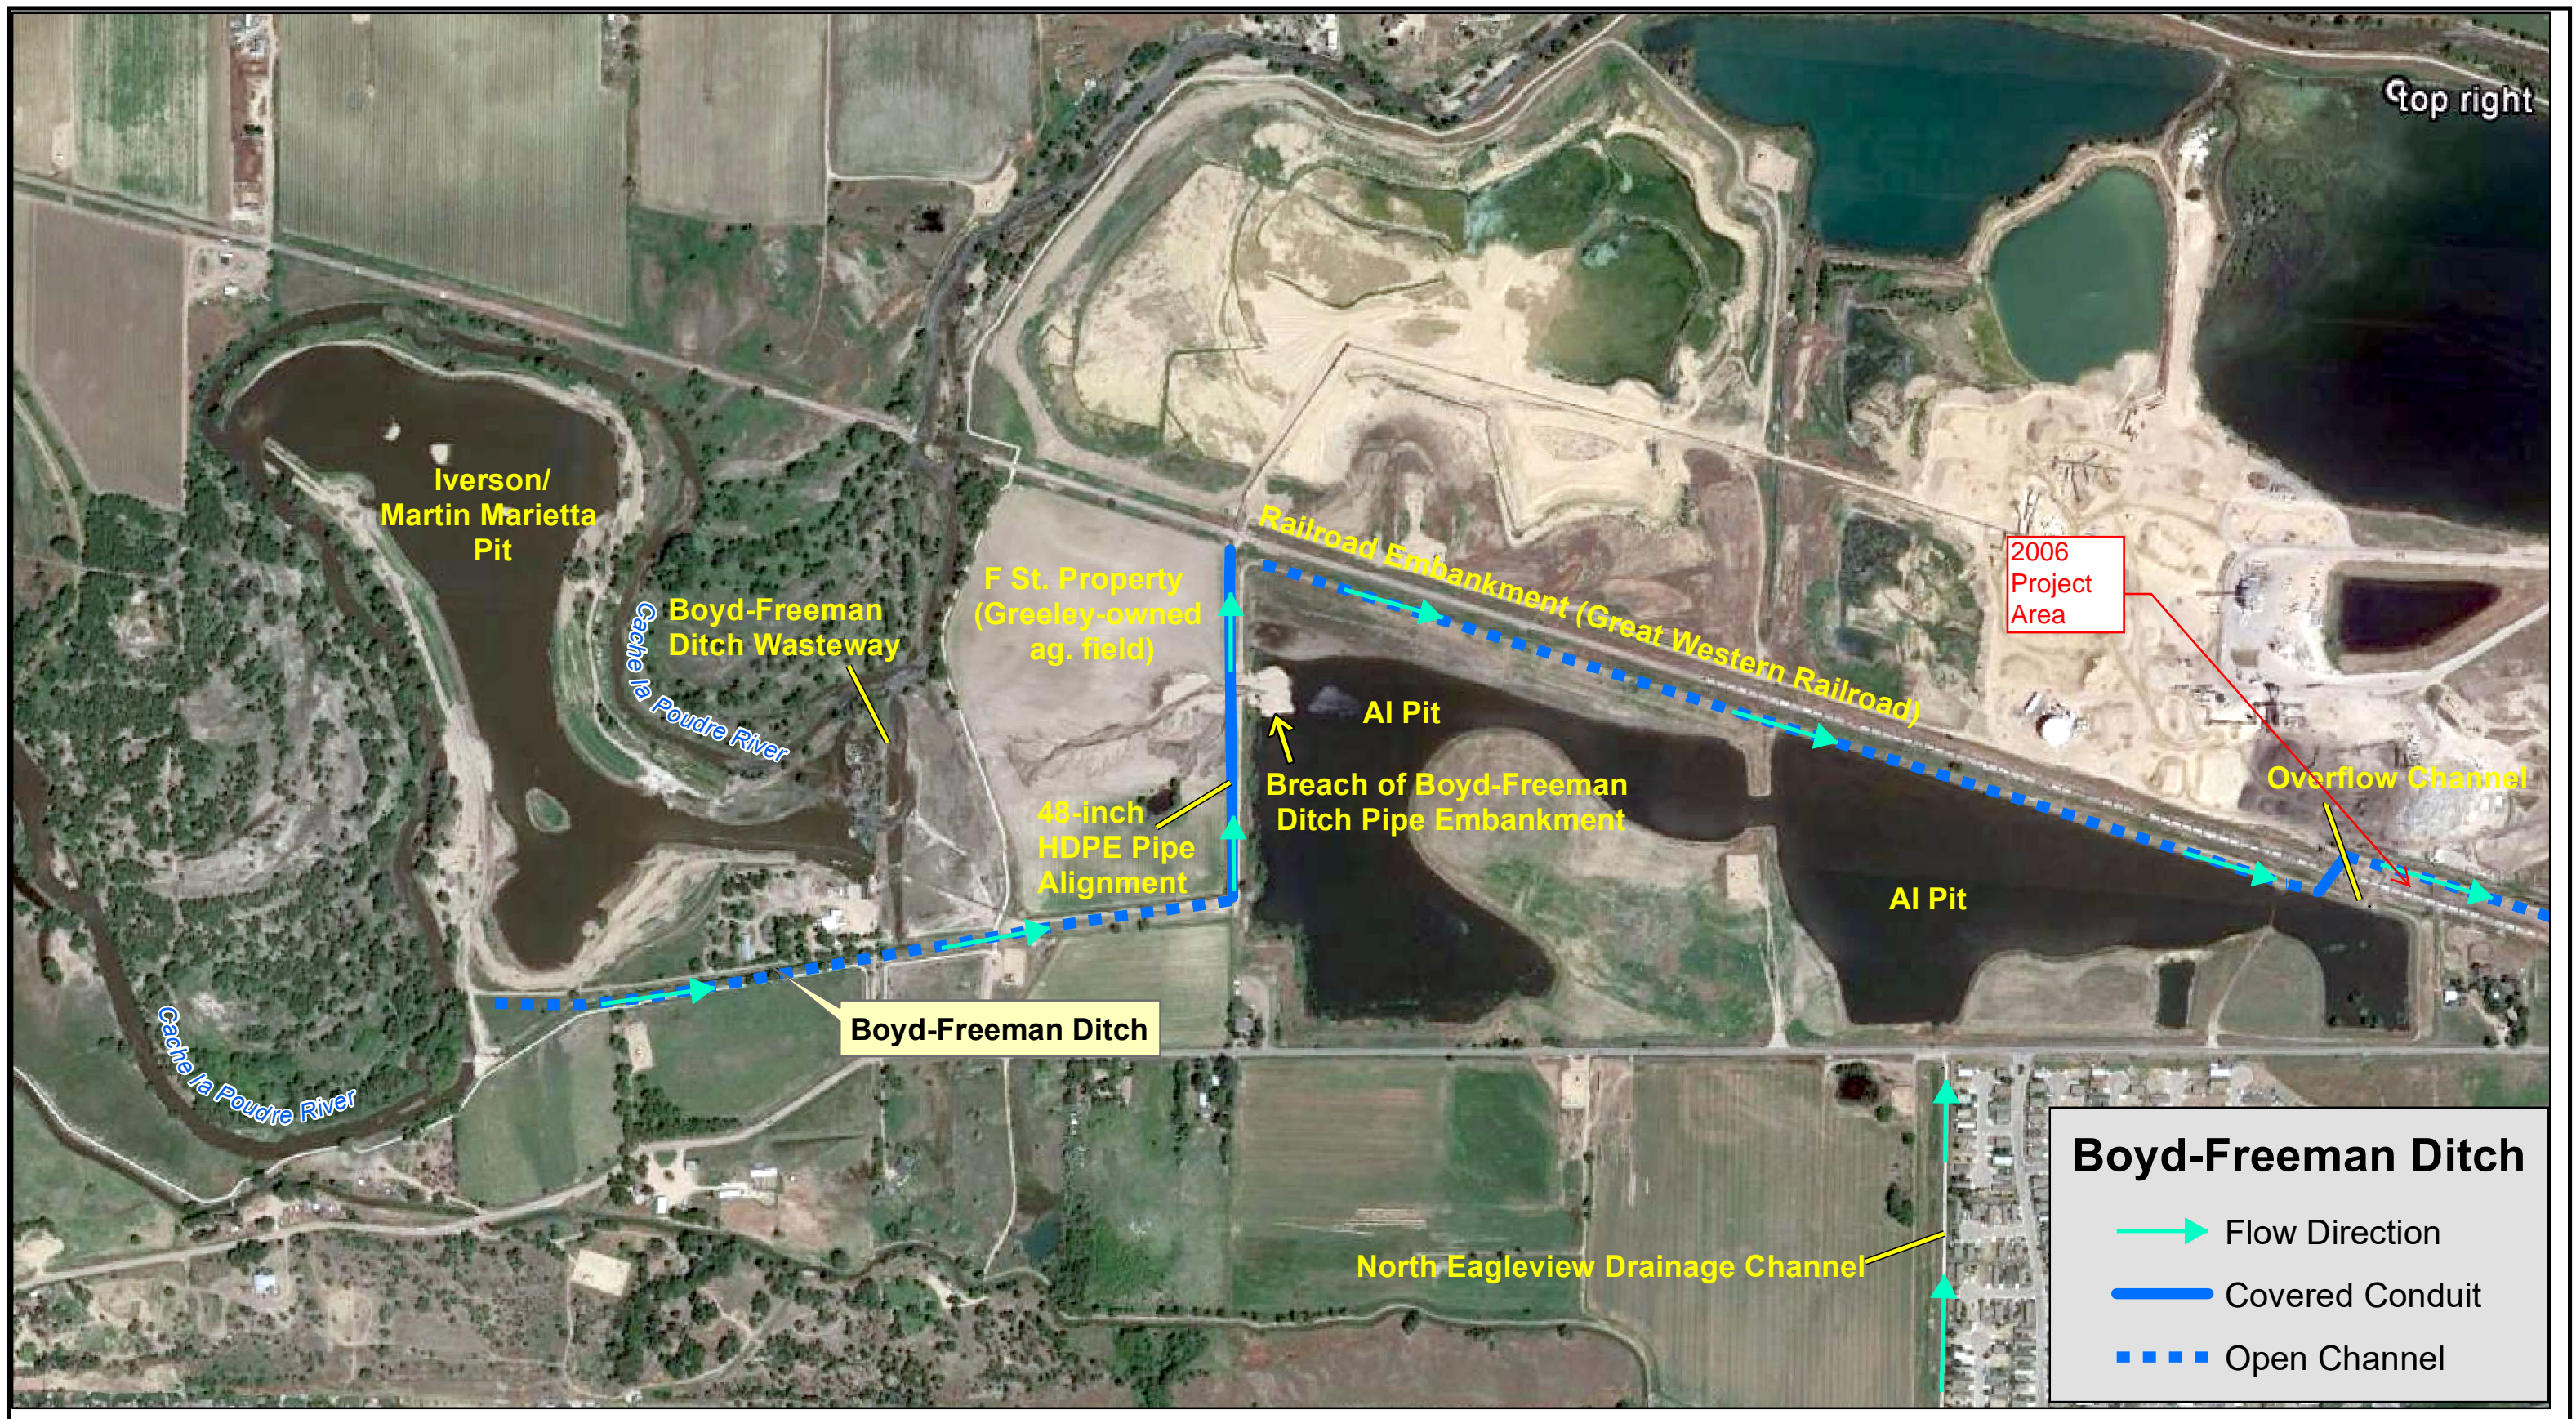
FIGURE
1

For clarification, the 2006 project referenced in the AI letter and in the attached correspondence is at the northeast end of the AI pit (see Figure in Appendix C). This location is separated by roughly 1,800 feet from the location where the ditch failure occurred in 2010 and where the pipeline breaches occurred in 2013 and 2014. In addition, the Boyd-Freemen Ditch was relocated by AI to its current alignment sometime between 1999 and 2001 (based on aerial imagery), which was several years before the referenced 2006 project took place.
