**MINERALS PROGRAM INSPECTION REPORT**  
**PHONE: (303) 866-3567**

<b>MINE NAME:</b> The Orr Pit	<b>MINE/PROSPECTING ID#:</b> M-2009-074	<b>MINERAL:</b> Sand/gravel/borrow	<b>COUNTY:</b> Pueblo
<b>INSPECTION TYPE:</b> Monitoring	<b>INSPECTOR(S):</b> Elliott R. Russell	<b>INSP. DATE:</b> March 1, 2017	<b>INSP. TIME:</b> 08:00
<b>OPERATOR:</b> Colorado Backhoe Service	<b>OPERATOR REPRESENTATIVE:</b> Thomas Joseph	<b>TYPE OF OPERATION:</b> 110c - Construction Limited Impact

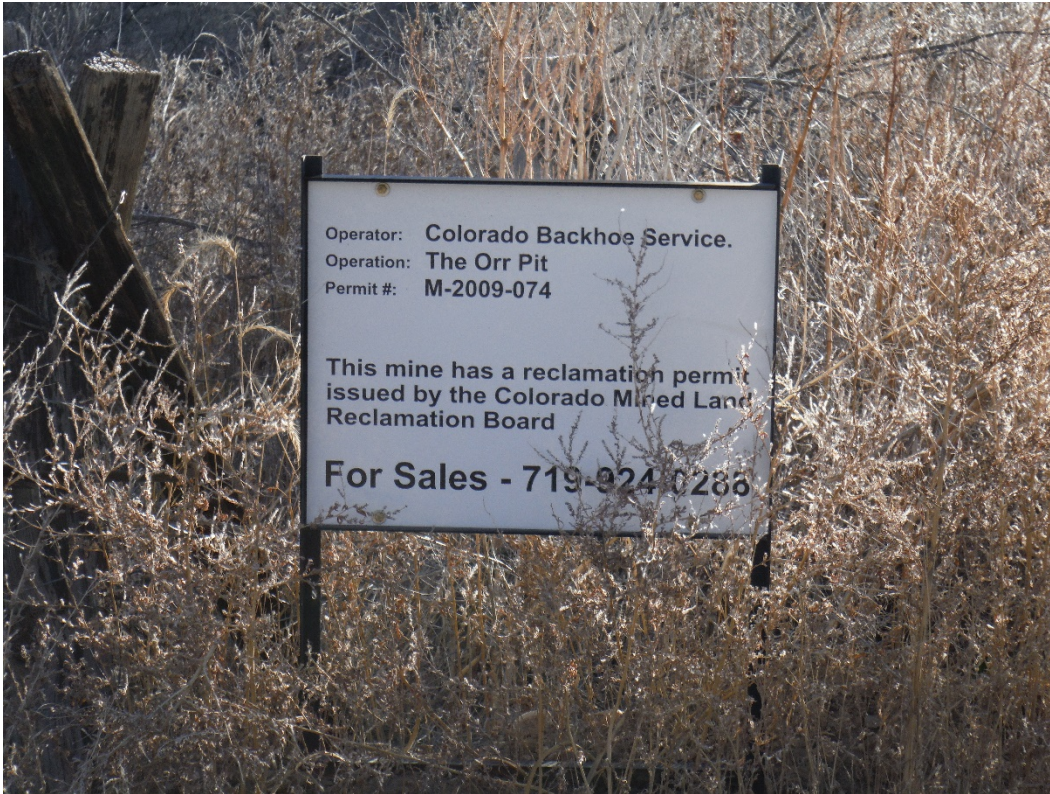
The Division met Mr. Thomas Joseph at the mine site entrance on the east side of 33<sup>rd</sup> Lane, approximately 750 feet south of US Business Highway 50. The mine site identification sign was posted at the entrance and was in compliance with Rule 3.1.12(1). The permit boundary was delineated by a metal t-posts and wood stakes. The site was active at the time of the inspection and equipment on the site consisted of four mobile crushers and screens, multiple conveyor stackers, two excavators, a front-end loader, and a bobcat.

**Fig 1.** Mine identification sign; looking east.

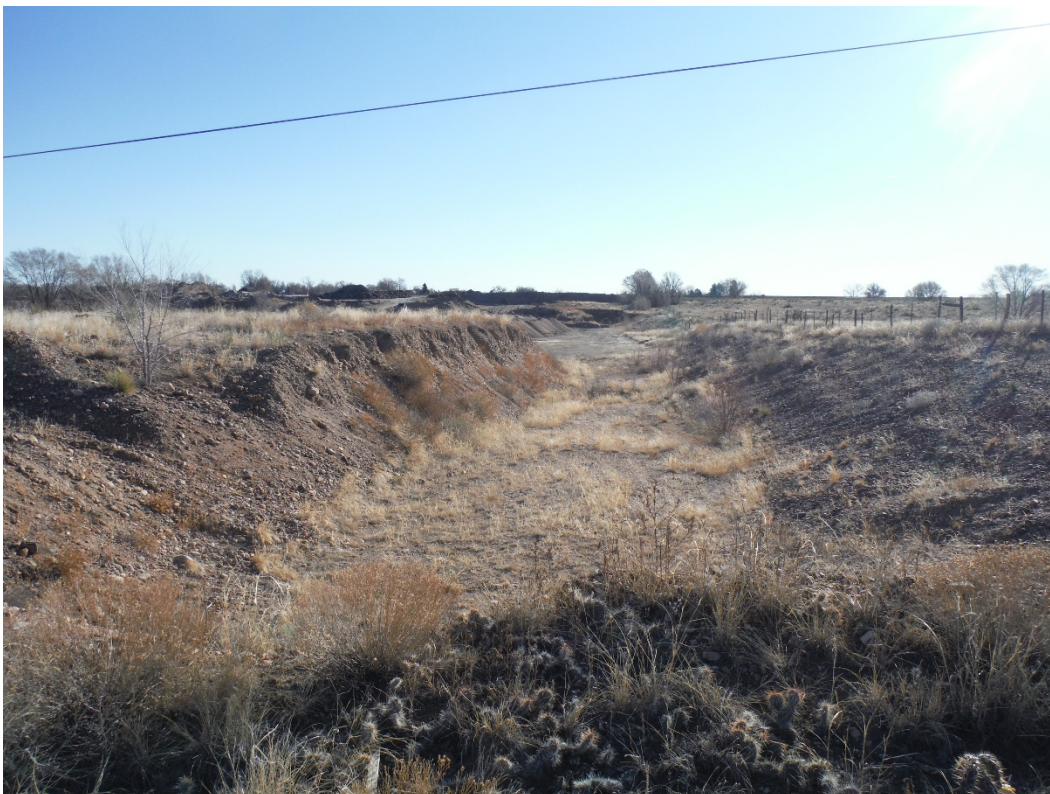
Based on field observations and a review of an August 28, 2013 Google Earth aerial image, the Division has determined the Operator has disturbed approximately six acres outside of the approved permit boundary. The Division considers mining more than 2 acres outside of the approved permit boundary as a violation of mining without a permit. The Division has attached a Google Earth image (*3-1-2017 Inspection Map M-2009-074*) as a reference. This map delineates the following:

**Fig 2.** Excavation located southwest of the permit boundary; looking east.

**CORRECTIVE ACTIONS:** This possible violation will require a hearing before the Mined Land Reclamation Board scheduled for the April 26-27, 2017 Board meeting. The schedule and other details for the MLRB hearing will be provided under a separate document to be sent via certified mail to the operator.

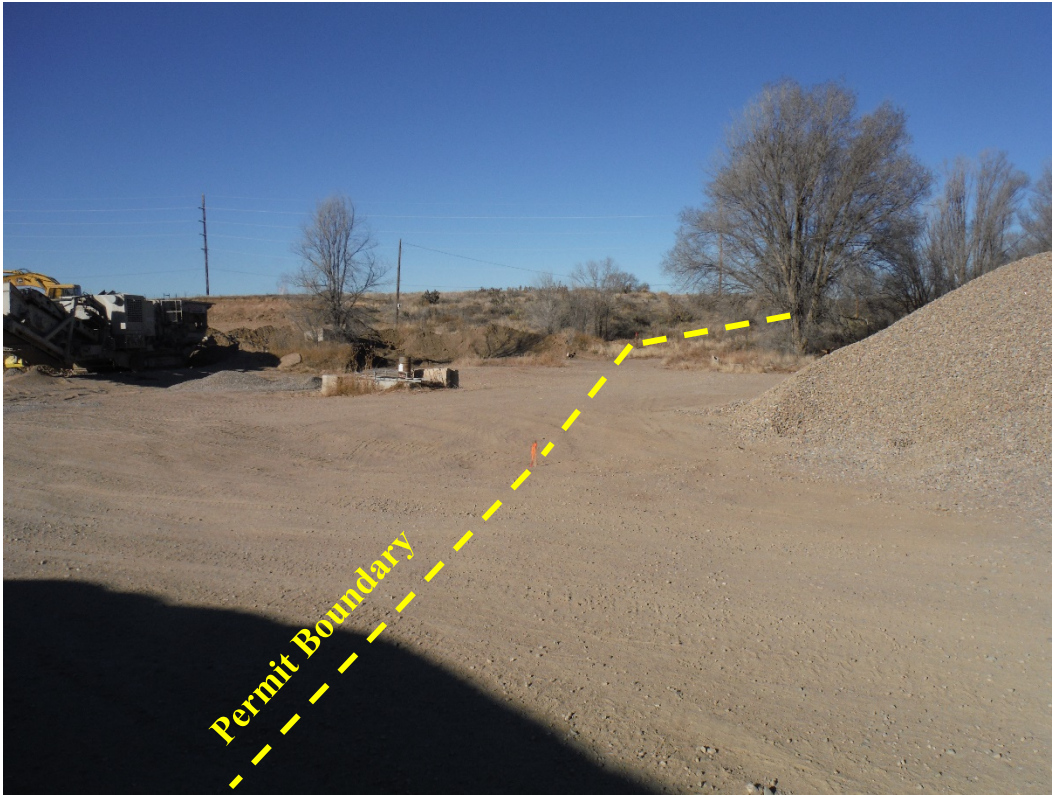
**Fig 3.** Processed 1 1/2" gravel stockpile (right) located north of the permit boundary (yellow dashed line); looking west.

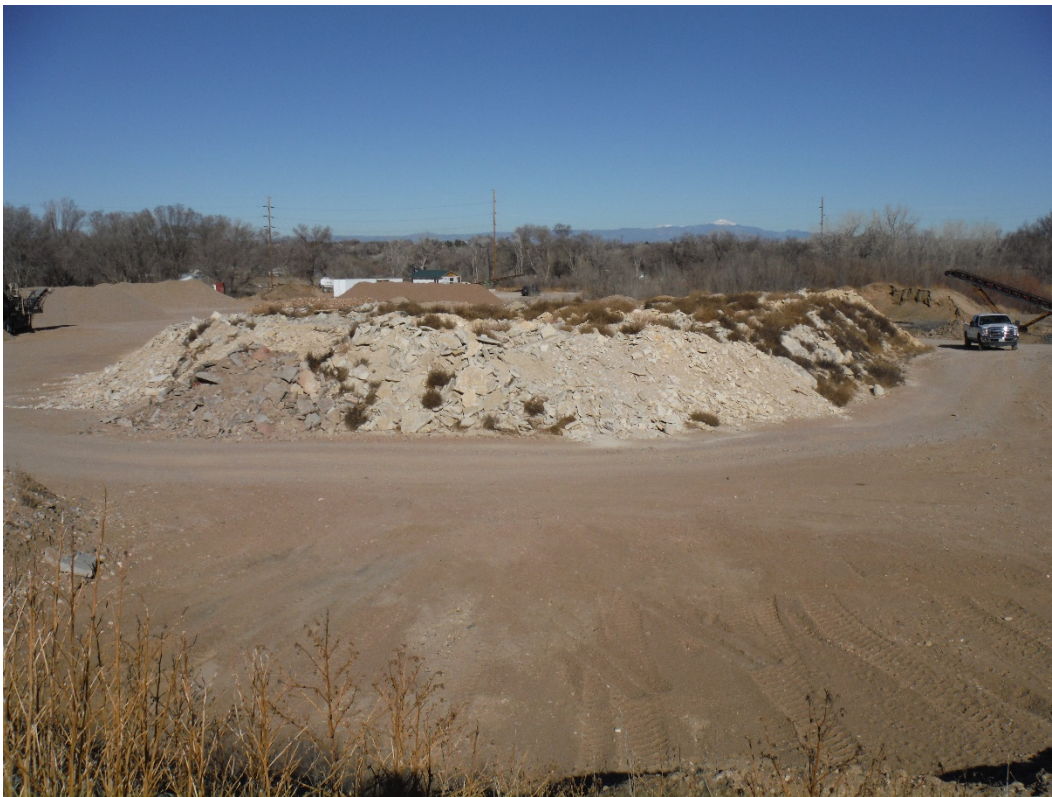
site from off-site projects and were being used for recycling and processing for possible re-sale or being backfilled; these included concrete, asphalt, bricks, shale, and fill dirt. Stockpiles of screened-to-size gravel and sand, which appeared to have originated from the deposit on site, and the imported shale stockpile were located on the pit floor in the central portion of the site. Large raw asphalt and raw concrete stockpiles and smaller processed/crushed stockpiles of each were located on the eastern portion of the site. A large stockpile of fill dirt was located in the northeast corner of the site; the operator stated this material came from a local storm sewer installation project and could possibly be used as topsoil. After further review of the permit file, the Division has determined the importation of materials for processing and/or backfilling is not authorized under the approved Mining and Reclamation Plans nor covered in the reclamation cost estimate. This has been cited as a compliance problem on page two of this report.

**Fig 4.** Imported shale stockpile; looking northwest.

**CORRECTIVE ACTIONS AND DUE DATE:** The operator shall submit a revision to update and clarify the current approved mine plan to reflect existing and proposed activities. The corrective action due date will be determined pending the April 26-27 hearing regarding the possible violation above.

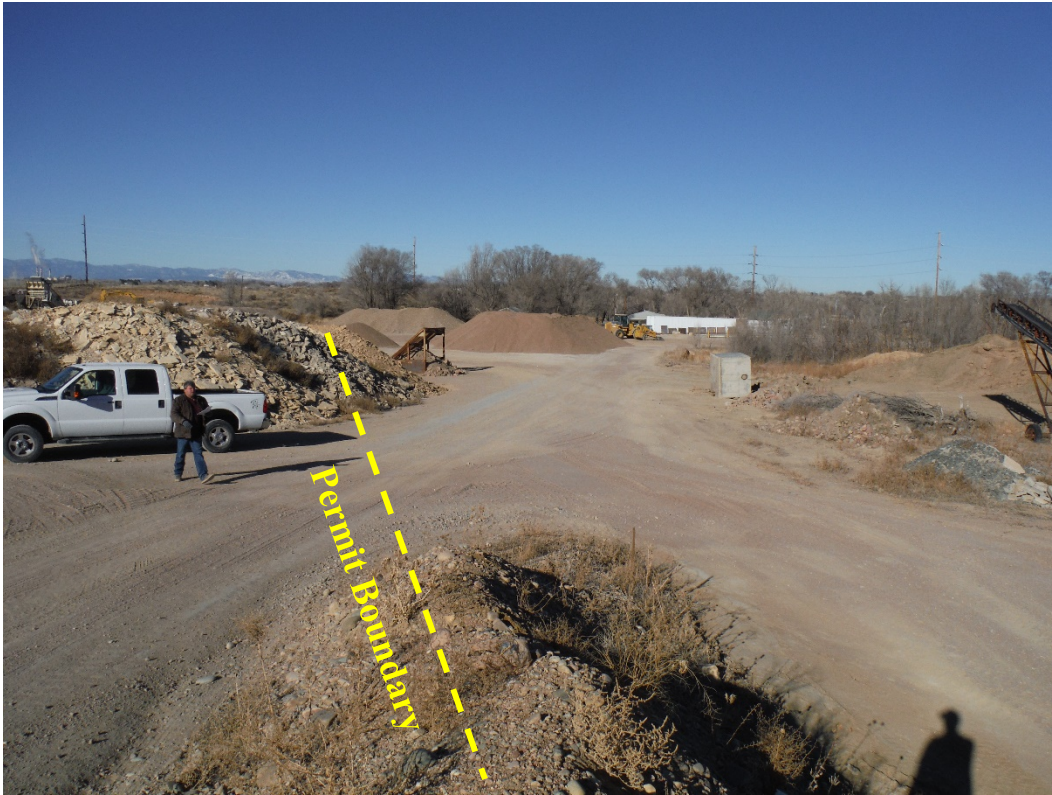
**Fig 5.** Re-disturbed old mining disturbance, conveyor stacker, and small stockpiles (right) located north of the permit boundary (yellow dashed line); looking west.

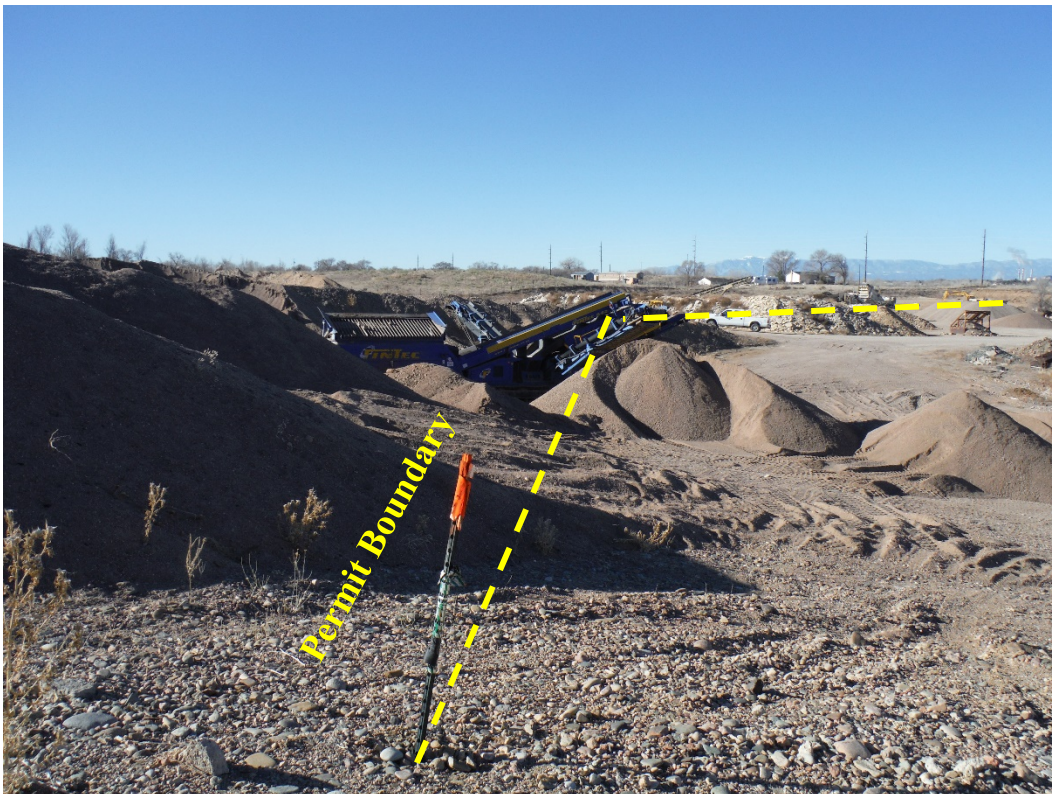
**Fig 6.** Re-disturbed old mining disturbance, mobile screen, and stockpiles located north of the permit boundary (yellow dashed line); looking south.

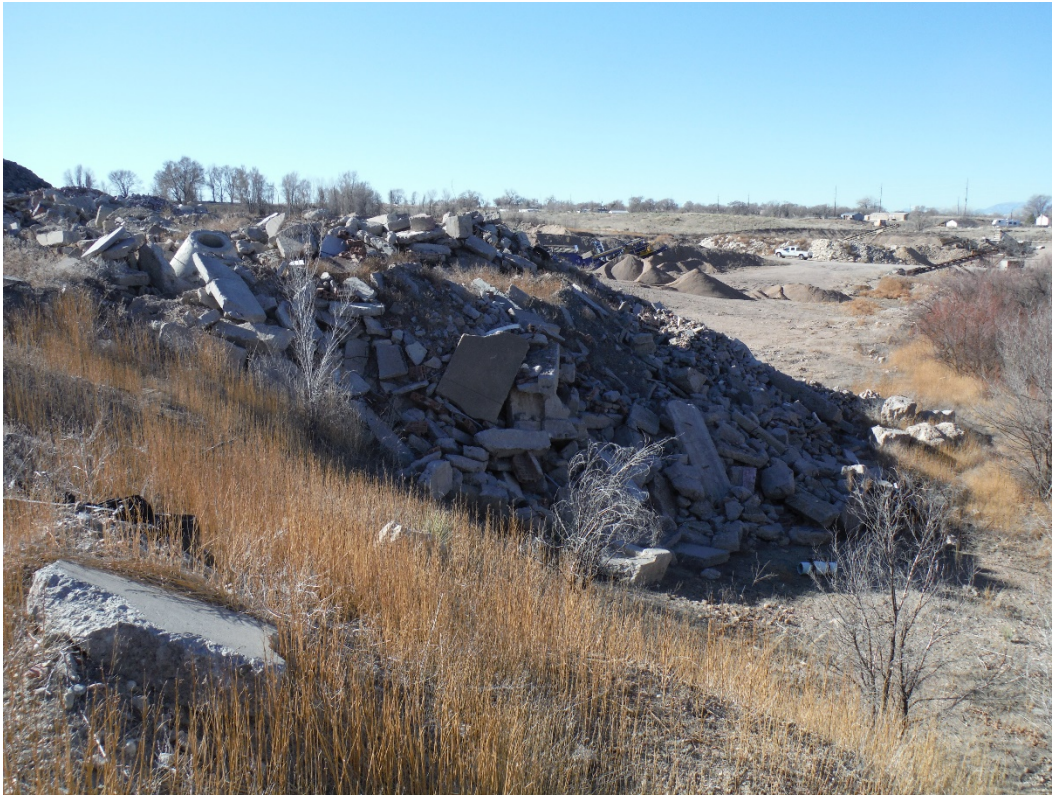
**Fig 7.** Stockpiled/backfilled concrete rubble; looking south.

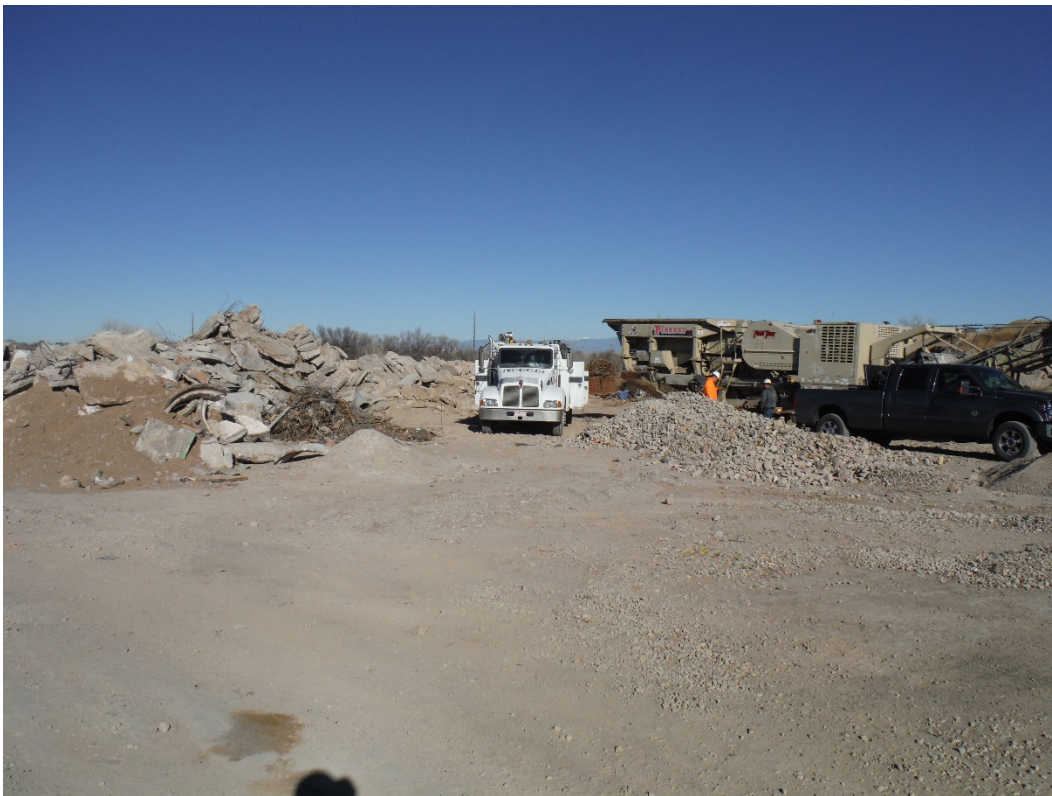
**Fig 8.** Stockpiled concrete rubble and mobile crusher; looking northwest.

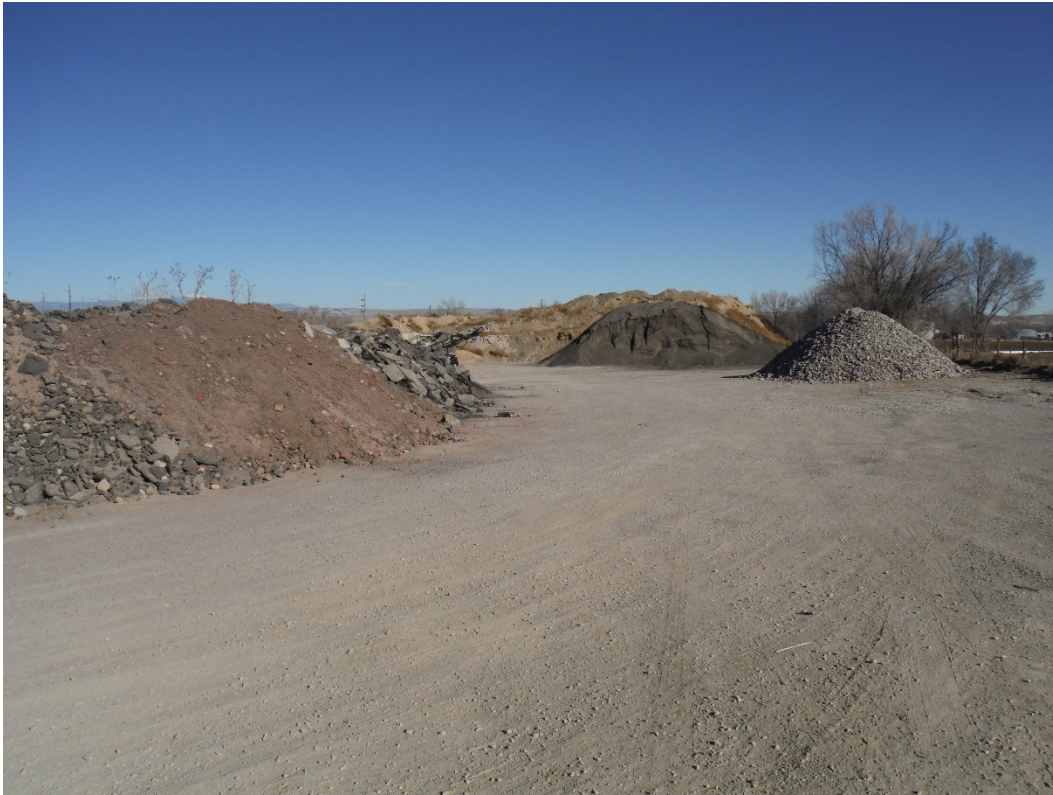
**Fig 9.** Various imported stockpiles located in eastern portion of the site; looking north.

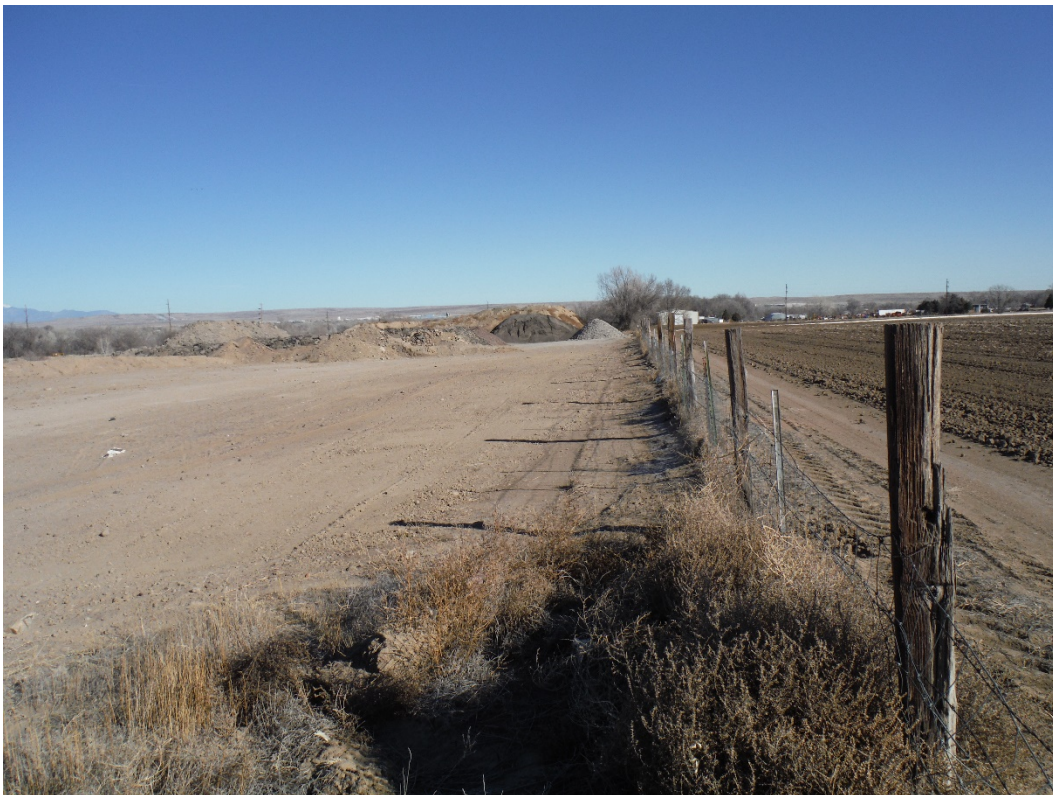
**Fig 10.** Fence line which is approximately 150 feet east of eastern permit boundary; looking north.

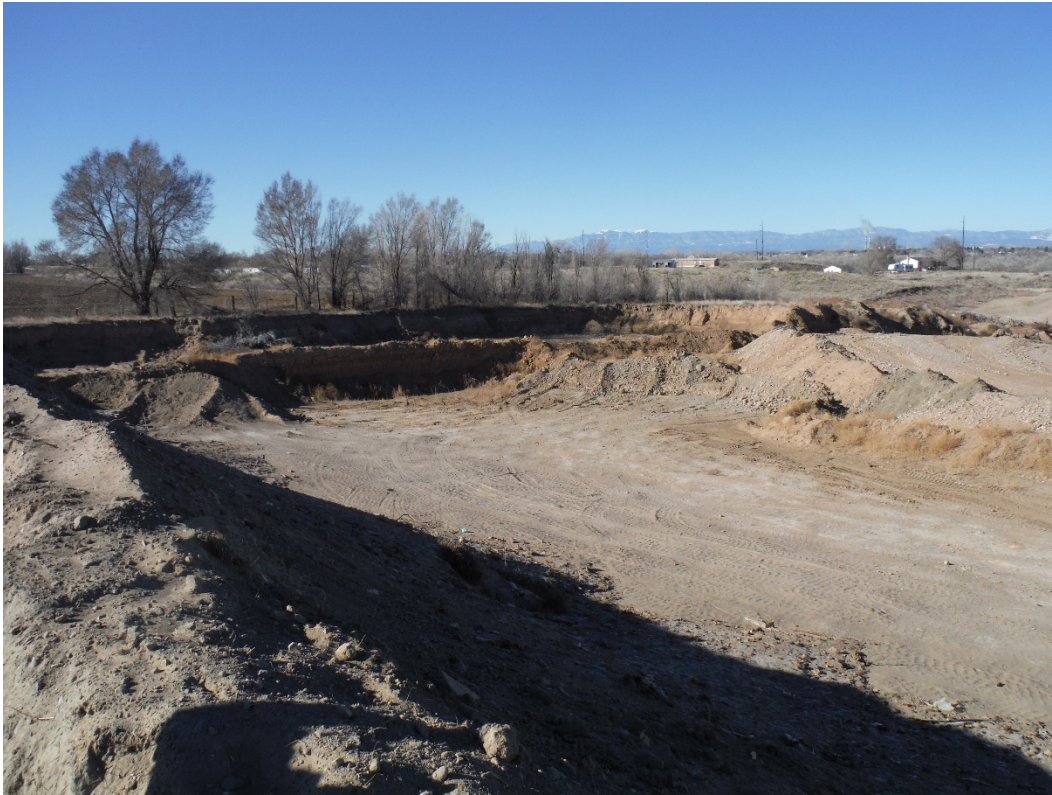
The excavation located in the southeast portion of the site was being backfilled with off-site material which Mr. Joseph stated had come from a local grading project for a new Walmart. The Division observed putrescible items within the backfilled material including woody debris, sod plugs, and trash. This backfilled material had a fluffy consistency and appeared to have not been compacted. The Operation is not authorized for backfilling of material and the material being backfilled on-site is not accordance with Rule 3.1.5(9). This has been cited as a compliance problem on page two of this report.

**Fig 11.** Southeast excavation being backfilled (lower left); looking southwest.

**CORRECTIVE ACTIONS AND DUE DATE:** The operator shall submit a revision to update and clarify the current approved reclamation plan to reflect existing and proposed backfilling activities in accordance with Rule 3.1.5(9). This revision shall also contain a plan to remove putrescible materials from the existing backfill. The corrective action due date will be determined pending the April 26-27 hearing regarding the possible violation above.

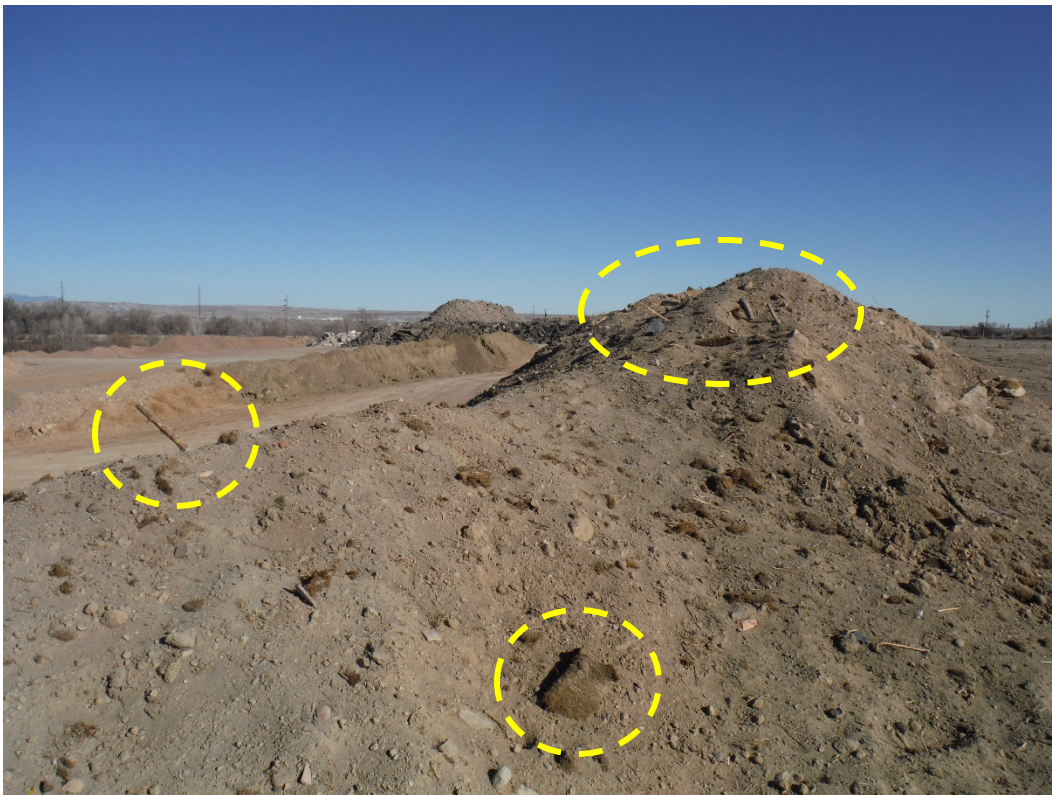
**COMPLIANCE PROBLEM:** Material containing putrescible solids has been backfilled at the site.

**Fig 12.** Backfilled material containing putrescible items; looking north.

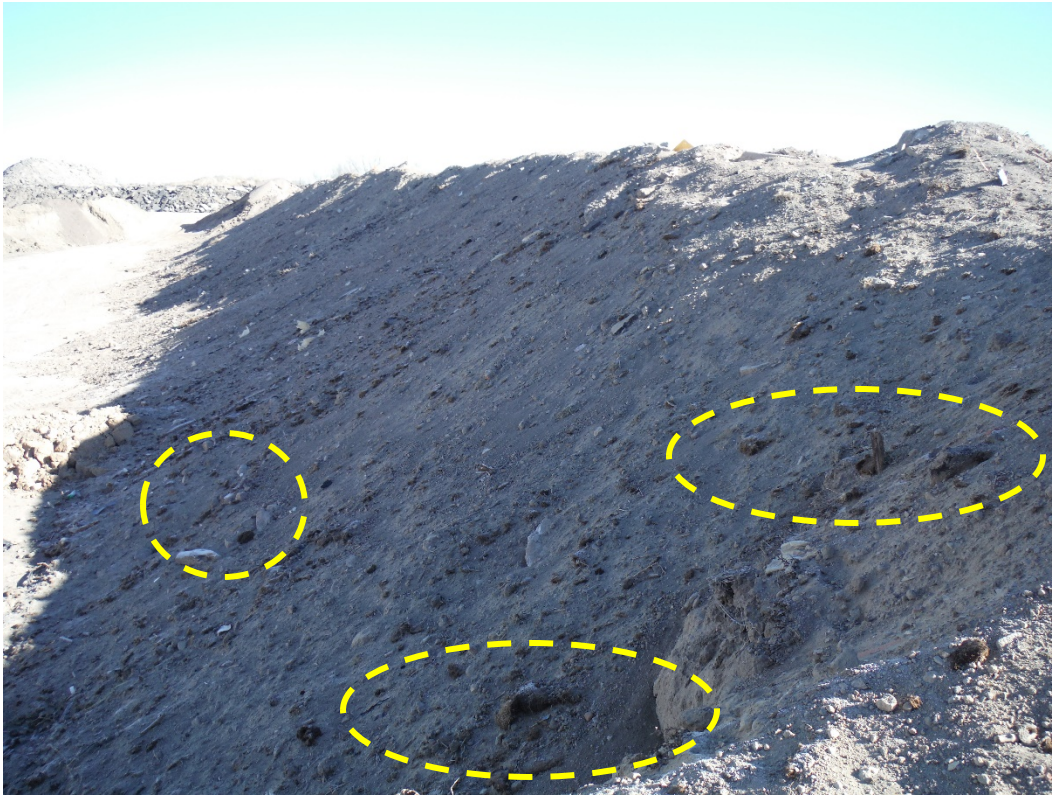
**Fig 13.** Backfilled material containing putrescible items; looking north.

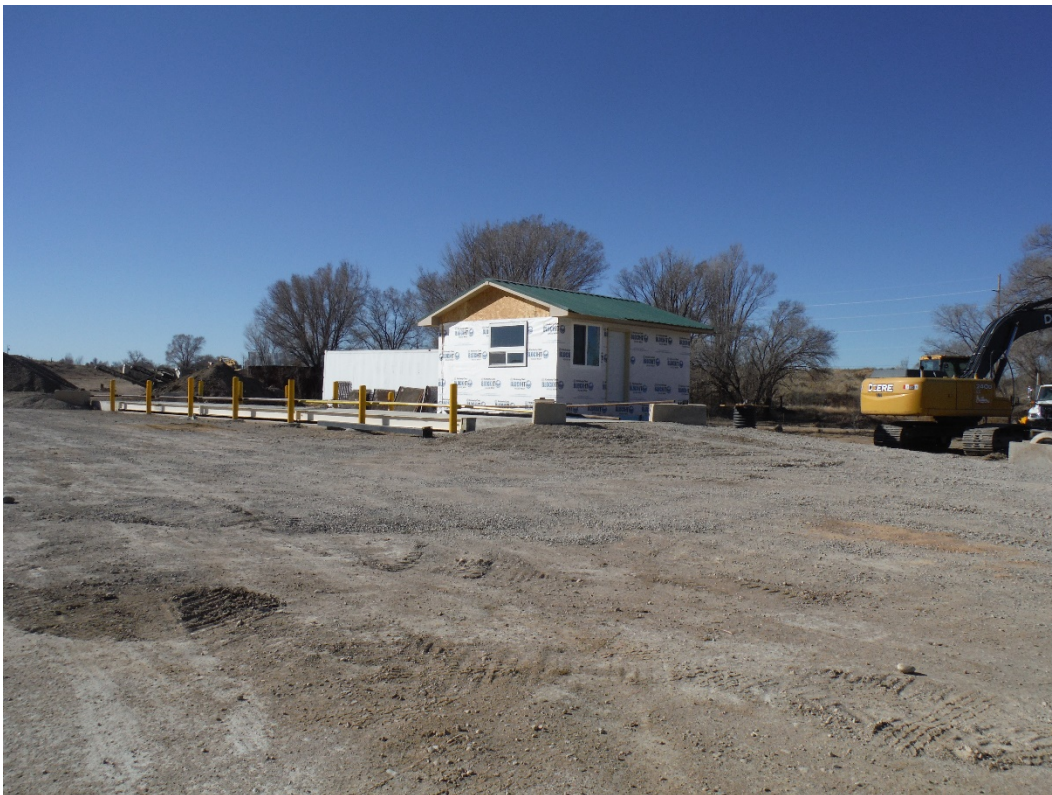
Mr. Joseph stated that the scale house, located just north of the approved permit boundary on the west side of the access road, was recently built over the last winter.

The current financial warranty held at the site is \$22,602.00. Due to the off-site disturbance, construction of a scale house, and the importation of various materials, the current bond is inadequate to cover the actual cost of reclamation. The financial warranty will be re-evaluated during corrective actions associated with the possible violation.

**Fig 14.** Recently constructed scale house located north of the permit boundary on the west side of the access road; looking south.

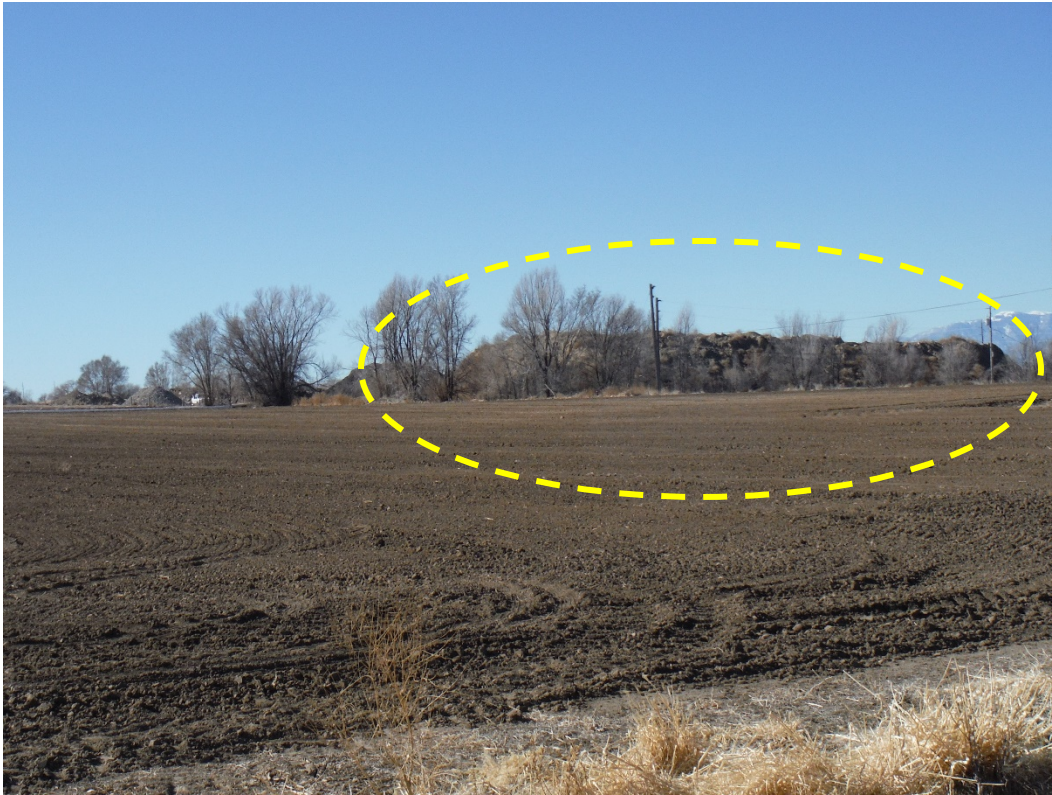
**Fig 15.** Large stockpile of imported fill dirt located in northeast portion of the site; looking southwest from US Business Highway 50.

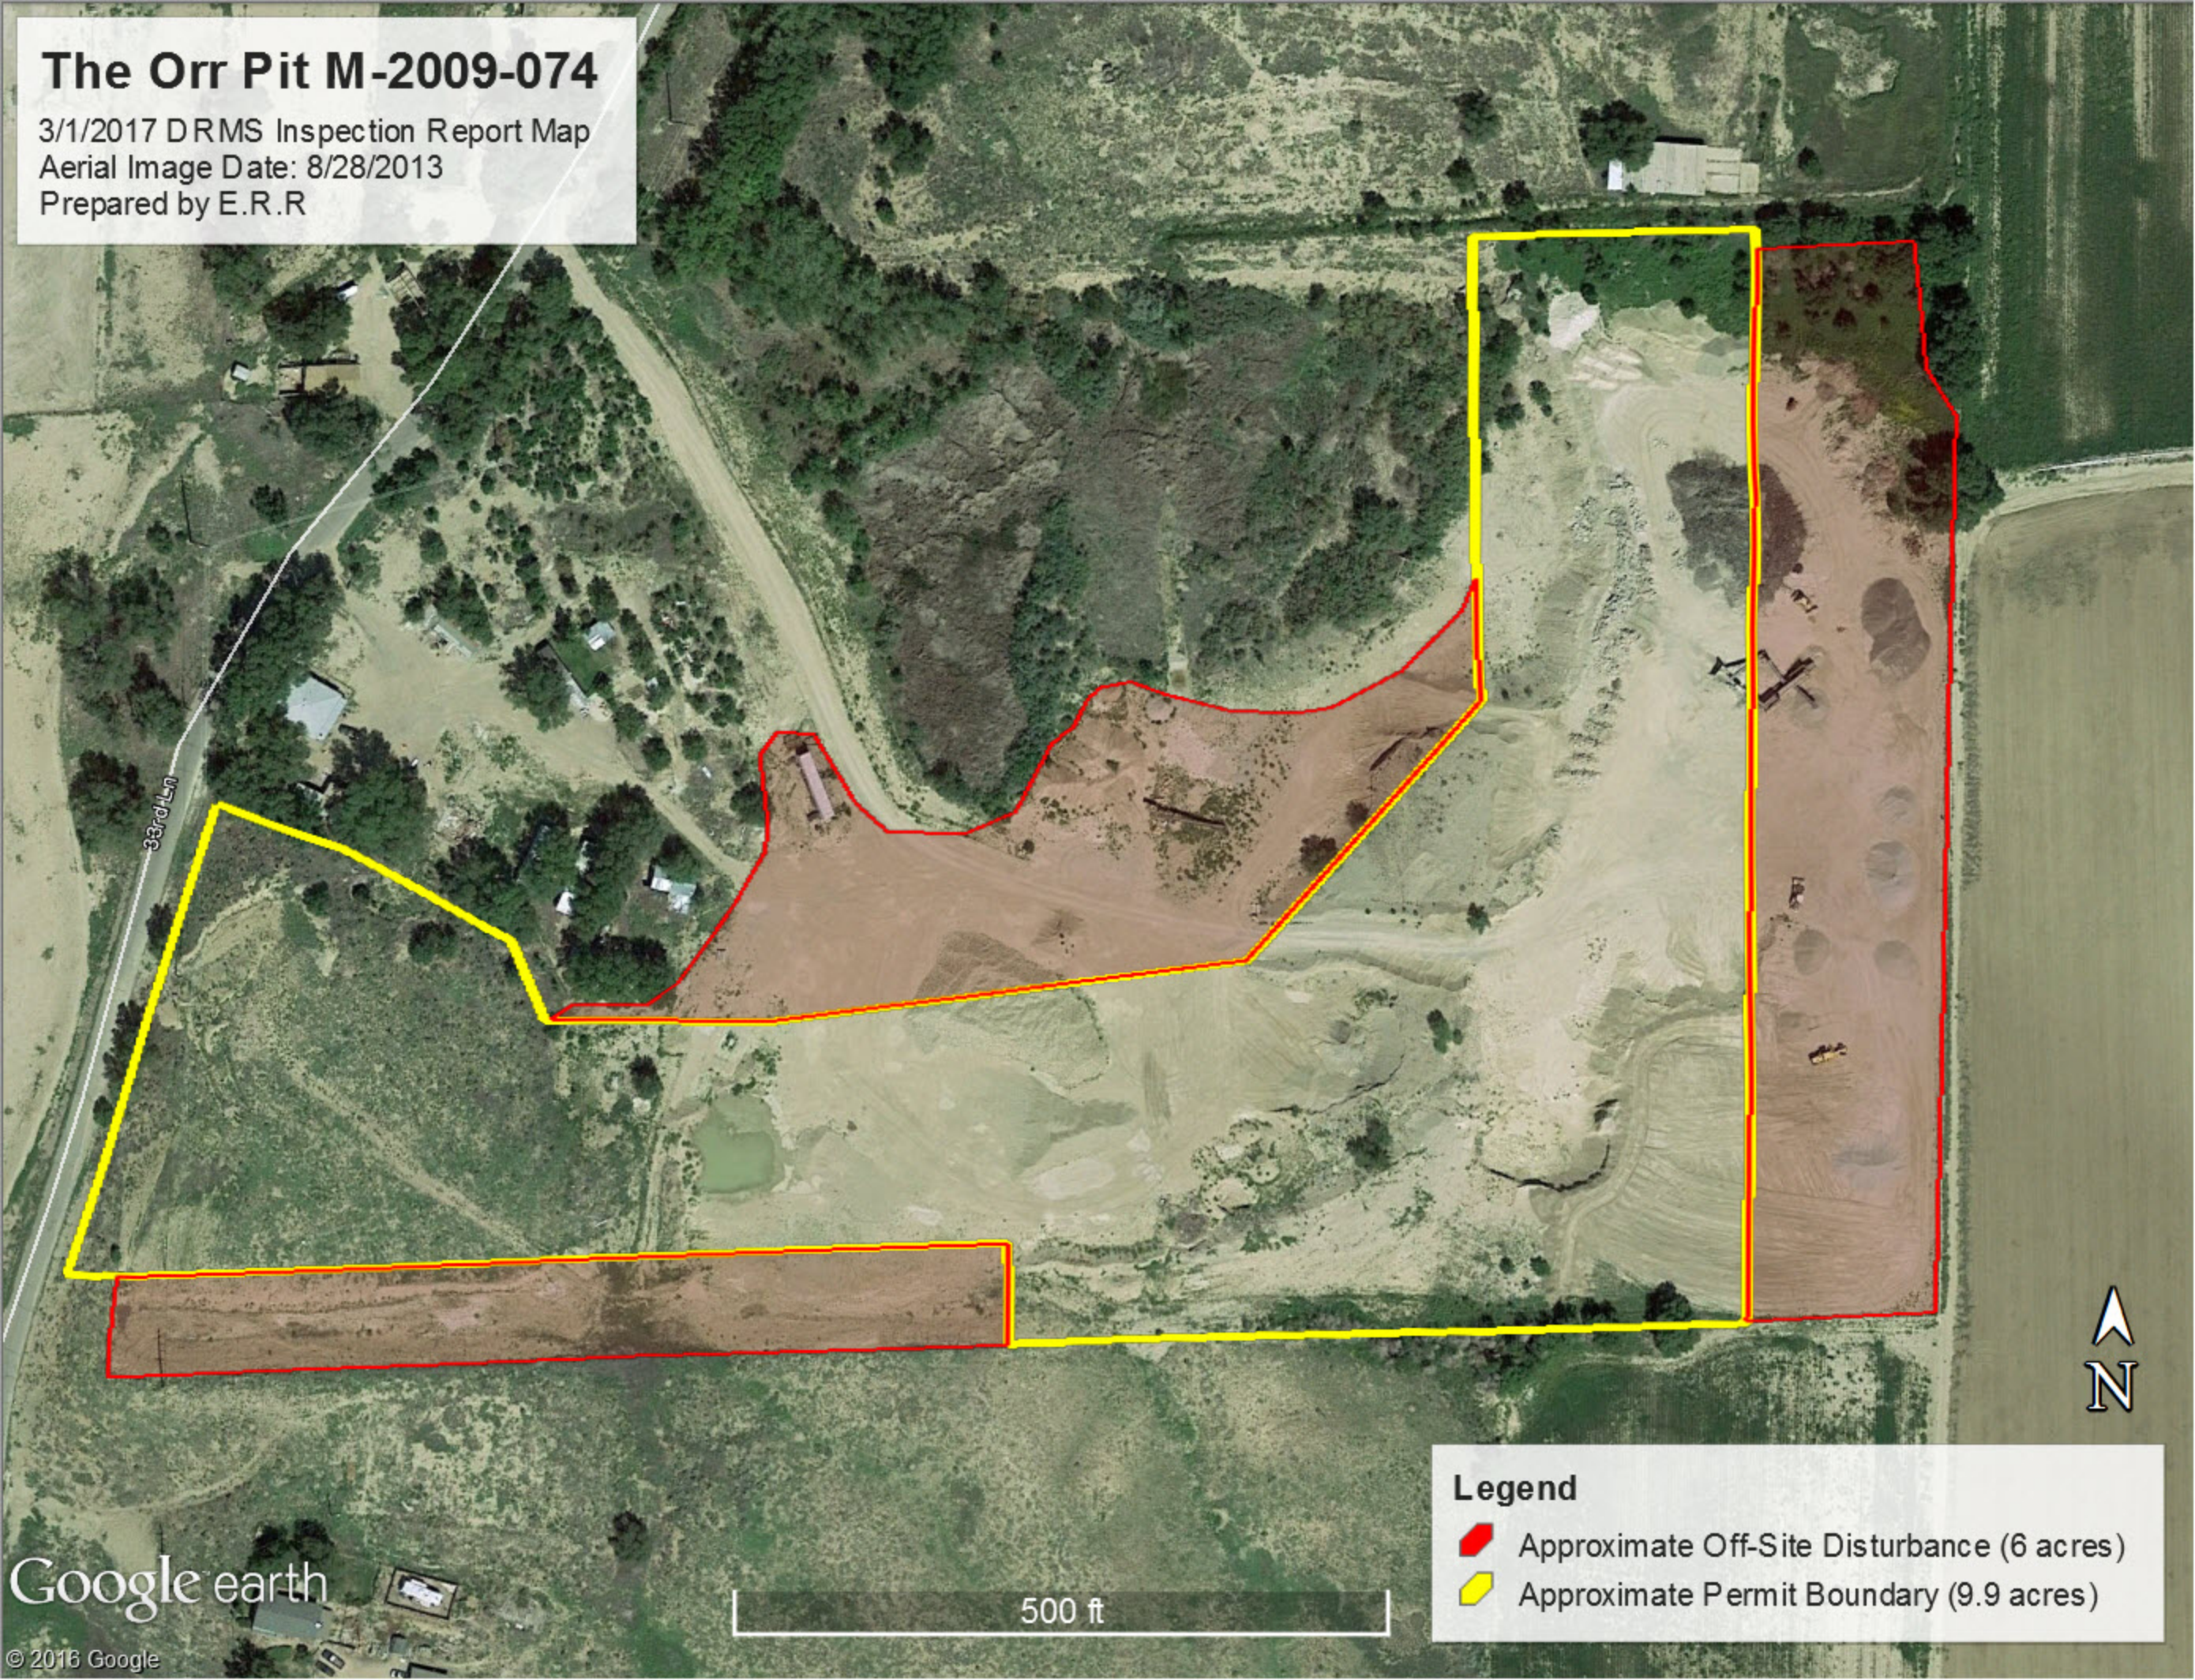
3/1/2017 DRMS Inspection Report Map  
Aerial Image Date: 8/28/2013  
Prepared by E.R.R

- Yellow line - the approximate approved permit boundary which was determined from the attached approved Mining Plan Map (*10-16-2009 Pre-Mining Map - Exhibit E-1 M-2009-074*)
- Red Line - the approximate limits of the off-site disturbance which was determined from a review of the August 28, 2013 Google Earth aerial image and the March 1, 2017 site inspection observations. This off-site disturbance includes:
  - a mined area located in the southwest of the approved permit boundary
  - scale house, processed stockpiles, and re-disturbance of the old mining disturbance located in the central portion of the site, north of the approved permit boundary
  - new disturbance and stockpiles of imported asphalt, concrete, and fill dirt located east of the east permit boundary
